HYDE END ROAD

PLANNING SUBMISSION (ARBORICULTURE)

-TREE SURVEY TO BS5837:2012
-ARBORICULTURAL IMPACT ASSESSMENT
-PROPOSED TREE RETENTION AND REMOVAL
-TREE PROTECTION PLAN &
ARBORICULTURAL METHOD STATEMENT

FLAC Instruction ref: 44-1023

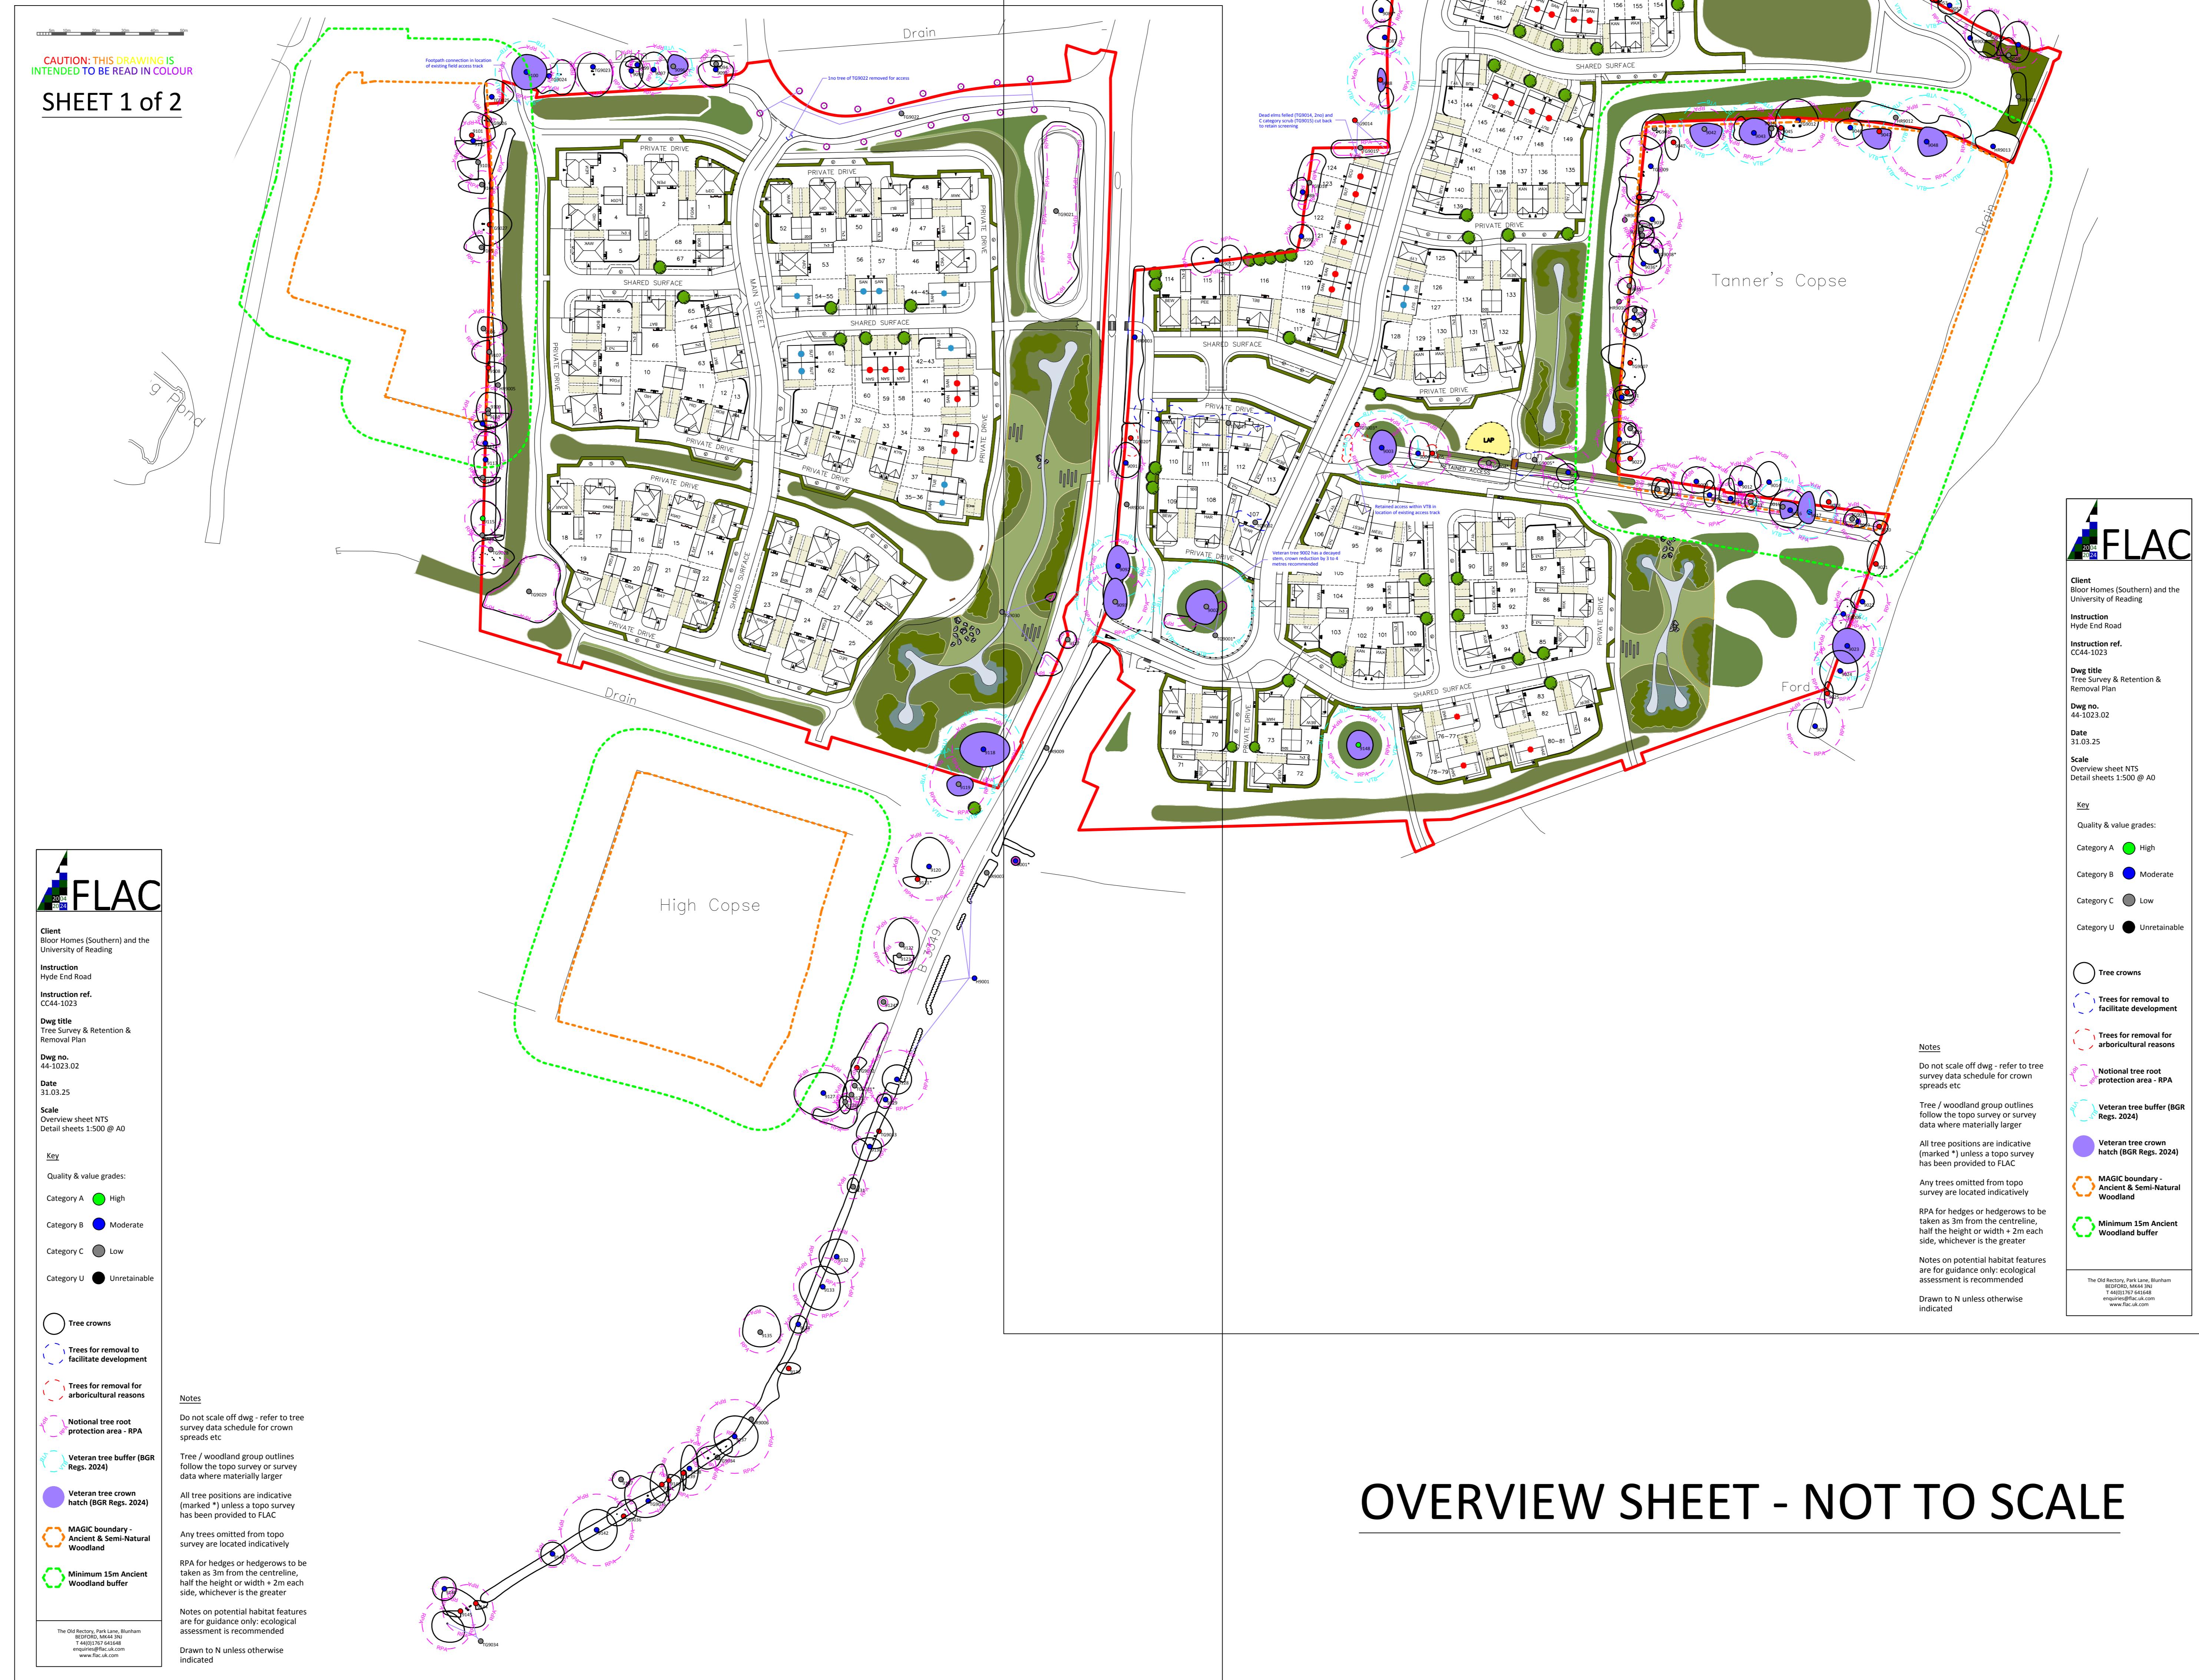
OVERVIEW SHEET - NOT TO SCALE

1.5 Tree removals to facilitate proposals are shown on the *Tree Survey and Retention & Removal Plan* project drawing ending .02, which follows. The crown coding on the plan can be cross-referenced to the Tree Survey Data Table, under the column headed *Proposal*.

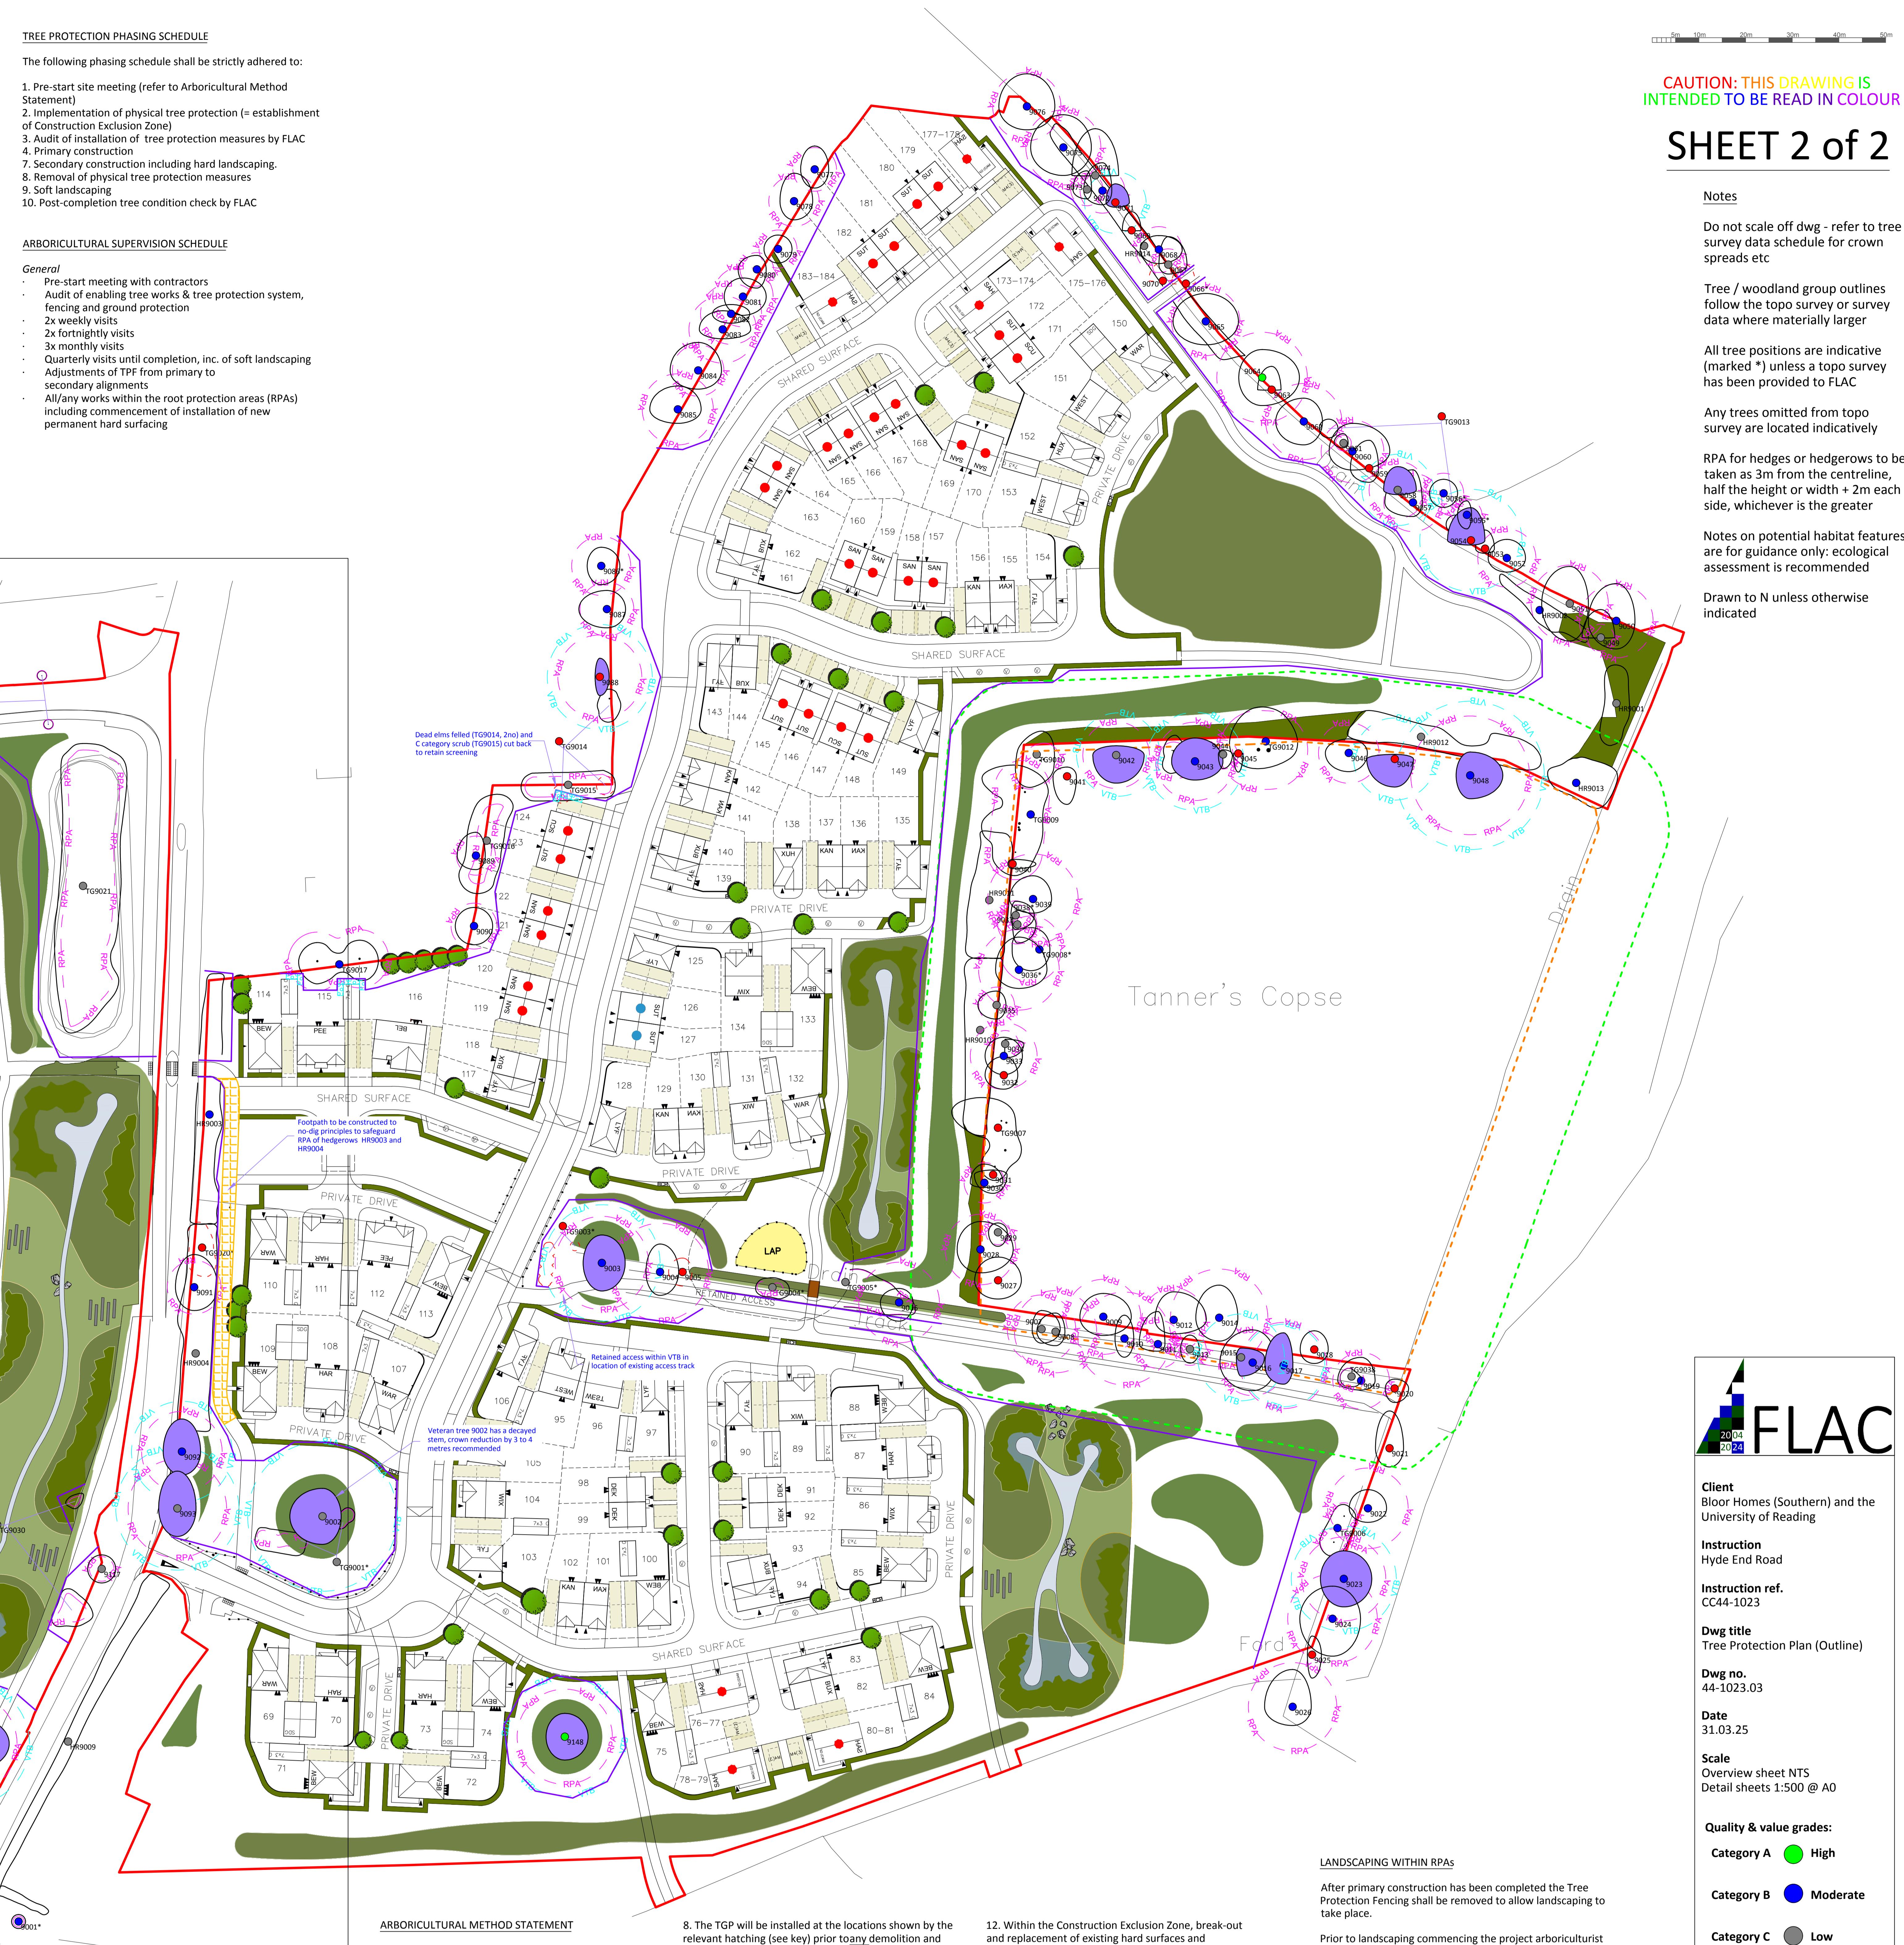
3.1 Standardised tree protection details for the development phase are provided upon our *Tree Protection Plan (Outline)* (TPP, project drawing ending .03, following) which includes an Arboricultural Method Statement, Tree Protection Phasing Schedule and an Arboricultural Supervision Schedule.

3.2 The TPP depicts the positions of tree protection fencing to separate retained trees from construction activity, in combination new permanent ground protection and temporary ground protection, a tree protection system designed in concert with the phasing and supervision schedules to deliver tree protection throughout the construction process.
