## Bat Emergence Surveys (BERS)

11 Old Bath Road, Sonning, Reading, Berkshire, RG4 6SZ

“The construction of a side and front extension with the roof being raised on the existing building, and the construction of a new build in the garden”

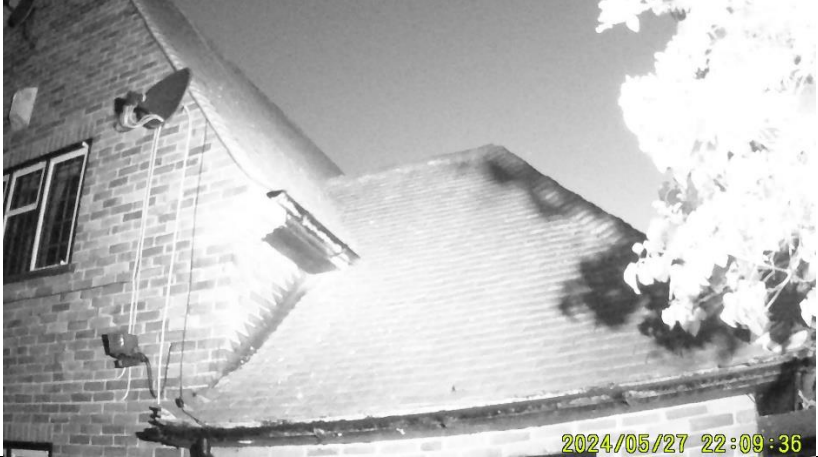
| <i>Surveyor 1</i> | | First activity at 21.15 a soprano pipistrelle (SP) was heard not seen. At 21.21 an SP passed across the east elevation towards the north. At 21.22 an SP flew from the rear garden around the South | | | | N/A | |

| | elevation towards the front of the property. At 21.22 an SP came from the front of the property around the side of the building and went East. At 21.23 what is thought might be a re-entry was a pass by an SP. There was foraging activity in the back garden by a CP at 21.32/33. Last bat heard was a Noctule at 22.10 | |
| <i>IR position</i> | The footage reflected the view of surveyor 1. | |

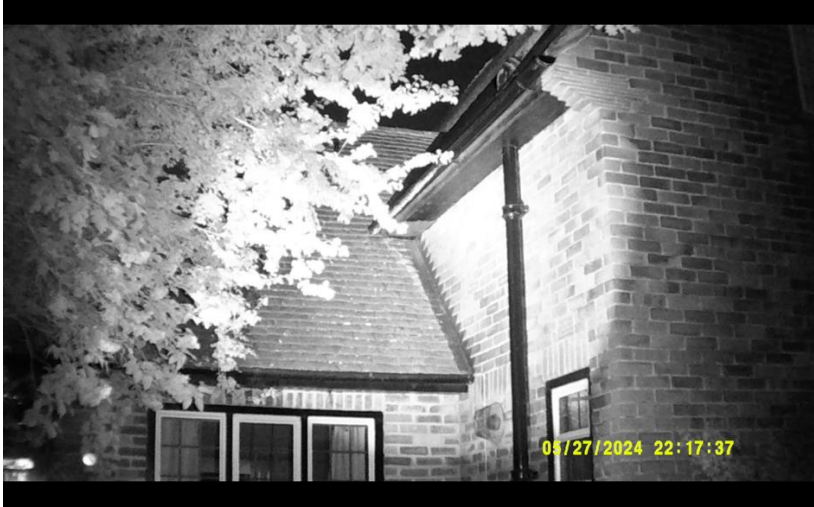
| <i>Surveyor 2</i> | First bat activity noted was a common pipistrelle at 21:22 that was seen foraging around the south-east elevation of the house. from 21:23 to 22:14, noctules, soprano pipistrelles, and common pipistrelles could be heard and not seen, and at 21:28 and 21:33, common pipistrelles were seen around the south-east elevation commuting and foraging. the last bat activity noted was an unseen noctule at 22:14. | N/A |

| <i>IR position</i> | The footage reflected the view of surveyor 2. | |

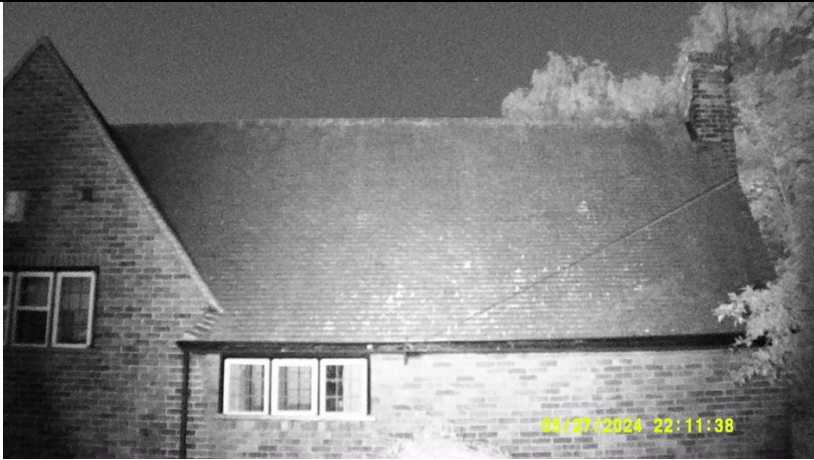
| <i>Surveyor 3</i> | From 21:23 to 21:47, soprano & common pipistrelles could be seen foraging in the front garden, with one BLE passing in front of the IR and at 21:27. Last bat activity noted was an unseen noctule at 22:10. | N/A |
| <i>IR position</i> | The footage reflected the view of surveyor 3. | |

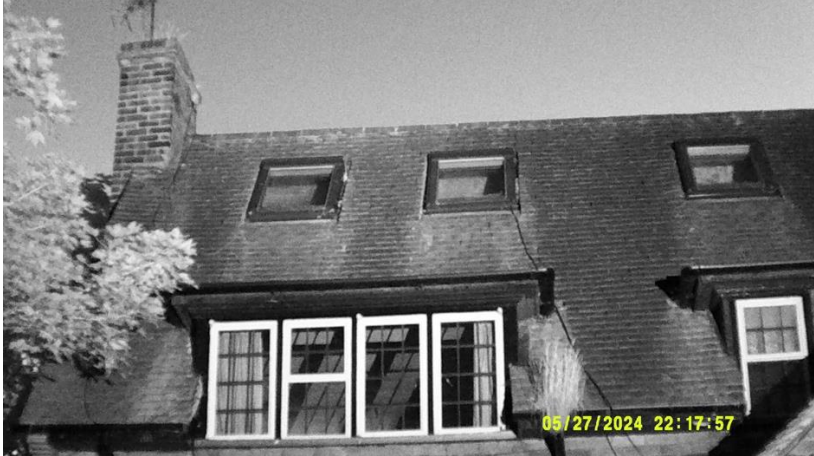
| <i>Surveyor 4</i> | <p>First activity was a soprano pipistrelle heard not seen at 21:14. There was constant soprano pipistrelle activity between 21:14 and 21:46, either heard not seen or commuting and feeding around the garden and passed the house to the east. Common pipistrelles were seen at 21:32, feeding over the garden and passed the house to the east. A noctules was seen commuting high above the property at 21:23 and 21:28. They were also heard not seen between 21:58 and 22:13 which was the final activity noted.</p> | N/A |
| <i>IR position</i> | <p>The footage reflected the view of surveyor 4.</p> | |
