# Preliminary Roost Assessment

The Coach House, Chapel Green, Wokingham RG40 3EP

This report is prepared to inform a planning application with Wokingham Borough Council. Householder application for the proposed erection of a single storey side extension with porch canopy roof.

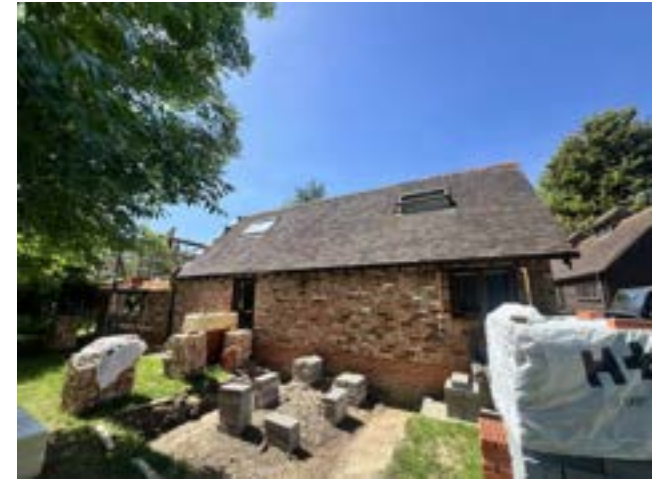
*Building B1*

The building is a residential dwelling constructed with brick walls in good condition. The roof comprises clay tiles, with the eastern elevation featuring mostly tight-fitting tiles and a small number of raised areas, while the western elevation has older, more raised reclaimed tiles. Raised tiles on the eastern roof elevation present suitable roosting habitat for crevice-dwelling bats, though no bat evidence was observed. Other components, including the eaves, window frames, and door frames, were in good condition and did not present suitable roosting features or access points. Only the eastern elevation of B1 will be affected by the proposed works, a classification of **low** has been given for suitability for roosting bats.

One bat emergence/re-entry survey is required on B1 during the active bat season (May – September) to confirm presence/likely-absence of bats roosting in or on the building.

Two survey positions are required to provide full coverage of the building's elevations to look for emerging/re-entering bats. An infrared camera should also be employed as part of the survey to see where any specific roost locations are located.

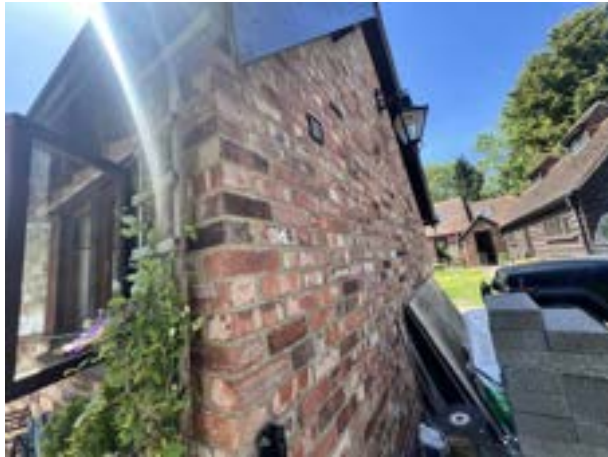
| Feature | Materials/Details | Condition / description / suitability | Photograph |
|---|---|---|---|
| Walls | Brick | <p><b>Condition/description</b><br/>The walls were in a uniformly good condition. No gaps or cracks were observed.</p> <p><b>Suitability/access/evidence of bats</b><br/>No suitable roosting features were recorded across the walls of B1. No evidence of bats observed.</p> | <p><i>B1 walls</i></p> |

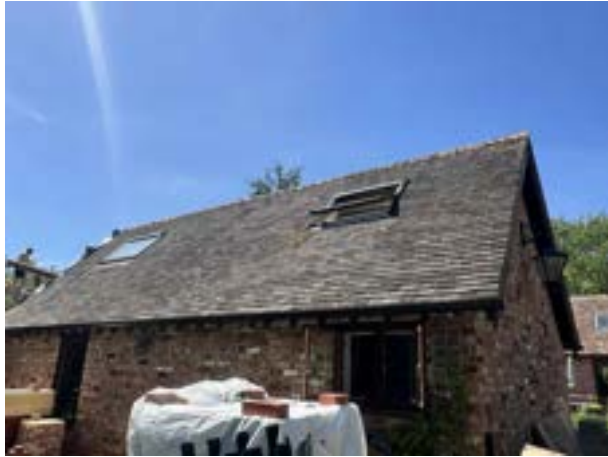
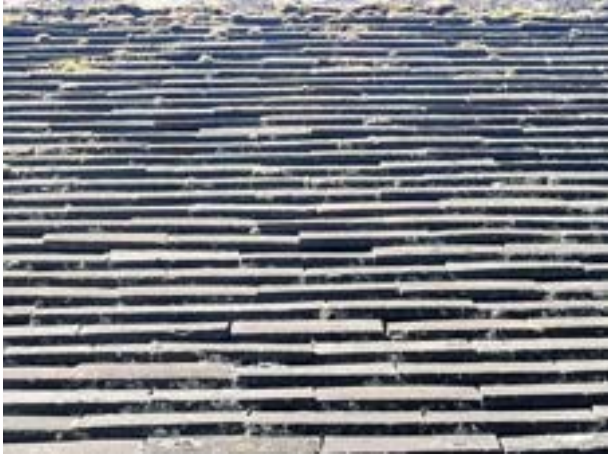
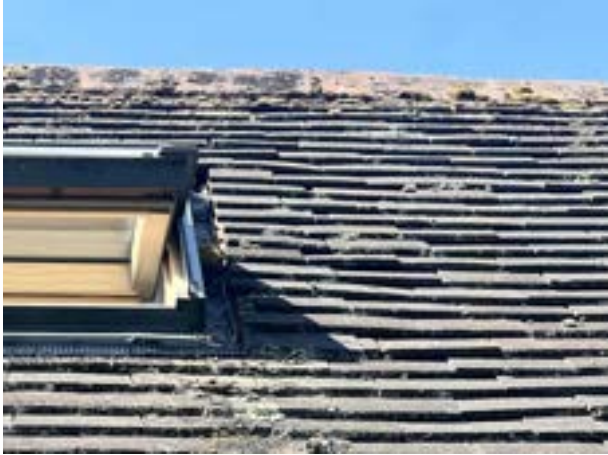
| Feature | Materials/Details | Condition / description / suitability | Photograph |
|---|---|---|---|
| Roof | Clay tiles | <p><b>Condition/description</b><br/>The clay tiles on the roof of B1 were in a mixed condition. The eastern roof elevation comprises tiles which are mostly tight-fitting with a small number of raised tiles. The western elevation of the roof of B1 featured older tiles which presented more raised tile areas, owing to the reclaimed nature of the tiles used. Only the eastern elevation of B1 will be affected by the proposed works.</p> <p><b>Suitability/access/evidence of bats</b><br/>Raised tiles present suitable roosting</p> | <p><i>B1 roof</i></p> |

| | | habitat for crevice-dwelling bats. No evidence of bats observed. | <p><i>B1 roof</i></p> <p><i>B1 roof</i></p> |

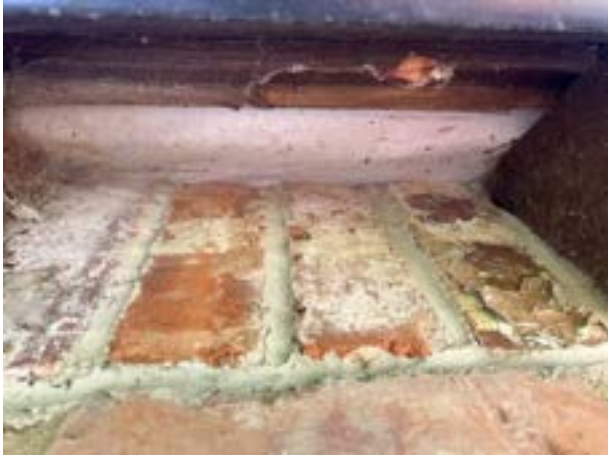
| Eaves | Overhanging | <p><b>Condition/description</b><br/>The eaves were overhanging over the walls of B1. The eaves were in a good condition, featuring no gaps, cracks, or points of access.</p> <p><b>Suitability/access/evidence of bats</b><br/>No suitable roosting features observed. No evidence of bats observed.</p> | <p><i>B1 eaves</i></p> |

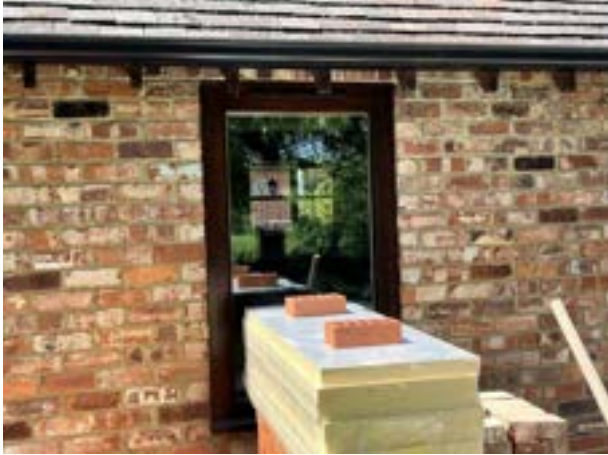
| Windows | Timber and metal | <p><b>Condition/description</b><br/>The windows and doors were in a uniformly good condition, fitting tightly to adjoining frames and brickwork.</p> <p><b>Suitability/access/evidence of bats</b><br/>No suitable roosting features recorded. No evidence of bats observed.</p> | <p><i>B1 window / doors frames and lintels</i></p> |

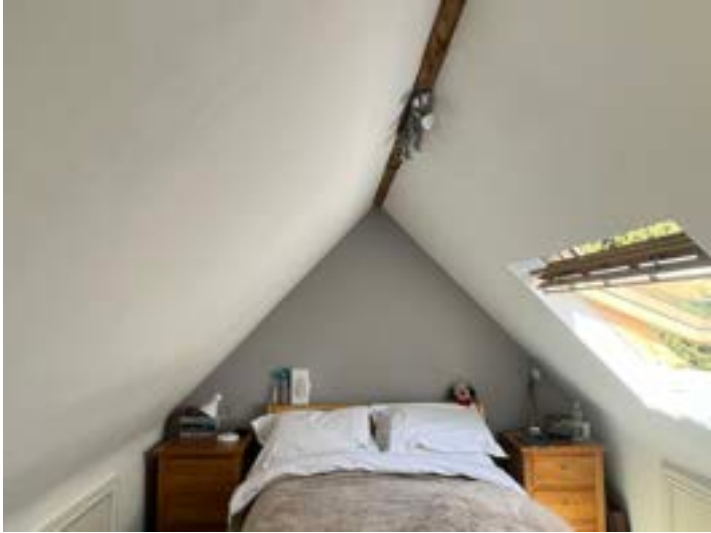
| Loft space | N/A | The loft space of B1 has been fully converted, presenting no suitability for roosting bats. | <p><i>B1 internal space</i></p> |

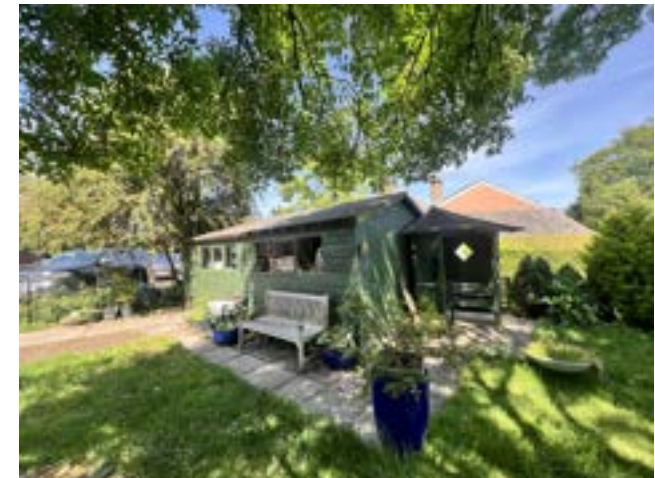
*Building B2*

The building is a timber shed located in the north corner of the site. Its construction, being a simple, well-sealed structure with no discernible voids or crevices, offers no suitable roosting opportunities for bats. Furthermore, the single-skinned nature of this building exposes the internal structure to unstable fluctuations in temperature and humidity. The building has **negligible** habitat value.

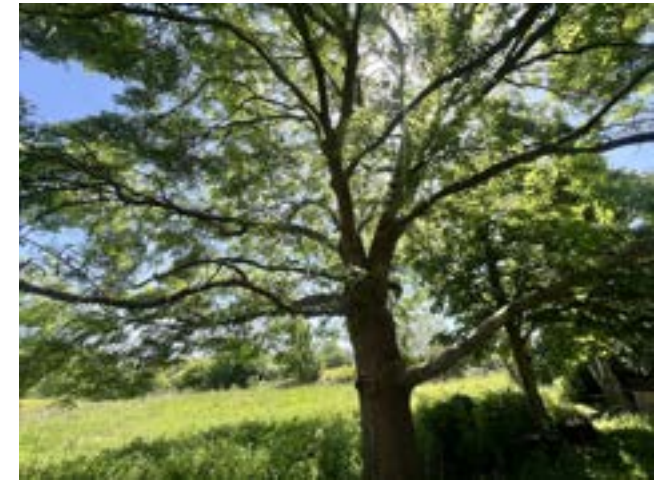
*Scattered trees; T1*

T1 is a common ash located at SU 81284 67508. The tree has a DBH of 75cm.

No roosting features were identified for this tree.

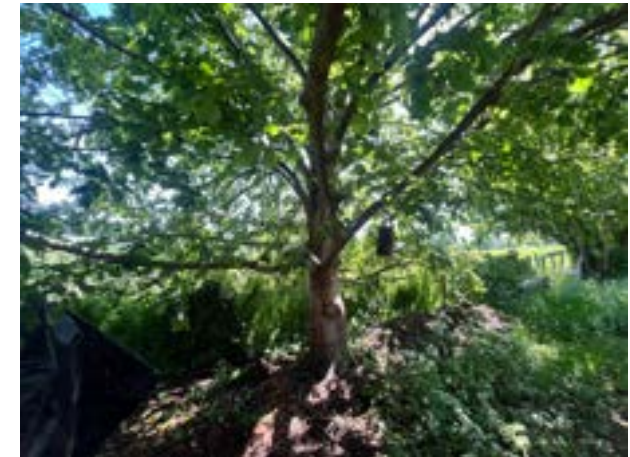
*Scattered trees; T3*

T3 is a common lime located at SU 81282 67492. The tree has a DBH of 18.8cm.

No roosting features were identified for this tree.

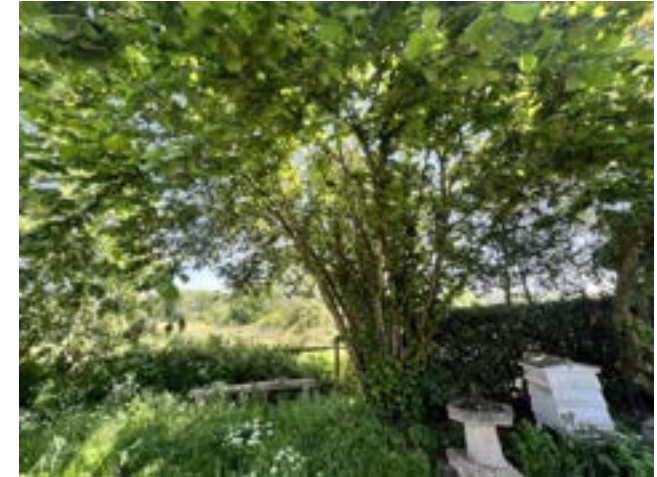
*Scattered trees; T4*

T4 is a common hazel located at SU 81280 67483. The tree has a DBH of 18.8cm.

No roosting features were identified for this tree.
