# HERITAGE STATEMENT

## High Barn, Wokingham Road, Hurst

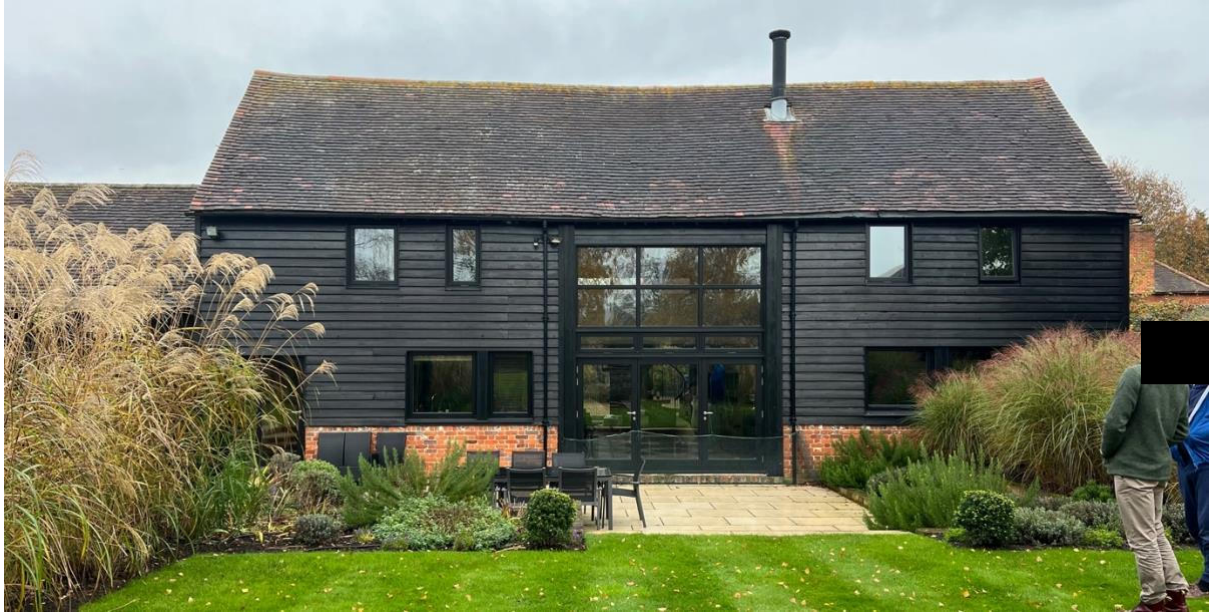
The buildings were in a derelict state in the early 1980’s (see photo below) when consent was gained to convert them into dwellings. The work was completed by the mid 1980’s. The photo above shows the south elevation today.

All that remains of the historic fabric of the barn is the original timber frame which is a mix of elm and oak. This appears to be largely intact and is exposed internally. During the conversion, the frame was wrapped with plasterboard and PIR insulation board, before being clad with timber shiplap boarding and stained black. The plinth wall appears to have been rebuilt at this time.

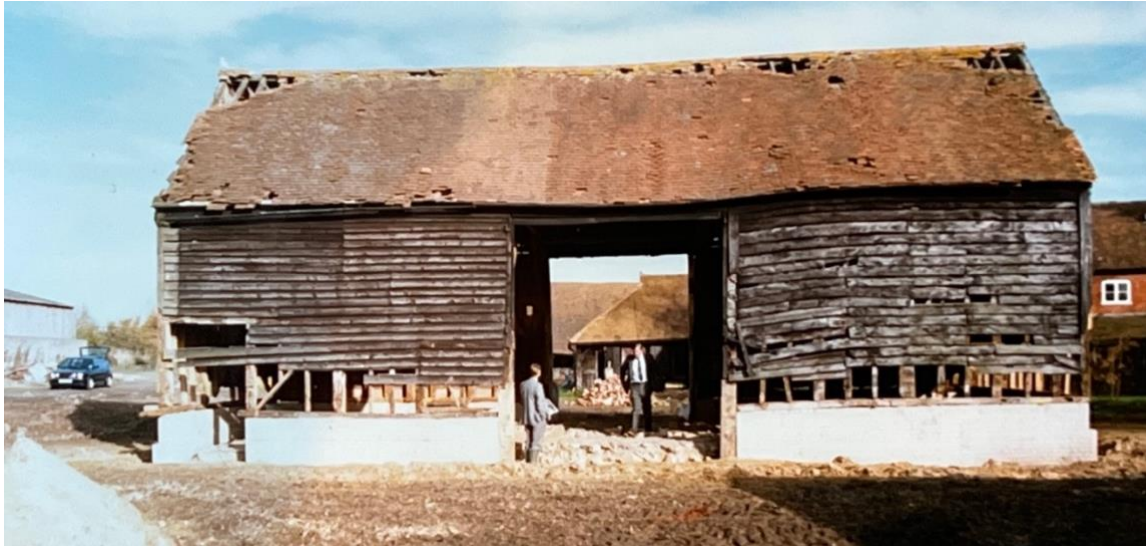
Photo of high Barn in the early 1980's, before work commenced

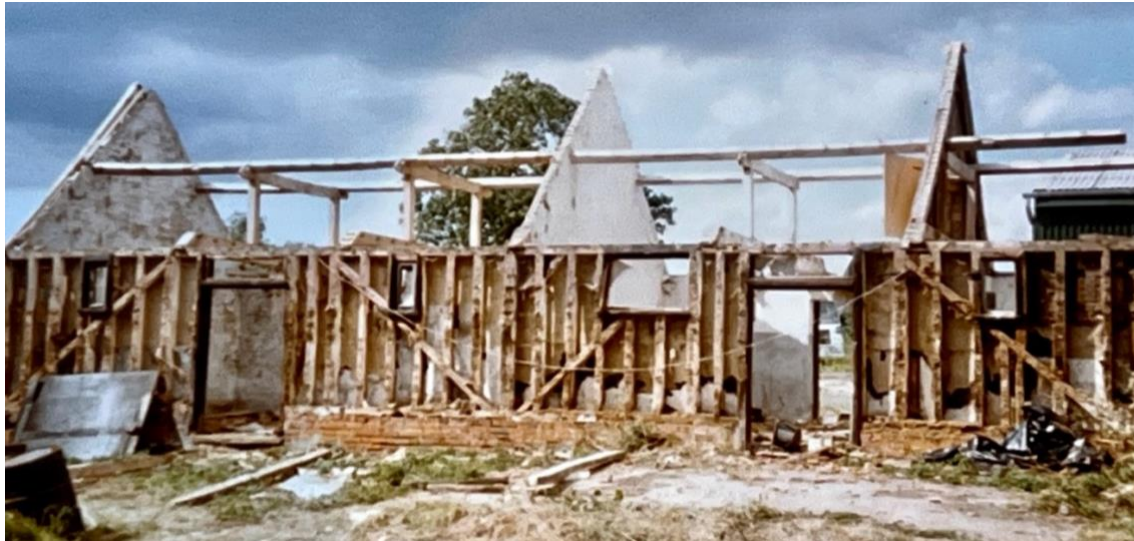
South side during renovation works, mid1980's.

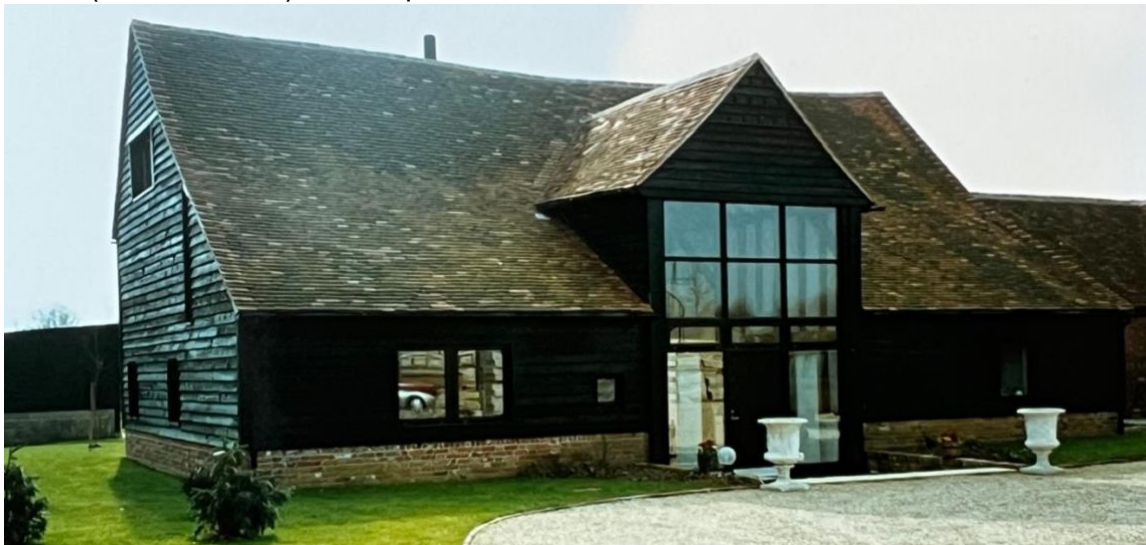
North (entrance side) on completion, mid 1980's.

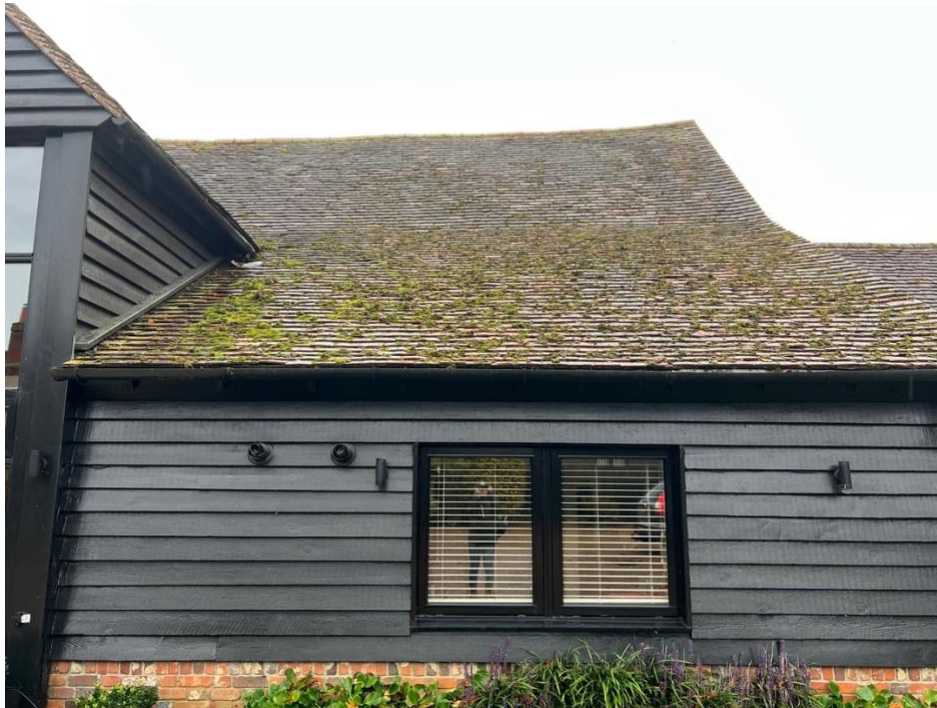
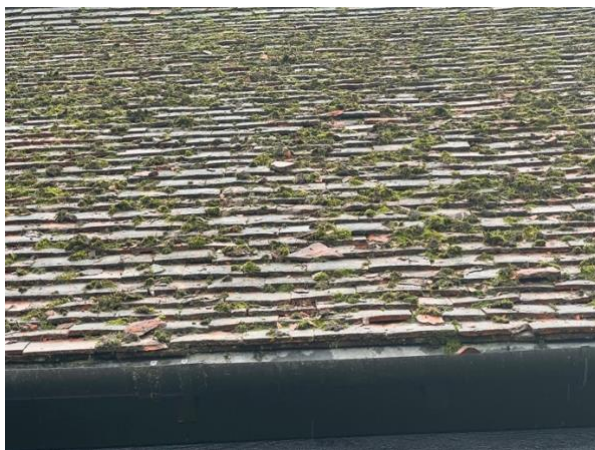
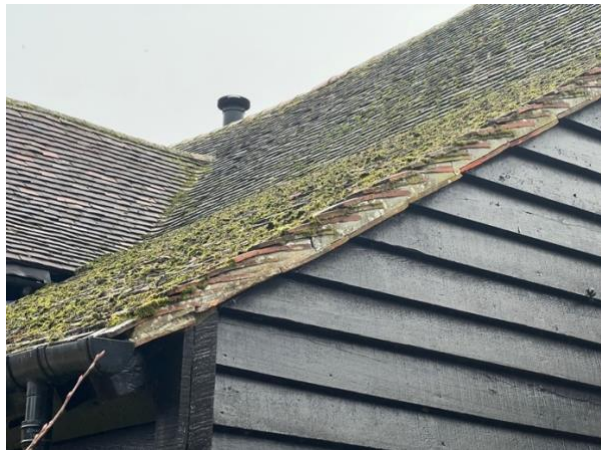
There is an excess of moss to the north side of the roof, particularly to the lower section. In addition, many of the tiles have spalled and disintegrated and are regularly collecting in the gutter, causing blockages. There is now concern that these failures could potentially lead to a breach of the tiled covering. The current owner of the barn is keen to address any maintenance issues, and therefore wishes to replace the northern slope in its entirety with new, handmade, plain clay tiles retaining all existing detailing.

In addition to replacing the tiles, the owner is keen to upgrade the existing cast aluminium rainwater goods with a larger diameter gutter and downpipes of similar material and appearance. This will be designed to cope with anticipated future rainfall.

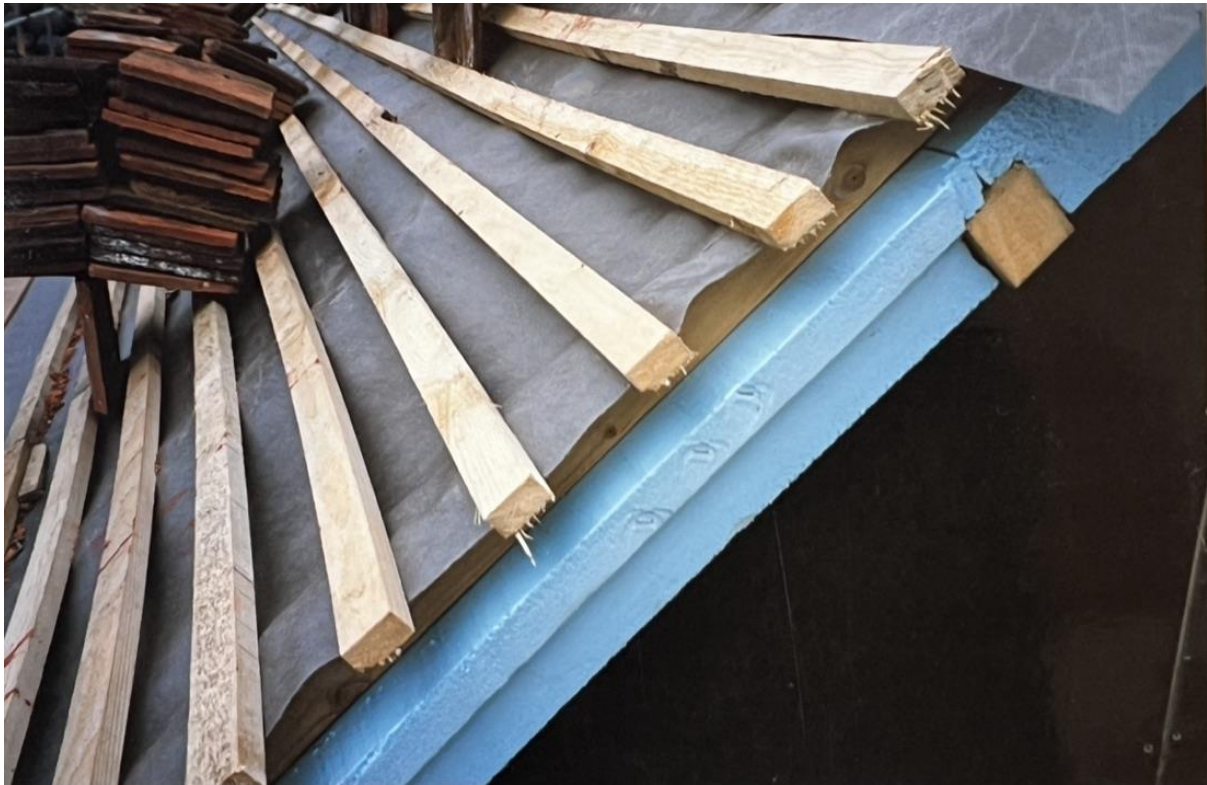
The roof was insulated during the 1980's renovation with "Roofmate" expanded polystyrene (XPS) panels of 120mm thick, laid over the rafters. This appears to be sound when inspected from the underside, forming a continuous airtight layer due to its tongued and grooved edge connections. The historic timbers are exposed on the internal face and can be inspected. Whilst the XPS system is not necessarily the material of choice today, it appears to have no detrimental effect on the frame and

Below: Photo from the 1980's showing the build up of XPS insulation boards laid over the rafter, as viewed from the verge.

provides a good level of energy efficiency. It is therefore suggested that the XPS panels remain in place when the roof tiles are renewed.
