PROJECT: PARCEL 4&5, HOGWOOD FARM, WOKINGHAM

PROPOSAL: INTERNAL ESTATE ROAD LAYOUT

CLIENT: JNP GROUP & CALA HOMES THAMES LTD
REPORT REF: 2025/018/0570-02

COMBINED STAGE 1 & 2 ROAD SAFETY AUDIT

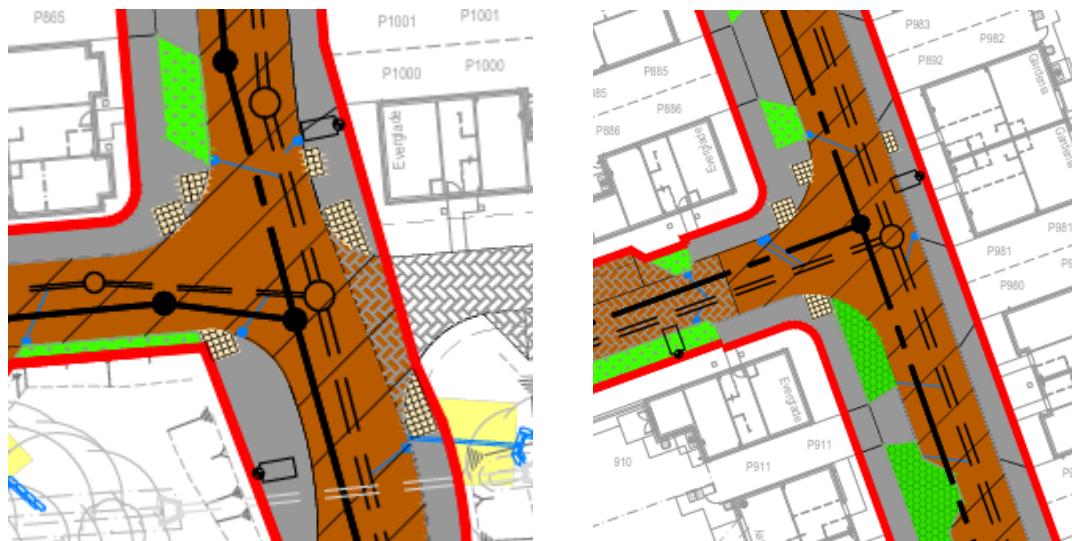
Problem 2

Location: Junction of four roads (with tactile paving shown at all four corners)

Summary: Pedestrian to vehicle collisions

The alignment of the pedestrian crossing points at the arms of the junctions are staggered with each crossing aligned diagonally in relation to each other. This may encourage pedestrians to change direction mid-crossing and may cause confusion to pedestrians with visual impairments.

The pedestrian crossings are also located at the mouth of the junction, at its widest point, which in our experience, directing pedestrians across the mouth of a junction, as opposed to inset, leads to poor implementation of tactile paving with often small sections of paving becoming dislodged or damaged over time resulting in a trip hazard for pedestrians.

Recommendation

It is recommended the pedestrian crossing are aligned to provide straight, continuous routes across the carriageway in accordance with Inclusive Mobility (DfT) and Manual for Streets to minimise confusion, in particular for those who are visually impaired.

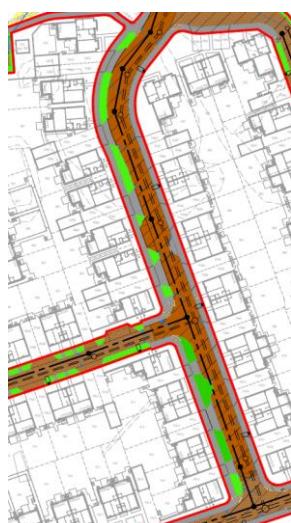
Problem 4

Location: Road Number 1

Summary: Increased risk of pedestrian and vehicle collisions

Road 1 within the development is approximately 70m in length from P881 to its junction with Road 13. With only a small build-out to control vehicle speeds to 20mph. The straight alignment and absence of significant speed-reducing measures may encourage higher approach speeds, particularly in the absence of speed enforcement or strong visual cues to slow drivers down.

Recommendation

It is recommended that additional horizontal and/or vertical measures are proposed to attain a design speed of 20mph.

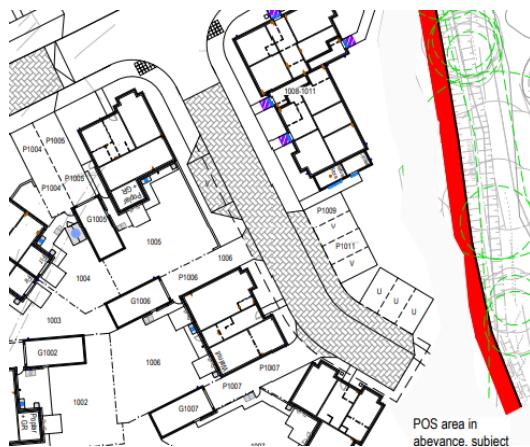
Problem 5

Location: Road 2

Summary: Risk of junction pull out type collisions as a result of vehicles reversing out onto the highway as turning facilities have not been provided.

The absence of a designated turning facility at the end of Road 2 could result in vehicles reversing a distance of 50m in a shared space environment and onto the main spine road through the development. Vulnerable road users, such as pedestrians and cyclists, will be at increased risk due to reduced driver awareness. Driver visibility of oncoming vehicles at the junction will also be reduced as a result of a vehicle leaving in a reverse gear risking junction pull out type collisions.

Recommendation

It is recommended that formal turning facilities appropriate for the largest vehicle requiring regular access are provided.

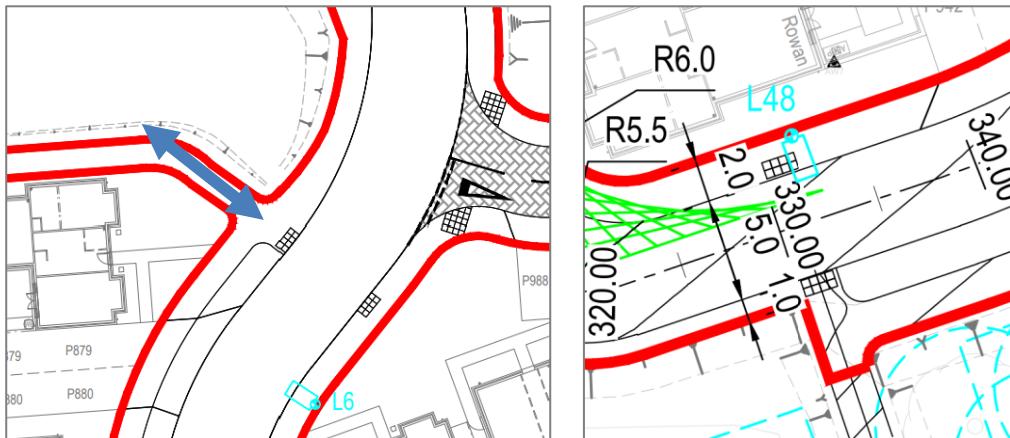
Problem 6

Location: Pedestrian crossings to the north of P879 and South of Plot 942

Summary: Risk of pedestrian stepping unawares into the highway carriageway

Where the tactile paving is too shallow, visually impaired pedestrians with larger strides, or those moving at speed, may overstep the tactile surface current positioned inline, without receiving the necessary tactile cue, and step out into the highway carriageway unexpectedly, increasing the risk of being struck by a vehicle

Recommendation

It is recommended that the tactile paving is extended to a minimum depth of 1.2m for these inline crossings in accordance with current standards and guidance to ensure effective warning for all users, especially those with visual impairments.

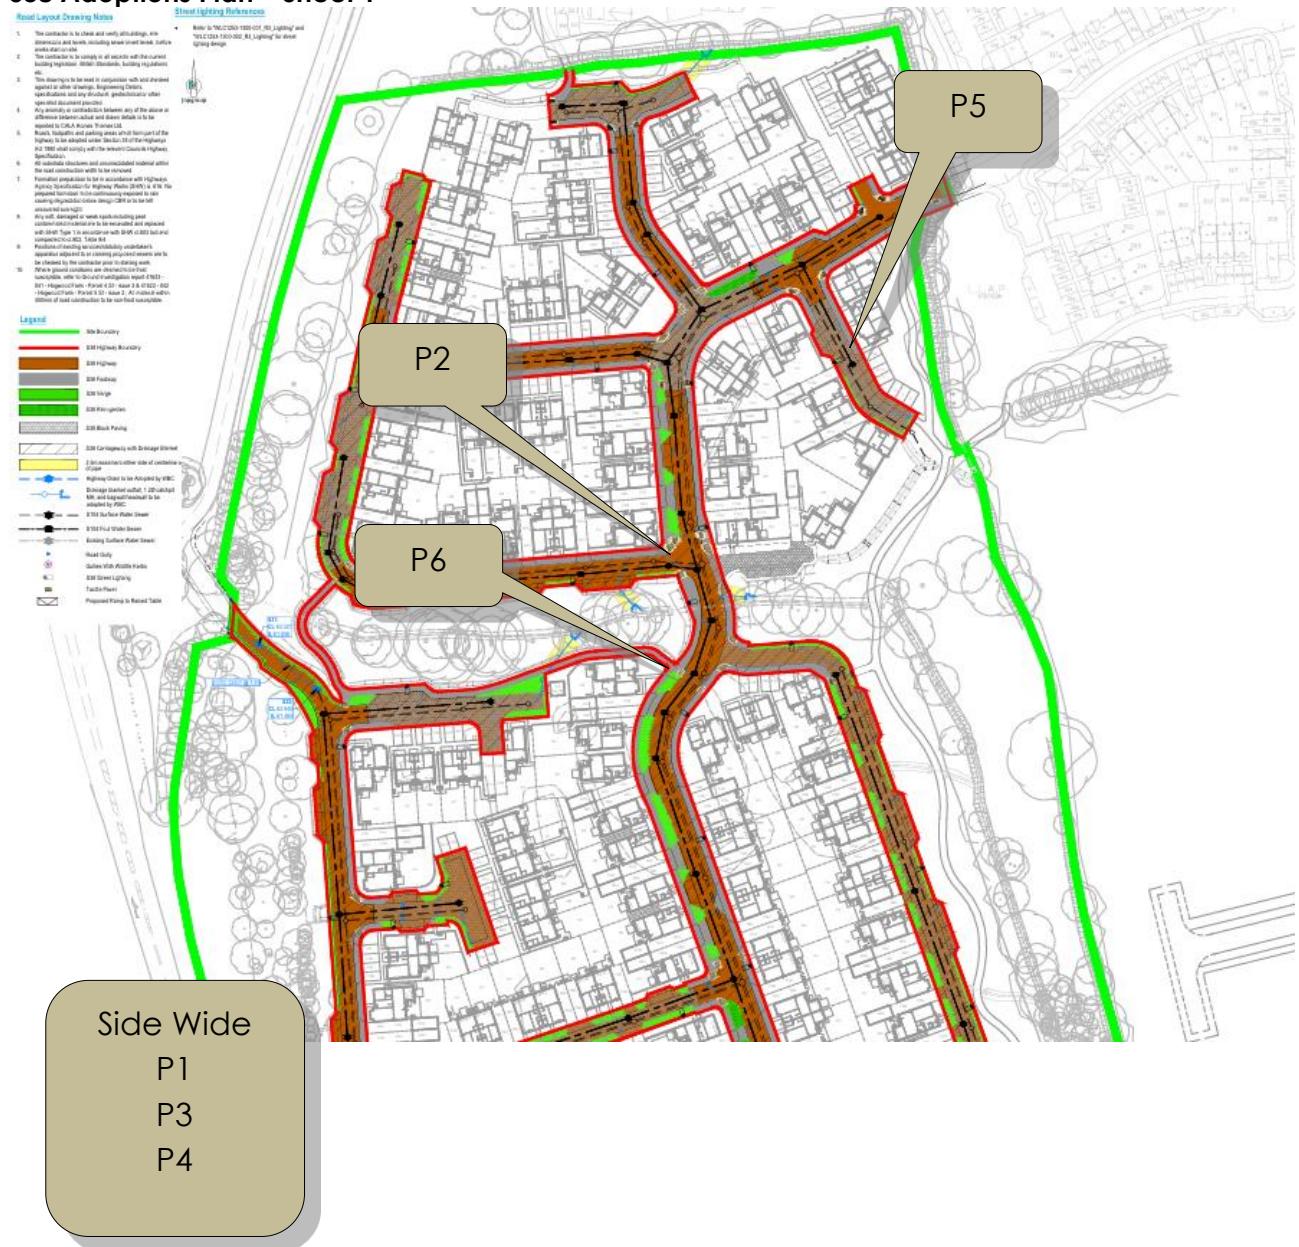
S38 Adoptions Plan – Sheet 1

Appendix C – Problem Identification Plan
