# **BAT MITIGATION STRATEGY**

**Heriots, Wokingham Rd,  
Hurst, RG10 0RX**

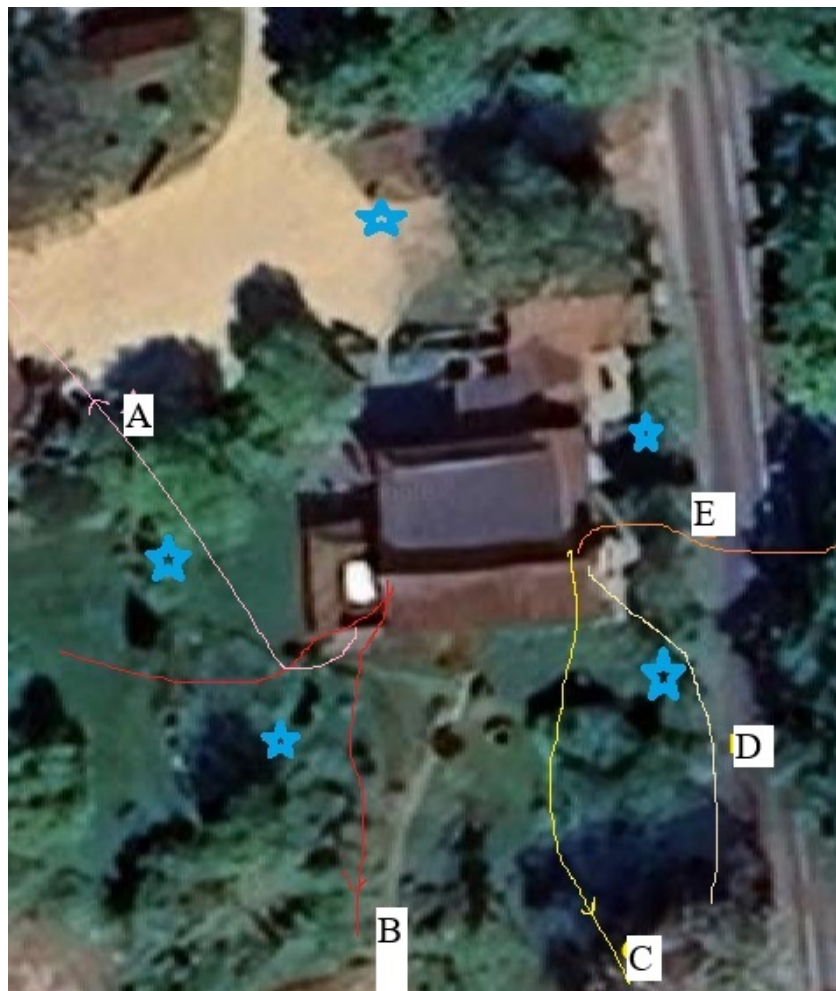
Figure 3. Emergence points 2025

- 4.2 The emergence surveys revealed the presence of a day roost of a common pipistrelle in the western extension and maternity roosts of common pipistrelle. It is not known whether this is a single roost with openings at either end of the inaccessible roof void or two separate roosts at either end of the original west-east roof ridge. (see figure 3).
- 4.3 Common pipistrelles increasingly utilise summer roosts as hibernation sites so it is possible they may be present year-round.

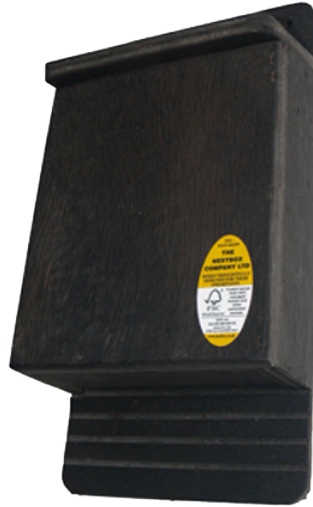
*Figure 4: The improved cavity box to be established on site*

- 4.5 The creation of a replacement bat roosting space in the revised lower western extension roof means no loss of roosting space. The tiles will be recycled, with the large ridge tiles replaced by smaller half rounds, and the new roof section will be lined with bituminous felting.
- 4.8 Two bat boxes, the Improved Cavity Bat Box (shown in figure 4 below) should also be established within the grounds. These are suitable for the smaller British bats, including pipistrelles.

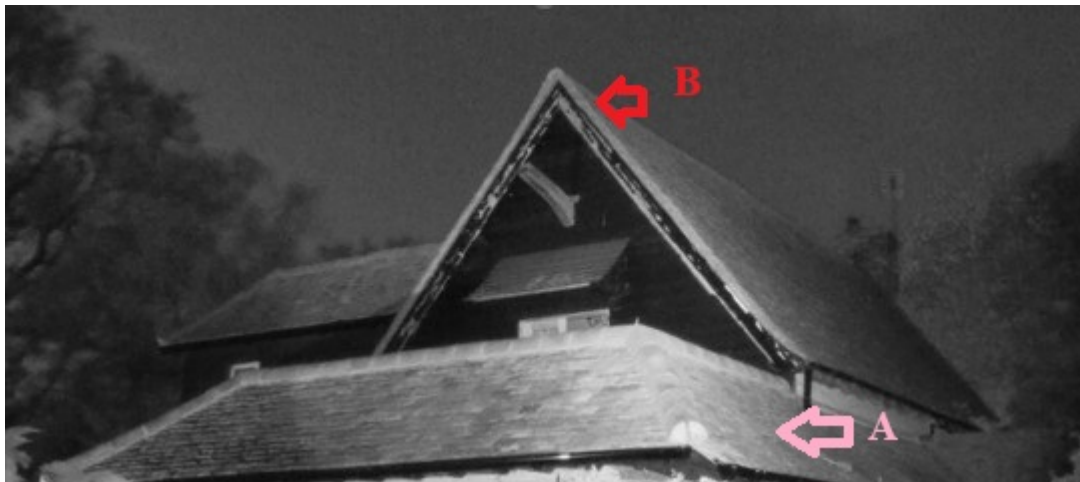
Figure 5. Emergence points west gable 2025

| SE, E | 20.55 | Common pipistrelle | 1 | 1 | Emerged from south ground floor roof (see A on fig 3 and fig 5) | | |

| SW | 21.23 | Common pipistrelle | 1 | 1 | Emerged from south side of ridge above west gable (see B on figures 3 & 5) |
| SW | 21.29 | Common pipistrelle | 2 | 2 | Emerged from south side of ridge above west gable (see B on figures 3 & 5) |

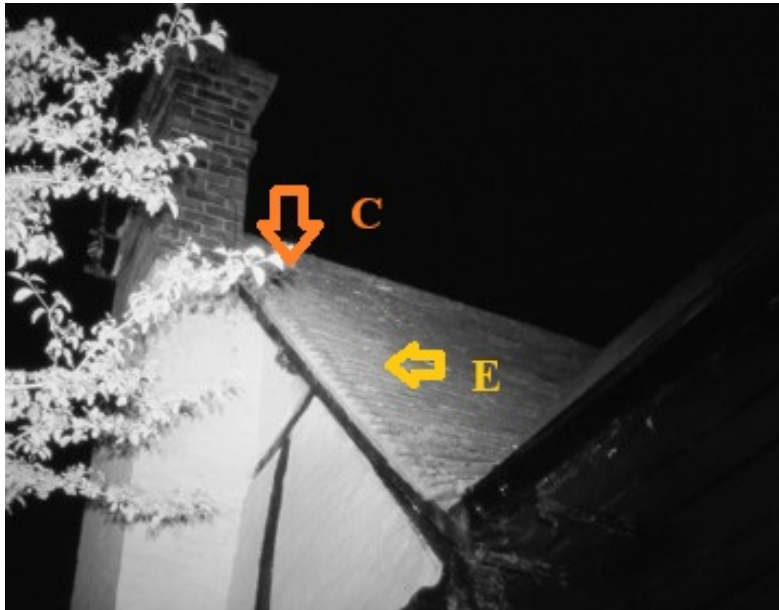
Figure 7. East gable north side emergence points 2025

| E, SE | 21.36 | Common pipistrelle | 2 | 2 | Emerged from north face near east chimney flew east (see C on figures 3 & 7) |
| SE, E | 21.39 | Common pipistrelle | 1 | 1 | Emerged from north face 1m south of east chimney flew south (see E on figure 3 & 7) |
