Our ref: GE22003/WH01/230912

**RE: Nine Mile Ride, Finchampstead – Soakage Testing**

Title : Figure 2 - Exploratory Hole Location Plan  
Scale: 1:1750  
Engineer:

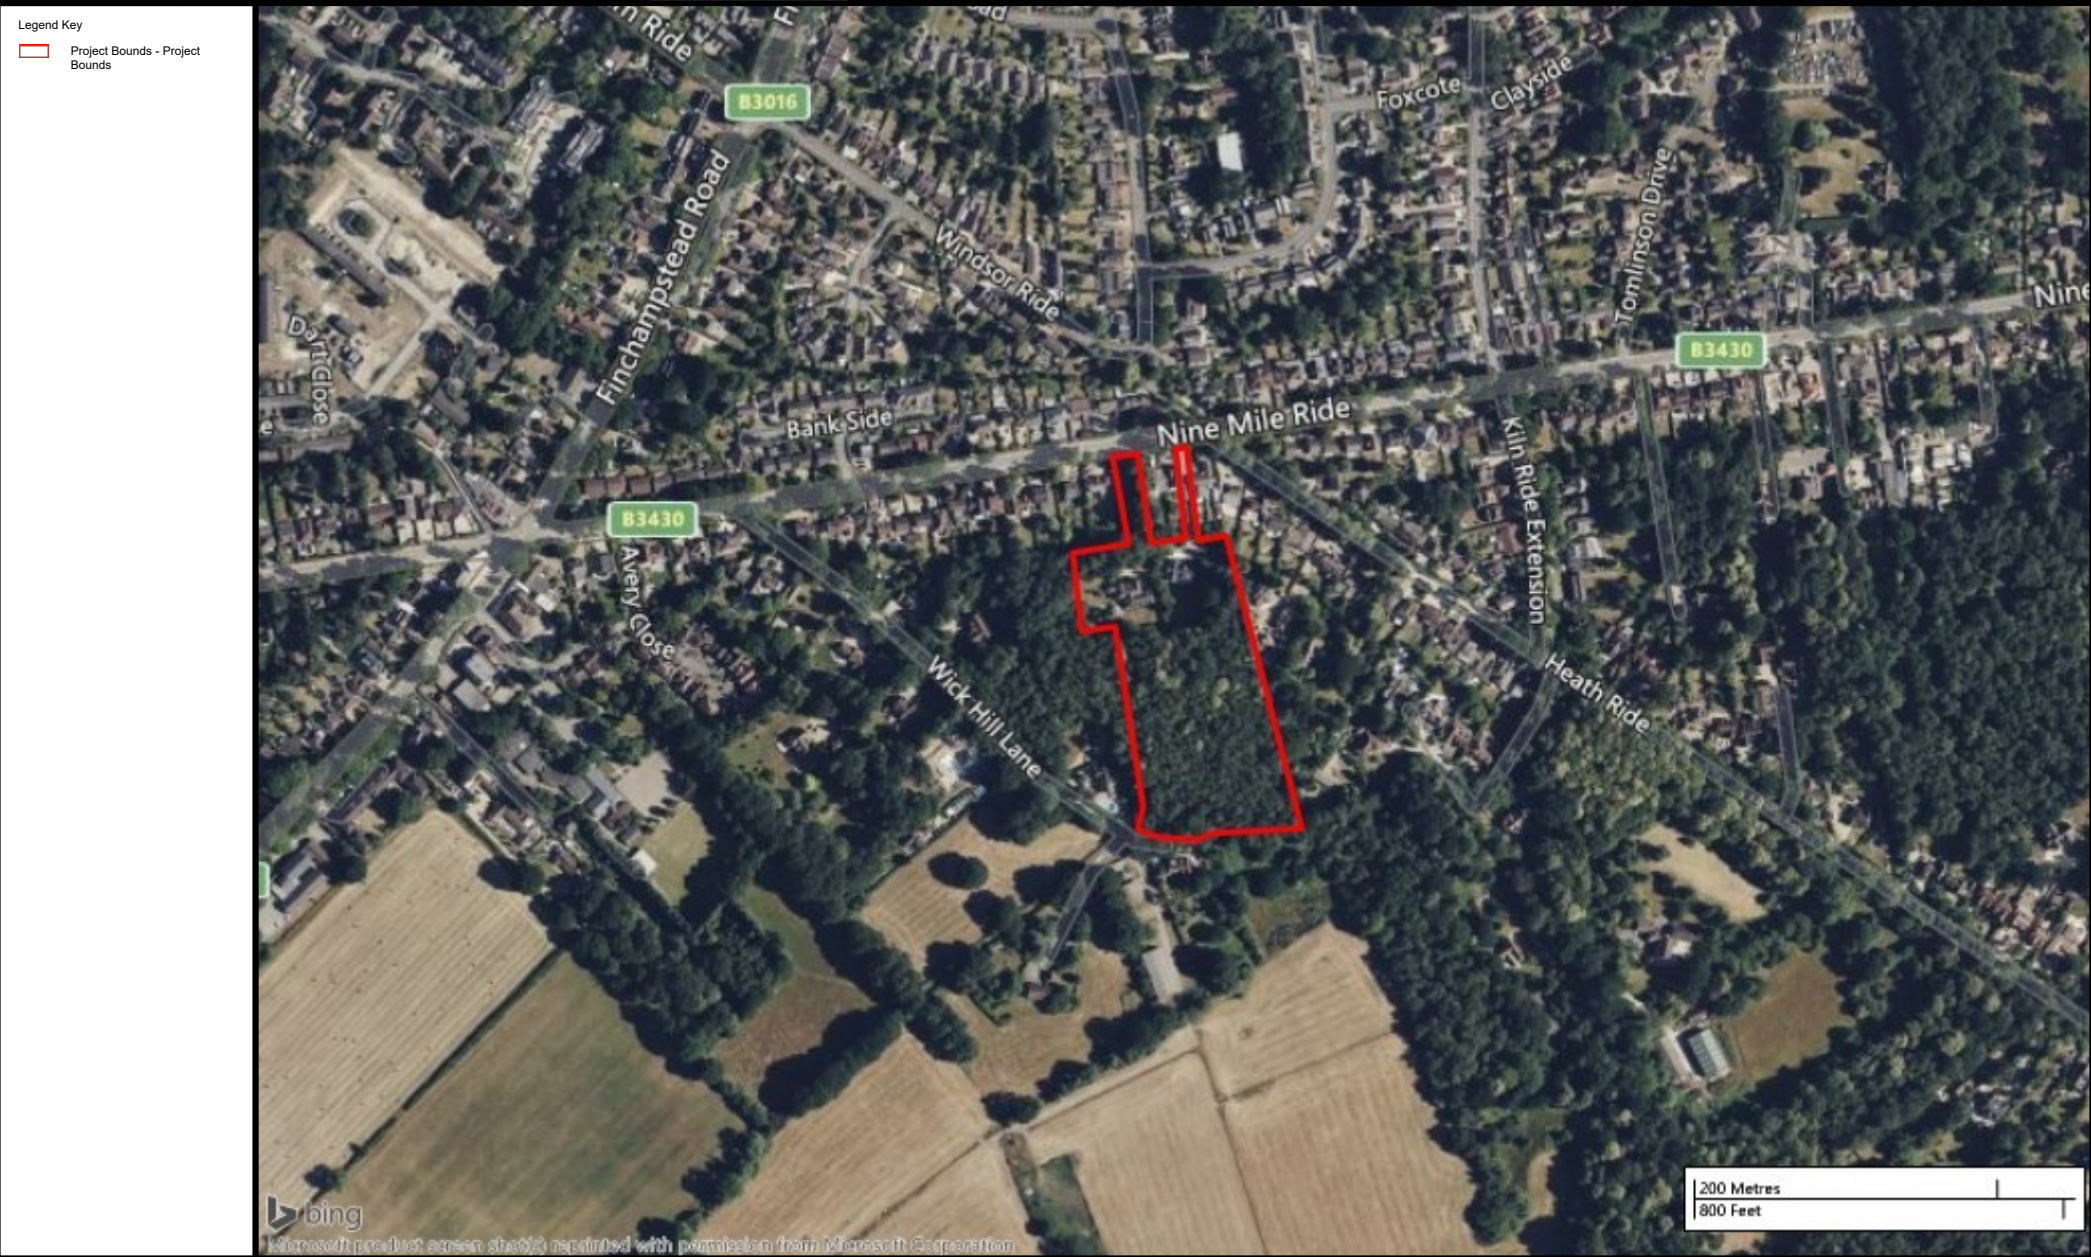
The exploratory holes were positioned approximately adjacent to hand pits (HP105 – HP109) undertaken by Omnia Consulting (ref: A12057/1.0, May 2023). The exploratory hole locations are shown on Figure 2.

A Geo-Environmental engineer attended the site on 7<sup>th</sup> and 8<sup>th</sup> September 2023 to undertake the intrusive investigation. Five hand excavated trial pits (HP05 – HP09) were completed to depths of 1.1 - 1.4m bgl (dependent on ground conditions) to assess ground, groundwater conditions and soakage infiltration rates.
