## **PRELIMINARY ECOLOGICAL APPRAISAL (DBW) AT 1 BEALE CLOSE WOKINGHAM**

**Prepared for:  
Mrs L & Mr D Saunders  
1 Beale Close  
Wokingham  
RG40 1GA**

**30 January 2026**

**Ref: SPH/NP/PEA-26/15.01**

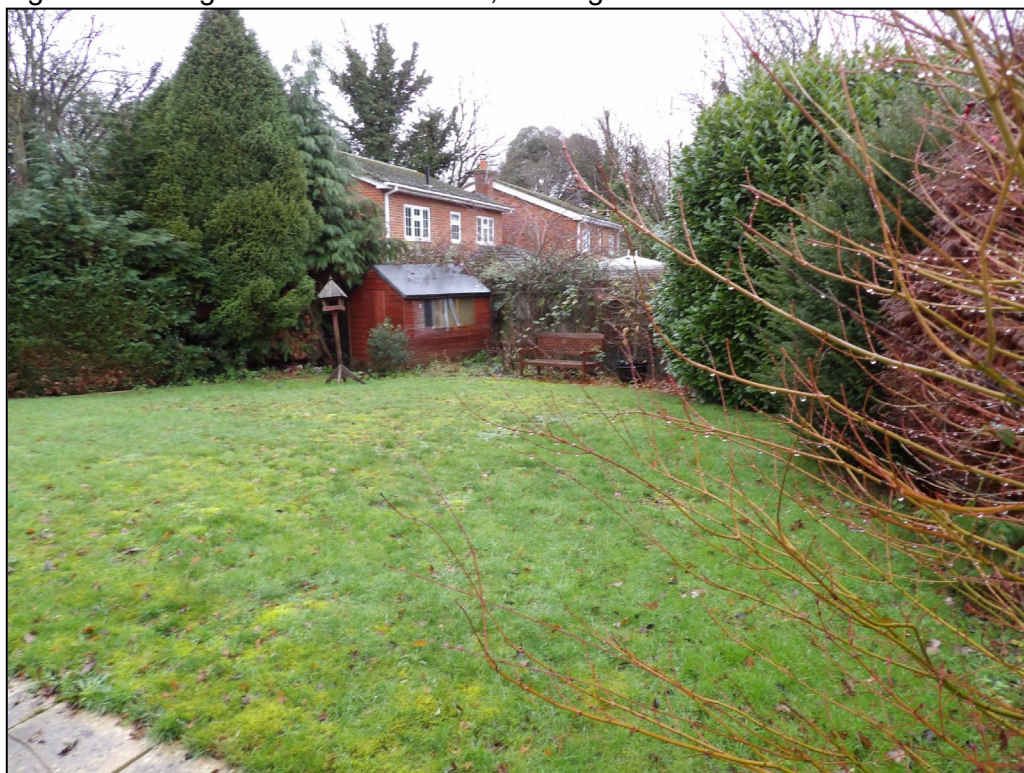
The application site comprises a detached, brick-built 2 storey property with part integrated garage and attached garage. The remainder of the site comprises a driveway/parking area and front garden with lawn and shrubs, see cover photograph. The rear garden contains a patio and is mainly laid to lawn with a number of shrubs and mature trees on the boundaries, see Figures 3 below. The site itself offers some foraging and commuting habitat for bats and there is ecological connectivity to bat foraging and commuting habitat in the wider landscape.

Figure 3. Rear garden. 1 Beale Close, Wokingham. 15.01.26

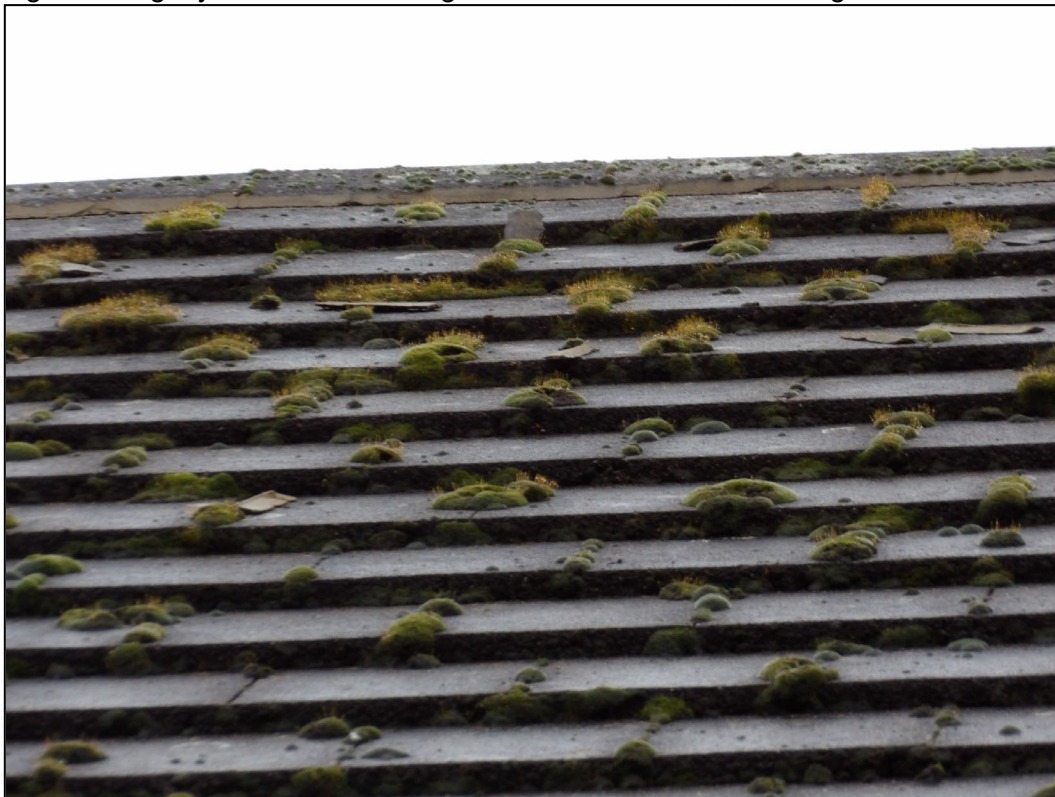
The property is a detached, brick-built 2 storey property that is in a good condition externally. The pitched roof is covered in composite tiles, none of which are missing or broken and there is no missing mortar from the ridge tiles, see Figure 4 below. The verges are sealed as is the lead flashing around the flue and affixing the porch/garage to the main dwelling, and offers no roosting opportunities, see Figure 5 on page 9. The roof and ridge tiles on the front porch and part integrated/part attached garages are also well fitted with no gaps that crevice dwelling bat species could exploit for roosting, see Figure 6 on page 9. The uPVC soffits and fascias on the building and interlocking uPVC cladding on the side of the porch are all tightly fitted with no cracks or splits in which roosting bats could exploit, see Figure 6 on page 10.

Figure 4. Tightly fitted roof and ridge tiles. 1 Beale Close, Wokingham. 15.01.26

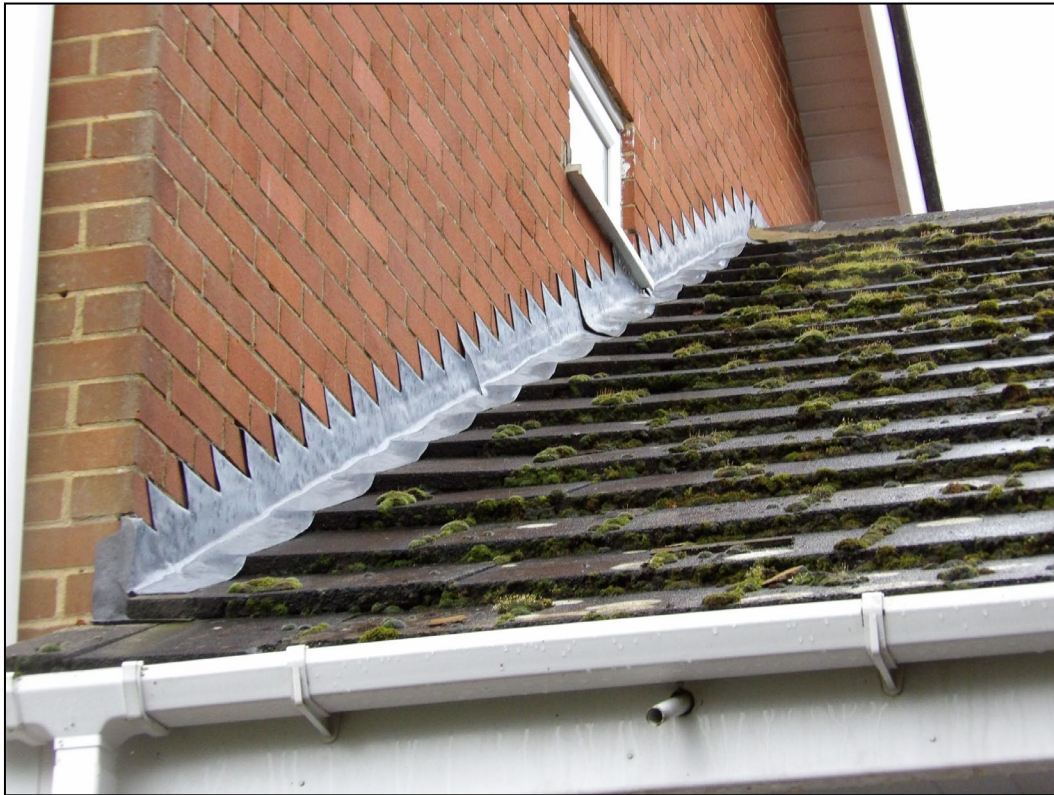
Figure 5. Example of sealed lead flashing. 1 Beale Close, Wokingham. 15.01.26

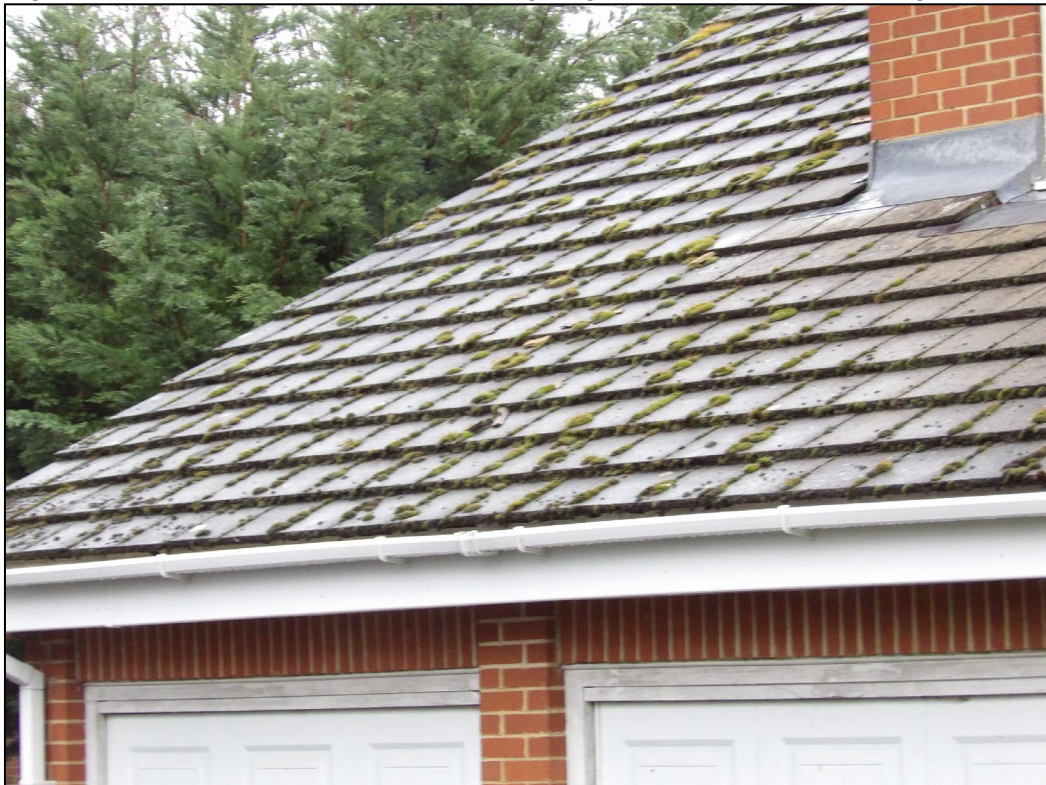
Figure 6. Example of roof tiles on porch/garage. 1 Beale Close, Wokingham. 15.01.26

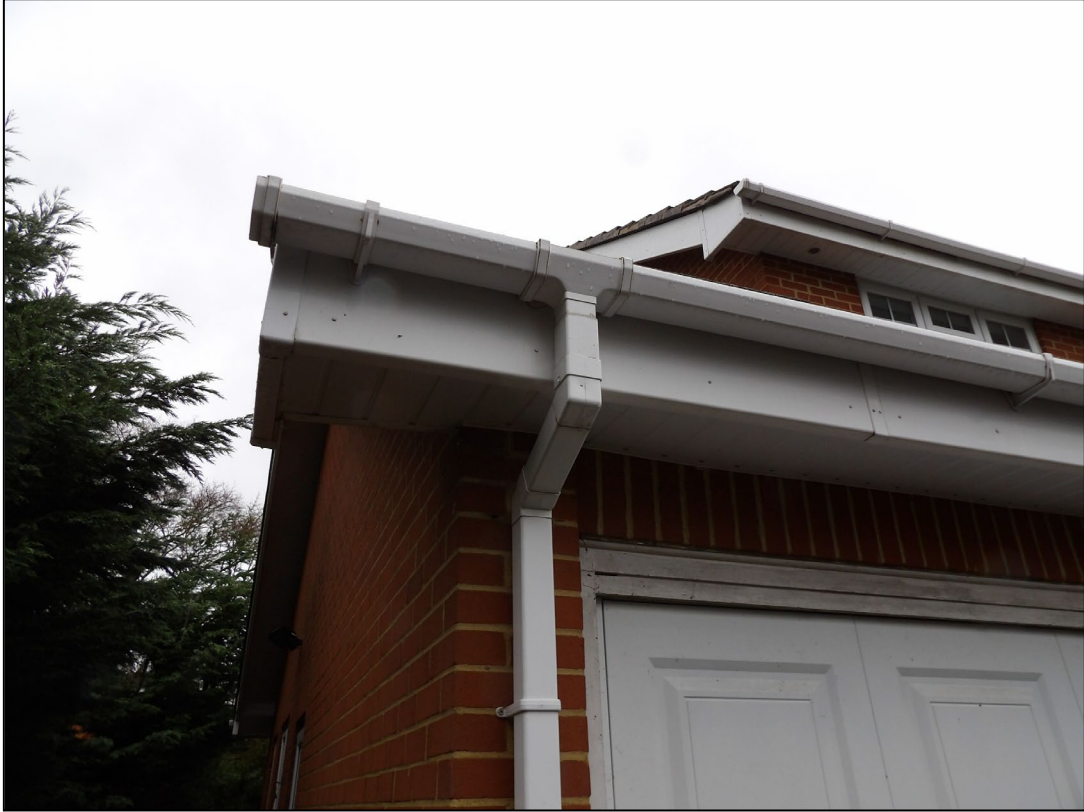
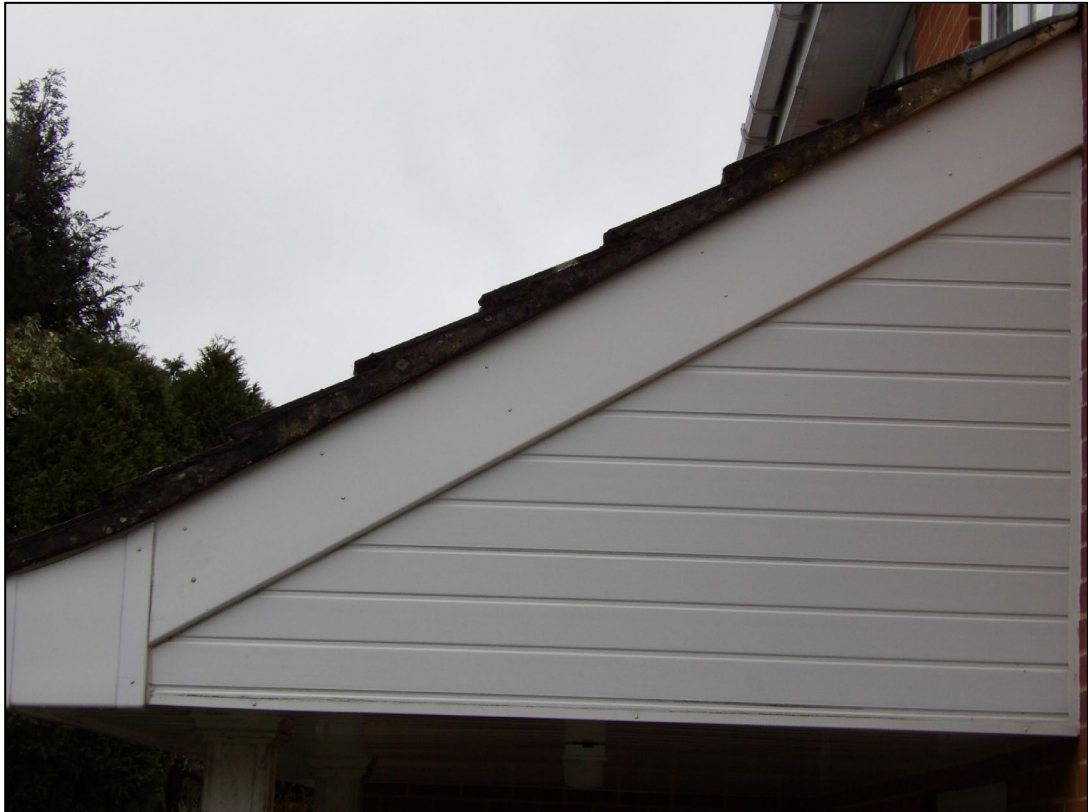
Figure 7. Example sealed uPVC soffits and fascias and cladding on property. 1 Beale Close, Wokingham. 15.01.26

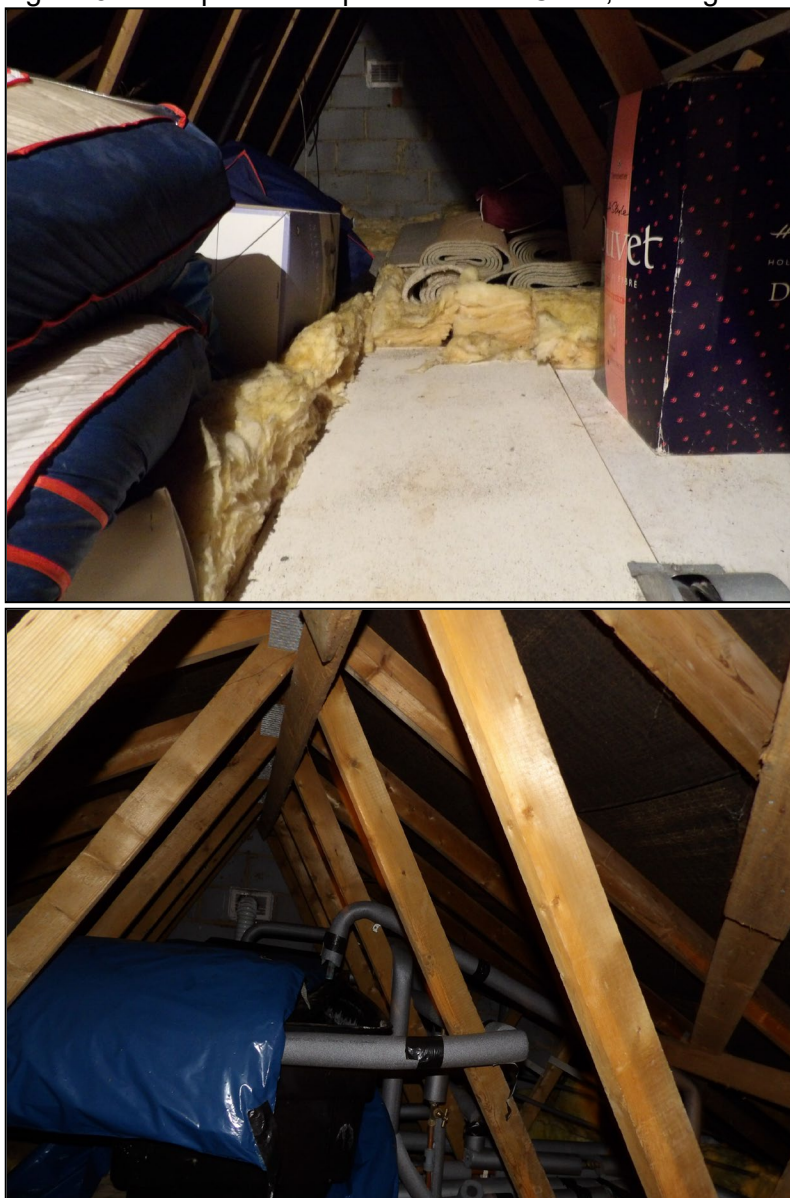
The loft space was accessed via a ladder through a hatch and is in a good condition internally. The loft is not lit, partially boarded and insulated, see Figure 8 below. The roof tiles are lined with bitumen felt, all of which is in a good condition with no rips or tears, see Figure 9 on page 12 below.

Figure 8. Example of loft space. 1 Beale Close, Wokingham. 15.01.26

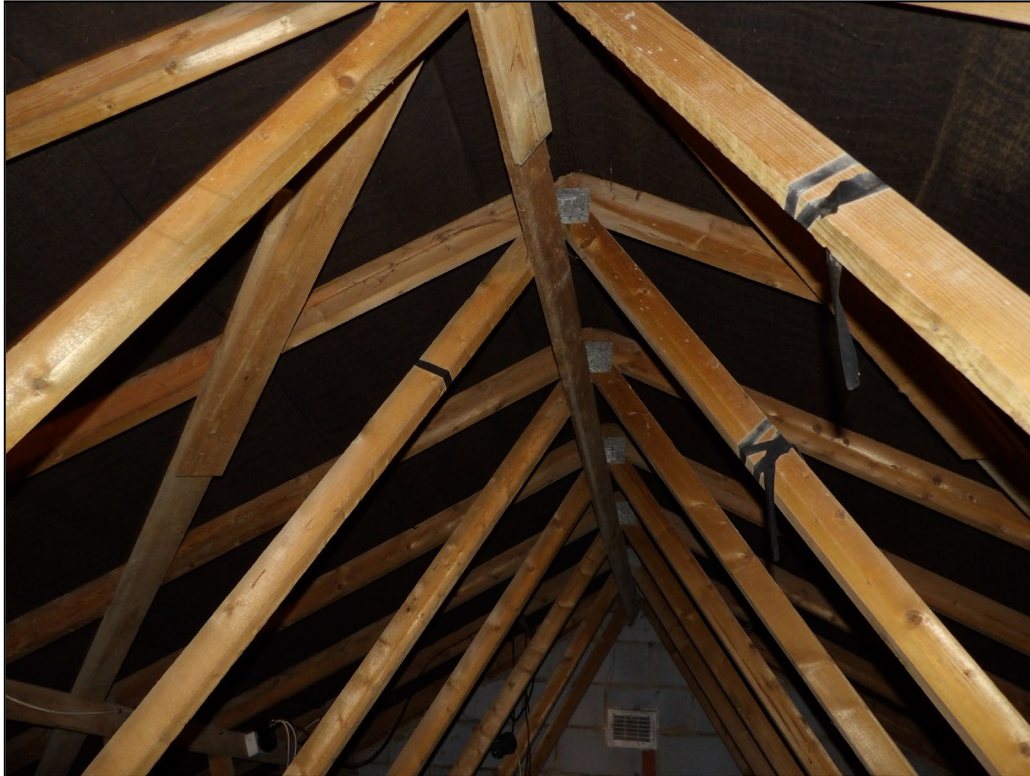
Figure 9. Example bitumen lining to main loft space. 1 Beale Close, Wokingham. 15.01.26

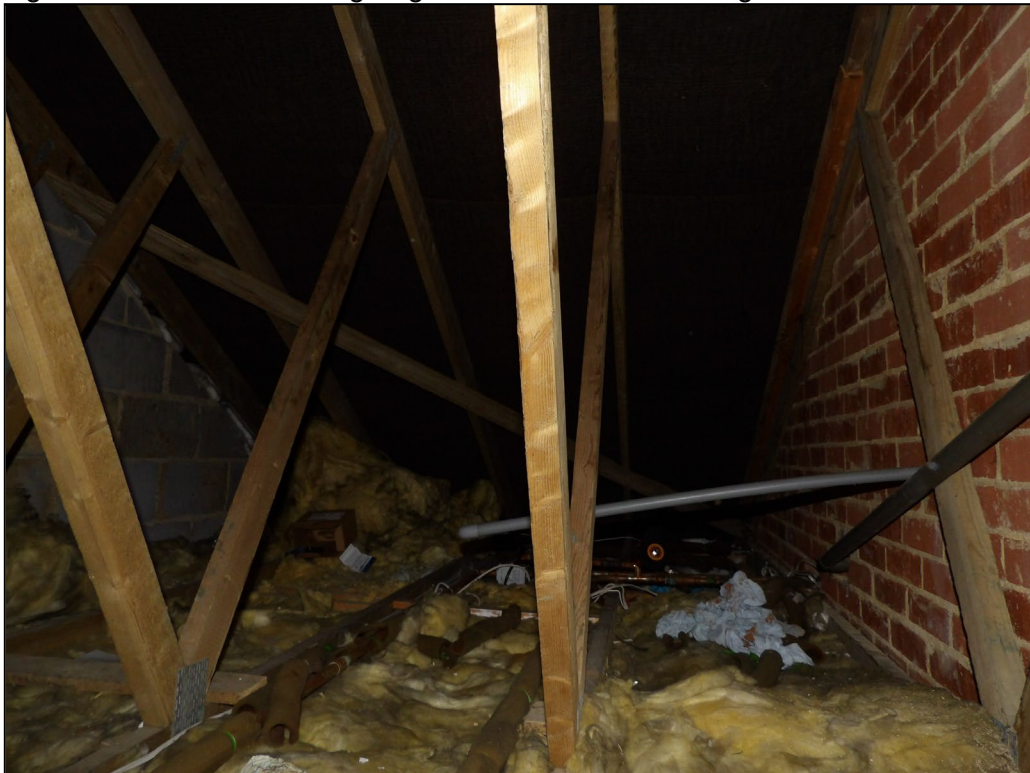
The ceiling of the garage is boarded and the roof void above accessed via a hatch. The space is in a good condition, not lit or boarded and the roof tiles are lined with bitumen felt, all of which is in a good condition with no rips or tears, see Figure 10 on page 12.

Figure 10. Loft void above garage. 1 Beale Close, Wokingham. 15.01.26
