Order Number: 297188414\_1\_1  
Customer Ref: E28112  
National Grid Reference: 476160, 166300  
Slice: A  
Site Area (Ha): 18.12  
Search Buffer (m): 1000

Ducks Nest Farm, Eversley Road, Arborfield Cross, READING, RG2 9PJ

## **Appendix F – Landmark Envirocheck - Mining and Ground Stability Report**

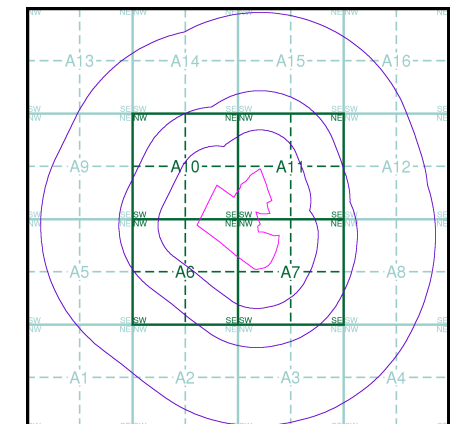
## Borehole Map - Slice A

## Agency and Hydrological (Boreholes)

For Borehole information please refer to the Borehole .csv file which accompanied this slice.

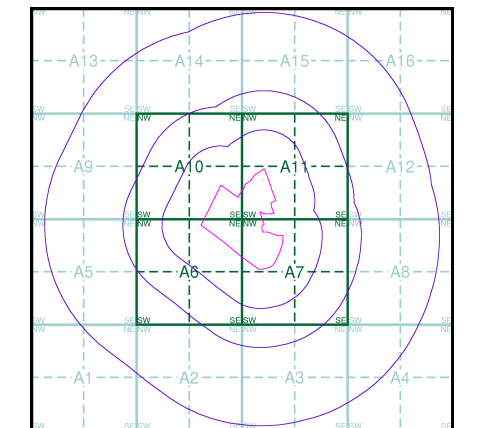
## OS Water Network Map - Slice A

## OS Water Network Data

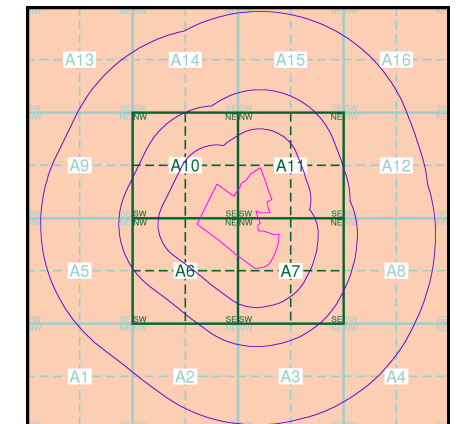
## EA/NRW Suitability Map - Slice A

## Risk of Flooding from Surface Water

- High - 30 Year Return
- Medium - 100 Year Return
- Low - 1000 Year Return

## Suitability

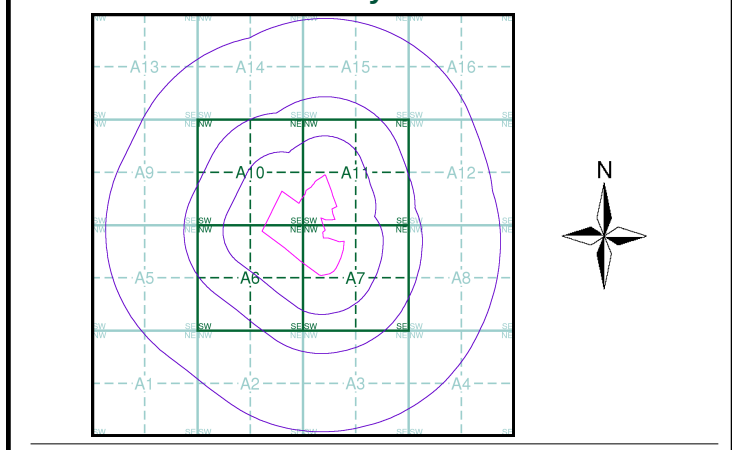
## Estimated Soil Chemistry Arsenic - Slice A

## Estimated Soil Chemistry Arsenic

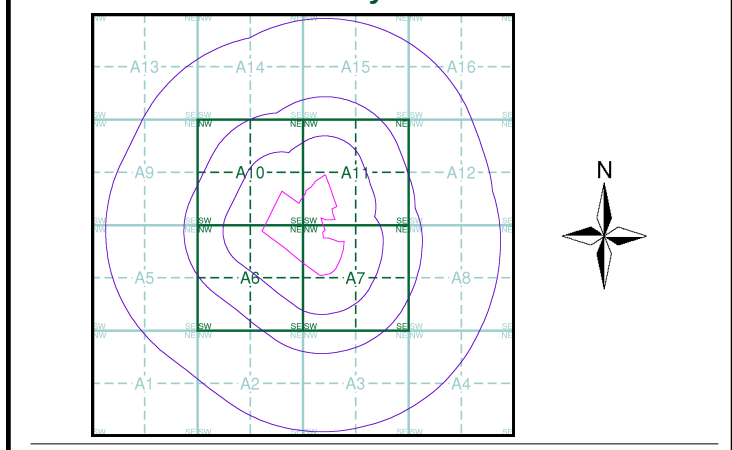
## Estimated Soil Chemistry Cadmium - Slice A

## Estimated Soil Chemistry Cadmium

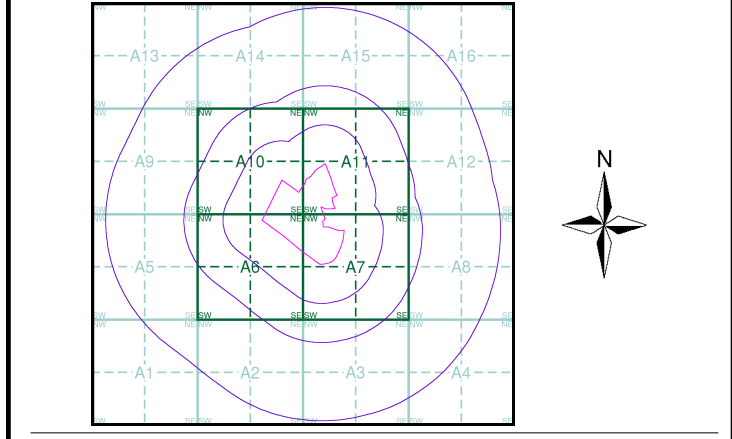
## Estimated Soil Chemistry Lead - Slice A

## Estimated Soil Chemistry Lead

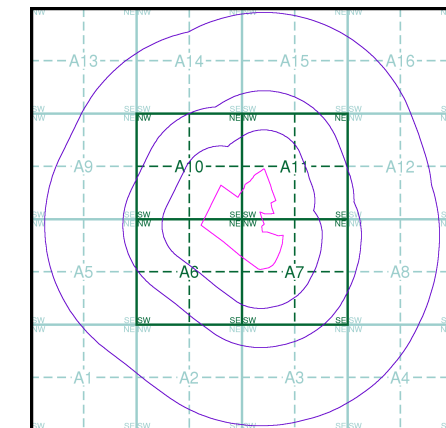
## Estimated Soil Chemistry Nickel - Slice A

## Estimated Soil Chemistry Nickel

Nickel Concentrations mg/kg

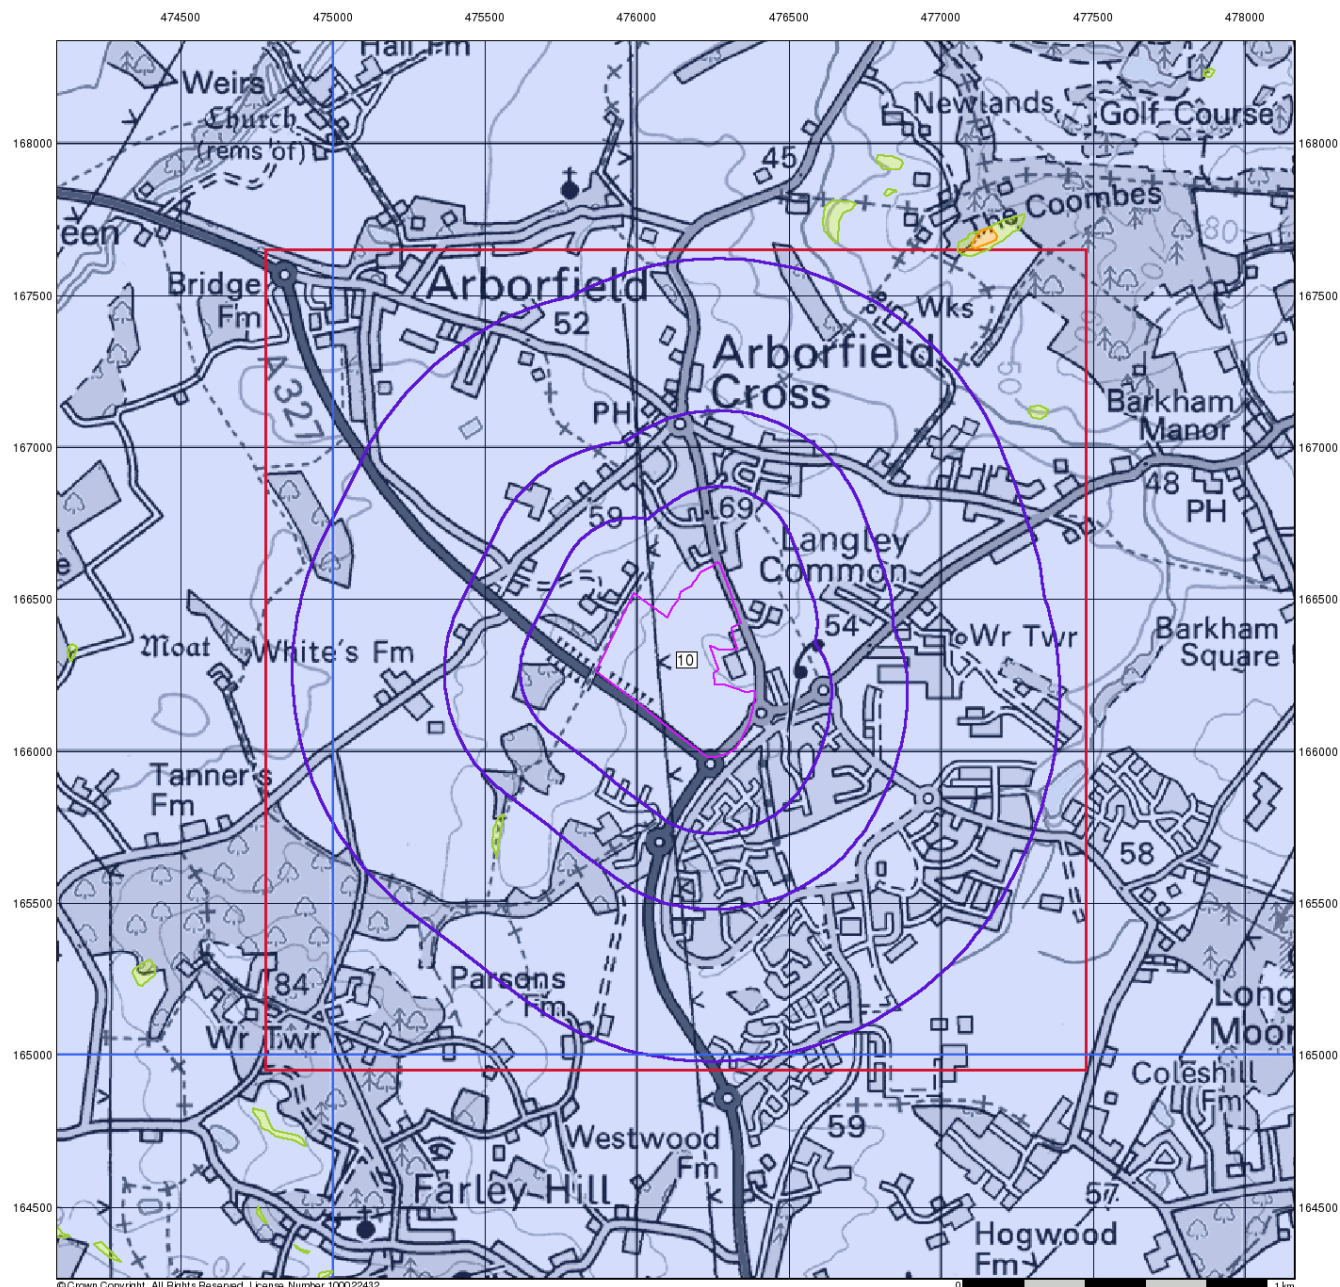
### Mining and Ground Stability - Slice A

## Ground Stability Data (1:50,000)

### Potential for Landslide Ground Stability Hazards

### Potential for Ground Dissolution Stability Hazards

| Map ID | Details | Quadrant Reference (Compass Direction) | Estimated Distance From Site | Contact | NGR |
|---|---|---|---|---|---|
| | <b>Potential for Ground Dissolution Stability Hazards</b><br>Hazard Potential: No Hazard<br>Source: British Geological Survey, National Geoscience Information Service | A7NW (NW) | 0 | 1 | 476163 166300 |
| 10 | <b>Potential for Landslide Ground Stability Hazards</b><br>Hazard Potential: Very Low<br>Source: British Geological Survey, National Geoscience Information Service | A7NW (NW) | 0 | 1 | 476163 166300 |

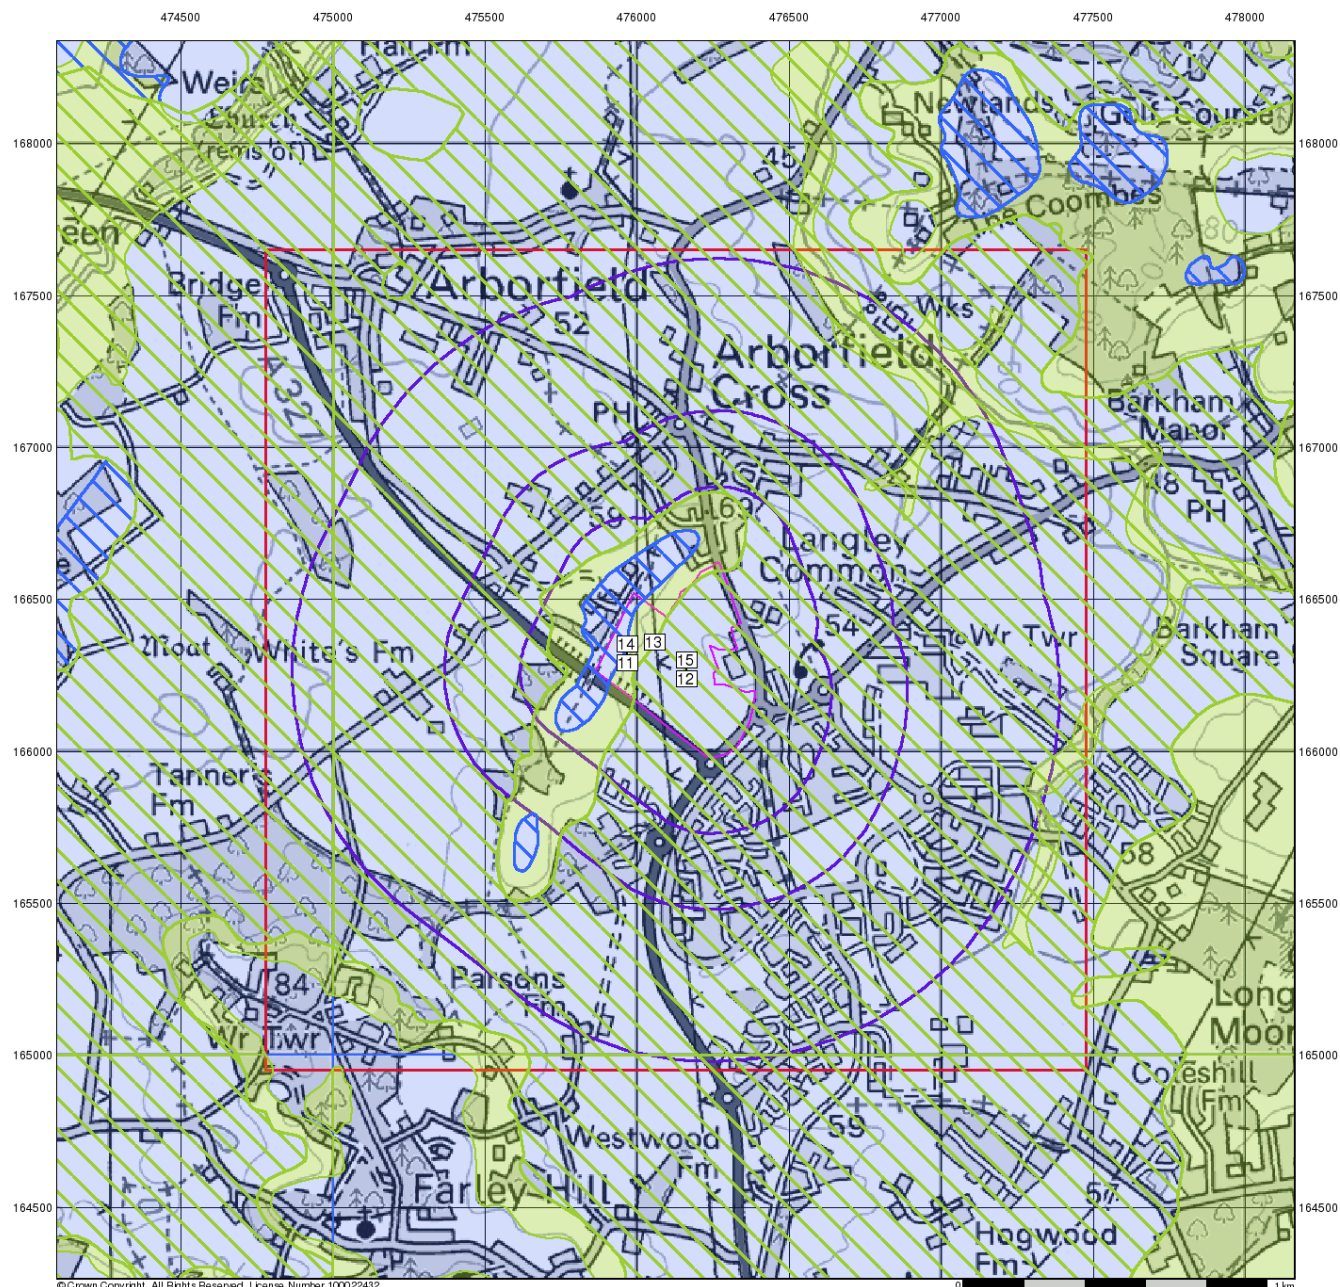
### Mining and Ground Stability - Slice A

## Ground Stability Data (1:50,000)

### Potential for Running Sand Ground Stability Hazards

### Potential for Shrinking or Swelling Clay Ground Stability Hazards

| Map ID | Details | Quadrant Reference (Compass Direction) | Estimated Distance From Site | Contact | NGR |
|---|---|---|---|---|---|
| 11 | <b>Potential for Running Sand Ground Stability Hazards</b><br>Hazard Potential: Very Low<br>Source: British Geological Survey, National Geoscience Information Service | A10SE (W) | 0 | 1 | 475967 166354 |
| 12 | <b>Potential for Running Sand Ground Stability Hazards</b><br>Hazard Potential: Very Low<br>Source: British Geological Survey, National Geoscience Information Service | A7NW (NW) | 0 | 1 | 476163 166300 |
| 13 | <b>Potential for Running Sand Ground Stability Hazards</b><br>Hazard Potential: Low<br>Source: British Geological Survey, National Geoscience Information Service | A10SE (NW) | 0 | 1 | 476057 166358 |
| 14 | <b>Potential for Shrinking or Swelling Clay Ground Stability Hazards</b><br>Hazard Potential: Very Low<br>Source: British Geological Survey, National Geoscience Information Service | A10SE (W) | 0 | 1 | 475967 166354 |
| 15 | <b>Potential for Shrinking or Swelling Clay Ground Stability Hazards</b><br>Hazard Potential: Low<br>Source: British Geological Survey, National Geoscience Information Service | A7NW (NW) | 0 | 1 | 476163 166300 |
| | <b>Potential for Shrinking or Swelling Clay Ground Stability Hazards</b><br>Hazard Potential: No Hazard<br>Source: British Geological Survey, National Geoscience Information Service | A10SE (NW) | 0 | 1 | 476057 166358 |
