## **ECOLOGICAL SURVEY REPORT (BATS) AT 3 BUCKHURST WAY EARLEY, READING**

**Prepared for:  
Mr R Lane  
c/o 3 Buckhurst Way  
Earley  
Reading  
RG6 7RL**

**23 September 2025**

**Ref: SPH/BAS-25/03.09**

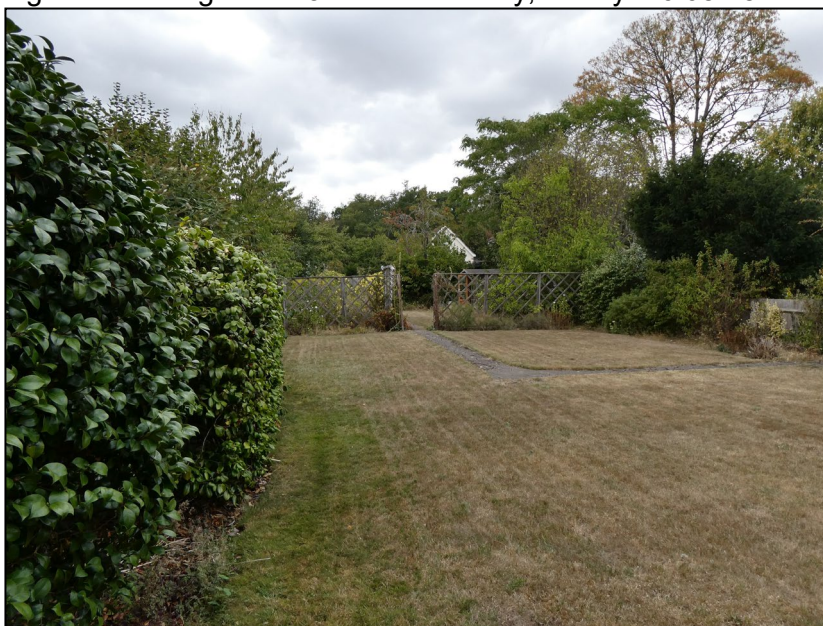
Figure 2. Rear garden. 3 Buckhurst Way, Earley. 26.08.25

The site comprises a detached, two-storey brick-built property with integral garage. The remainder of the site comprised a gravelled front driveway/parking area with lawn with shrubs and hedges, see cover photograph. The rear garden is mainly laid to lawn with shrubs and mature hedgerows, see Figure 2 below. The site itself provides some foraging and commuting habitat for bats and there is some ecological connectivity to the wider landscape via the garden network.

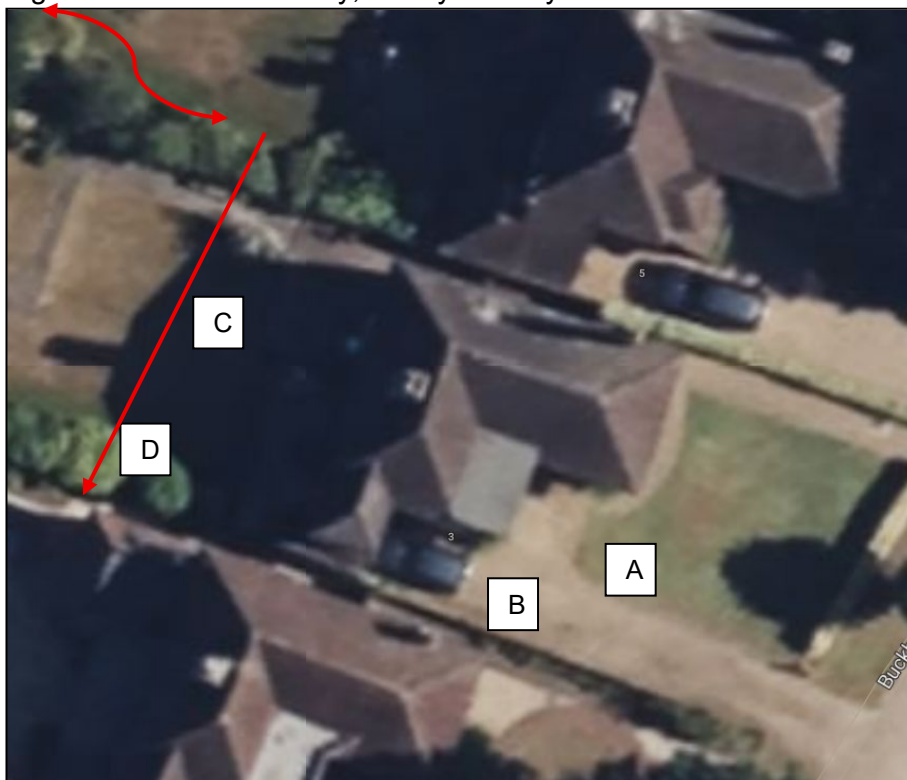
Figure 3. 3 Buckhurst Way, Earley. Surveyor/remote camera locations.

The surveyors/remote cameras were stationed (as shown in Figure 3 below), to ensure the features identified in the DBW could be observed. Screenshots from the darkest point of the survey areas are included at Appendix 2.

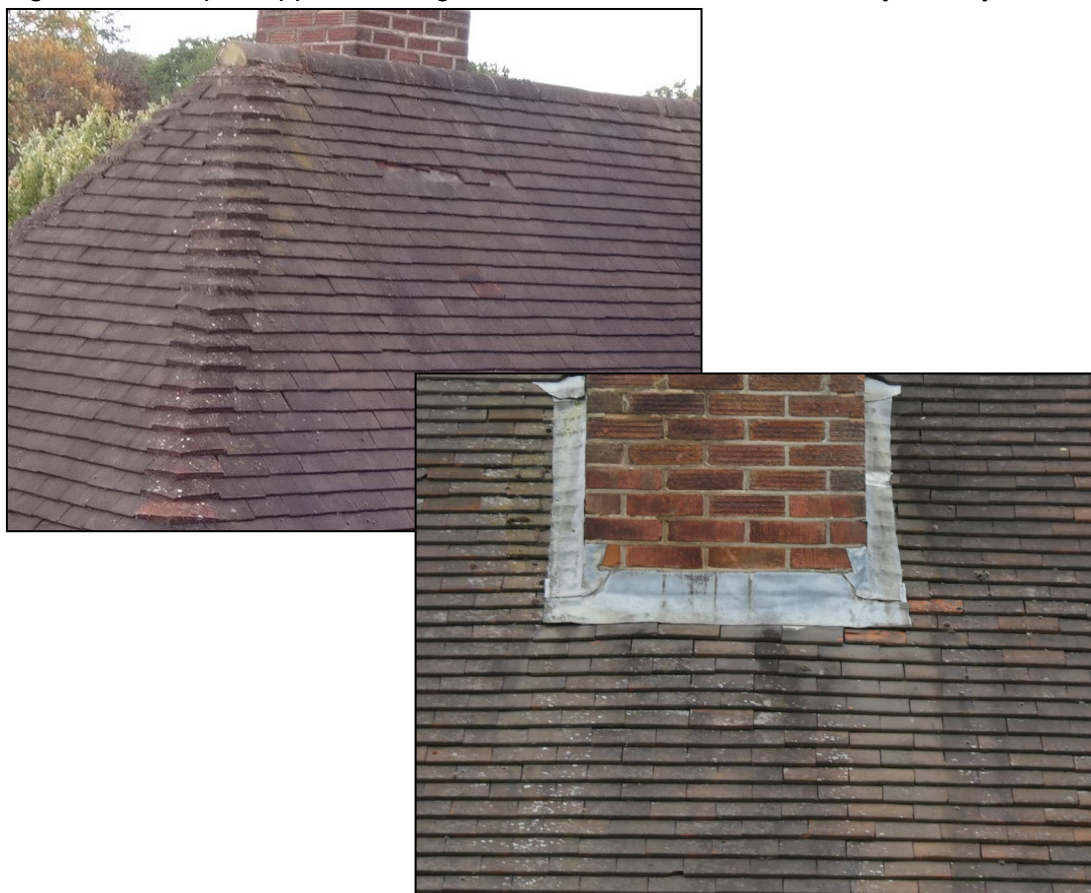
Figure 4. Example slipped/missing/raised roof tiles. 3 Buckhurst Way, Earley. 26.08.25

The property is a detached, brick-built building that is in a fair condition externally. The majority of the cross-hipped roof with catslide section over the integral garage is covered in close fitted tiles that are in a good condition however, on the front elevation some tiles have broken/slipped (see Figure 4 below) and, on the rear elevation, under the chimney stack, some tiles are lifted, see Figure 4 below. There is no missing mortar from the ridge or bonnet tiles (see Figure 5 on page 10), or from the verge on the catslide roof section over the integral garage. At the front is a two-storey extension, the flat roof of which is covered in well fitted bitumen felt with no rips or tears (see Figure 6 on page 10) and the sides are covered in hanging tiles, some of which on the corners have moved leaving gaps, see Figure 7 on page 11. On the side (southern) elevation is a dormer window, the hipped roof of which is covered in well fitted tiles and the ridge and bonnet tiles are firmly attached (see Figure 8 on page 11) however, the sides are covered in hanging tiles, some of which have moved leaving gaps, see Figure 9 on page 12. On the rear elevation are two single storey extensions (see Figure 10 on page 12), the roofs of which are covered in tiles, some of which have moved leaving gaps, see Figure 11 on page 13. The soffits and fascias across the building are tight to the walls with no splits or gaps (see Figure 12 on page 14) and the lead flashing across the building is flush with no gaps.

No bats or evidence of bats were observed during the external inspection of the property but externally there are features on the property (moved/lifted roof and hanging tiles) which could be utilised by crevice dwelling bat species for roosting.

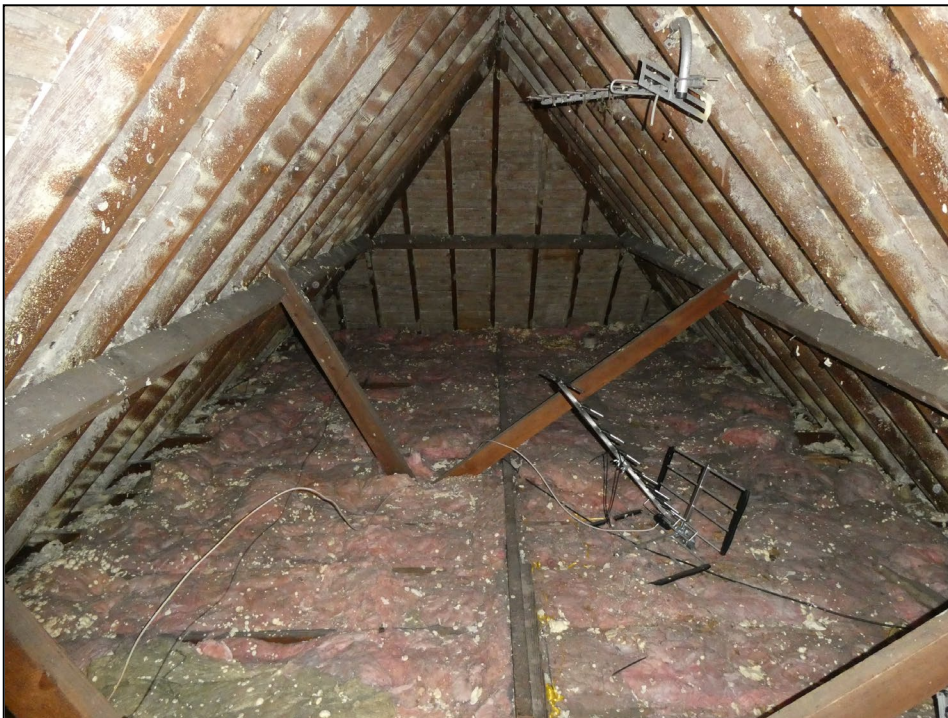
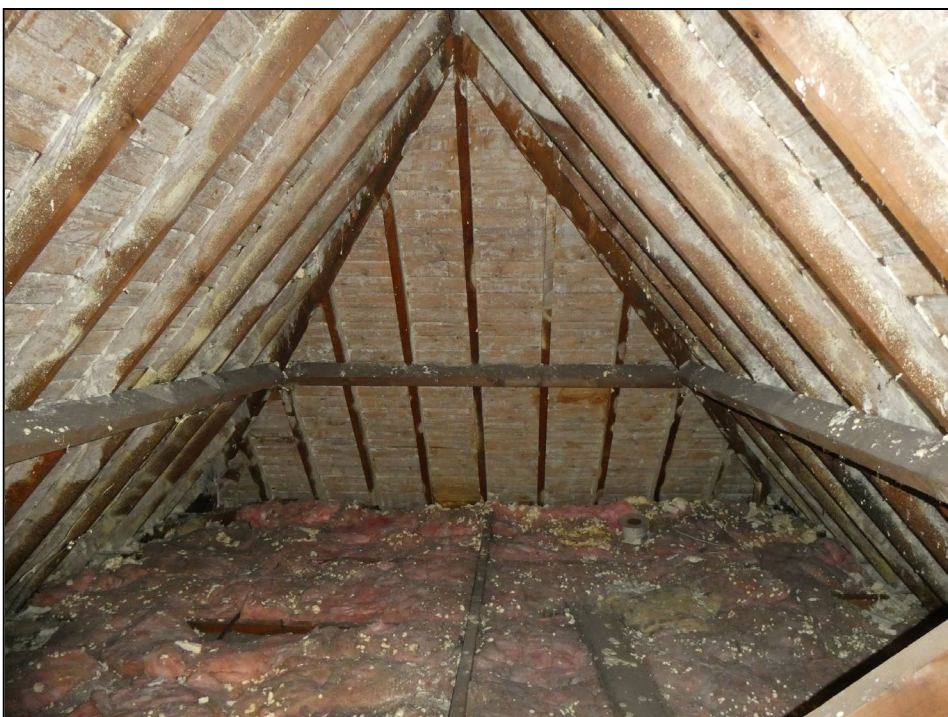
Figure 13. Loft space and sarking. 3 Buckhurst Way, Earley. 26.08.25

The loft was accessed through a hatch, via a ladder. The loft is not lit, not boarded and insulated and the roof tiles are lined with sarking, see Figure 13 below.

No bats or evidence of bats was recorded during the internal inspection of the property and internally there appeared to be no roosting opportunities for bats within the main loft of the property.

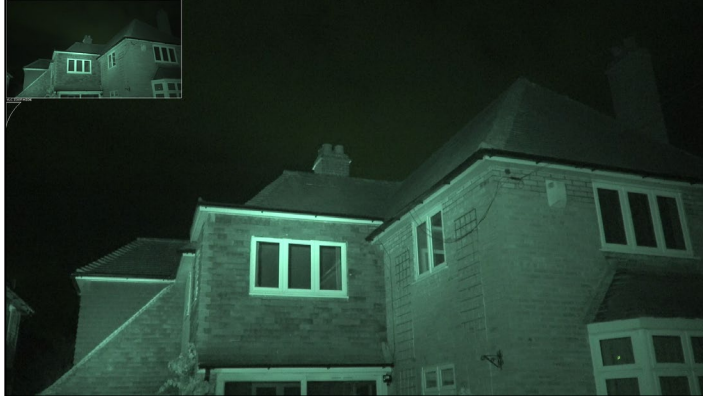
A

Screenshots from the darkest point of the survey areas from night vision cameras
