## **PRELIMINARY ECOLOGICAL APPRAISAL (DBW) AT 58 REDHATCH DRIVE EARLEY**

**Prepared for:  
Mr & Mrs Polnik  
c/o 58 Redhatch Drive  
Earley  
Wokingham  
RG6 5QR**

**2 September 2024**

**Ref: SPH/NP/PEA-24/20.08**

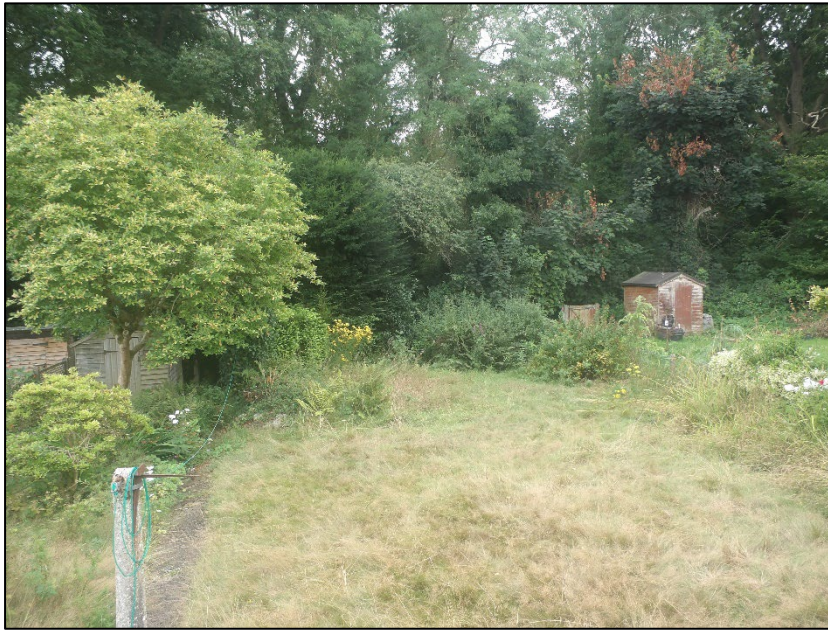
The application site comprises a detached, brick-built bungalow with a rear extension and attached garage. The remainder of the site comprises a paved driveway/parking area and lawn with mature shrubs, see cover photograph. To the rear the garden is mainly laid to lawn with shrubs and mature trees on the boundaries, see Figure 3 below. The site itself offers some foraging and commuting habitat for bats and, via the back garden, there is direct ecological connectivity to the Redhatch Copse.

Figure 3. Rear garden. 58 Redhatch Drive, Earley. 20.08.24

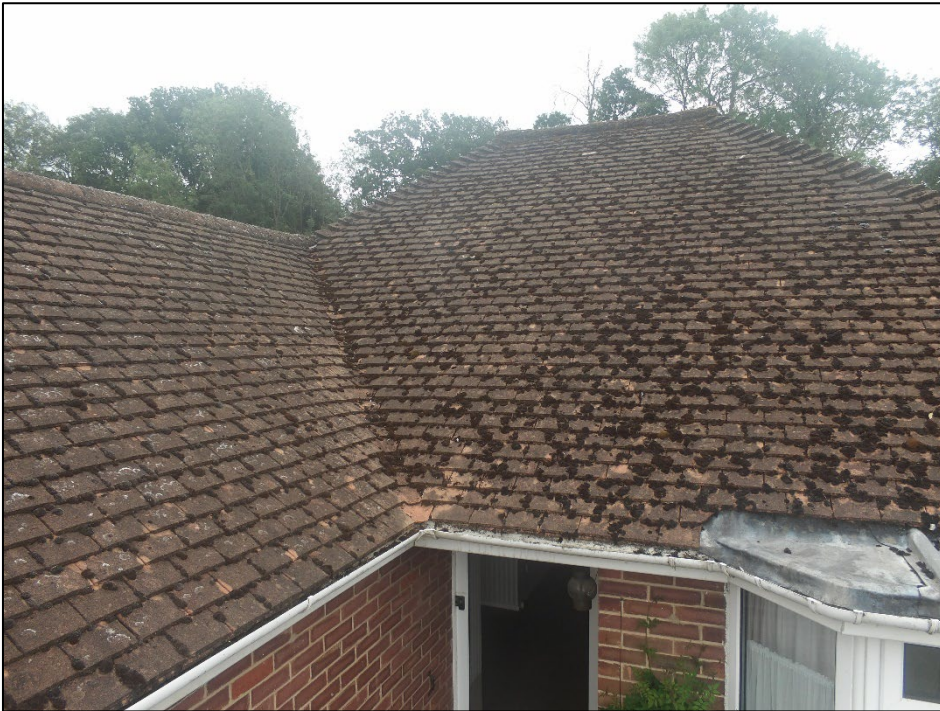
Figure 4. Example roof and ridge tiles. 58 Redhatch Drive, Earley. 20.08.24

The property is a detached, brick-built bungalow with attached garage and rear extension, all of which are in a good condition. The cross hipped roof is covered in composite tiles, all which are in a good condition and offer no roosting opportunities, see Figure 4 on page 8. There is no missing mortar from the ridge and hip tiles or verges, and they have no gaps which roosting bats could exploit, see Figure 5 on page 8. The flat roof of the rear extension is covered in well fitted bitumen felt with no rips or tears (see Figure 6 on page 9), and the bitumen felt covering the flat roof of the garage is in a similar good condition, see Figure 7 on page 9.

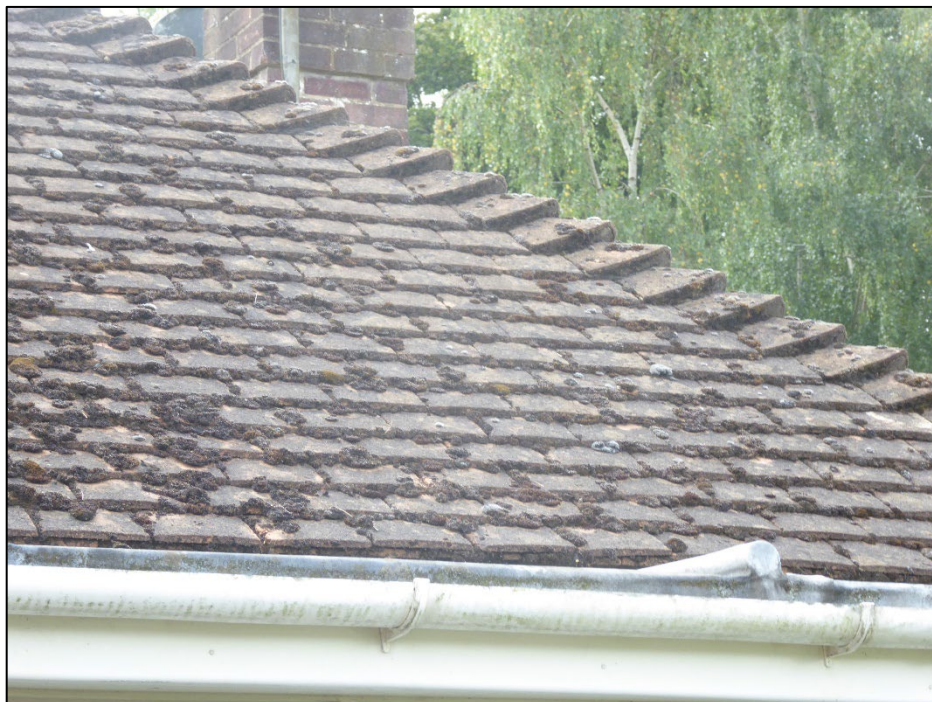
Figure 5. Example of sealed hip tiles. 58 Redhatch Drive, Earley. 20.08.24

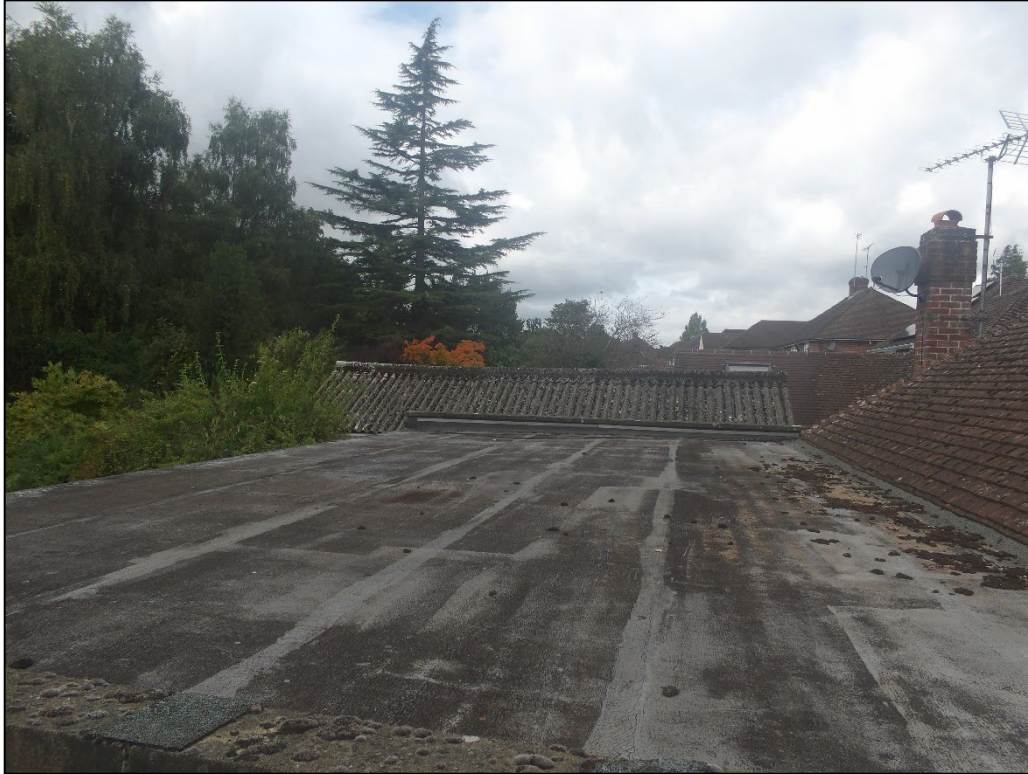
Figure 6. Example sealed bitumen felt on rear extension. 58 Redhatch Drive, Earley. 20.08.24

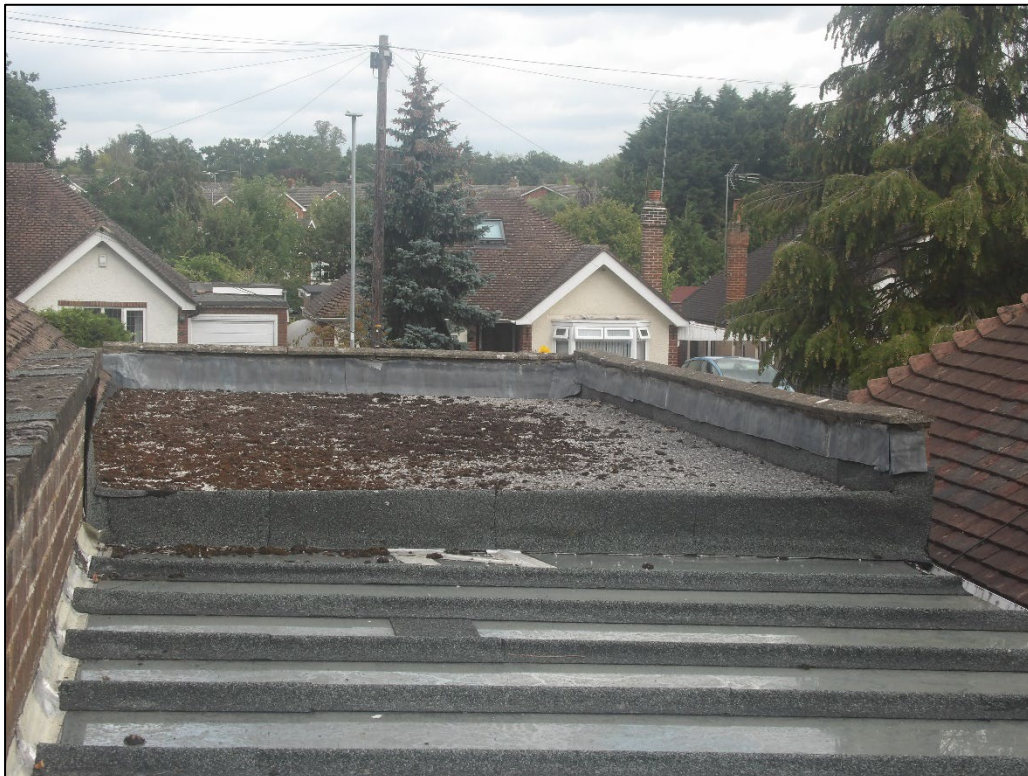
Figure 7. Example sealed bitumen felt on garage. 58 Redhatch Drive, Earley. 20.08.24

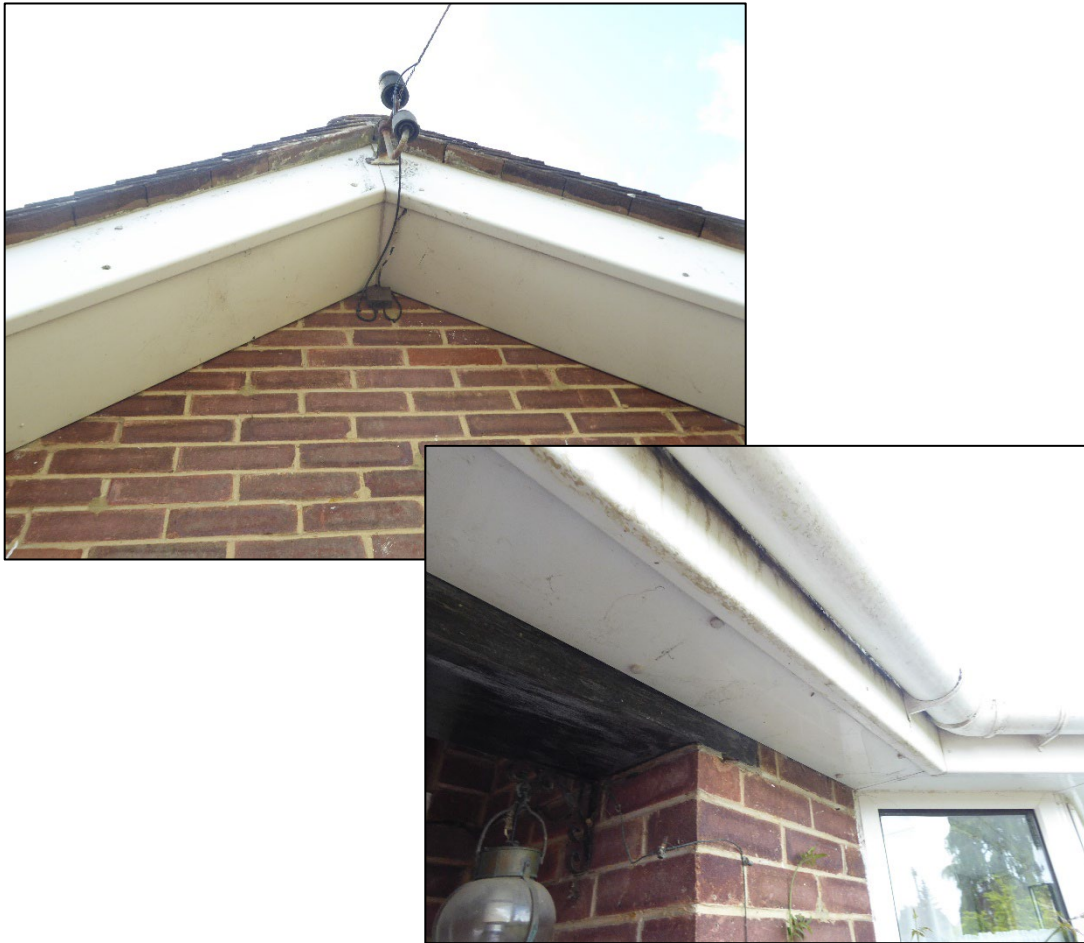
The uPVC fascias and soffits are tightly fitted to the wall with no gaps (see Figure 8 on page 10), and the led flashing around the chimney is also tightly fitted with no gaps that could be exploited by crevice dwelling bat species, see Figure 9 on page 10.

Figure 8. Example sealed soffits and fascias. 58 Redhatch Drive, Earley. 20.08.24

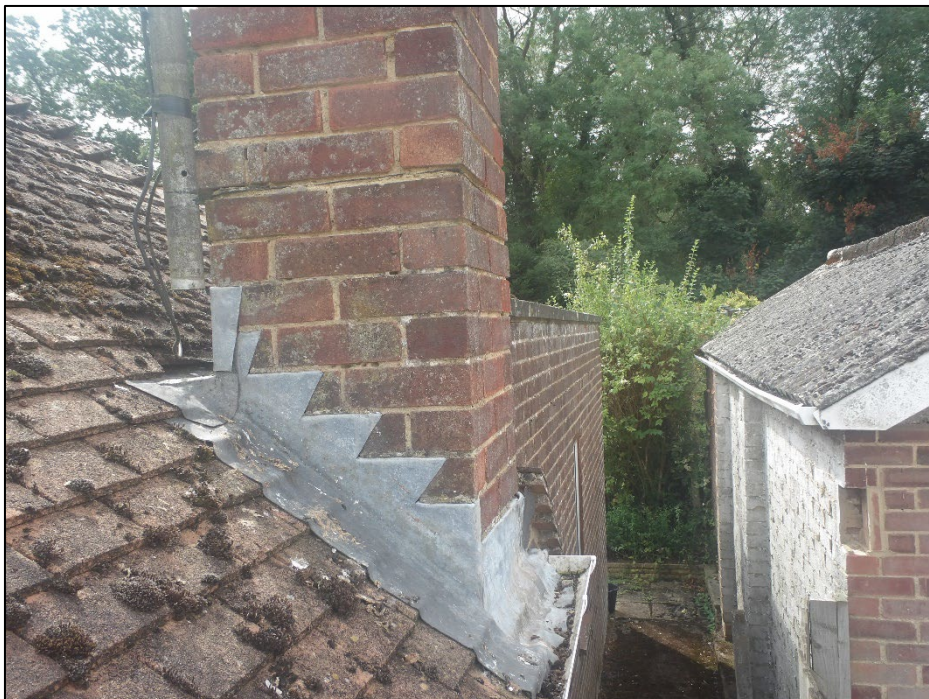
Figure 9. Example lead flashing on chimney stack. 58 Redhatch Drive, Earley. 20.08.24

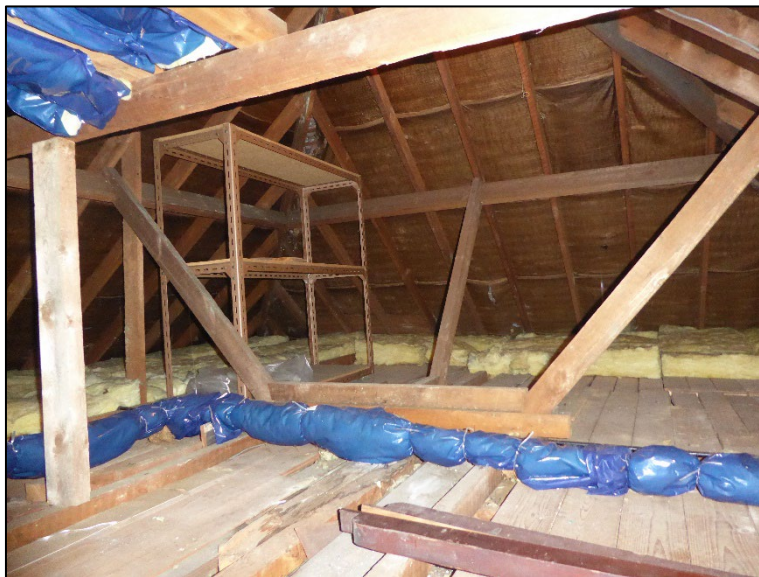
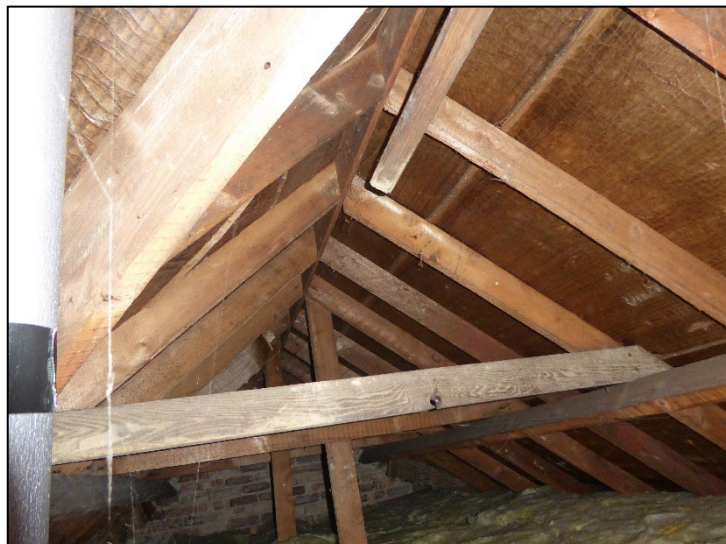
The loft of the property was accessed via a loft ladder and was in a fair condition internally. The loft was partially lit, partially boarded and insulated, see Figure 10 below. The roof tiles are lined with tar paper, some of which was ripped/torn but given the good state of the roof tiles externally the tar paper is unlikely to be a constraint, see Figure 11 on page 12.

Figure 10. Example loft space. 58 Redhatch Drive, Earley. 20.08.24

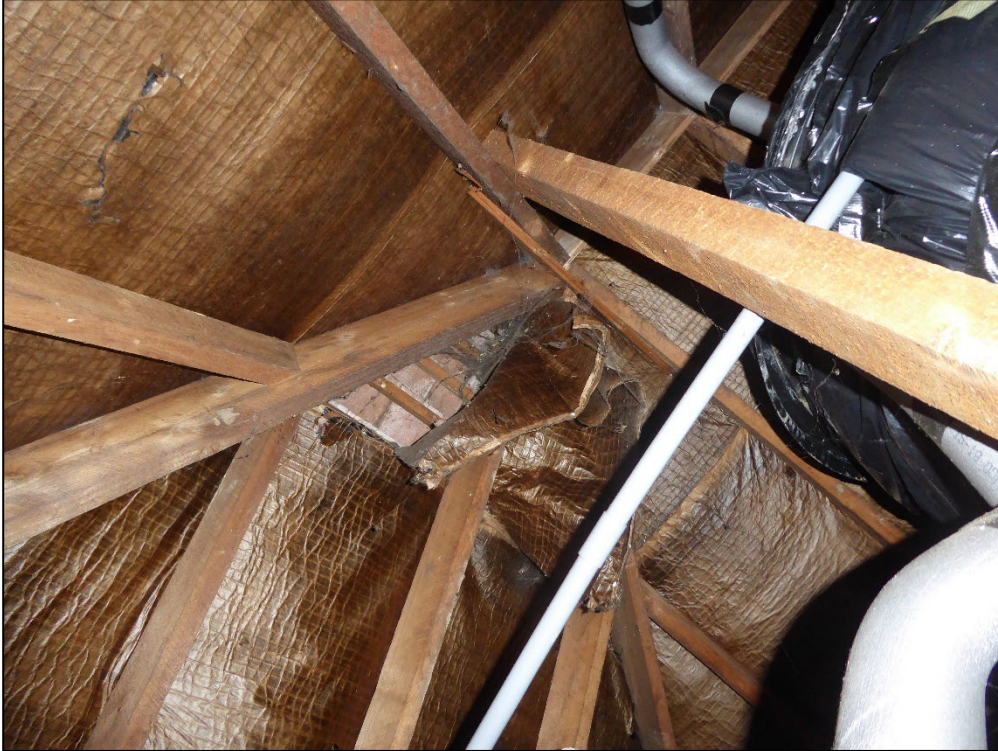
Figure 11. Example torn tar paper lining to roof tiles. 58 Redhatch Drive, Earley. 20.08.24

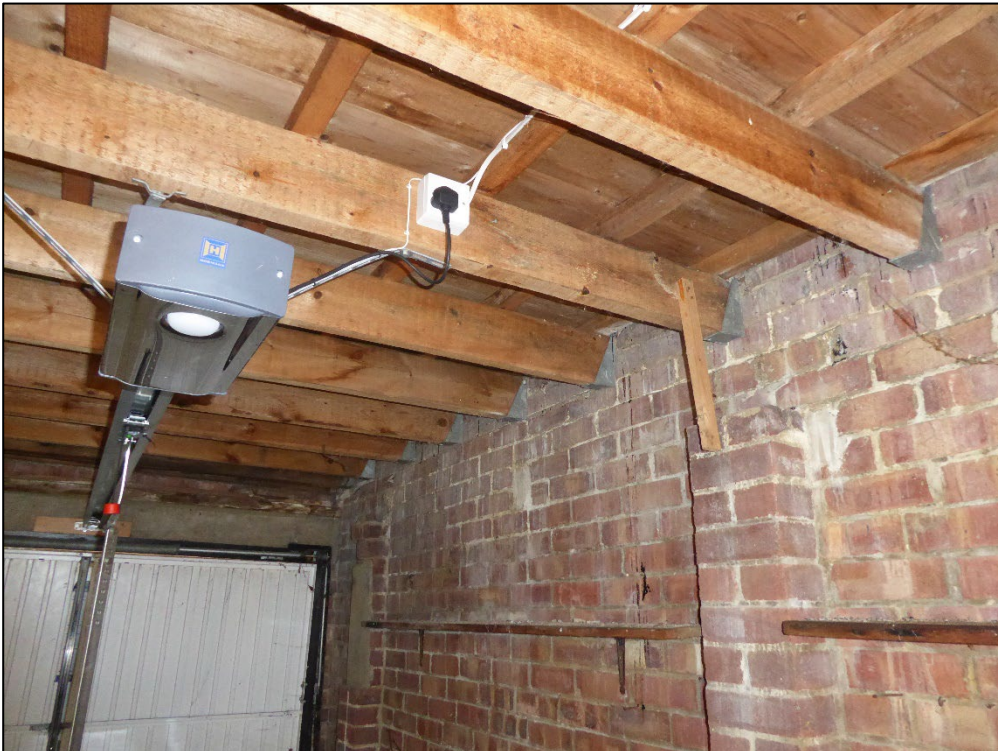
The garage did not have a loft but was inspected internally. The ceiling is boarded, all of which is in a good condition, see Figure 12 on page 12.

Figure 12. Example boarded garage ceiling. 58 Redhatch Drive, Earley. 20.08.24
