**Arboricultural Implications  
Assessment  
for a proposed development  
at  
145 Nash Grove Lane  
Finchampstead  
RG40 4HE  
Rev C**

**Client: Chris Evans Consultancy Ltd  
145 Nash Grove Lane  
Finchampstead  
RG40 4HE**

**Date**  
07/08/2025

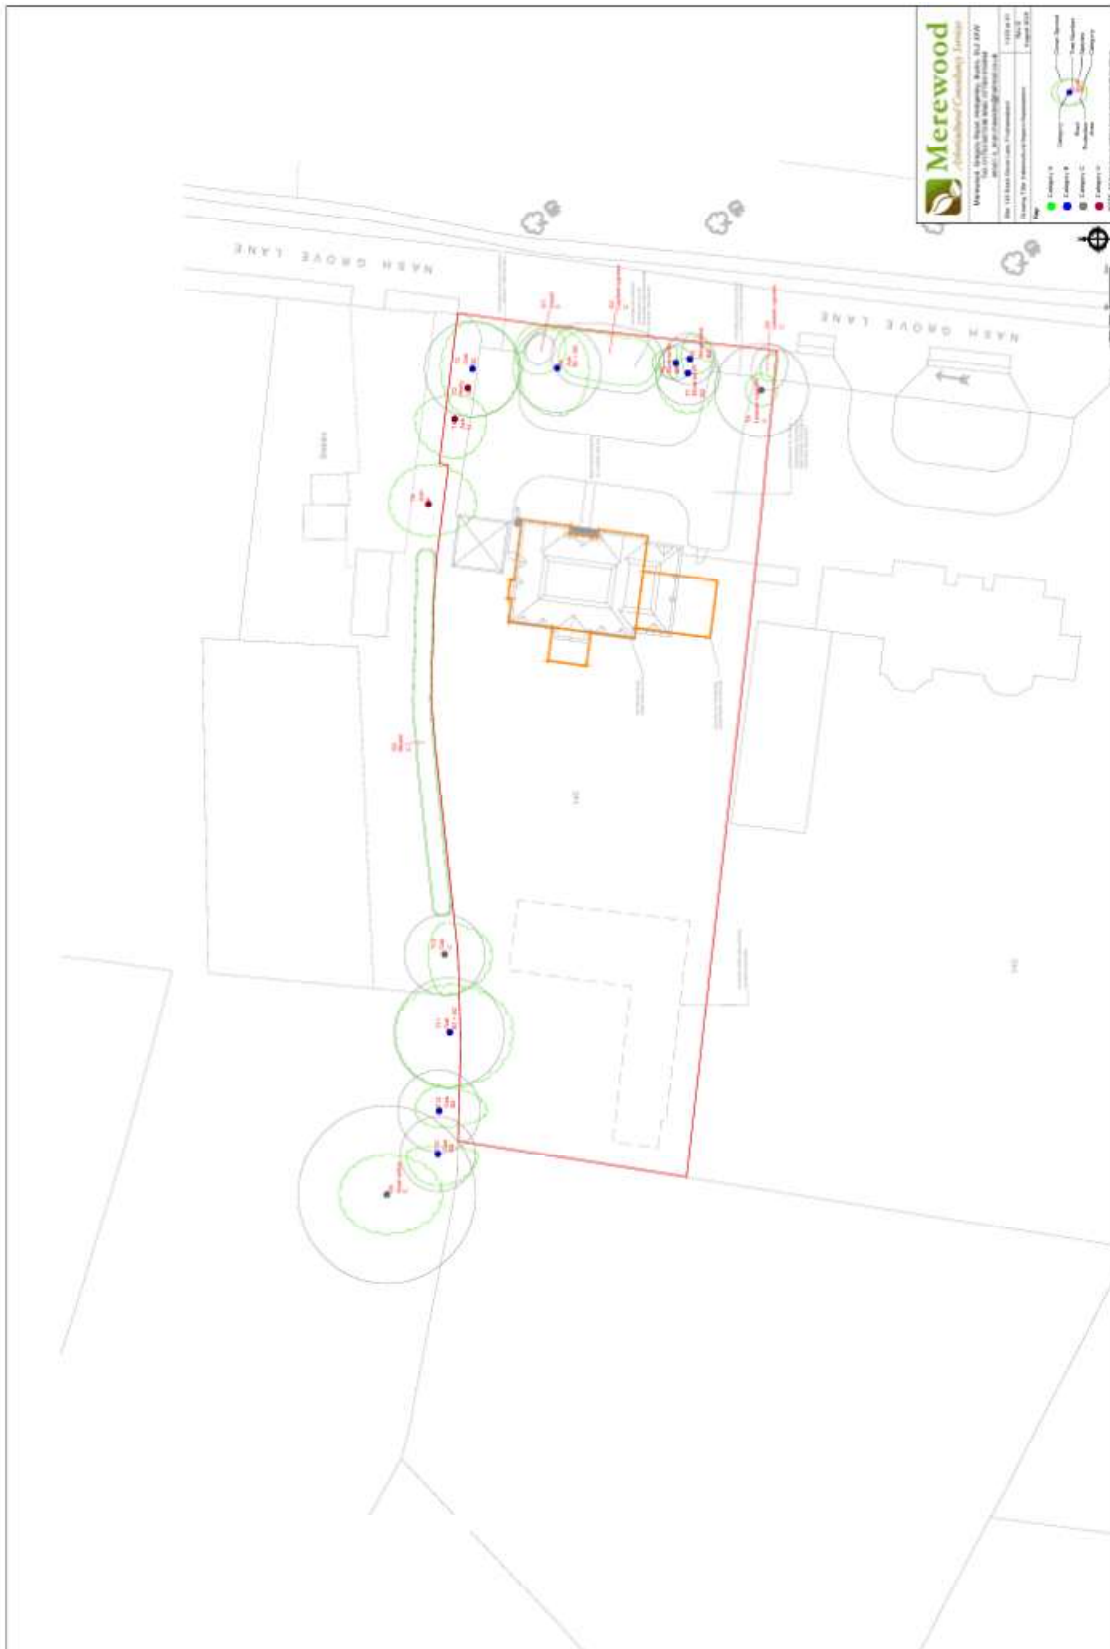
## Impact Assessment Plan

- 3.6.1 The excavations of the proposed foundations for the new house will take place outside the RPA's of any of the retained trees and will therefore have no bearing on the wellbeing of those trees.

- 3.7.1 The site working area will be established to the side of the new house away from the RPA's of the retained trees. There is enough space about the site for this to be possible.
- 3.7.2 Deliveries will be made by means of the existing driveway entrances off Nash Grove Lane. Materials are to be set down at the front of the site where they can remain in situ until needed or moved to a more appropriate area or be brought under cover if necessary.
- 3.7.3 The existing lawn area at the front of the site is to be used for the storage of cement and plaster bags hazardous chemicals and petrochemical products and will also provide a suitable area for mortar mixing in line with COSHH regulations to ensure there is no detrimental effect on trees.

3.4.1 The tree protection plan (see method statement) shows where fencing is to be erected prior to the commencement of works on the site.
