# Preliminary Roost Assessment

Lambwood Hill Farm, Lambwood Hill, Grazeley, Wokingham RG71JN

This report is prepared to inform a planning application with Wokingham Borough Council. The proposal can be described as: "A storey above an existing single storey building making complete building two storey."

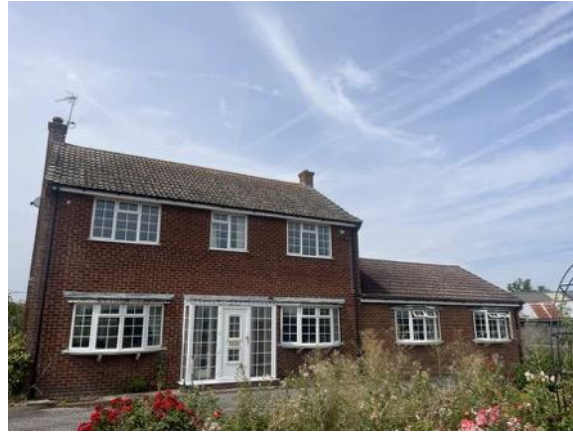
*Building B1 - eastern elevation*

The building is a residential dwelling with a gabled roof which. It is a single storey at the northern end and two-storey at the southern end. There is a single storey conservatory extension at the western elevation. The main roof is clad in interlocking concrete tiles, which have a small number of of lifted tiles and lead flashing which provide suitable access for crevice-dwelling bats. The hole in the chimney flue in loft void 1 provides suitable access for void dwelling bats. No bats or evidence of bats was found in either loft space. B1 has low value for roosting bats.

One bat emergence/re-entry survey is required on B1 during the active bat season (May – September) to confirm presence/likely-absence of bats roosting in or on the building.

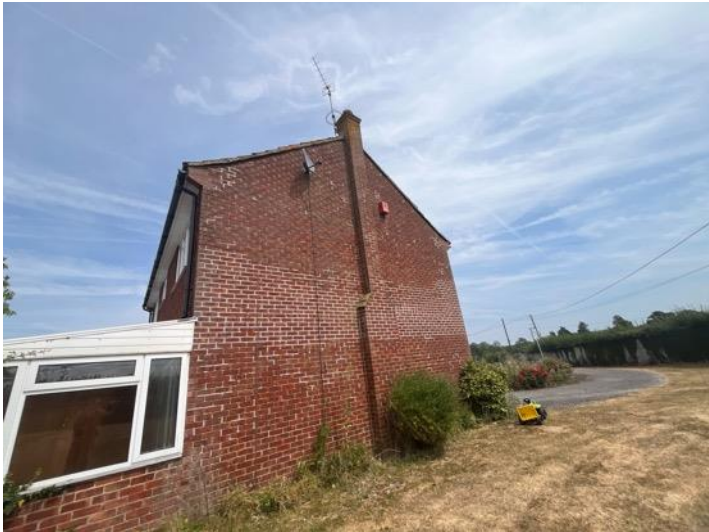
| Feature | Materials/Details | Condition / description / suitability | Photograph |
|---|---|---|---|
| Walls | Brick | <p><b>Condition/description</b><br/>The brick walls in good condition and are well sealed with no visible cracks or gaps.</p> <p><b>Suitability/access/evidence of bats</b><br/>The walls do not provide suitable roosting opportunities or access for crevice dwelling bats.</p> | |

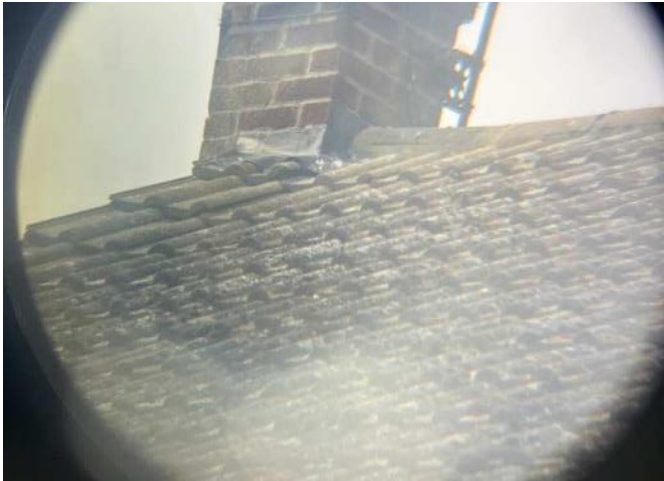
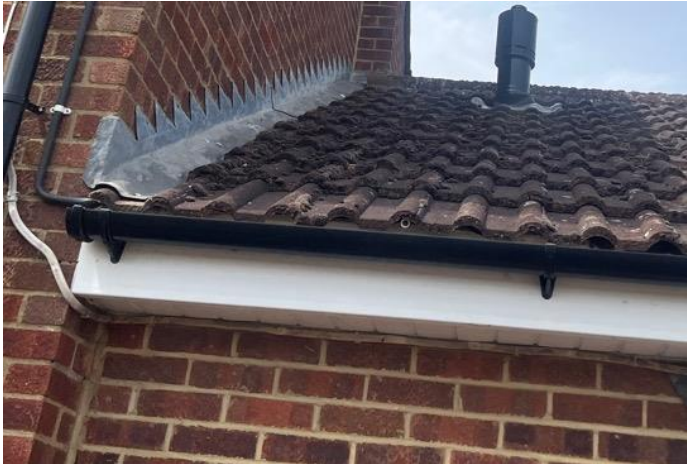
| Feature | Materials/Details | Condition / description / suitability | Photograph |
|---|---|---|---|
| Roof | Interlocking concrete tiles | <p><b>Condition/description</b><br/>Most of the tiles appear to be well sealed however there are a small number of lifted tiles and areas of lifted lead flashing, particularly associated with the the base of the chimney and vent pipes, and edge tiles.</p> <p><b>Suitability/access/evidence of bats</b><br/>The lifted tiles on both the eastern and western elevations of the single storey and two-storey elevations provide suitable access for crevice dwelling bats to utilise the space between the tiles and roof lining.</p> | <p><i>B1 roof – lifted tiles</i></p> |

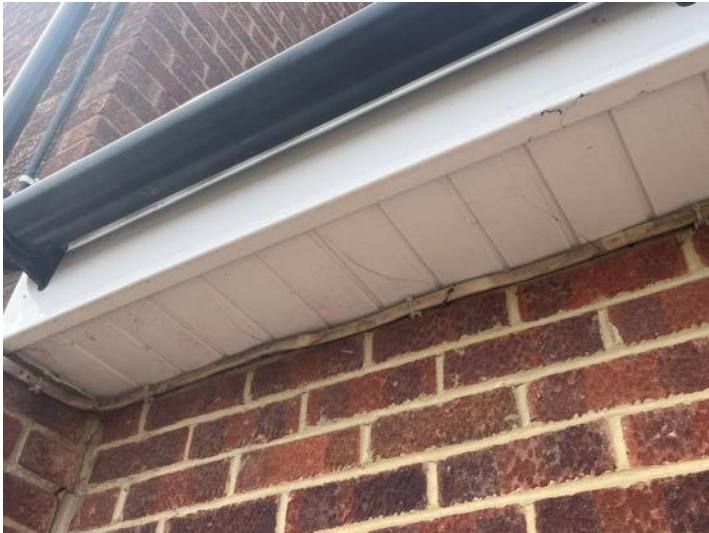
B1 roof – flashing gap

| Eaves | uPVC soffits | <p><b>Condition/description</b></p> <p>The uPVC soffits appear to be in good condition and are well sealed accross all elevations.</p> <p><b>Suitability/access/evidence of bats</b></p> <p>The soffits no not provide suitable roosting opportunities or access for crevice dwelling bats.</p> | |

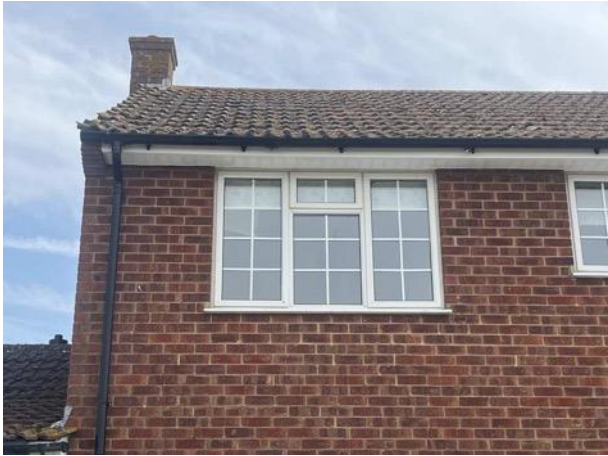
| Windows | uPVC | <p><b>Condition/description</b></p> <p>The uPVC framed windows are well sealed and in good condition.</p> <p><b>Suitability/access/evidence of bats</b></p> <p>The window and door frames do not provide suitable access or roosting opportunities for crevice dwelling bats.</p> | <p><i>B1 window / doors frames and lintels</i></p> |

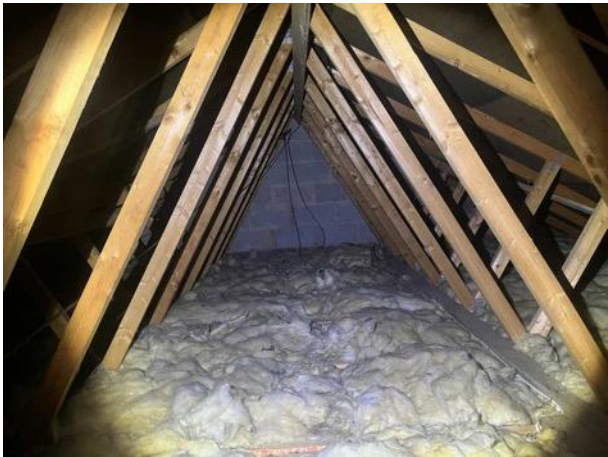
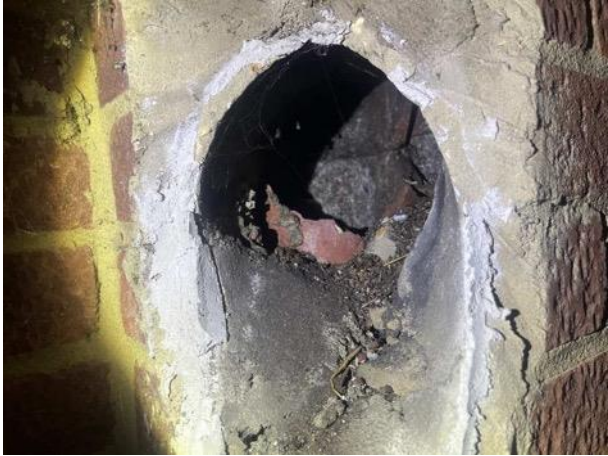
| Internal void 1 | <p>The first loft space inspected was of the single storey, northern end of B1. The loft space has timber rafter and is lined with bitumen felt. There are timber joists which are largely covered by mineral wool throughout floor area.</p> | <p><b>Condition/description/suitability and access</b></p> <p>The loft space is a disused, rarely visited loft space. No light ingress was noted in this loft space.</p> <p>Dimensions (approx): ~7m long, ~4m wide and ~1.5m peak height.</p> <p><b>Suitability/access/evidence of bats</b></p> <p>There is a large hole at the base of the chimney that provides suitable access for void dwelling bats.</p> <p>No bats or evidence of bats was found within this loft space.</p> | <p><i>B1 internal void 1</i></p> |

| | | | <p><i>B1 internal void 1 - base of chimney</i></p> |

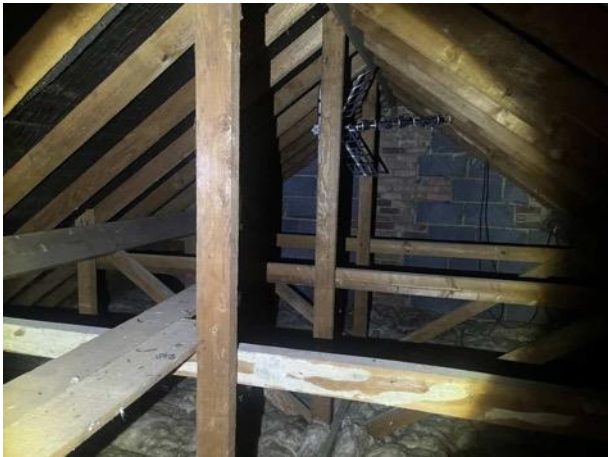
| Internal void 2 | <p>The second loft void inspected was of the two-storey, southern end of B1. The loft space is similar to that of loft space 1 but larger. There are timber joists and rafters, with mineral wool insulation covering most of the floor.</p> | <p><b>Condition/description</b></p> <p>The loft space is a disused, rarely visited loft space. Small areas of light ingress were visible at the eaves.</p> <p>Dimensions (approx): ~8m long, ~6m wide and ~2m peak height.</p> <p><b>Suitability/access/evidence of bats</b></p> <p>The gaps at the eaves are likely too small for void-dwelling bats to use as access points. No bats or evidence of bats was found in this loft space.</p> | <p><i>B1 internal void 2</i></p> |

B1: Nesting material (dry grass) was visible at the eaves of loft void 2 is indicative of house sparrows or starlings.

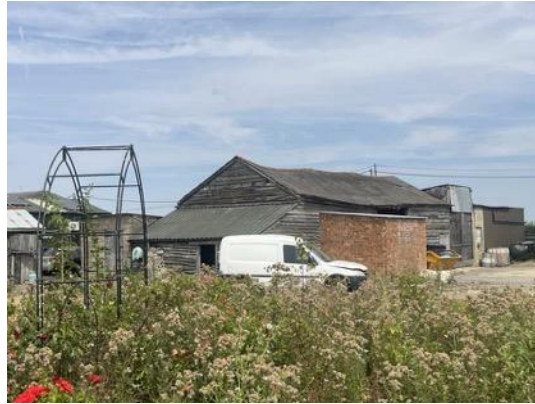
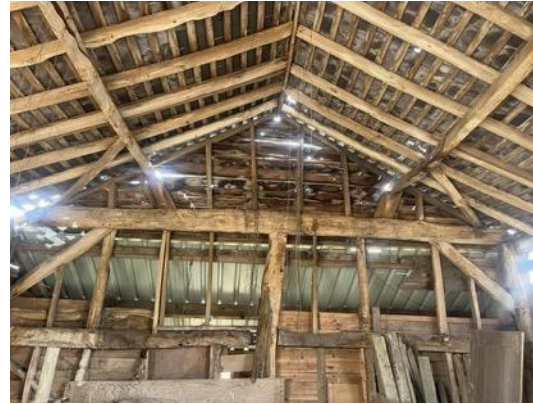
*Building B2*

The building is a barn with timber weatherboard walls and a gabled roof clad in slate tiles. Lifted timber slats on the walls present suitable roosting opportunities for crevice-dwelling bats, and the open nature of the barn provides access points for both crevice and void dwelling species. While the numerous lifted and missing

tiles offers suitable gaps, the significant light ingress and lack of a roof lining limit its suitability for daytime roosting. The internal void consists of timber rafters with no lining. The building has low habitat value.

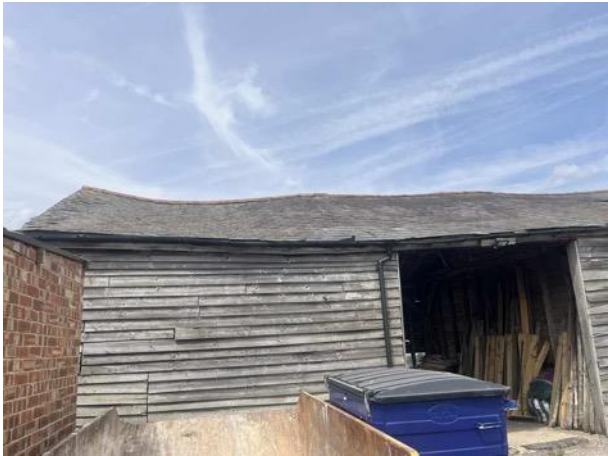
| Feature | Materials/Details | Condition / description / suitability | Photograph |
|---|---|---|---|
| Walls | Timber | <p><b>Condition/description</b><br/>The timber weatherboarding is in poor condition and many slats are lifted.</p> <p><b>Suitability/access/evidence of bats</b><br/>The lifted timber slats provide suitable roosting opportunities for crevice-dwelling bats.</p> | <p>B2 walls</p> |

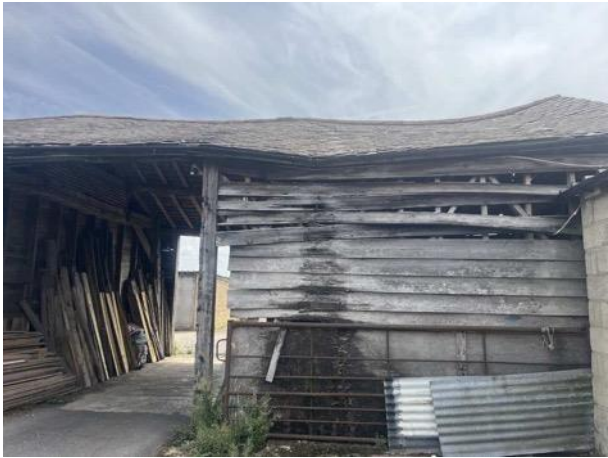
| Feature | Materials/Details | Condition / description / suitability | Photograph |
|---|---|---|---|
| Roof | Slate | <p><b>Condition/description</b><br/>The roof appears to be in poor condition as it is now misshapen. There are a high number of lifted and missing tiles across both elevations of the gabled roof.</p> <p><b>Suitability/access/evidence of bats</b><br/>Although the roof is in poor condition with tile gaps, there is no roof lining under the tiles and there is significant light ingress in the barn, owing to the lack of doors. Therefore, the roof</p> | <p>B2 roof</p> |

| | | provides minimal suitability for crevice dwelling bats to roost in during the day. | <p><i>B2 roof</i></p> |

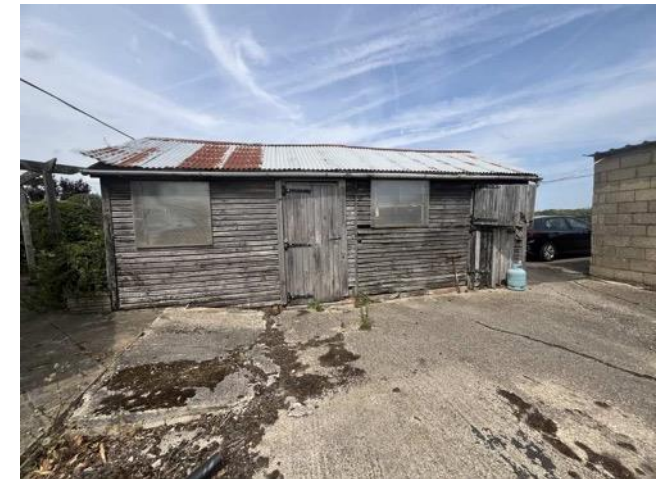
*Building B3***Table 5c:** The roosting features associated with building B3.

The building is a barn with timber weatherboard walls and a metal sheet roof. While the walls are generally well-sealed, an open window presents a potential access point for crevice and void dwelling bats into the internal space. The internal void, lined with timber sarking and rafters, offers suitable roosting opportunities, though significant light ingress through the open window reduces its suitability as a day roost. No bat evidence was observed during the survey. The building has low habitat value.

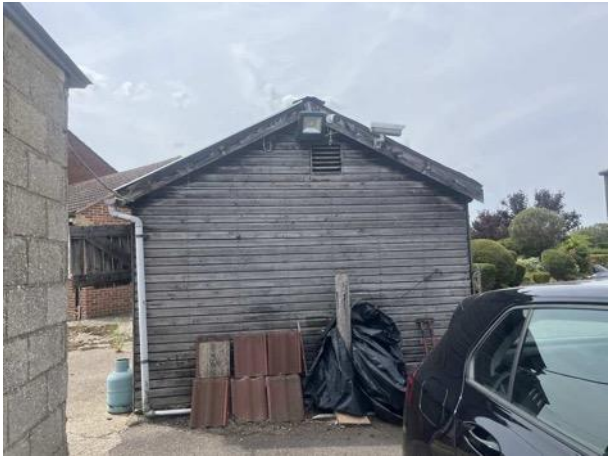
| Feature | Materials/Details | Condition / description / suitability | Photograph |
|---|---|---|---|
| Walls | Timber | <p><b>Condition/description</b><br/>The walls appear to be well sealed and in good condition with no obvious gaps.</p> <p><b>Suitability/access/evidence of bats</b><br/>The walls do not provide suitable roosting opportunities for bats, however, the window does not seal shut and was observed as being left open during the survey. Although the timber weatherboarding does not provide suitable roosting opportunities for crevice dwelling bats, the window may provide suitable access to crevice and void dwelling bats to utilise spaces within the barn.</p> | <p><i>B3 walls</i></p> |

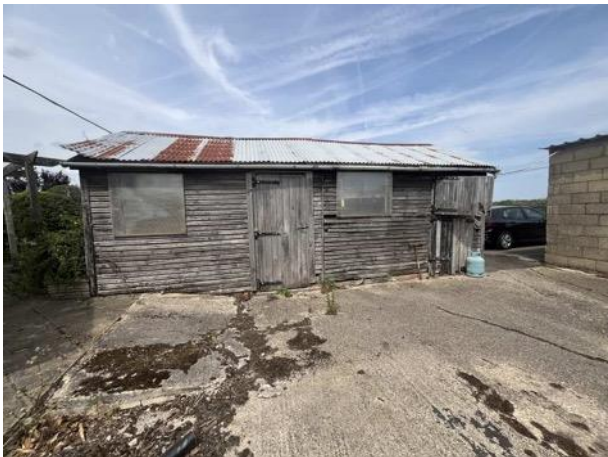
| Feature | Materials/Details | Condition / description / suitability | Photograph |
|---|---|---|---|
| Roof | Metal sheeting | <p><b>Condition/description</b><br/>The roof appears to be in good condition with no obvious damage.</p> <p><b>Suitability/access/evidence of bats</b><br/>The roof does not appear to provide suitable access for bats. Additionally, due to the thermal properties and texture of the metal (the temperature fluctuates drastically and smooth surface offers no grip), the roof is unsuitable for roosting bats.</p> | <p><i>B3 roof</i></p> |

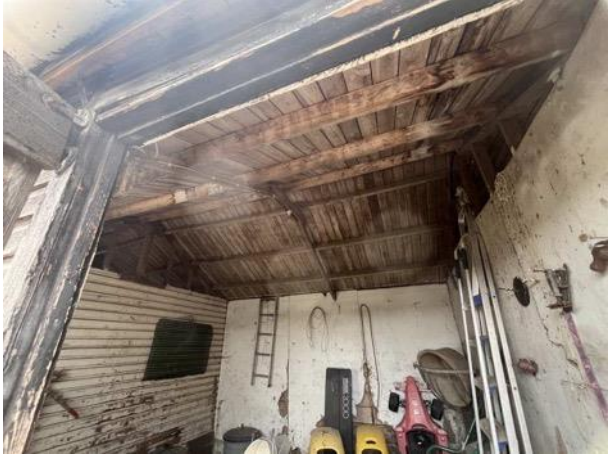
| Internal void 1 | The roof is lined with timber sarking and there are timber rafters. | <p><b>Condition/description</b></p> <p>The internal void appeared to be in good condition with no obvious cracks or holes in the internal walls or roof.</p> <p><b>Suitability/access/evidence of bats</b></p> <p>The barn window provides suitable access for crevice and void dwelling bats to access the internal space within the barn. The timber rafters provide suitable roosting opportunities for roosting bats however, the open window introduces significant light ingress which lowers the suitability for a day roost. No bats or evidence of bats was found internally.</p> | <p><i>B3 internal void 1</i></p> |

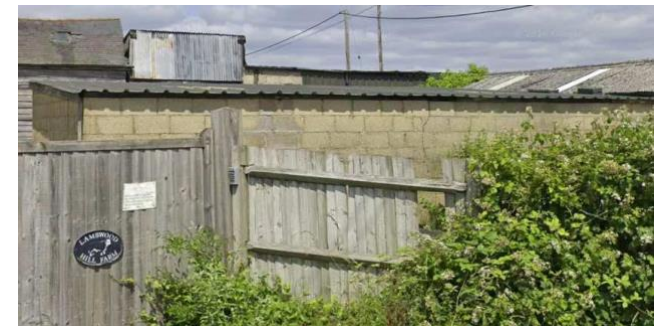
*Building B6*

B6 is a brick-built, small shed with a flat corrugated metal roof and is deemed as having negligible value for roosting bats due to a lack of suitable roosting features.

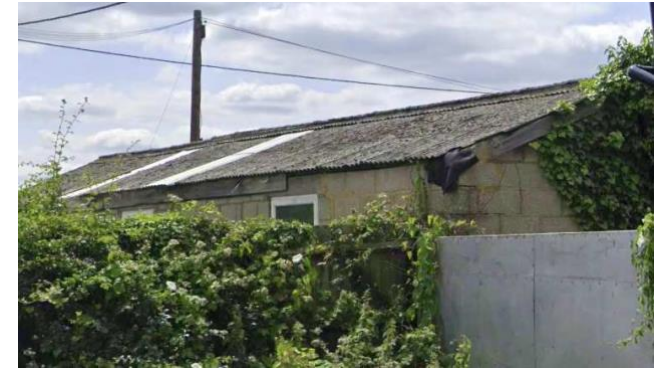
*Building B7*

B7 is a brick-built shed with a gabled, corrugated metal roof. B7 is deemed as having negligible habitat for roosting bats due to a lack of suitable bat features.

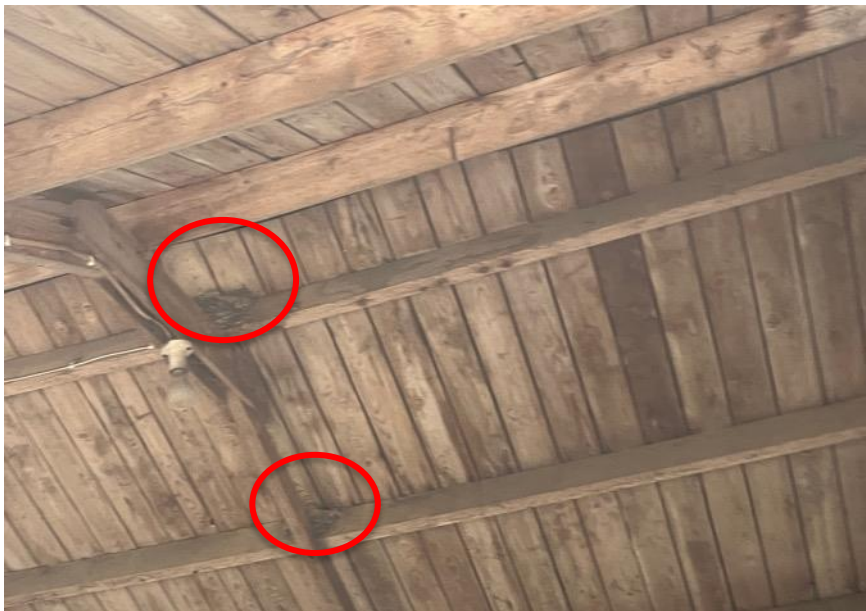
B3: Active barn swallow nest cups are present inside of B3, along the timber rafters. High levels of barn swallow activity were observed during the site visit.

*Barn swallow nest cups inside B3*

Precautions should be taken with machinery and noise levels when working close to any retained nests (within B3) so as not to disturb any nearby nesting birds during construction works. At least a 3-5m buffer should be created between any machinery and active nests until the young have fledged or an ecologist has confirmed the nesting attempt has concluded.

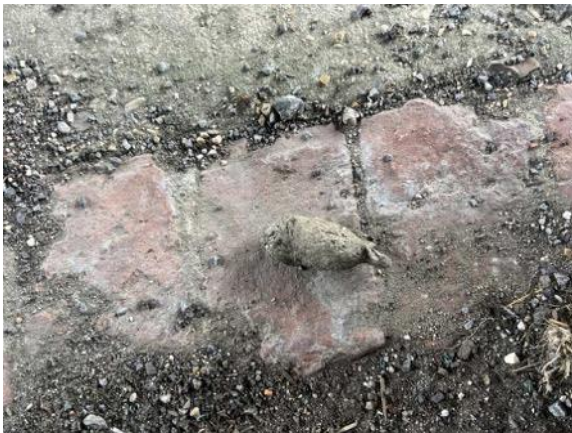
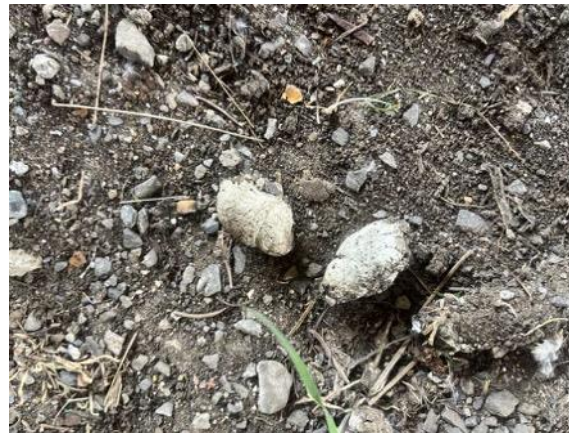
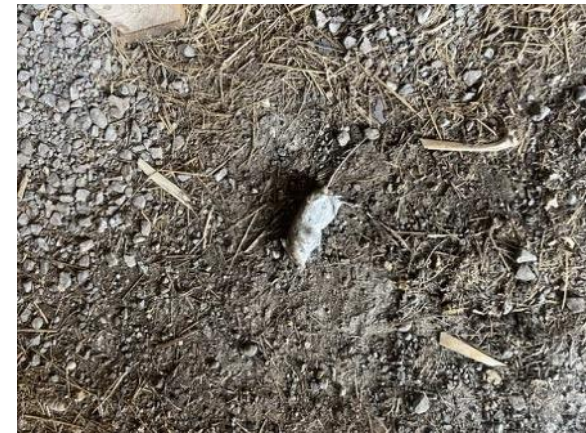
Roughly six (suspected) barn owl pellets were found on the floor of B2 along with a dead mouse and a large bone. They are grey in appearance indicating they are ~2 years old. No barn owls were seen at the time of the survey.

*Barn owl pellet*

*Barn owl pellets*

*Bone and mouse on floor of barn*

- As owls can nest at any time of year, a pre-commencement check for nesting birds will be conducted (within 48 hours of the start of works).
- Use of a Heras style buffer around the barn to prevent encroachment of heavy machinery near the barn which would disturb nesting barn owls if present.
