**1 Talbot Cottages  
Forest Road  
Wokingham  
RG40 5SG**

## **Preliminary Roost Assessment**

Report ref.: R2798\_PRA\_a

**November 2024**

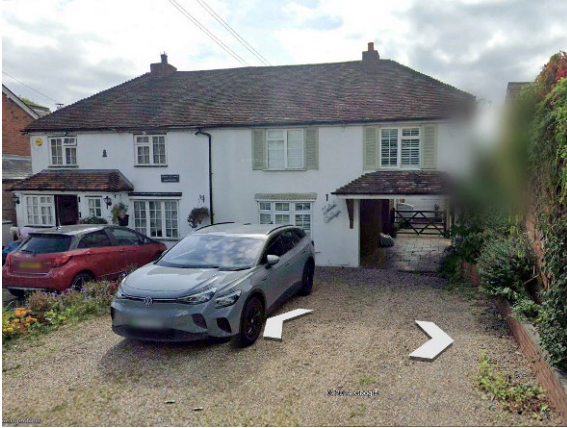
- 5.2.2** The property was a semi-detached house with brick walls and a hipped roof with a carriage way and rear gable end; single-storey extensions, including a conservatory, were present to the rear (**Photographs 1 & 2**).

Photograph 1. Front of property viewed from north (Google Earth 09/2023).

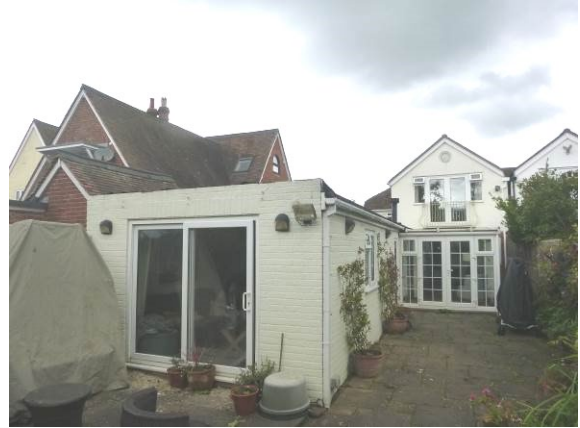
Photograph 2. Rear of property viewed from south.

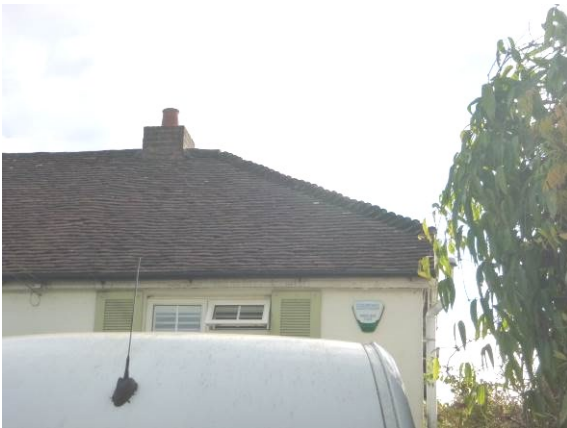
- 5.2.3** The roof was covered in overlapping clay tiles that were uneven, with a tile missing on the front elevation, giving rise to numerous potential ingress opportunities for crevice-dwelling bats (**Photograph 3; Target note 1**). The rear gable end featured tight uPVC barge boards and intact verge mortar with no potential bat access points (**Photograph 4**). The rear conservatory had a clear corrugated roof with tight uPVC fascias (**Photograph 5**). There was a hole at the corner of the conservatory roof that was considered unsuitable for use by roosting bats (**Photograph 6**).

Photograph 3. Uneven clay tiles (front elevation).

- 7.1.2** The development proposals only affect the single-storey elements of the house and therefore will have no impact on any of the potential roost sites associated with the uneven clay tiles at the roof level. **Therefore, it is considered highly unlikely that the construction activities would result in the damage/destruction of a bat roost or lead to disturbing/harming bats.**

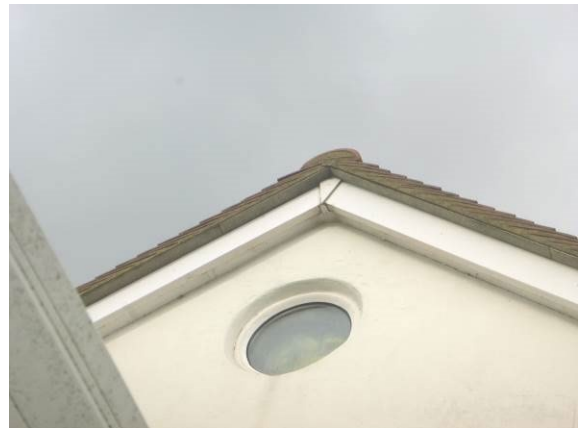
Photograph 4. Tight uPVC barge boards on rear gable end (rear elevation).

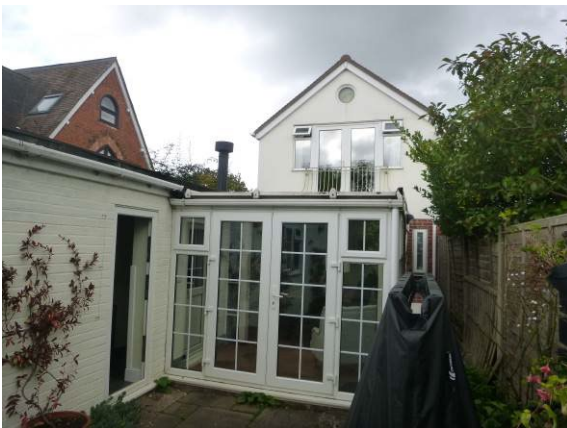
Photograph 5. Rear conservatory (rear elevation).

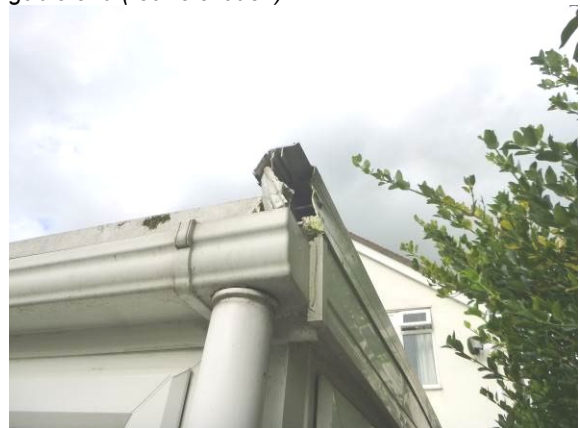
Photograph 6. Hole in conservatory roof (rear elevation).

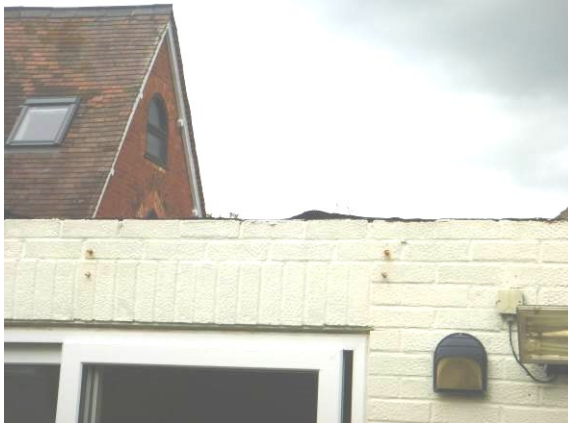
- 5.2.4** The single-storey rear extension was of brick construction and had a bituminous flat roof that had been subject to temporary patch repairs. The bituminous roofing felt was lifted at the end of the extension and there was a slight gap behind the uPVC fascia on the eastern elevation; both gaps were of limited extent and of negligible value to roosting bats (Photograph 7). A gap behind roofing felt at the corner of the extension had low suitability for use by crevice-dwelling bats but a close inspection of the feature found no evidence of bat presence (Photograph 8; Target note 2).

Photograph 7. Lifted roofing felt bituminous on extension (rear elevation).

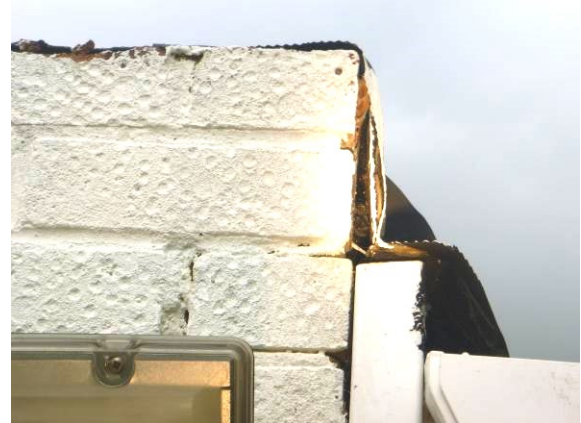
Photograph 8. Gap behind roofing felt at corner of extension (rear elevation).

- 6.1.3** A gap behind bituminous roofing felt on the single-storey rear extension was assessed as a low suitability potential roost site due to its location and scale, and a thorough inspection of the feature confirmed bat absence. But the house also has numerous potential roosting opportunities for small crevice-dwelling bats, such as the locally recorded common pipistrelle (*P. pipistrellus*) and soprano pipistrelle (*P. pygmaeus*), between uneven overlapping clay tiles and intact hessian-reinforced bituminous roofing felt beneath. These potential roost sites in the roof of the house are considered likely to have capacity to support regular use by individual or small groups of non-breeding bats. The current evidence suggests that a maternity colony is unlikely to be present but it cannot be conclusively ruled out at this stage. Therefore, the house has been assigned moderate potential suitability for bats (see **Appendix 1** for potential suitability categories).

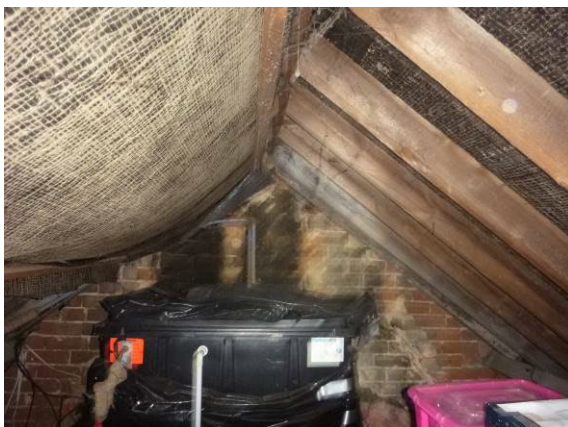
- 5.2.6** Two loft spaces were present in the roof and were separated by a brick internal wall (Roof voids 1 & 2); each roof void was accessible via a first floor loft hatch (Photographs 7 & 8).

Photograph 7. Roof void 1.

- 5.2.7** The voids had an approximate floor-to-ridge height of 1.5m, were of 'cut and pitch' hipped construction and each had a covered water tank. The roof was lined with an

intact hessian-reinforced bituminous felt and the ridge was cobwebbed throughout, indicating a lack of recent void-dwelling bat activity. The floor was partially boarded and insulated with fibreglass throughout; the eaves were filled with vermiculite insulation in Roof void 1 and with fibreglass in Roof void 2.

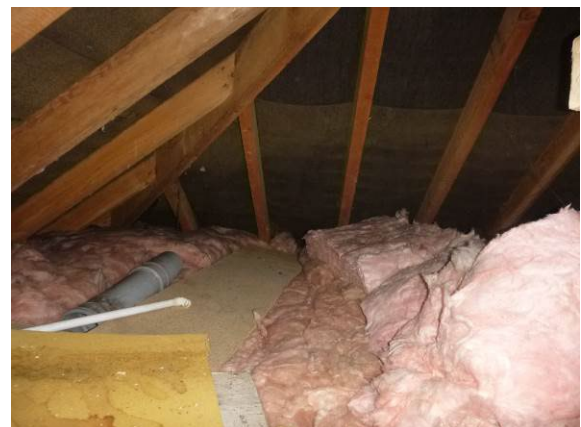
Photograph 8. Roof void 2.
