## Preliminary Roost Assessment

The Horns, Crazies Hill, Berkshire, RG10 8LY

Horns Hospitality Ltd

Remove internal walls and chimney breasts from both ground and upper floors to open up the bar area and allow for bedroom accommodation upstairs.

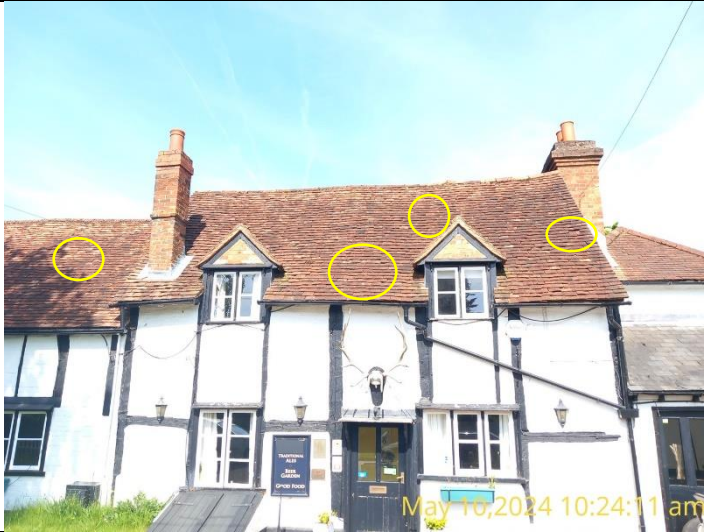
**B1 – Southeast elevation**  
This elevation of B1 is clad in clay tiles. There are numerous tiles which are raised and/or missing. These gaps provide suitable roosting features of which crevice dwelling bats could exploit.

| <i>Recommendations</i> | <p><b>Three bat emergence surveys</b> are required during the active bat season (optimal May to August, suboptimal September) to confirm presence or likely absence of a bat roost in the building. Both surveys should be completed during the optimal survey period mid-May to August inclusive.</p> <p>Infra-red cameras should be used as an aid. Surveys should be a minimum of three weeks apart.</p> <p><b>Four surveyors</b> are required to provide full coverage of the building.</p> <p>If bat roosts are confirmed in the building one additional survey will be required to characterise the roost and to inform an EPSL application to Natural England. The EPSL application requires that surveys have been undertaken within the most recent active bat season and planning permission must have been granted and all relevant wildlife-related conditions have been discharged prior to submission.</p> <p>A low impact lighting strategy will be adopted for the site during post-development which outlines the areas of the site that will be retained as dark corridors. Parameters can be found on the Bat Conservation Trust website:<br/> <a href="https://www.bats.org.uk/our-work/buildings-planning-and-development/lighting-2">https://www.bats.org.uk/our-work/buildings-planning-and-development/lighting-2</a></p> <p>Habitat creation could be considered to enhance opportunities at the site for foraging and commuting bats post development: (list out nice things for bats, night scented flowers, native trees and native flowering</p> |

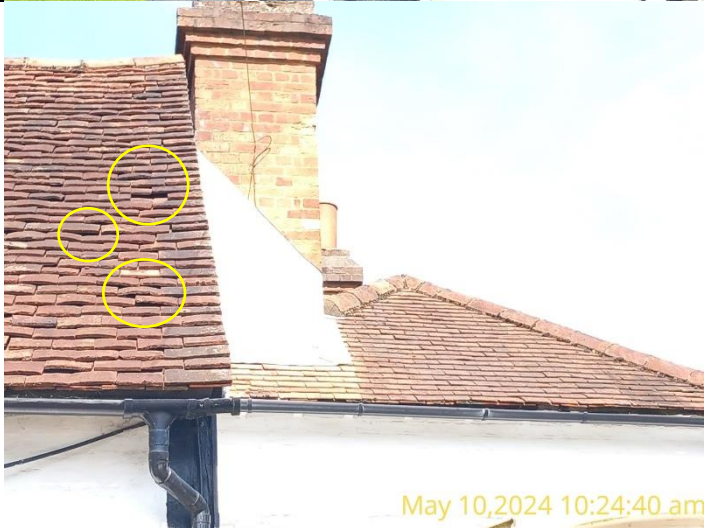
**B1 – North elevation**  
The raised clay tiles provide opportunities for crevice dwelling bats to roost.

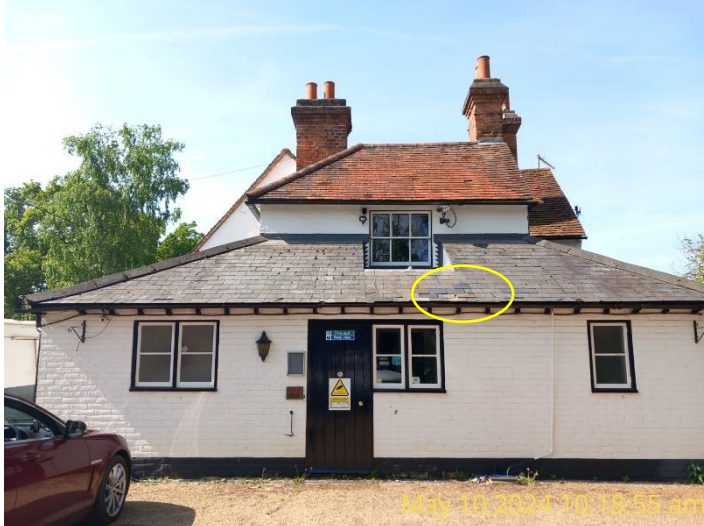
**B1 – Northeast elevation**

The sub roof on this elevation is clad in slate tiles. There are areas of cracked tiles on the slate roof, which provide roosting potential for crevice dwelling bats. The clay roof provides roosting features (as seen in the close-up photo above).

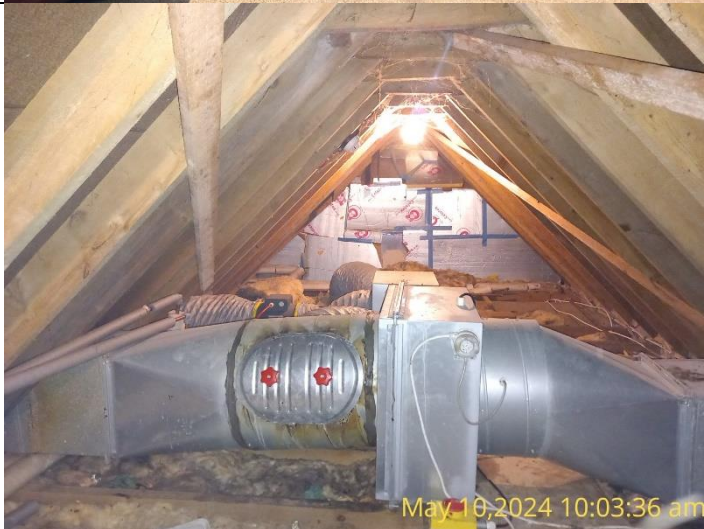
**B1 – Interior**

Abiotic recordings within loft space one: 21.1°C and 55.2% relative humidity at the time of the survey. The loft was unboarded and was viewed from the loft hatch, the floor of the loft was covered in mineral wool insulation and the interior of the roof was lined with bitumen. No evidence of bats was found within this loft space.

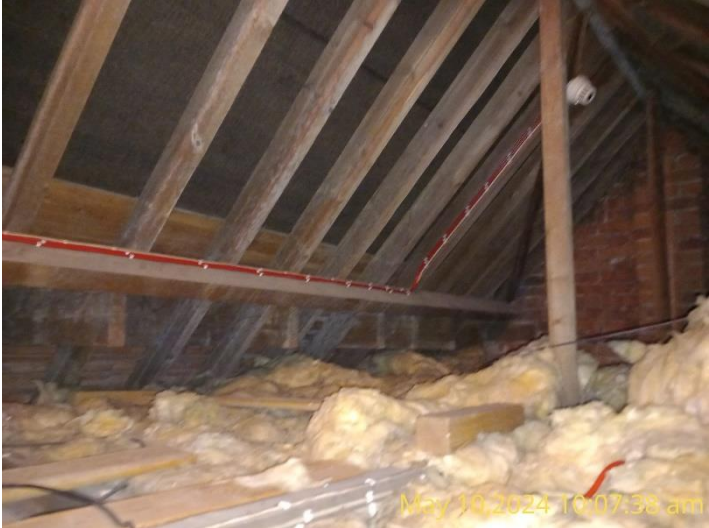
| | <p>B1 – Interior</p> <p>Abiotic recordings within loft space two: 21.2°C and 65.9% relative humidity at the time of the survey. The loft was unboarded and was viewed from the loft hatch, the floor of the loft was covered in mineral wool insulation and the interior of the roof was lined with bitumen. No evidence of bats was found within this loft space.</p> |

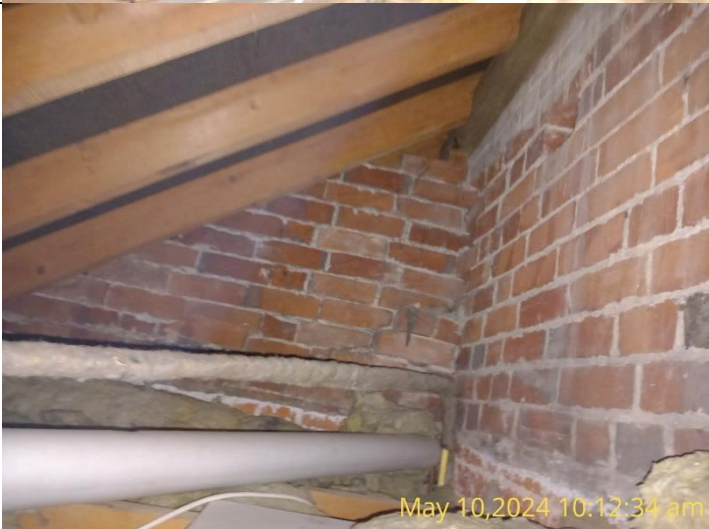
| | <p>B1 – Interior</p> <p>Abiotic recordings within loft space three (small loft space): 21°C and 67.9% relative humidity at the time of the survey. The loft was unboarded and was viewed from the loft hatch, the floor of the loft was covered in mineral wool insulation and the interior of the roof was lined with bitumen. No evidence of bats was found within this loft space.</p> |

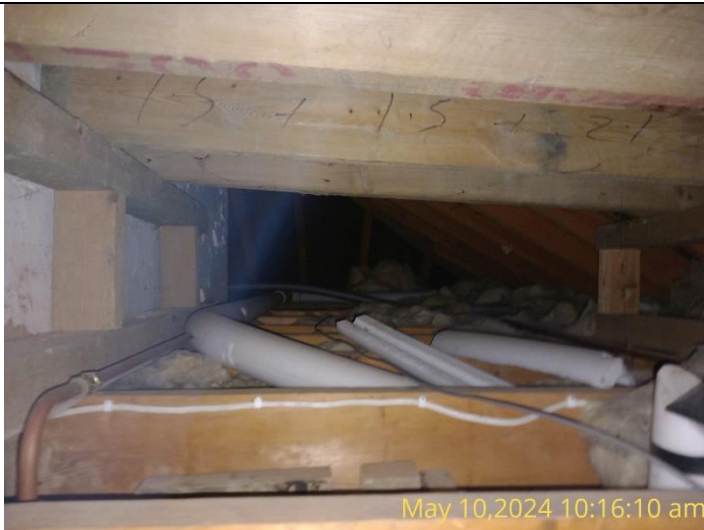
**B1 – Interior**

Abiotic recordings within loft space four (small loft space): 21.7°C and 73.9% relative humidity at the time of the survey. The loft was unboarded and was viewed from the loft hatch, the floor of the loft was covered in mineral wool insulation and the interior of the roof was lined with bitumen. No evidence of bats was found within this loft space.
