# Contaminated Land Watching Brief

23 July 2024

Land at 304 London Road, Wokingham, Wokingham, RG40 1RD

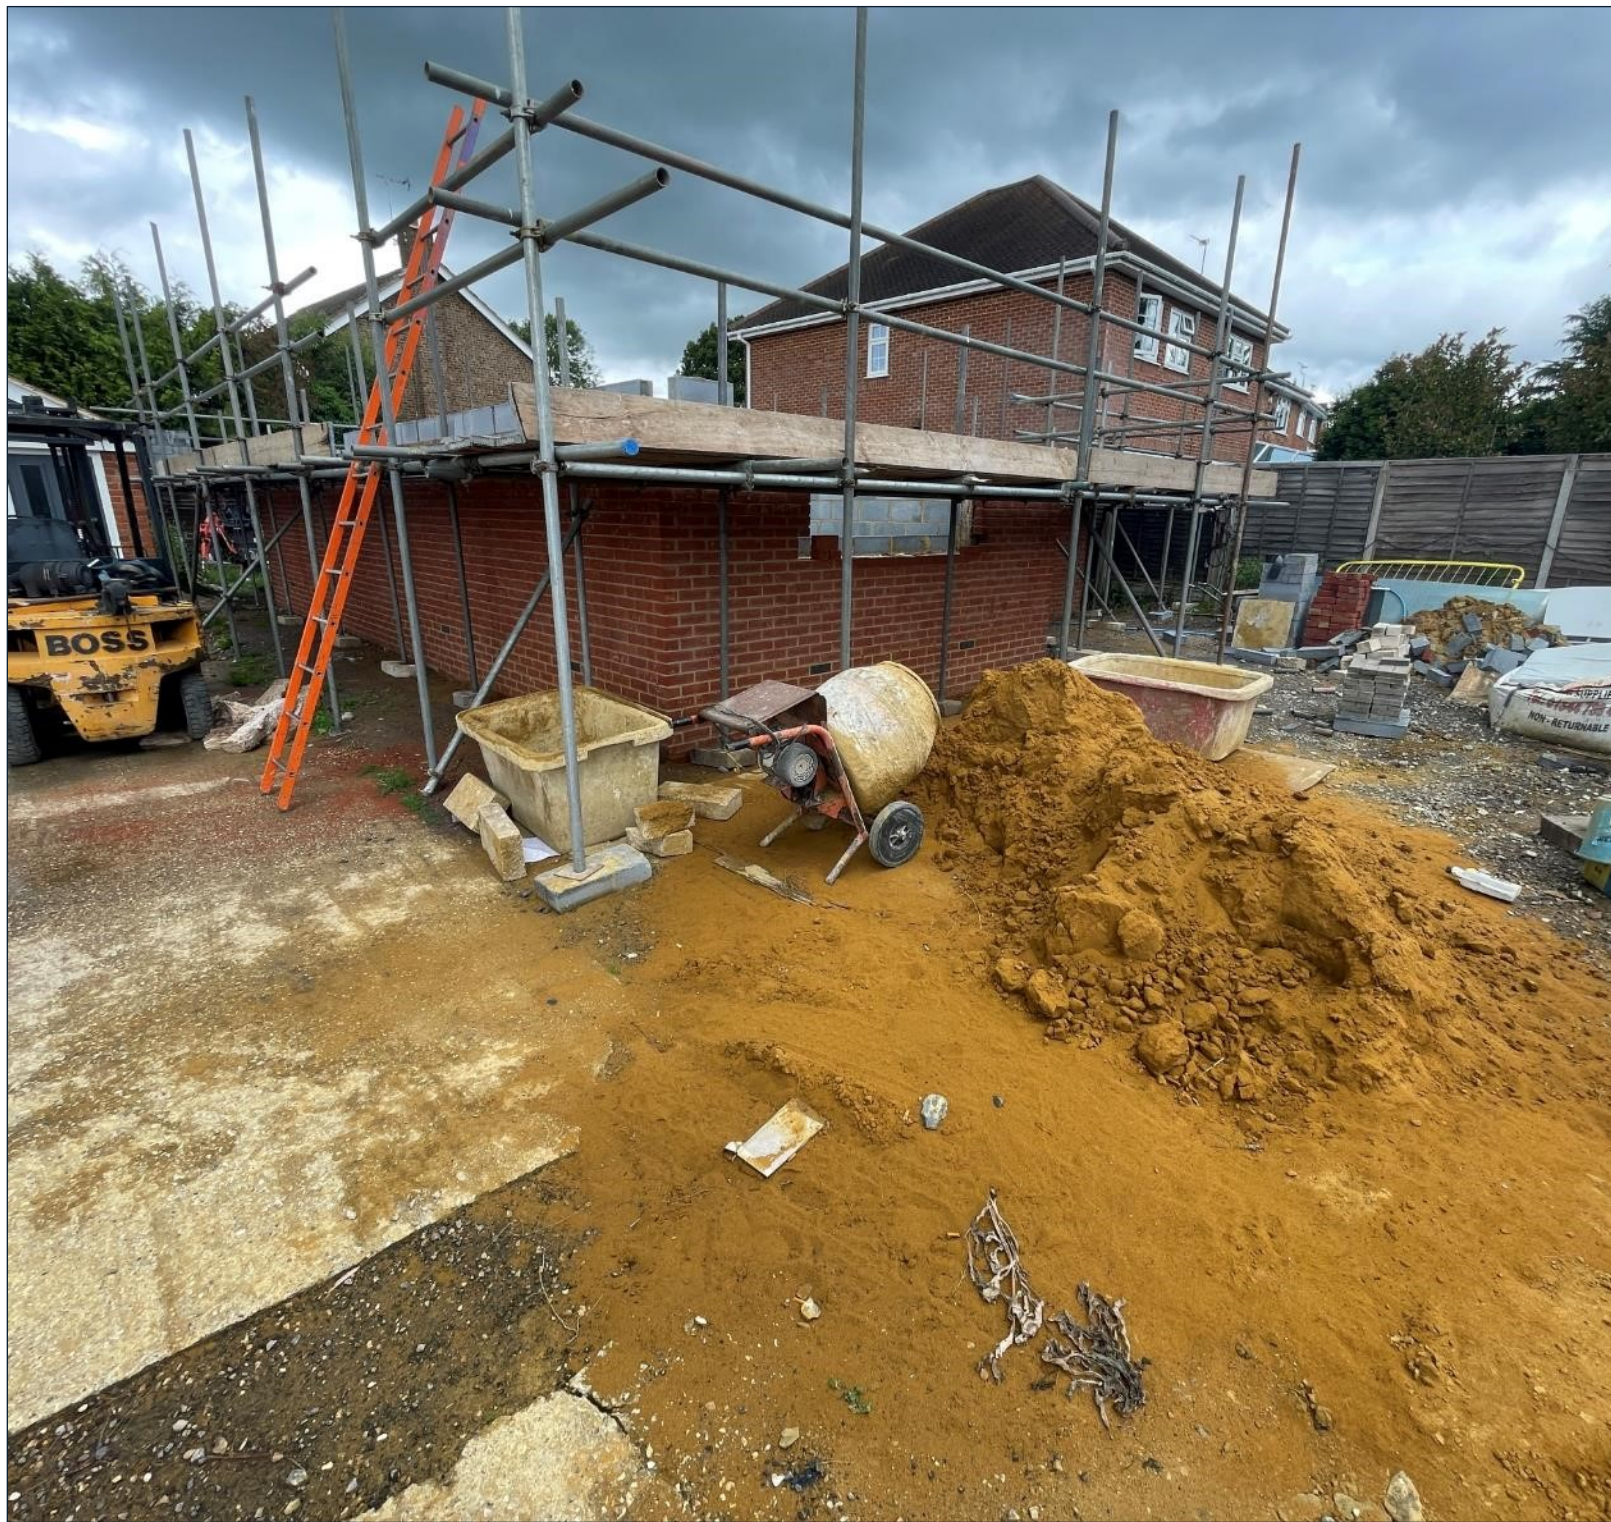
During the site visit it was observed that the foundations and block and beam floor of the proposed dwelling had been completed, in addition, the brick external walls had been partially completed at the ground floor.

No visible or olfactory evidence of contamination was identified within surface soils and no evidence of recent contamination or pollution events was found.

Photo showing the dwelling and site during a site inspection on 5<sup>th</sup> July 2024

Based on a review of supporting evidence and a site inspection, no further investigation is considered necessary.

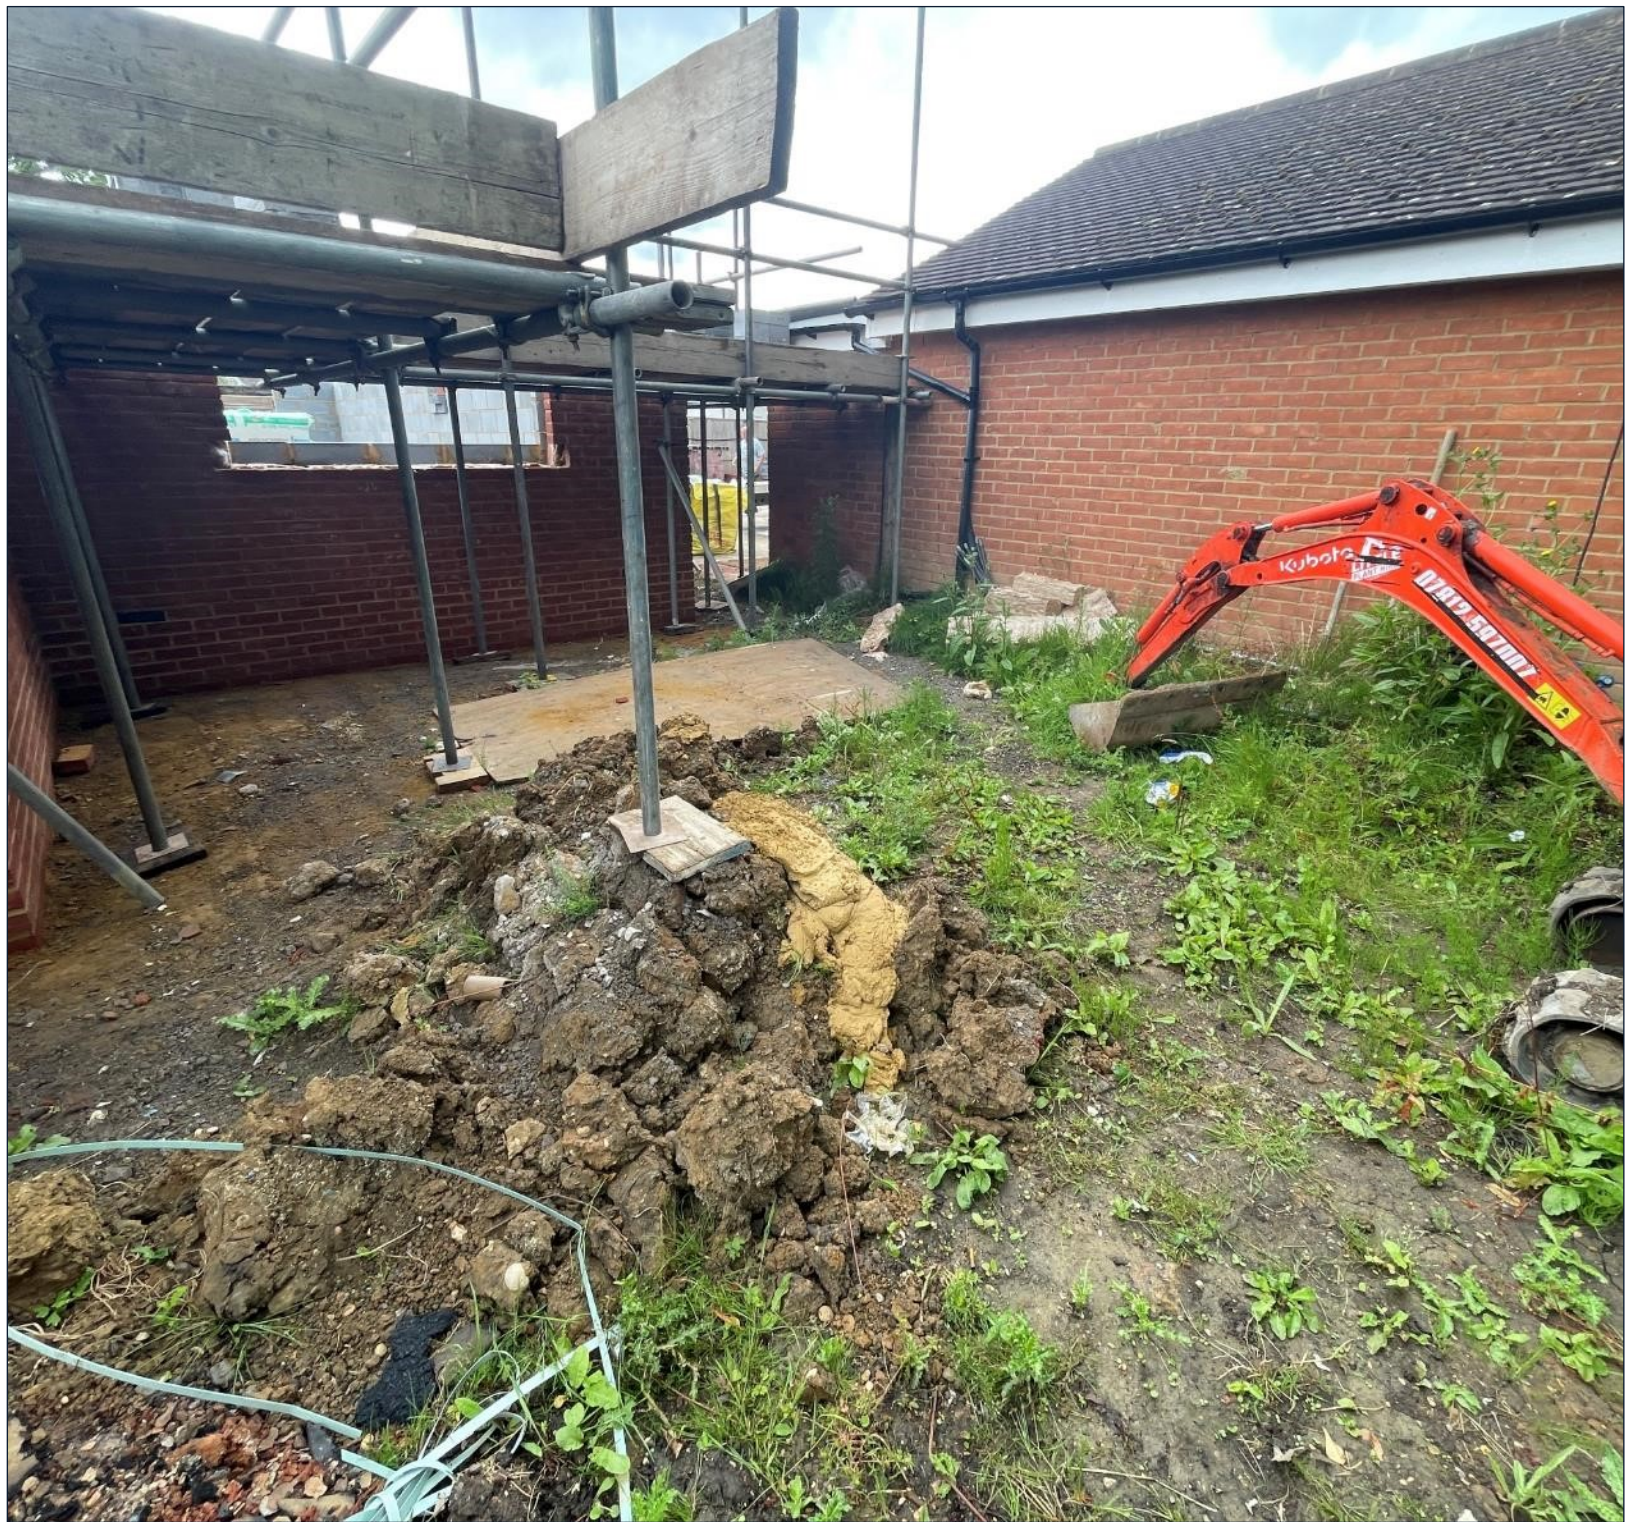
As no exposed excavations were present on site during the site visit, a trial pit was hand dug to a depth of 1m in the proposed rear garden, in order to further investigate the presence of potentially contaminated made ground. Ground conditions encountered comprised shallow dark brown silty clay topsoil with light brown clay below. No made ground or visible or olfactory evidence of contamination was identified in the trial pit.

Photo showing the rear garden and dwelling during a site inspection on 5<sup>th</sup> July 2024

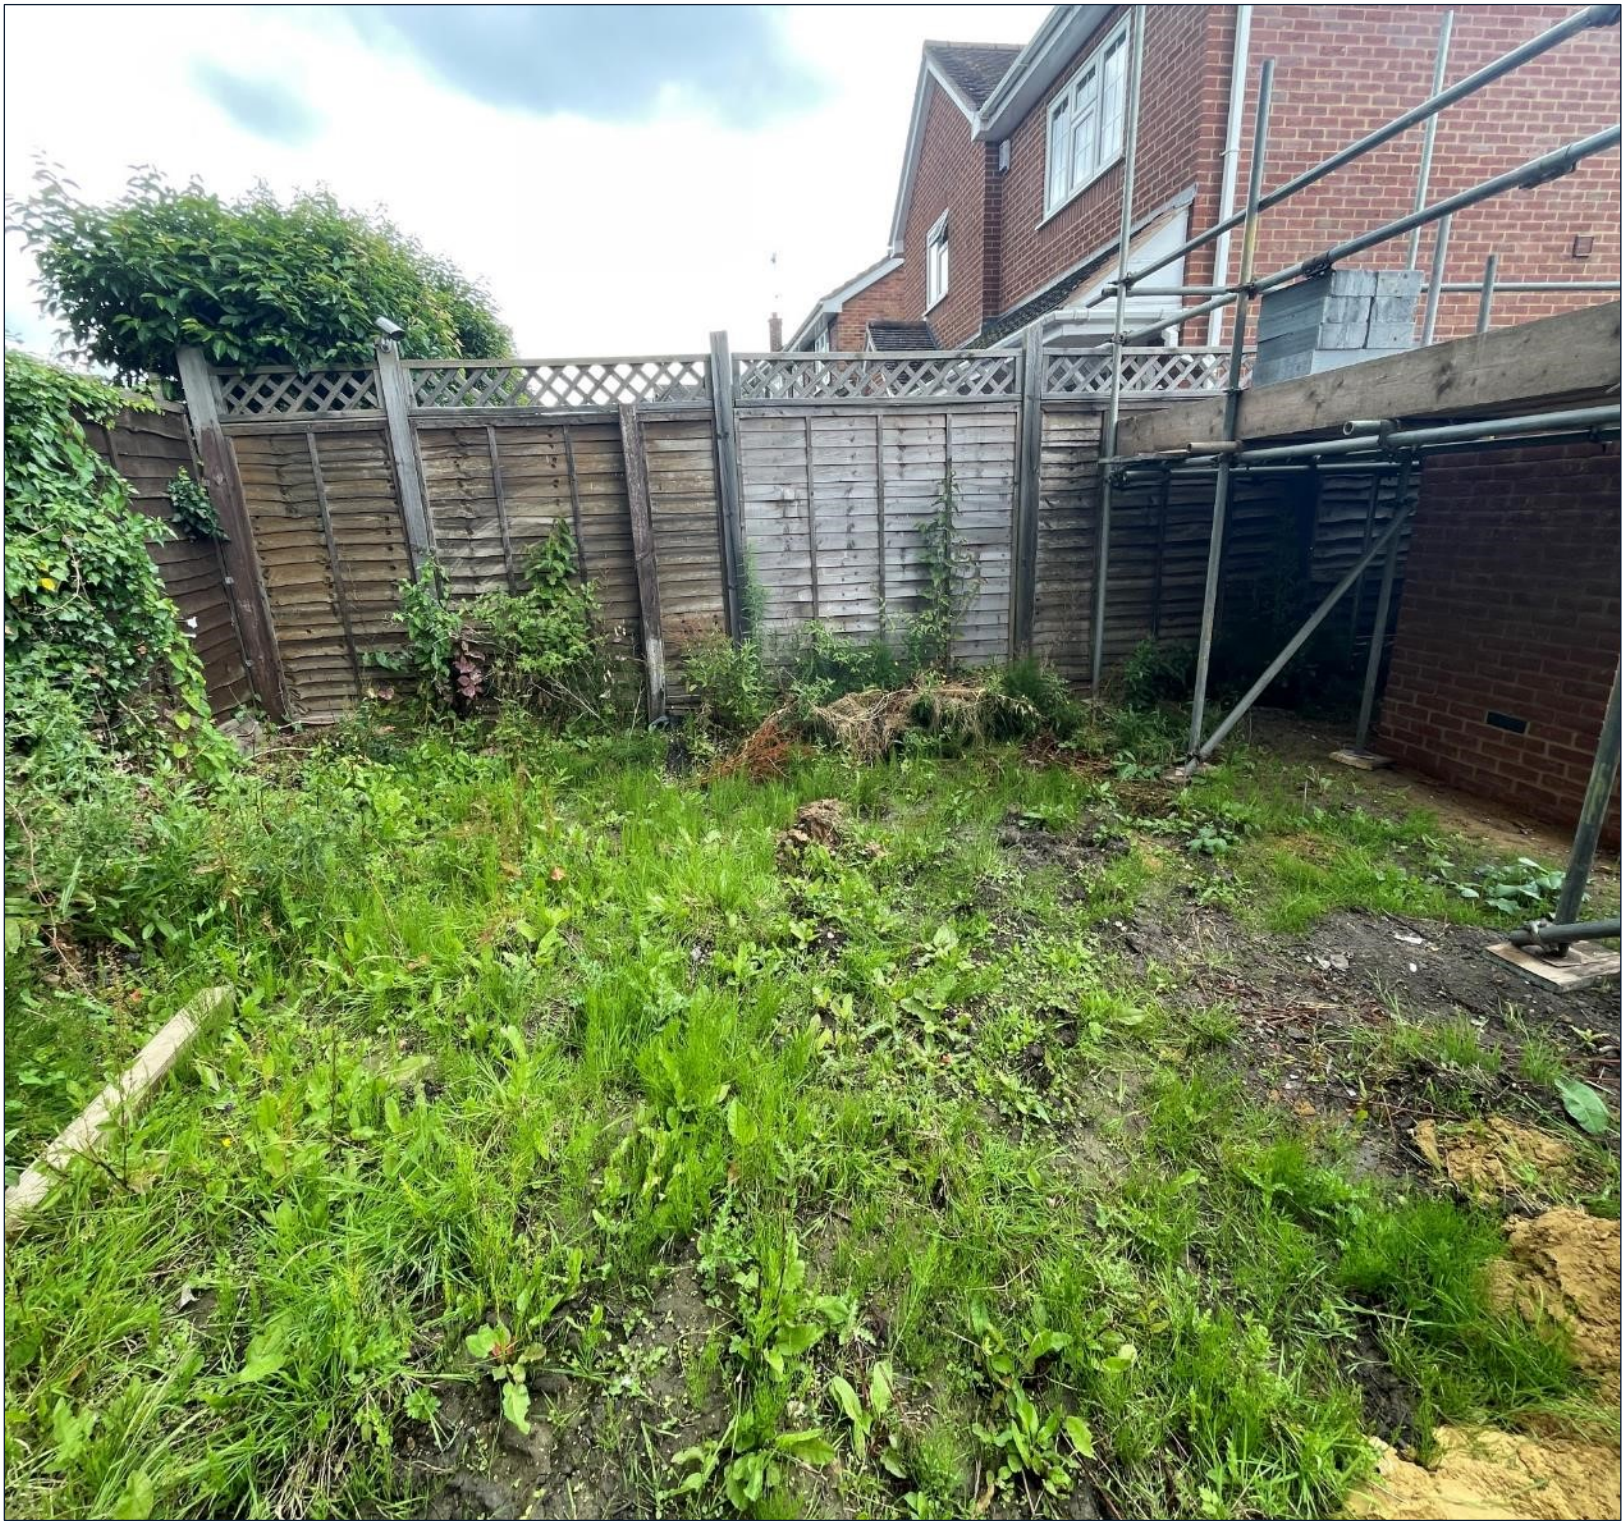
Photo showing the rear garden and dwelling during a site inspection on 5<sup>th</sup> July 2024

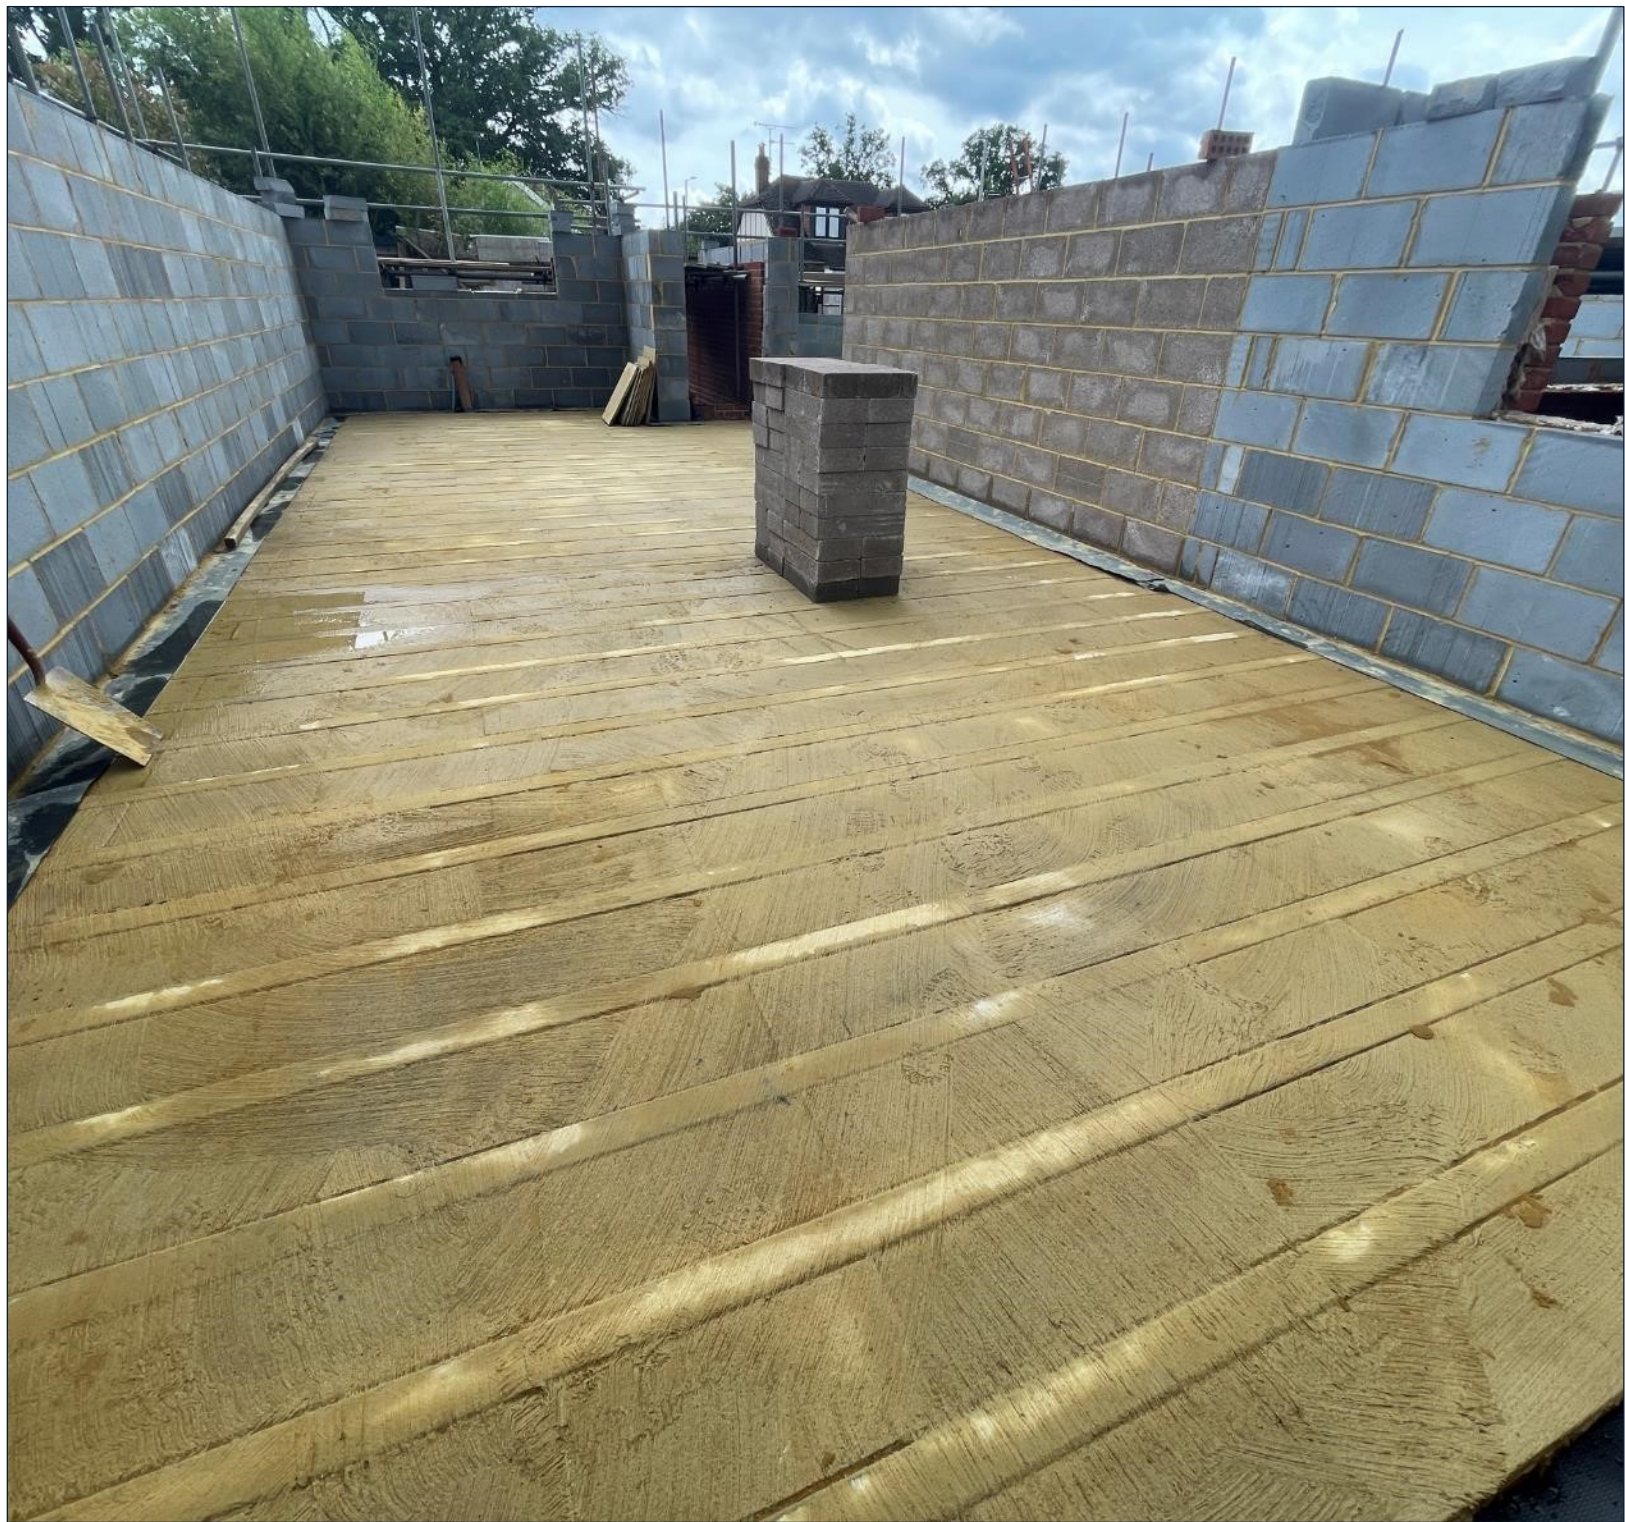
Photo showing the dwelling during a site inspection on 5<sup>th</sup> July 2024
