47 Samborne Drive  
Wokingham  
Berkshire  
RG40 1GF

## Preliminary Roost Assessment

Report ref.: R3057\_PRA\_a

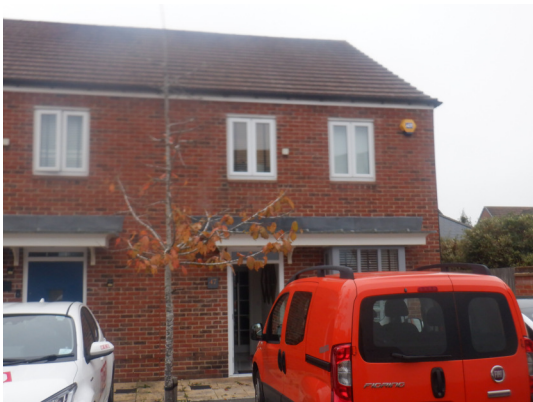
- 5.2.2** The end of terrace house was of modern brickwork construction, with a pitched roof (**Photographs 1 & 2**).

*Photograph 1. Front of the property viewed from the west.*

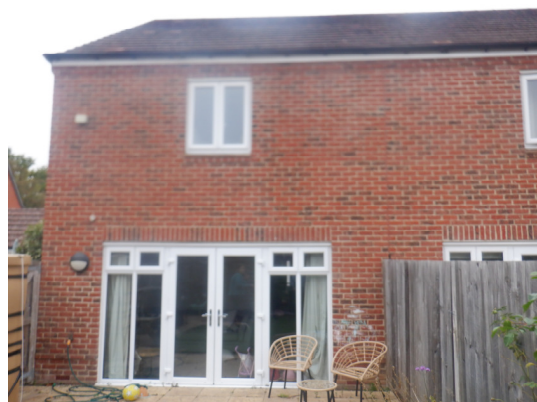
*Photograph 2. Rear of the property viewed from the east.*

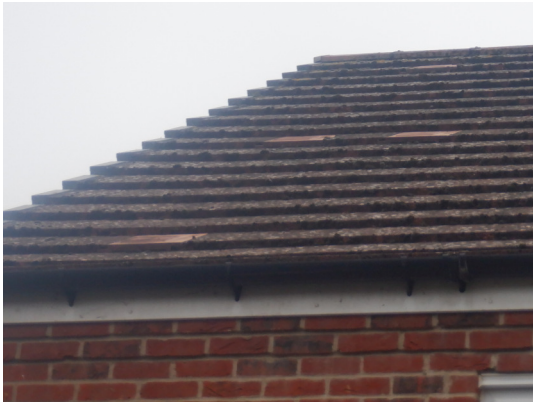
- 5.2.3** The roof featured flat overlapping roof tiles with occasional plastic vent tiles present on the eastern elevation (**Photograph 3**). The roof featured tightly fitted ridge tiles across the roof (**Photograph 4**).

*Photograph 3. Flat roof tiles with vents (rear elevation).*

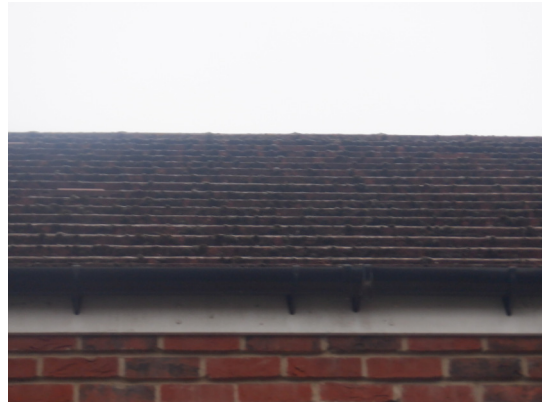
*Photograph 4. Tight and intact ridge tiles (front elevation).*

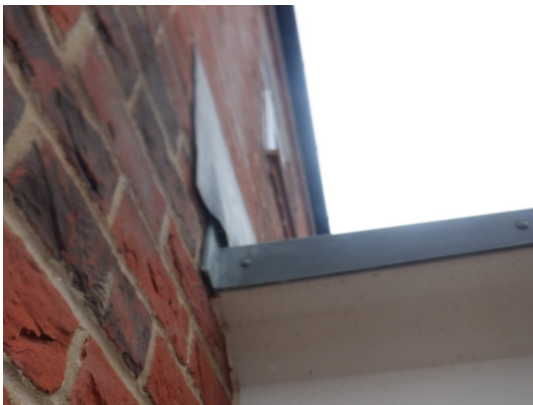
- 5.2.4** The lead flashing was flat where the porch roof joined the house on the front elevation (**Photograph 5**). The barge board was tight to the brickwork on both the front and rear elevations (**Photograph 6**). The verge caps along the southern gable were tight to the brickwork, while the verge cap at the apex had a slight gap underneath, which could offer roosting opportunities for crevice-dwelling species (**Photograph 7; Target note 1**).

*Photograph 5. Lead flashing flush to wall above porch roof (front elevation).*

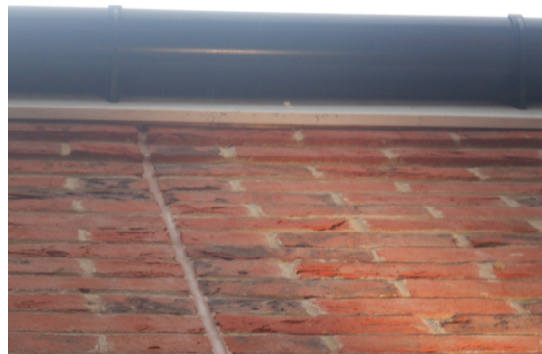
*Photograph 6. Barge board tight to brickwork (rear elevation).*

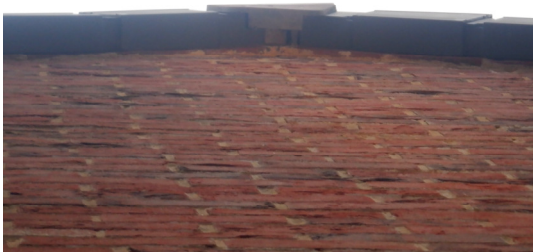
*Photograph 7. Gap below the verge cap at the apex (southern elevation).*

6.1.2 The house lacks any evidence of roosting bats within the roof void, which is of a size and condition that is suitable for void-dwelling species, such as the locally recorded brown long-eared (*P. auritus*) bat. Externally, there was a gap beneath the verge cap at the apex of the southern gable which could be used by crevice-dwelling bats, such as the locally recorded common pipistrelle (*Pipistrellus pipistrellus*) and soprano pipistrelle (*Pipistrellus pipistrellus*). Therefore, the house has been classified as having low bat roost suitability (see **Appendix 1** for potential suitability categories).

6.2.1 The development proposals include the conversion of the roof void into habitable space, with the addition of skylights on the front and rear elevations and therefore the external potential roost feature at the gable will be retained and available for use by bats in the future. Based on this assessment, no further survey to determine the presence or likely absence of roosting bats (i.e. emergence survey) is deemed necessary (see **Appendix 2** for Further Survey Rationale).

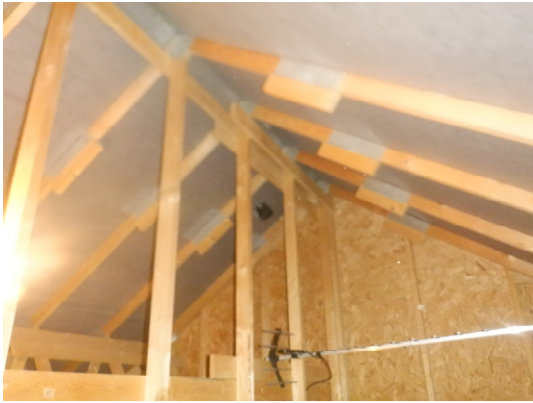
- 5.2.6** The inside of the void had a floor to ridge height of approximately 3m and was of pre-trussed rafter construction (**Photograph 8**). The roof was lined with a breathable roofing membrane that was mostly intact, apart from slight gaps created for ventilation tiles and extraction flues (**Photograph 9**).

*Photograph 8. Roof void.*

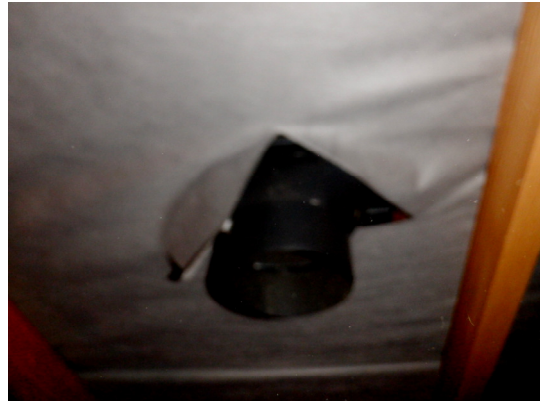
*Photograph 9. Tear in breathable roofing membrane around ventilation tile (roof void).*

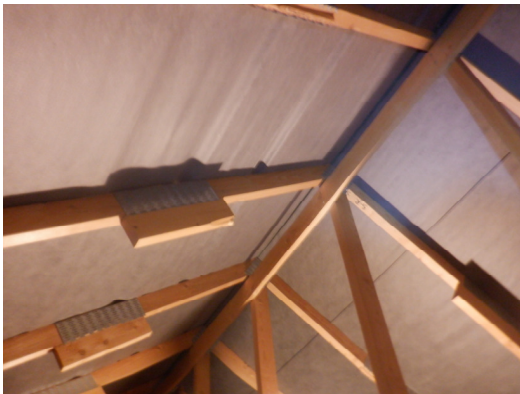
- 5.2.7** The ridge was clear of cobwebs (**Photograph 10**). The void was partly boarded, with thick fibreglass insulation present throughout which filled the eaves (**Photograph 11**).

*Photograph 10. The cobweb free ridge (roof void).*

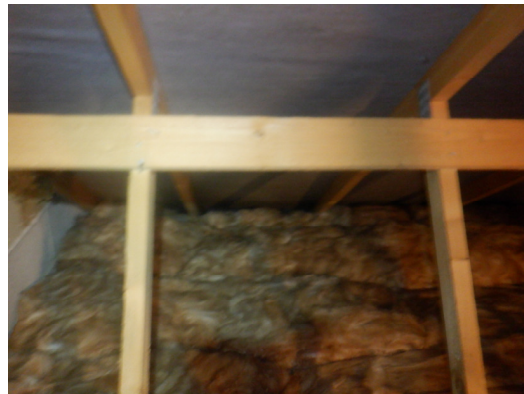
*Photograph 11. Fibreglass insulation on floor filling the eaves (roof void).*

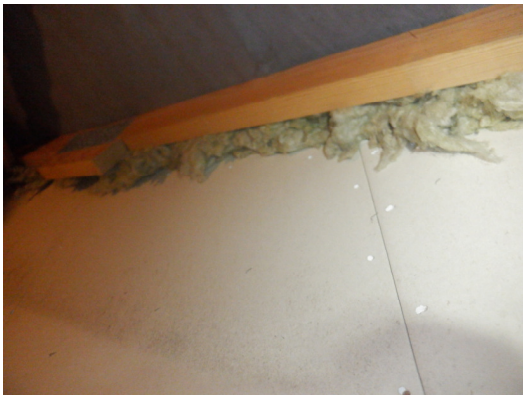
- 5.2.8** The party wall was of plasterboard construction, with fibreglass insulation present between the edge of the boarding and the timber rafters (**Photograph 12**). The southern gable was of chipboard construction which was tight to the timber rafters (**Photograph 13**).

Photograph 12. Fibreglass insulation present around party wall (roof void).

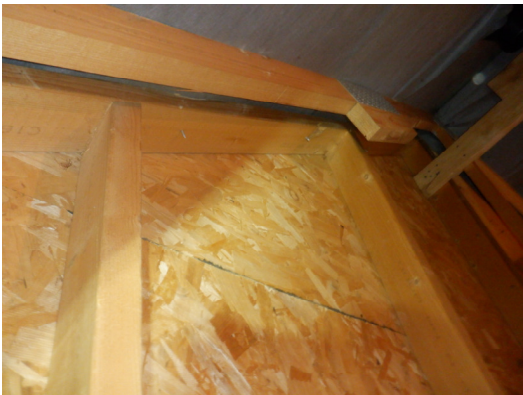
Photograph 13. Southern gable of chipboard construction tight to rafters (roof void).

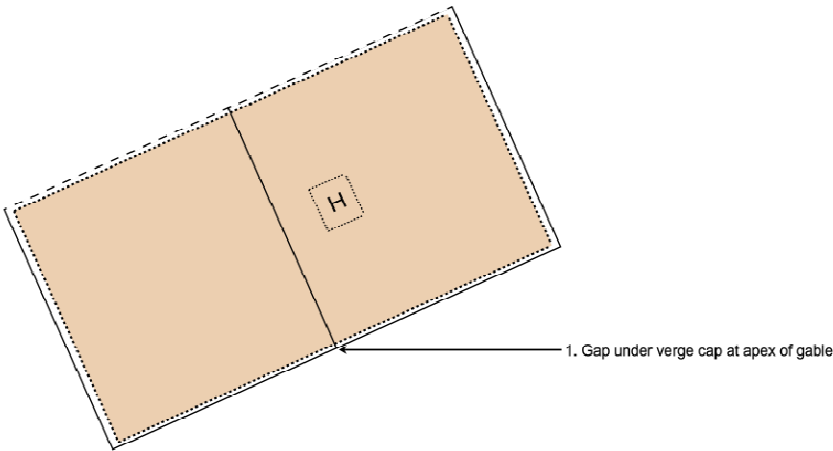
Figure 1. Plan of Preliminary Roost Assessment findings
