## **PRELIMINARY ECOLOGICAL APPRAISAL (DBW) OF 628 WOKINGHAM ROAD EARLEY**

**Prepared for:  
Dr M Demirdag  
628 Wokingham Road  
Earley  
Reading  
RG6 7HN**

**12 February 2025**

**Ref: SPH/NP/PEA-24/26.11v2**

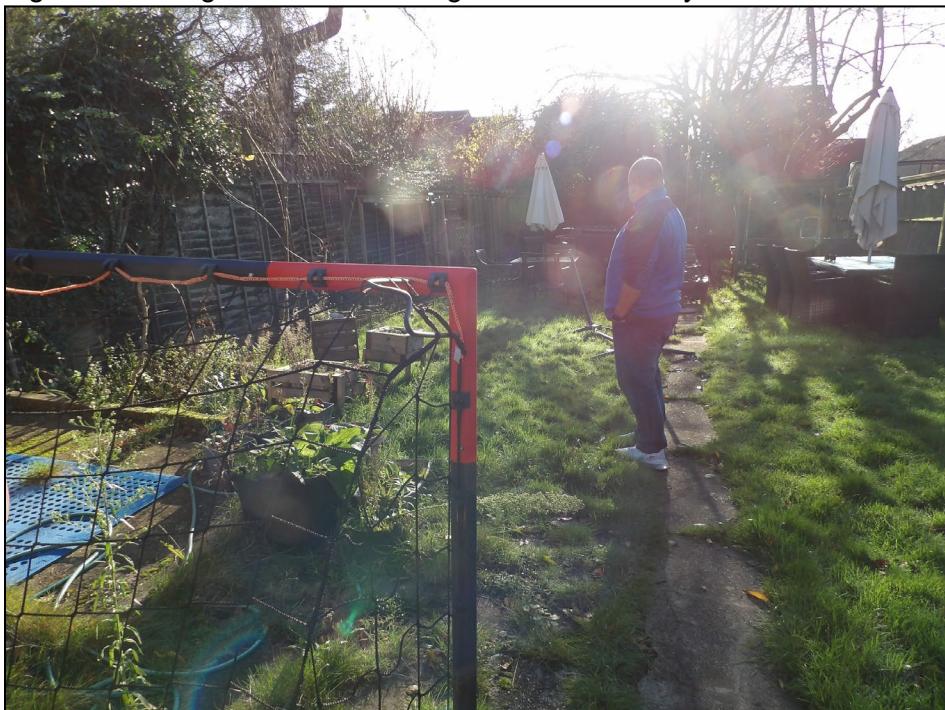
The application site comprises a semi-attached, brick-built property with rear outbuilding. The remainder of the site comprises a gravelled driveway and parking area, and a rear garden with patio area, lawn and some shrubs and trees on the boundaries, see Figure 3 below. The site itself offers some foraging and commuting habitat for bats however, via back gardens, there is some ecological connectivity to alternative habitat for foraging and commuting bats in the wider landscape.

Figure 3. Rear garden. 628 Wokingham Road, Earley. 26.11.24

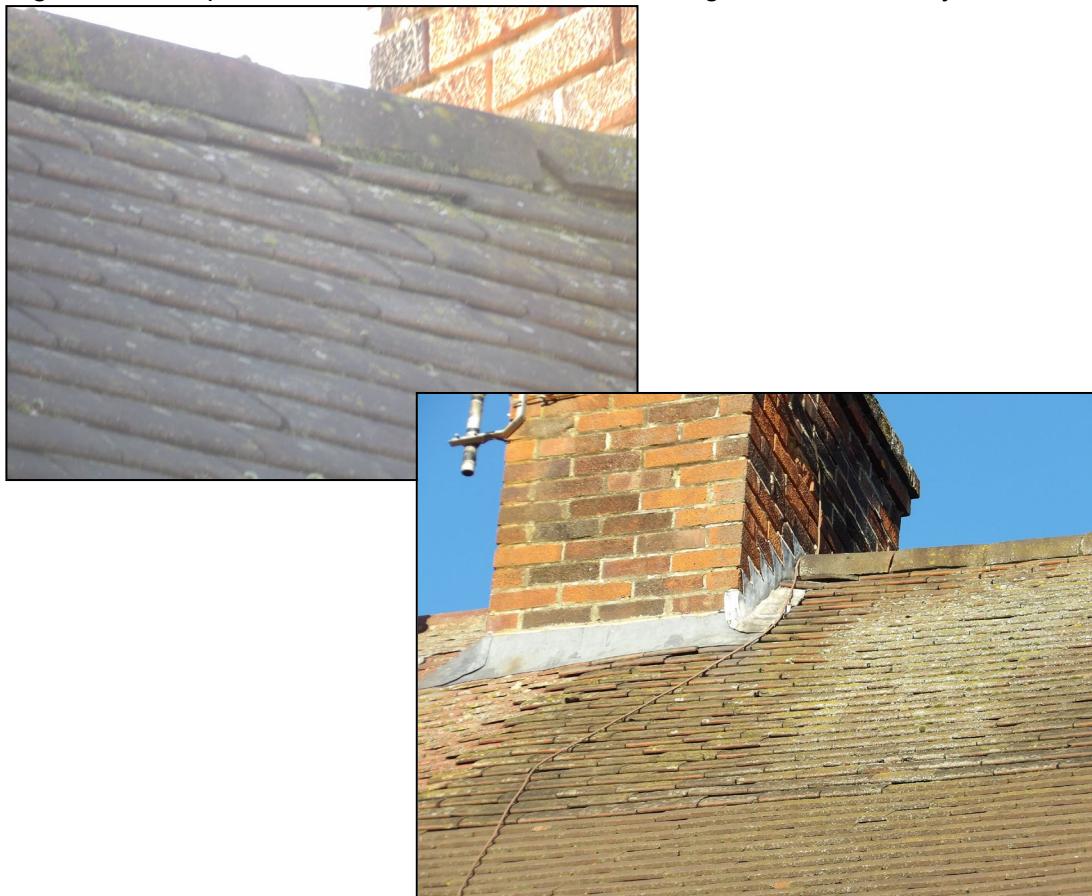
The property is a semi-detached, two-storey brick-built building that is in a fair condition externally. The cross-hipped roof is covered in tiles, some of which on the front/side and rear elevations and around the rear chimney stack have moved/raised leaving gaps that could be exploited by crevice dwelling bat species or allow access into the loft space for roosting bats, see examples at Figure 4 below. There is also missing mortar from the ridge and hip tiles that could be exploited by bat species, see Figure 5 on page 9. The soffits and fascias are flush to the walls with no gaps or splits, see Figure 6 on page 9. To the rear is a single-storey 'lean-to' style building constructed of brick, with a breeze block section attached, see Figure 7 on page 10. The roof of the 'lean-to' style section is covered in tiles that have slipped/moved leaving gaps that could be exploited by crevice dwelling bat species, see Figure 8 on page 10. There is also missing mortar from the front verge, see Figure 9 on page 11.

Figure 4. Example moved/raised roof tiles. 628 Wokingham Road, Earley. 26.11.24

Based on the Bat Workers Manual and the Bat Surveys Good Practice Guidelines, a single dusk emergence survey needs to be undertaken on the property, rear single storey 'lean-to' section and outbuilding, between May and August, to establish the presence or absence of roosting bats and in order to inform appropriate mitigation for the proposed works if necessary.

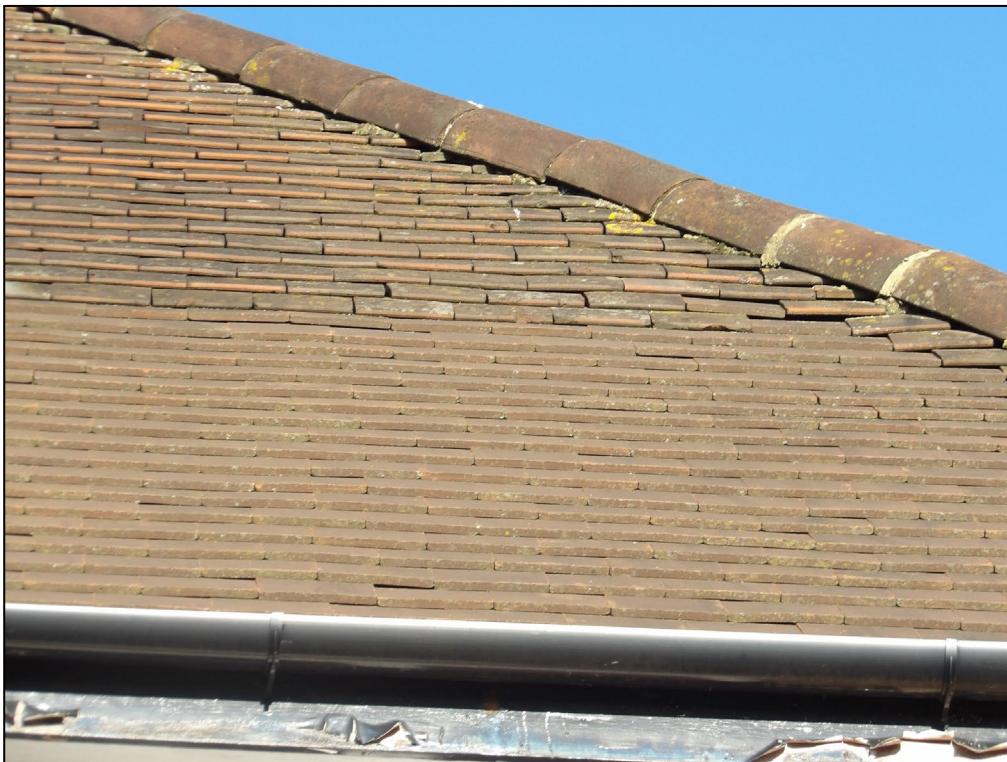
Figure 5. Example missing mortar from hip tiles. 628 Wokingham Road, Earley. 26.11.24

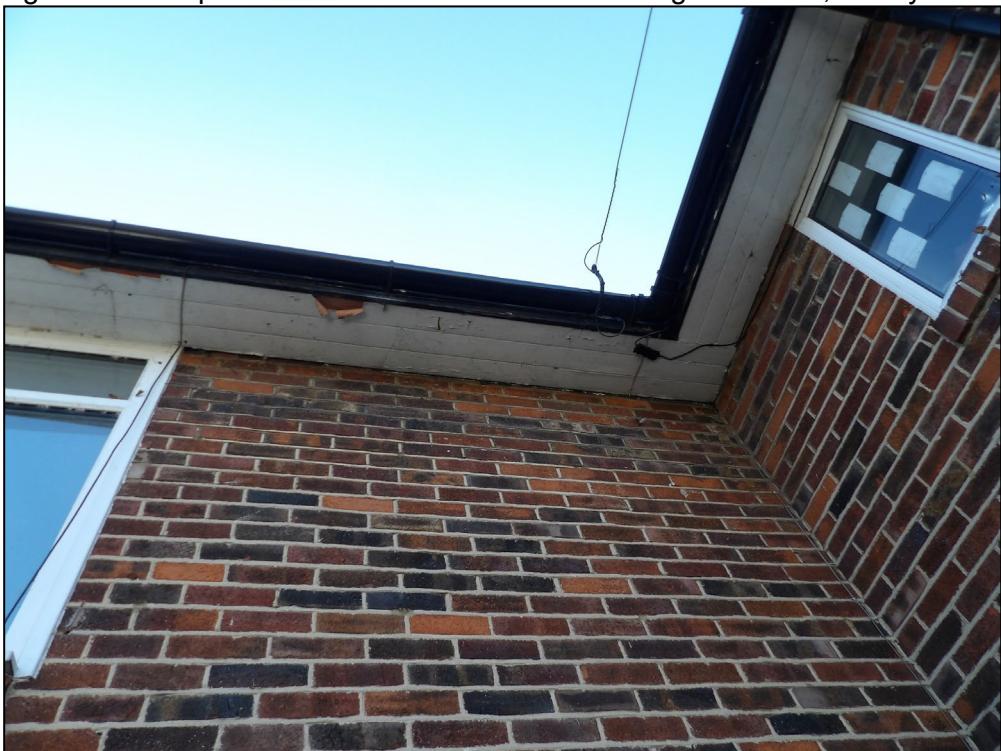
Figure 6. Example sealed soffits/fascias. 628 Wokingham Road, Earley. 26.11.24

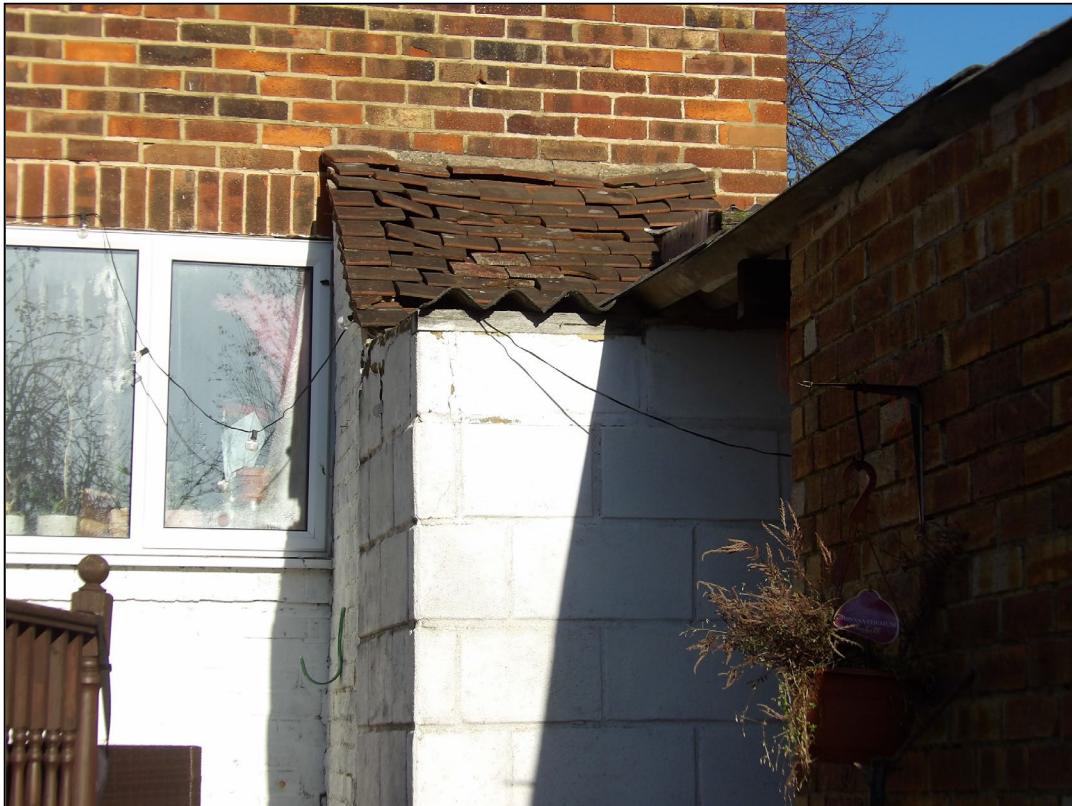
Figure 7. Rear, lean-to style section of the property. 628 Wokingham Road, Earley. 26.11.24

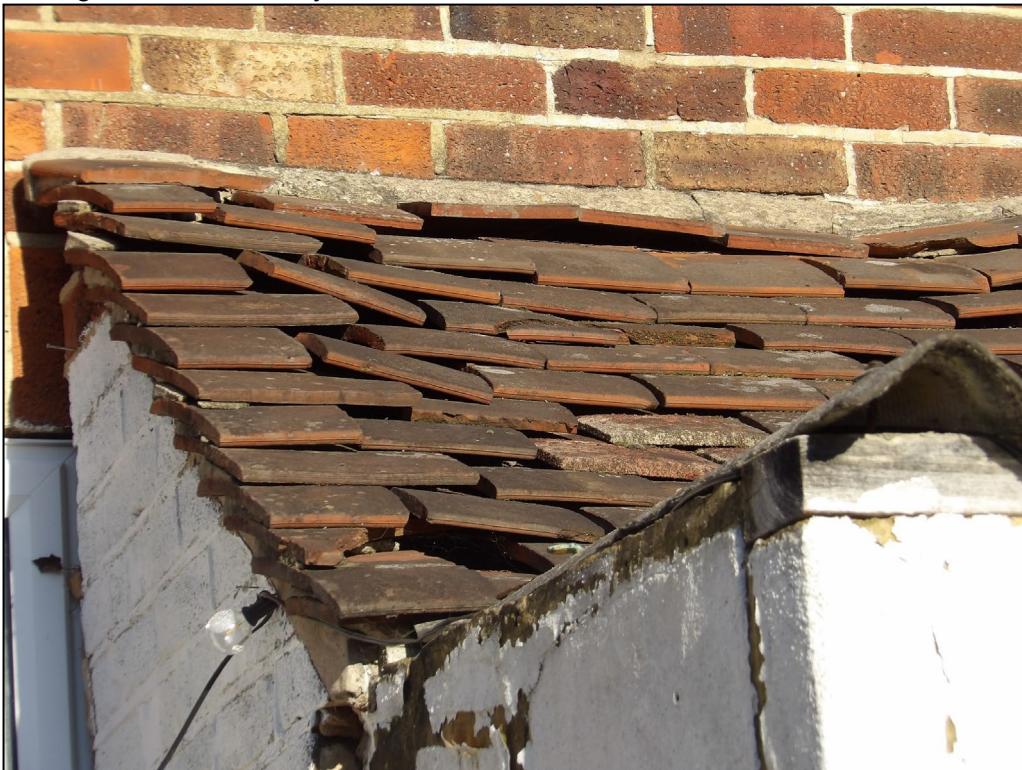
Figure 8. Gaps in tiles covering rear, lean-to style section of the property. 628 Wokingham Road, Earley. 26.11.24

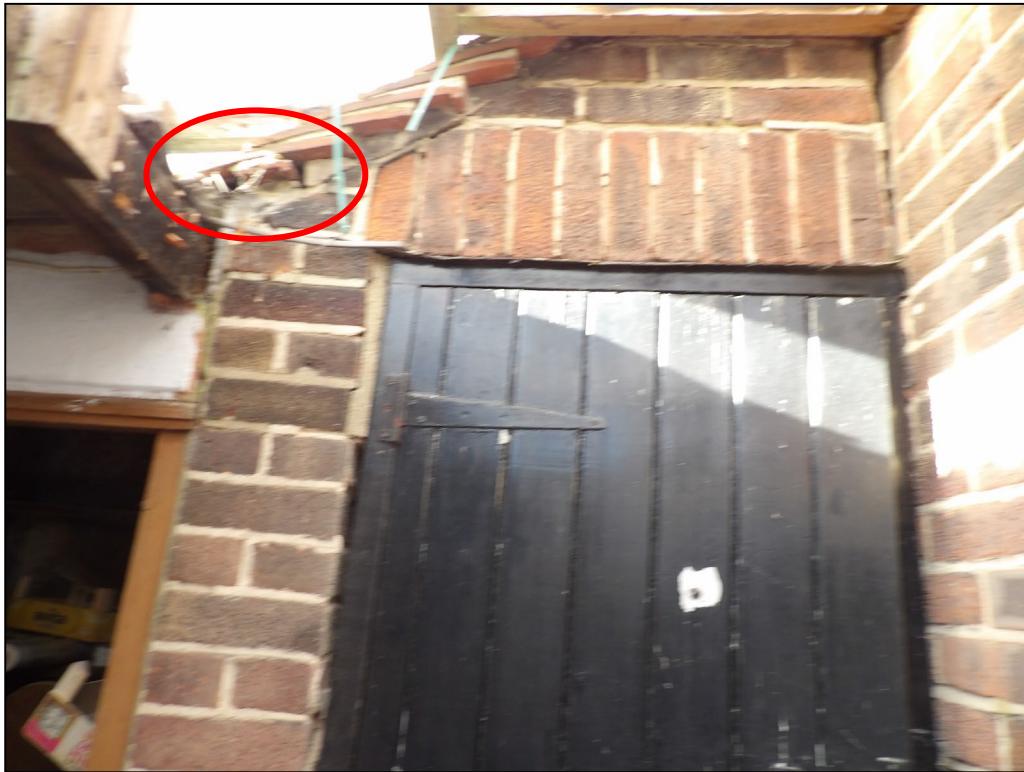
Figure 9. Missing mortar in verge of lean'-to section of the property. 628 Wokingham Road, Earley. 26.11.24

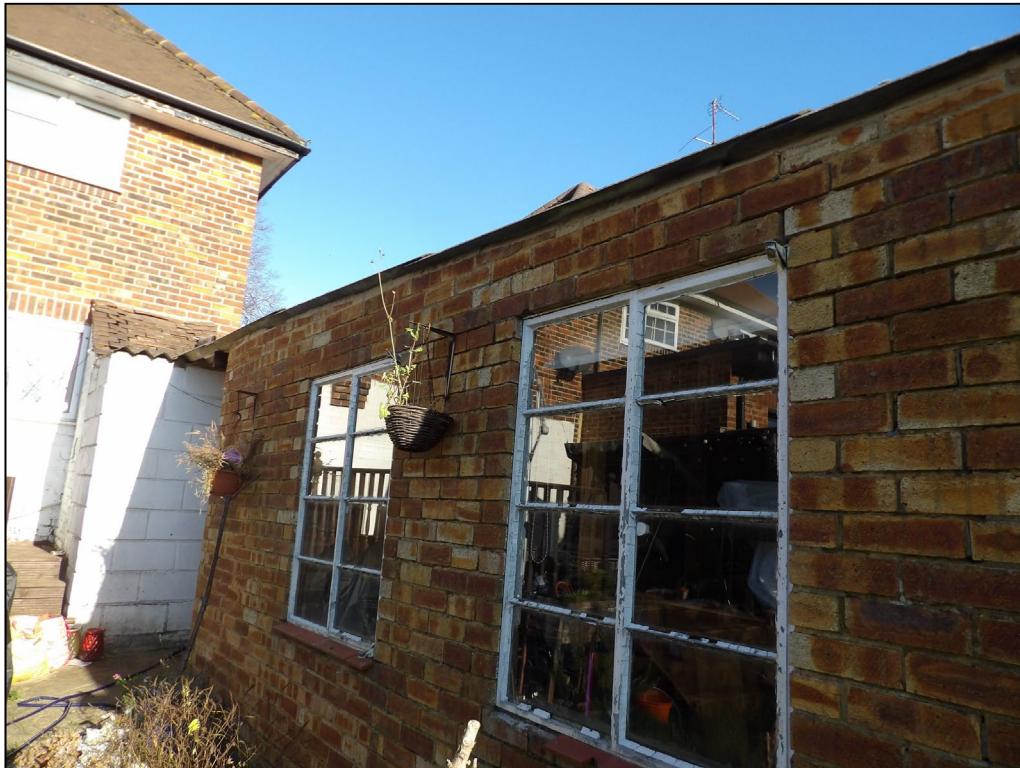
The outbuilding is attached to the above-mentioned breeze block section and is also constructed of brick, see Figure 10 on page 11. The roof is covered in corrugated asbestos, all of which is tightly fitted, see Figure 12 on page 12. However, to the rear of the outbuilding there is missing mortar/open gaps created by the corrugation which could allow crevice dwelling bat species to enter the building to roost, see Figure 13 on page 12.

Figure 10. Outbuilding. 628 Wokingham Road, Earley. 26.11.24

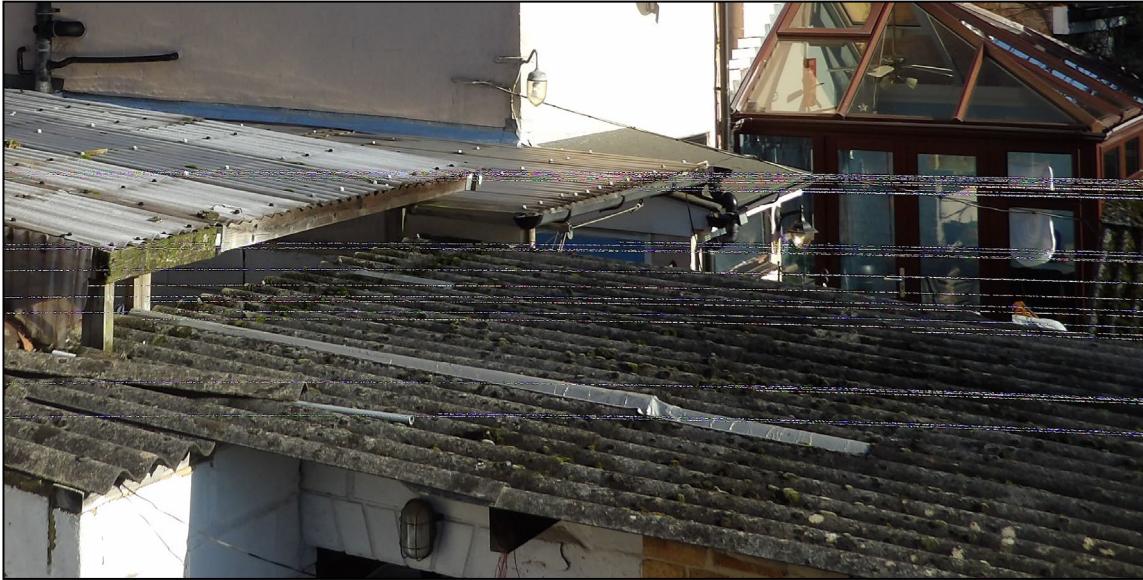
Figure 11. Example of corrugated asbestos covering outbuilding and attached breeze-block section. 628 Wokingham Road, Earley. 26.11.24

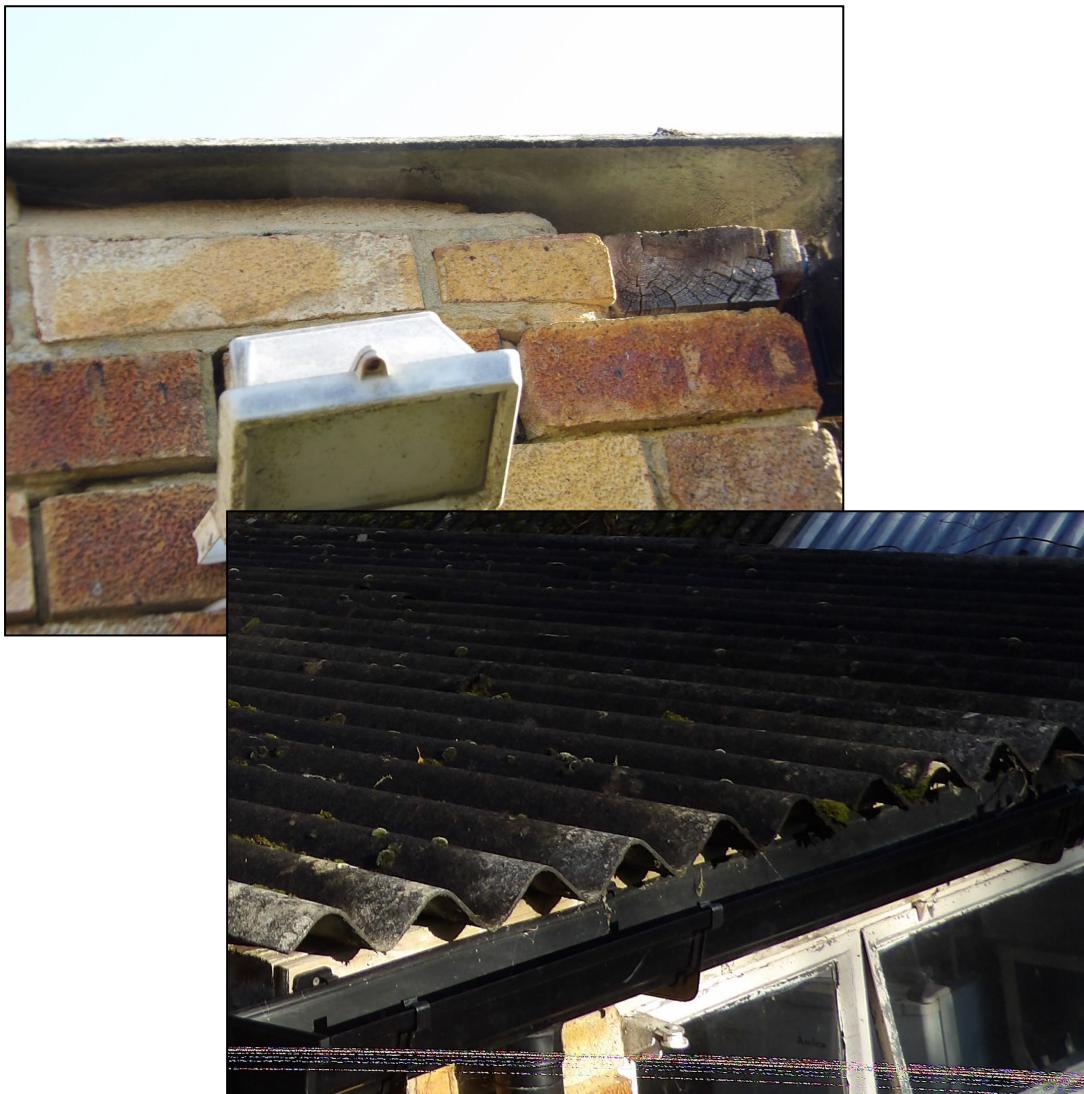
Figure 12. Missing cement/gaps at rear of outbuilding. 628 Wokingham Road, Earley. 26.11.24

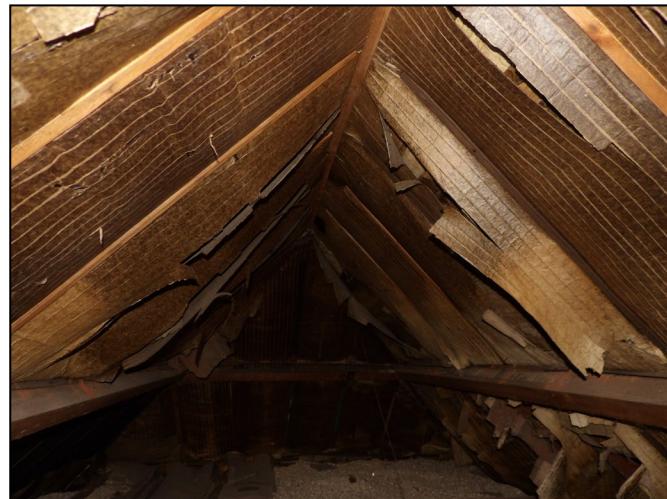
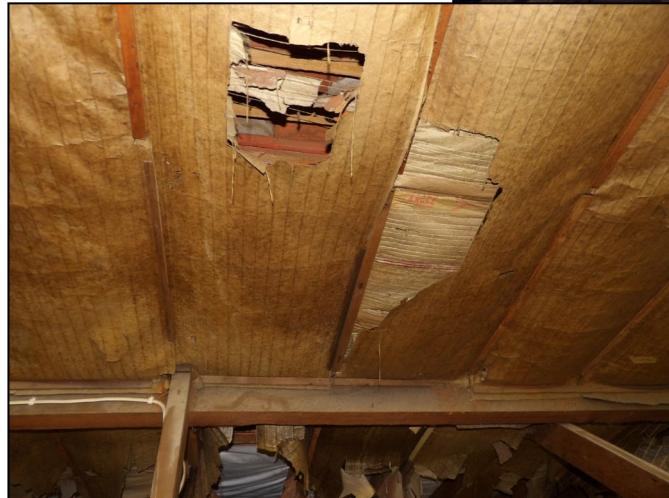
The loft of the property was accessed via an integral ladder and is in a fair to poor condition. The loft is being used for some personal storage. It is partially lit, partially boarded and insulted, see Figure 13 below. The roof tiles are lined with tar paper, much of which is torn, see Figure 13 below.

Figure 13. Example loft space and torn tar paper in loft. 628 Wokingham Road, Earley. 26.11.24

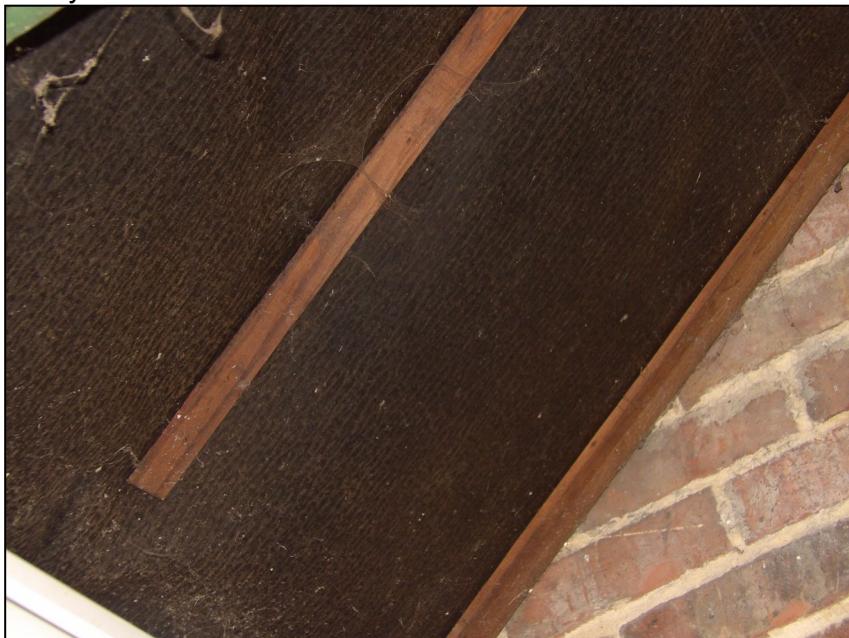
There is no loft space in the single storey 'lean-to' section of the property, the tiles are lined with bitumen felt, all of which appeared to be in a good condition, see Figure 14 on page 14.

Figure 14. Example of bitumen lining to 'lean-to' building. 628 Wokingham Road, Earley. 26.11.24

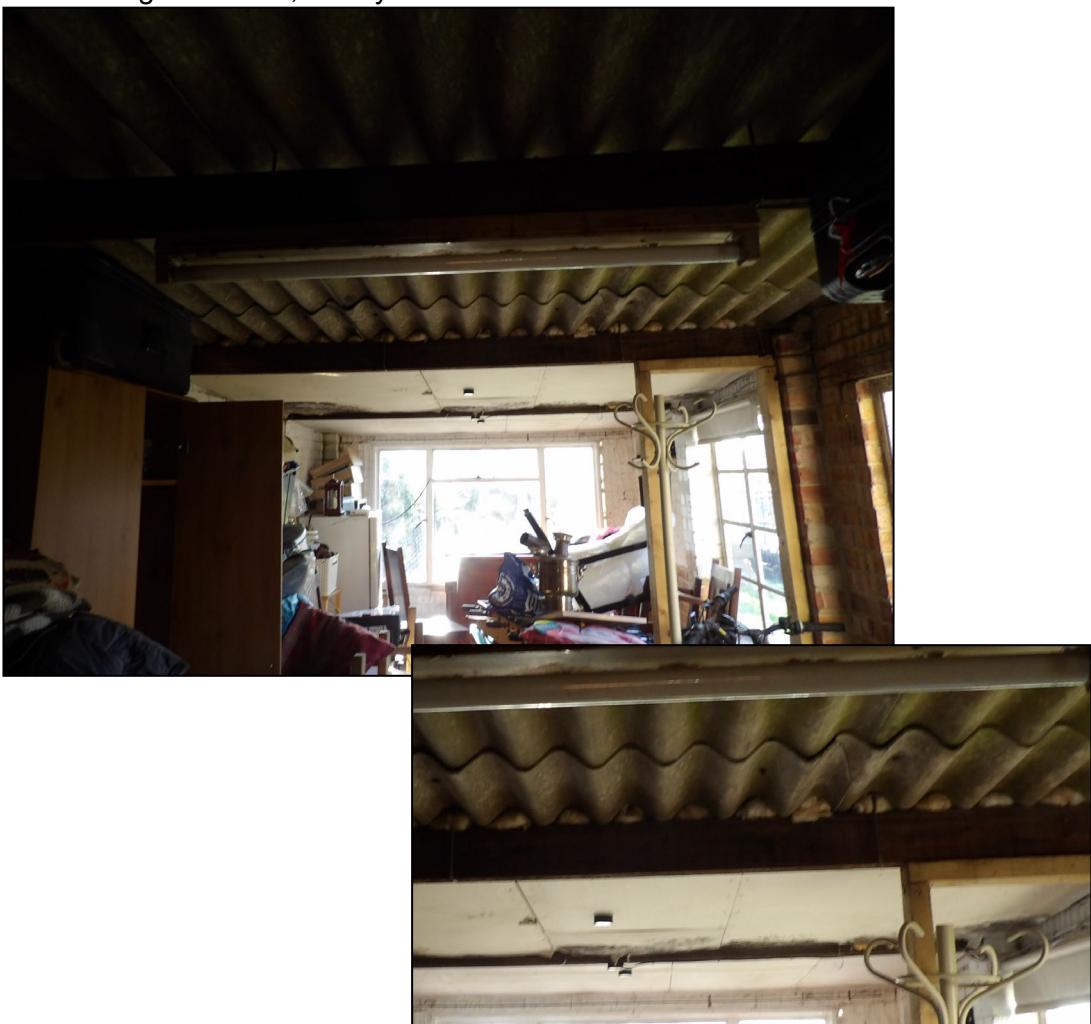
The outbuilding was also inspected internally. The outbuilding is used for storage and is cluttered, this did not hinder the inspection, see Figure 15 on page 14. A section of the ceiling is boarded and sealed with expanding foam internally, resulting in a void between the boarding and asbestos sheets providing potential roosting opportunities for crevice dwelling bat species with access externally, see Figure 15 on page 14.

Figure 15. Internal view of outbuilding showing partly lined ceiling and expanding foam. 628 Wokingham Road, Earley. 26.11.24
