## Surface Water Drainage Strategy 4106\_RG41\_Wokingham\_06

Site Address 424-426 Reading Road,  
Winnersh,  
Wokingham,  
RG41 5EP

**Project:** 424-426 Reading Road

**Reference:** 4106\_RG41\_Wokingham\_06

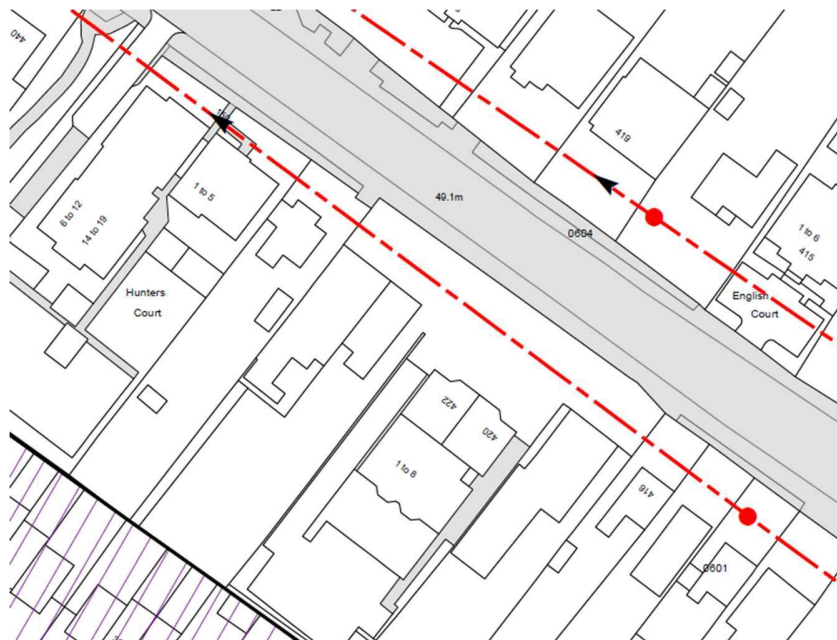
Figure 2: Extract of Thames Water's Sewer Map

- 3.1. Existing Thames Water sewer mapping is included within Appendix B, with an extract provided below. The map shows an existing 150mm diameter foul water sewer running within the site boundary adjacent to Reading Road to the North of the site, where it is understood the site currently connects. There is currently no surface water sewers indicated on the Thames water mapping. There are various surface water gullies shown within reading road and adjacent properties leading to the assumption that the foul sewer shown on the records could be a combined sewer. This is to be confirmed with Thames water.

- 3.2. A CCTV survey of the existing private surface water sewer network has yet to be undertaken, this will be undertaken at detailed design stage.
- 3.3. It is understood that surface water run-off from roofs and hard paved areas currently discharge to an assumed public combined Thames Water sewer located within the site boundary.

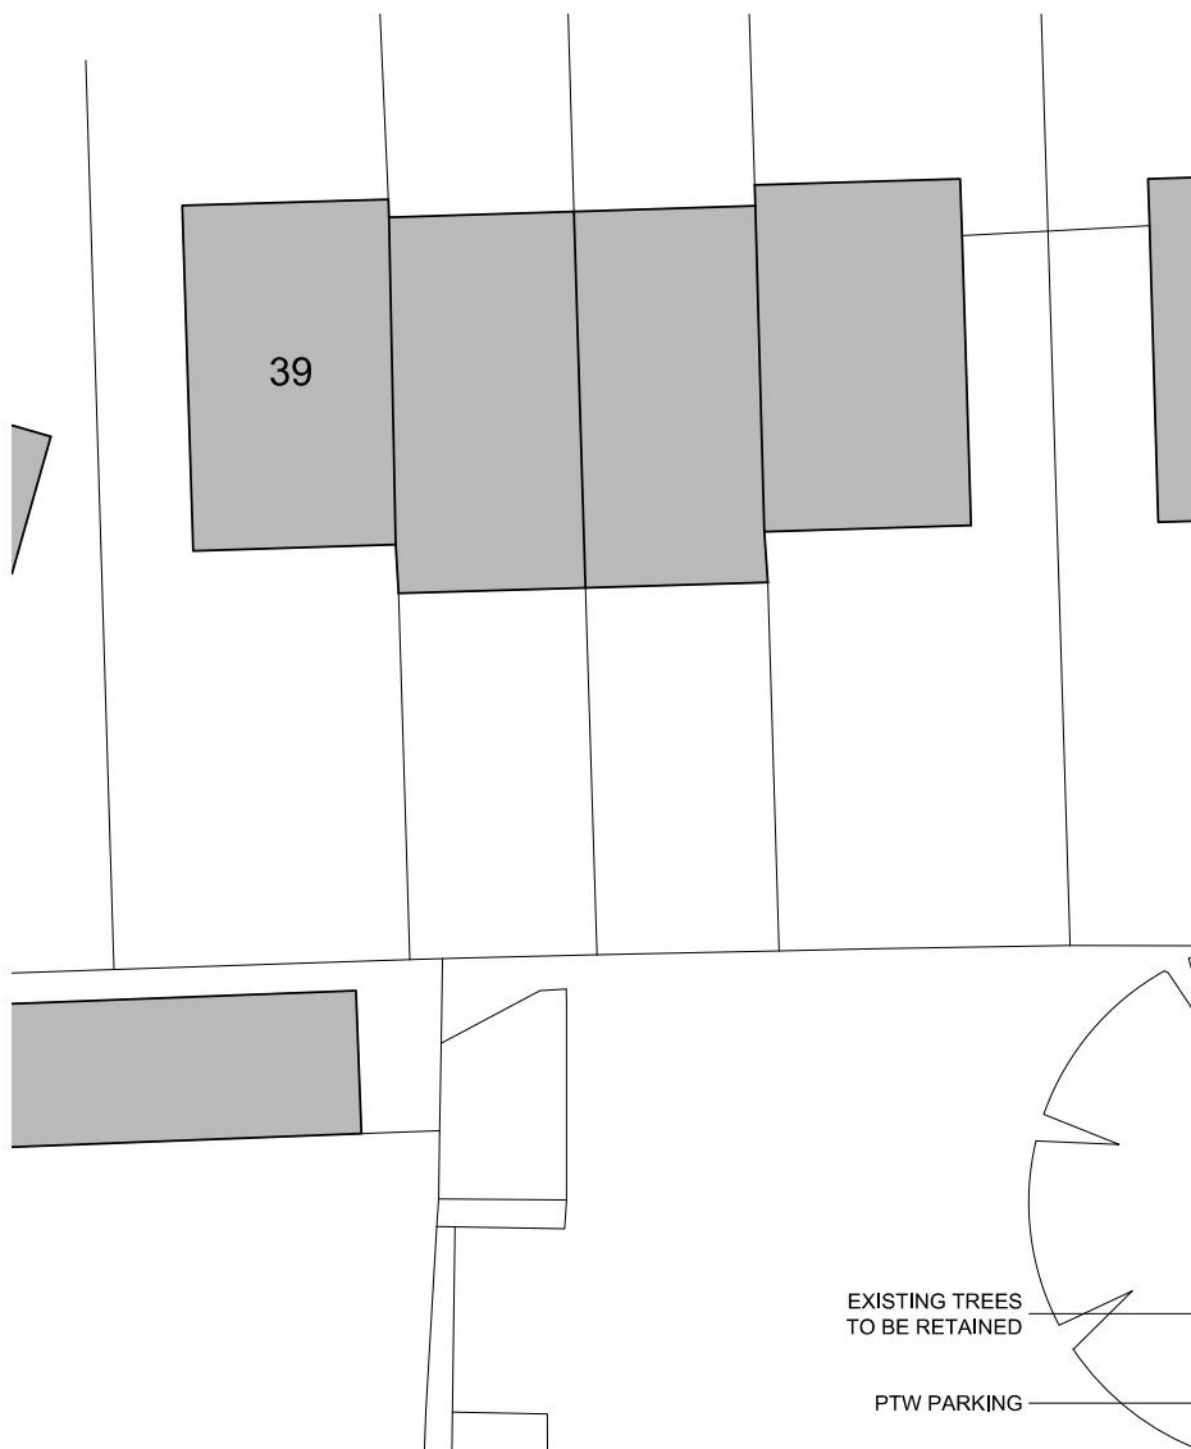
## Appendix A - Proposed Site Layouts

EXISTING TREES  
TO BE RETAINED

PTW PARKING

- 1.10. The development comprises of the erection of a three-storey building, including 6 No flats and 2 no. takeaway/restaurants to the ground floor with associated parking following demolition of existing takeaway restaurant and 2 no. flats.
- 1.11. The proposed site layout is included in Appendix A.

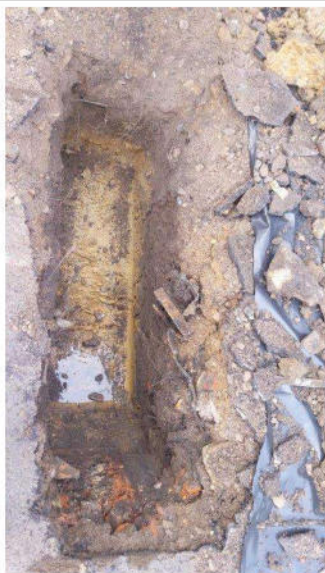
Photograph 5 - Looking down at water seepage encountered at 0.8m bgl within TP01.

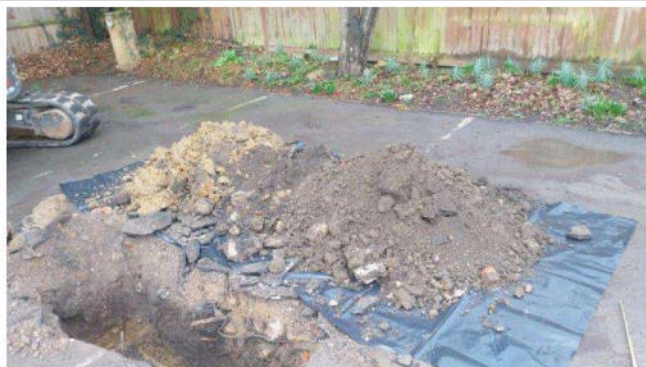
Photograph 6 - Looking down at TP01 spoil arisings.

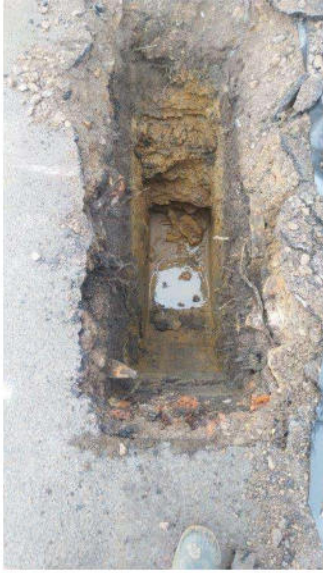
Photograph 7 - Looking down at water seepage encountered at 1.4m bgl within TP01.

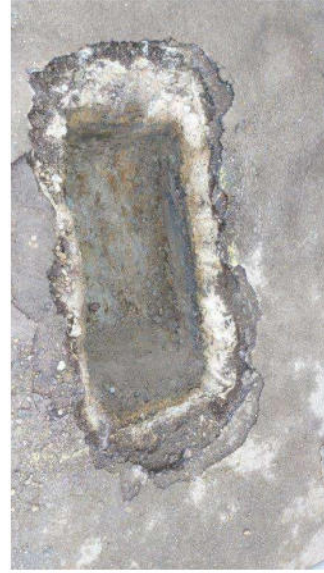
Photograph 8 - Looking down at TP02.
