**Phase I**  
**Geo-Environmental Site Assessment**

Land at Pearce's Farm, Easthampstead Road, Wokingham, RG40 3BN

**January 2023**

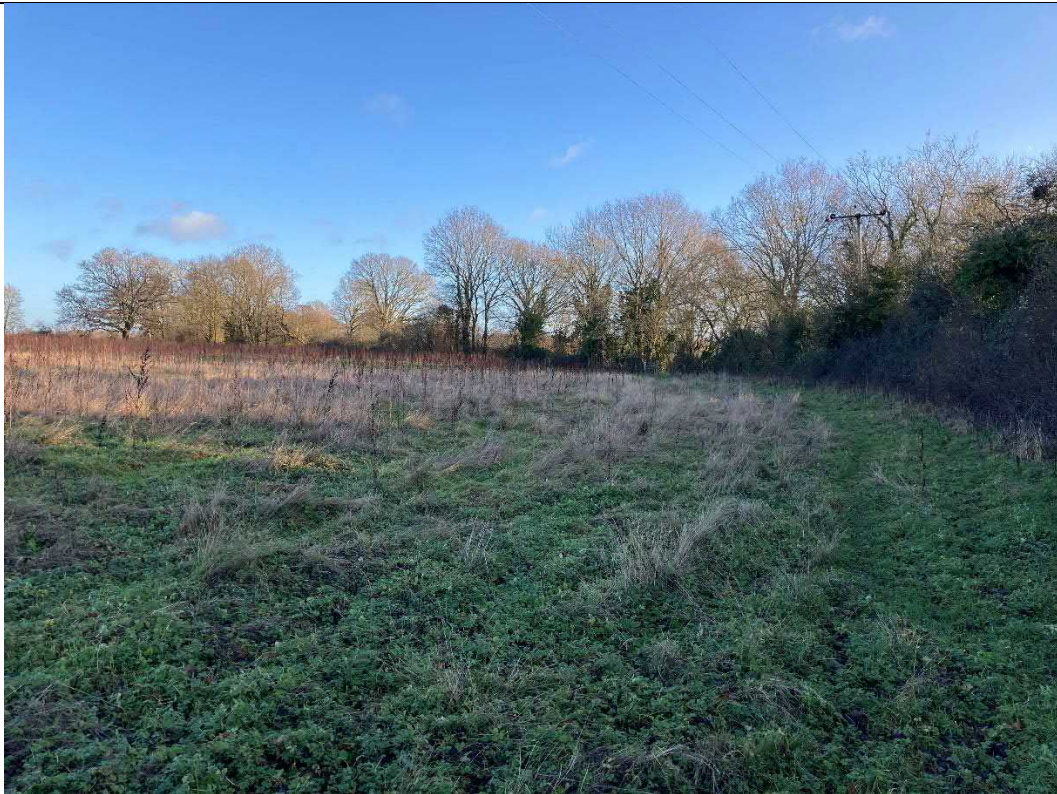
Field 2 was accessed off Easthampstead Road through a metal 5-bar gate, which was secured by a bike chain and padlock. Additionally, at the time of the site walkover two concrete blocks measuring 1.00x0.50x1.50m were positioned in front of the gateway. The field was grass-laid and along the southern boundary of the site was wet underfoot, with multiple puddles of pooled water at the surface.

All four (4no.) boundaries of Field 2 consisted of metal fencing, with hedgerows and multiple mature deciduous trees beyond. The topography of the field was relatively flat with a gentle downwards slope from northeast to southwest observed.

Photograph 1 – View of Field 2 facing north

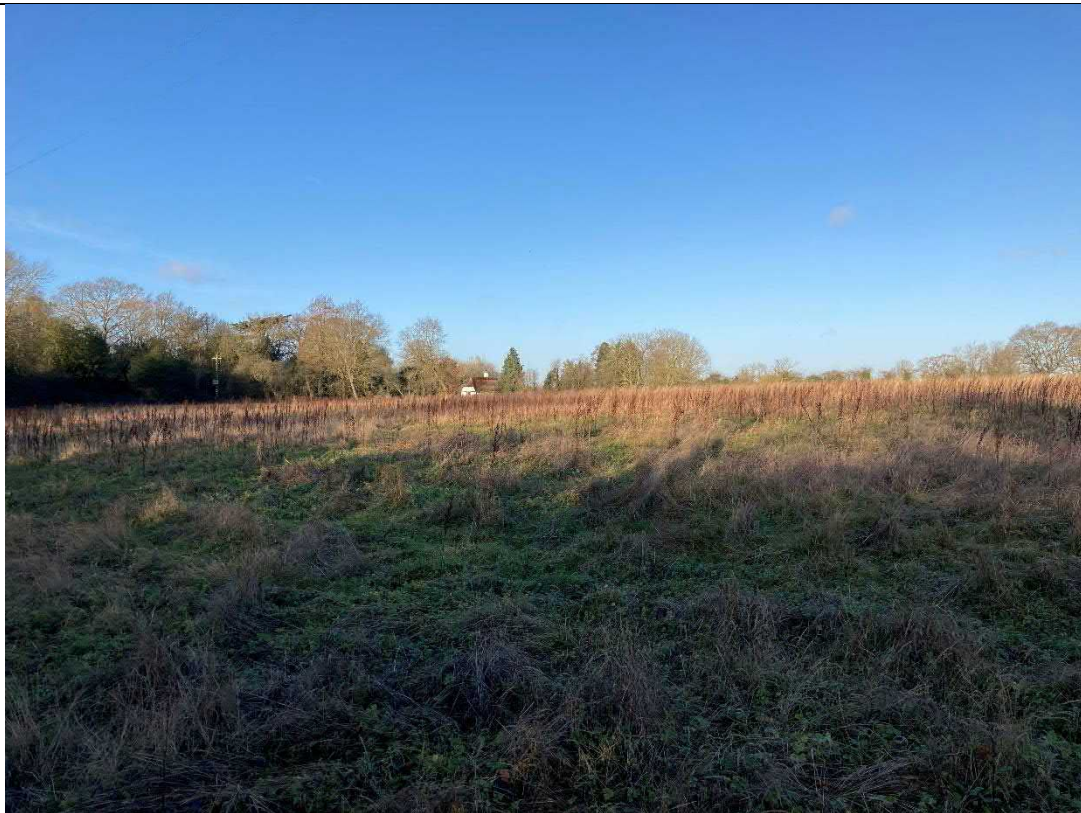
Photograph 2 – View of Field 2 facing west

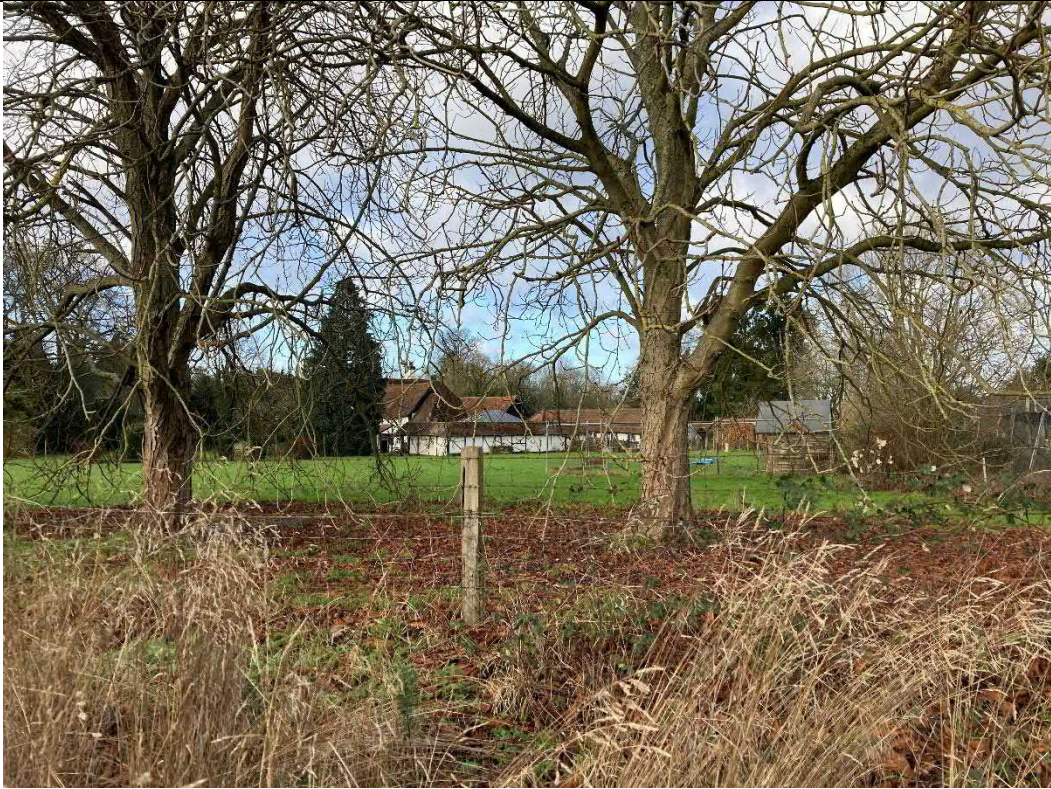
The western buildings were comprised of brick built Tudor style structures, with clay roof tiling, and eastern buildings were wood cladded with clay tile roofing. All buildings at the time of the site walkover were in good visual condition.

Photograph 3 – Overview of Pearce's Farm facing west
