# **FINCHWOOD PARK**

## **Arboricultural Impact Assessment**

JSL5287\_770  
Arboricultural Impact  
Assessment  
P01  
11 March 2025

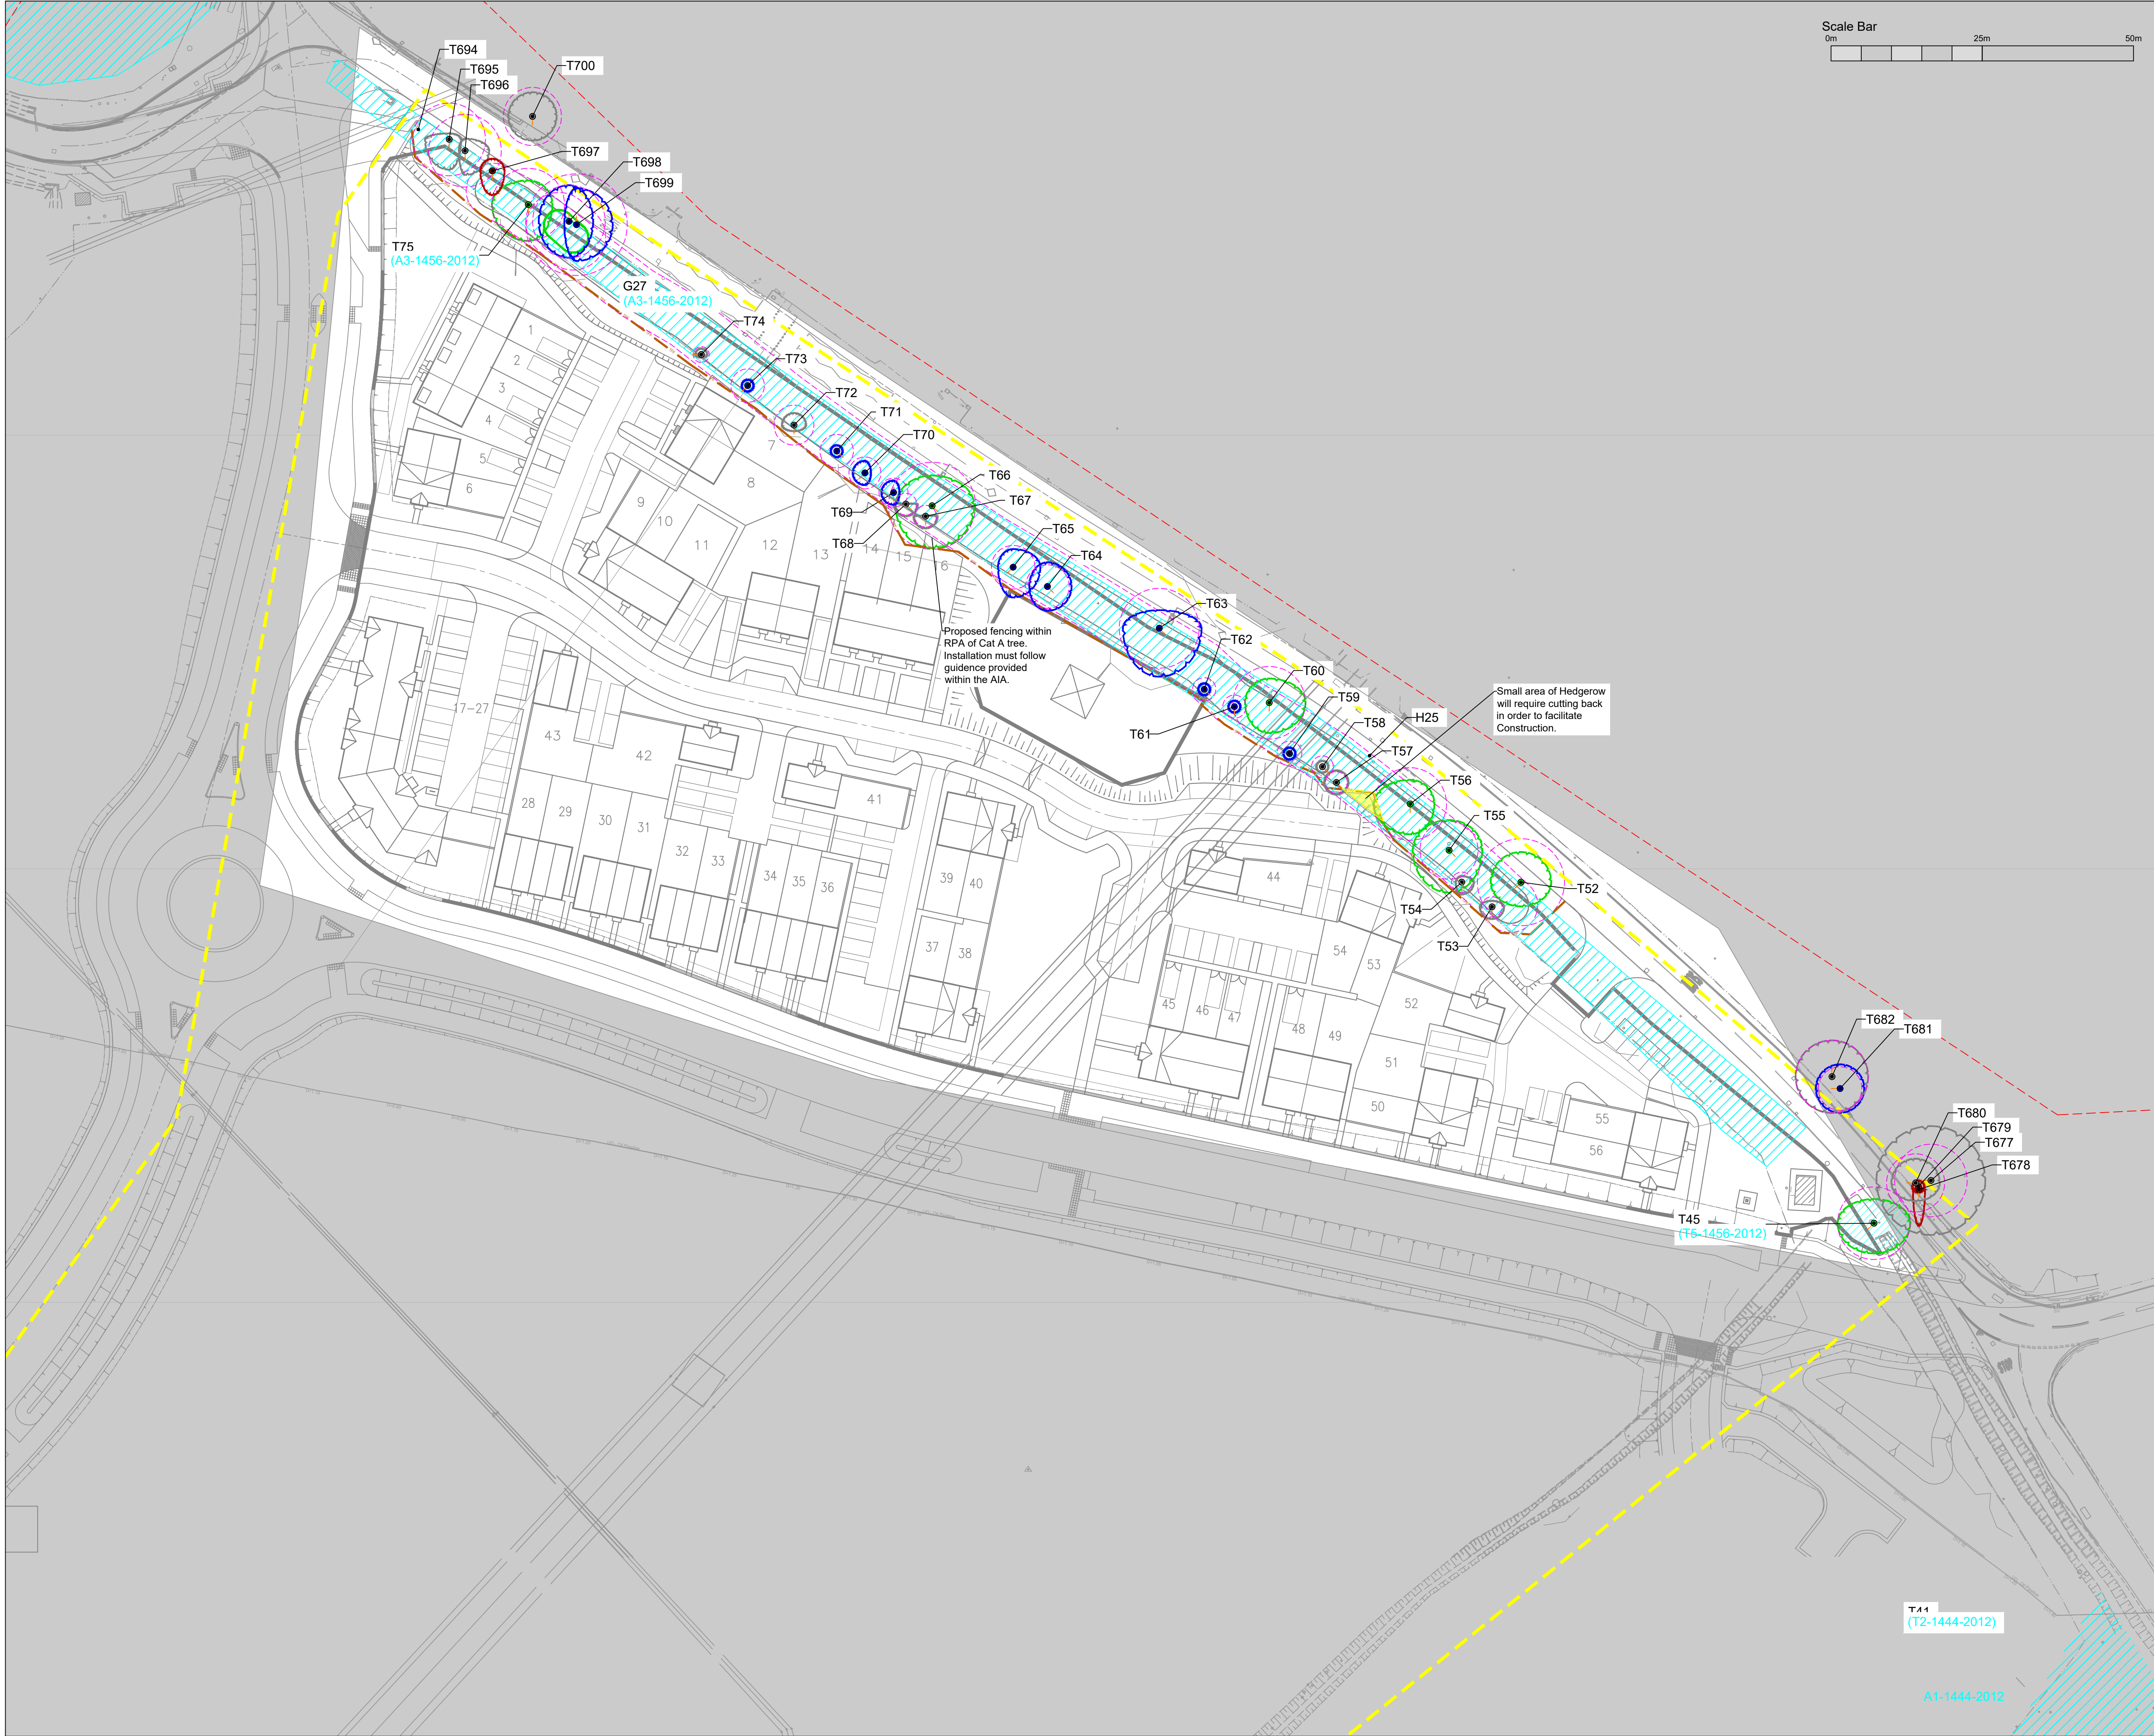
### Tree Removal & Protection Plan

- Key**
- Hogwood development boundary.
  - Tree with numbered reference. Canopy spread and coloured BS5837:2012 tree quality category as shown below.  
# = Tree details estimate (inaccessible tree)  
\* = Tree in off site location

- Vegetation group with numbered reference. Canopy extents and coloured BS5837:2012 tree quality category as shown below.
  - Hedge with numbered reference. Canopy extents and coloured BS5837:2012 tree quality category as shown below.

- 8.11 Copies of the Tree Removal and Protection Plan shall be placed in the site office for reference by all site staff.
- 8.12 Signs detailing the purpose of the protective barrier shall be attached to the barriers at 10m intervals. Such signs should be weatherproof and shall be substantially in the form of the examples provided in. Signs must Appendix F be replaced as necessary should they be removed or become illegible.

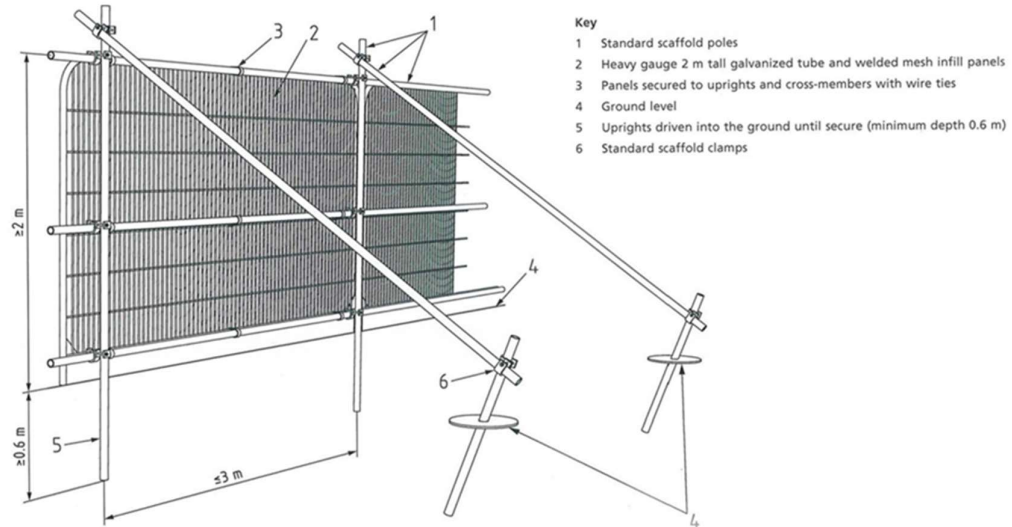
Figure 2 Default specification for protective barrier

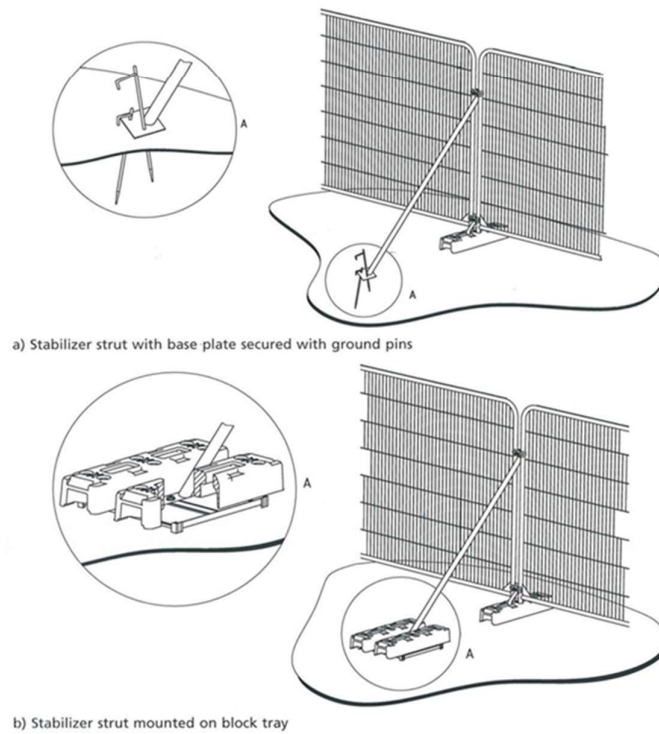
Figure 3 Examples of above-ground stabilizing systems
