## Bat Emergence and Re-Entry Surveys (BERS)

2 Cedar Close, Wokingham, Berkshire, RG40 1EA

“The demolition of the existing single storey extension and car port in order to be reconstructed and extended forwards to align with the main building”

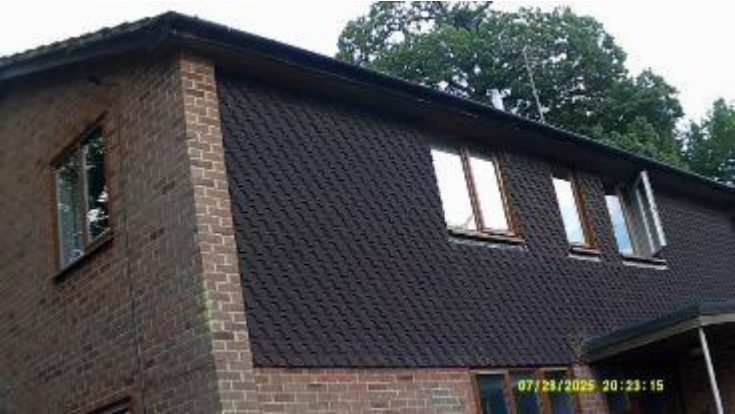
| <p><i>Surveyor 1</i></p> | <p><b>No emergencies observed</b></p> <p>Key flight paths: South to north over B1 and south to north in front of the northeast elevation.<br/>Key foraging activity: N/A<br/>Species observed: Common pipistrelle</p> <p>Summary of general activity:<br/>The first bat activity recorded during the survey was a common pipistrelle seen commuting south to north above B1 at 21:12, another was seen flying the same path at 21:25. At 21:18 a common pipistrelle was seen commuting from south to north in front of the northeastern elevation. Another common pipistrelle followed the same flight path from north to south at 21:23 and south to north at 21:46. Between 21:27 and 22:25 there were four occurrences of common pipistrelles heard and not seen, including the final activity at 22:25.</p> | <p>Full elevation photo showing surveyor's view.</p> |

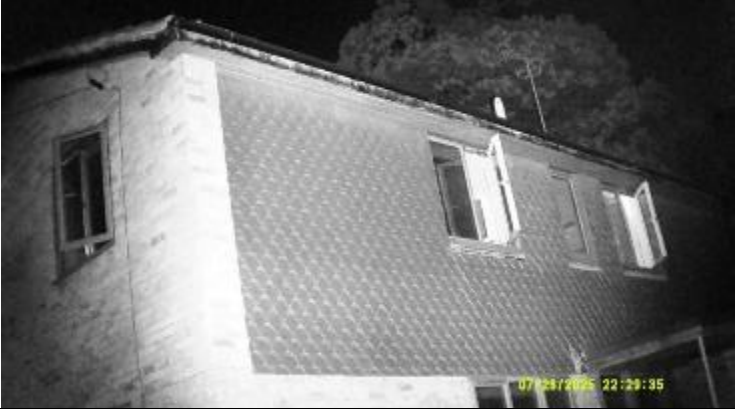
| <p><i>IR position 1</i><br/><i>Nightfox Whisker and</i><br/><i>Nightfox XB5 PRO</i></p> | <p>Camera position: observing north elevations of building.</p> <p><b>No emergencies or entries into the building seen upon review.</b></p> <p>No additional observations or bat activity recorded upon review.</p> | <p>Darkest point full elevation photo showing surveyor's view.</p> |

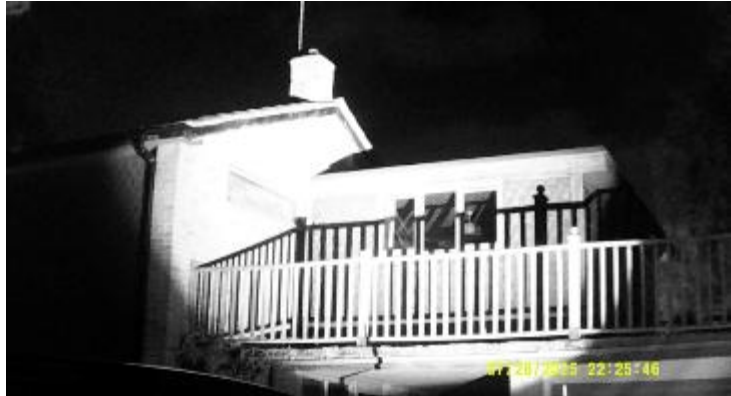
| <i>IR position 2</i><br><i>Nightfox Whisker and</i><br><i>Nightfox XB5 PRO</i> | <p>Camera position: observing west elevations of building.</p> <p><b>No emergences or entries into the building seen upon review.</b></p> <p>No additional observations or bat activity recorded upon review.</p> | <p>Darkest point full elevation photo showing surveyor's view.</p> |

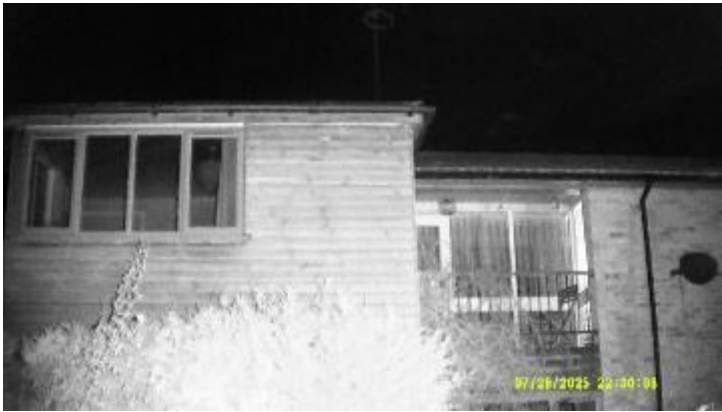
| <p><i>IR position 3</i><br/><i>Nightfox Whisker and</i><br/><i>Nightfox XB5 PRO</i></p> | <p>Camera position: observing south elevation of building.</p> <p><b>No emergences or entries into the building seen upon review.</b></p> <p>No additional observations or bat activity recorded upon review.</p> | <p>Darkest point full elevation photo showing surveyor's view.</p> |

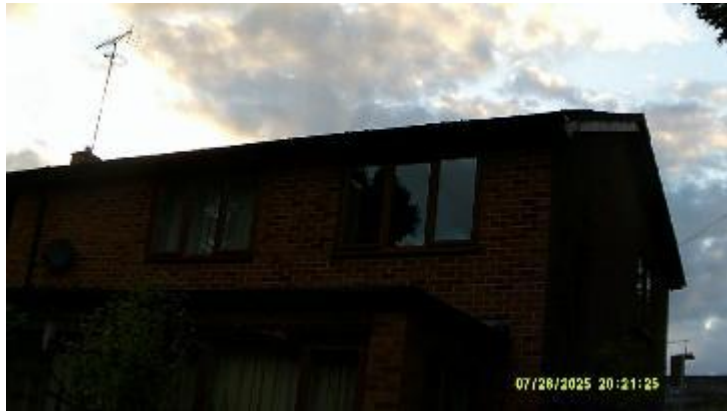
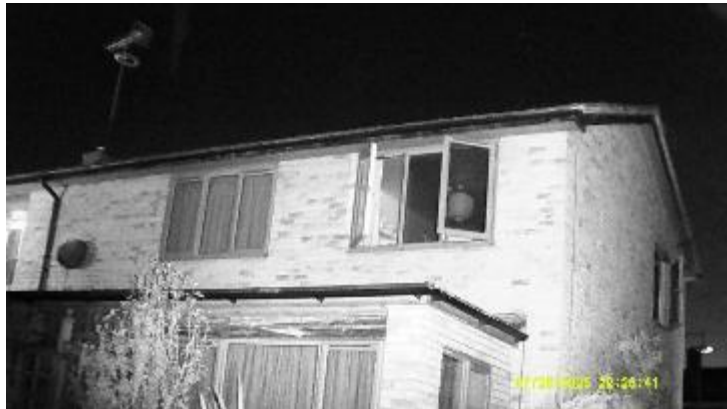
| <p><i>IR position 4</i><br/> <i>Unmanned IR</i><br/> <i>Nightfox Whisker and</i><br/> <i>Nightfox XB5 PRO</i></p> | <p>Camera position: observing south elevation of building.</p> <p><b>No emergencies or entries into the building seen upon review.</b></p> <p>Summary of additional observations:<br/> Two common pipistrelles can be seen commuting from north to south in front of the northeastern elevation at 21:23 and 21:24. A final common pipistrelle can be seen using the same flight path at 21:27.</p> | <p>Full elevation photo showing unmanned IR's view.</p> <p>Darkest point full elevation photo showing unmanned IR's view.</p> |

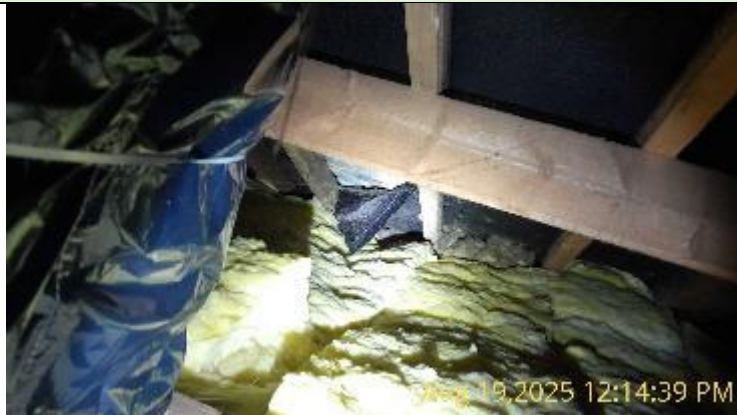
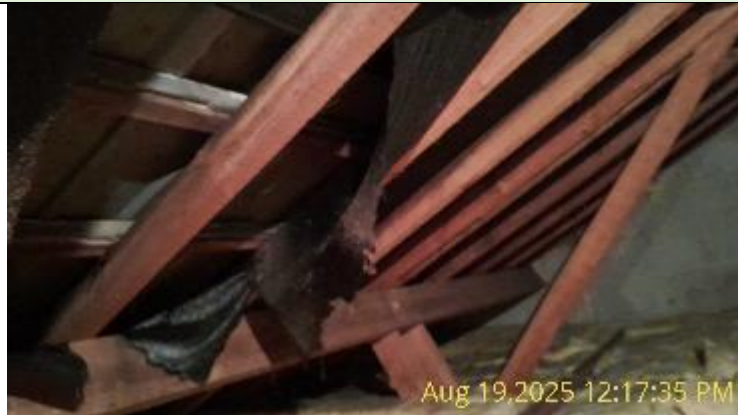
| <i>Building inspection prior to survey</i> | An inspection of both the exterior and interior of B1 was completed by Anna Dolby BSc (Hons), [Accredited Agent: Natural England Protected Species Licence Numbers: [Bats] (2018-33540-CLS-CLS)] on the 19/08/2025 to search for evidence of roosting bats. No evidence of bats roosting such as droppings or moth wings were found within the loft void or around the hanging tiles on the northwest elevation. The exterior and interior of B1 remained relatively unchanged since the original site visit in June 2025. | |
| | B1: Gap within bitumen felt | B1: Gap within bitumen felt |

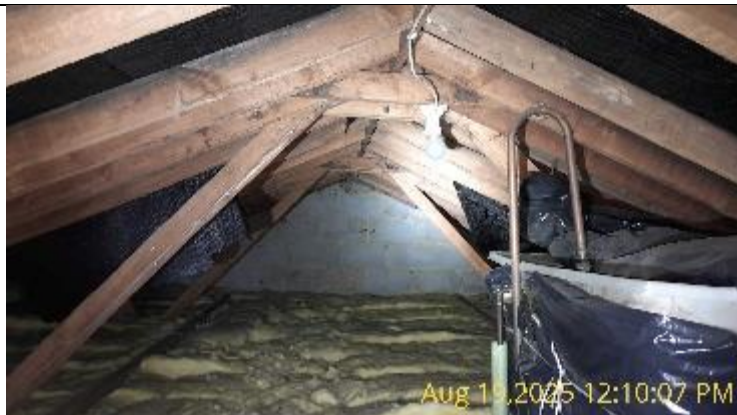
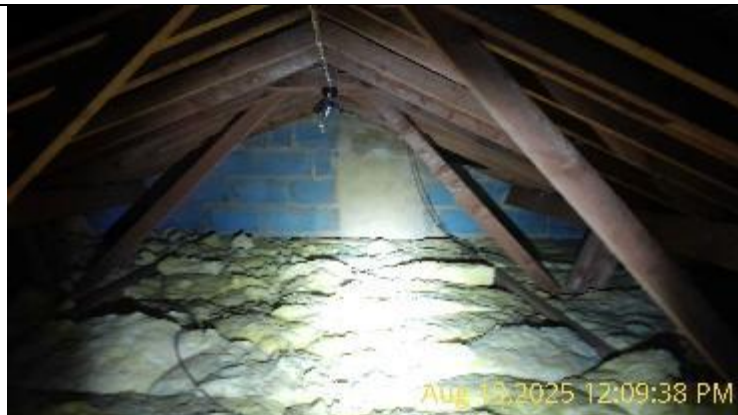
| | B1: northeastern end of the loft void | B1: Western end of the loft void |

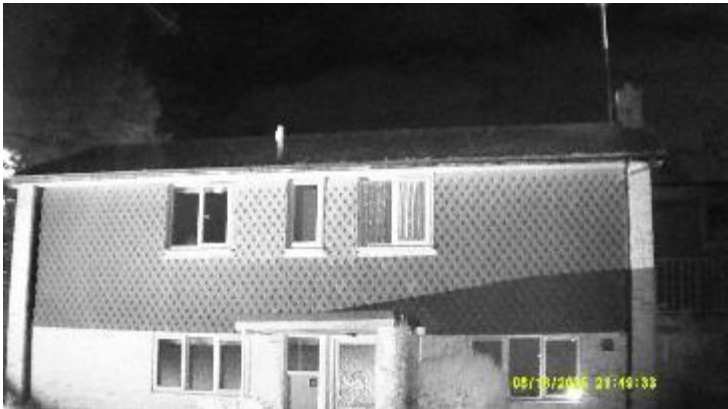
| <p><i>IR position 1</i><br/><i>Nightfox Whisker and</i><br/><i>Nightfox XB5 PRO</i></p> | <p>Camera position: observing northwestern elevation of building.</p> <p><b>No emergencies or entries into the building seen upon review.</b></p> <p>No additional observations or bat activity recorded upon review.</p> | <p>Darkest point full elevation photo showing surveyor's view.</p> |

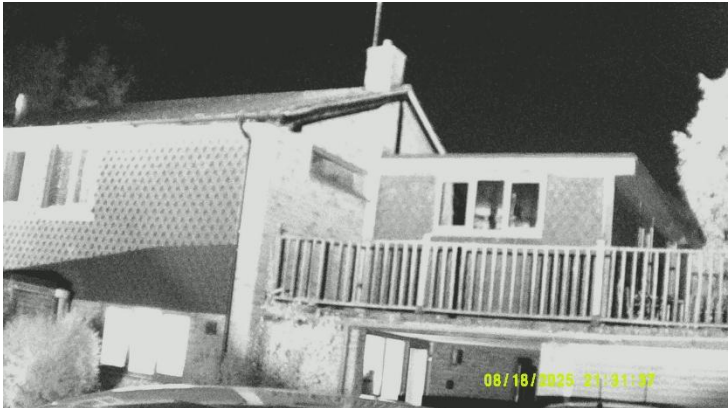
| <p><i>IR position 2</i><br/><i>Nightfox Whisker and</i><br/><i>Nightfox XB5 PRO</i></p> | <p>Camera position: observing west elevations of building.</p> <p><b>No emergencies or entries into the building seen upon review.</b></p> <p>No additional observations or bat activity recorded upon review.</p> | <p>Darkest point full elevation photo showing surveyor's view.</p> |

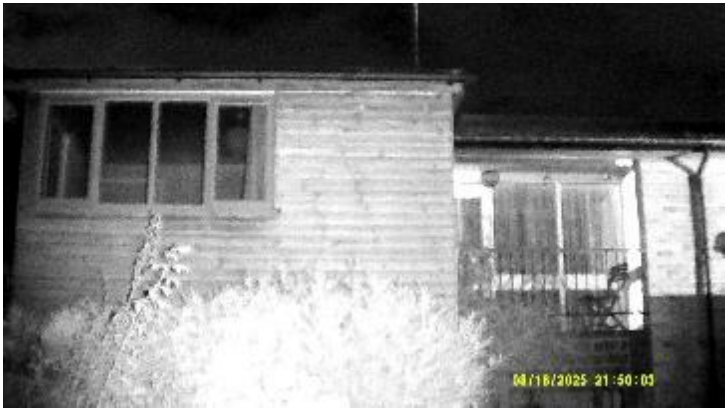
| <p><i>IR position 3<br/>Nightfox Whisker and<br/>Nightfox XB5 PRO</i></p> | <p>Camera position: observing south elevation of building.</p> <p><b>No emergencies or entries into the building seen upon review.</b></p> <p>No additional observations or bat activity recorded upon review.</p> | <p>Darkest point full elevation photo showing surveyor's view.</p> |

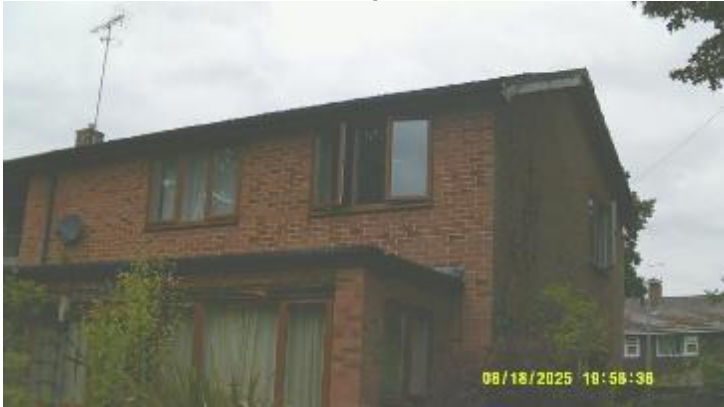
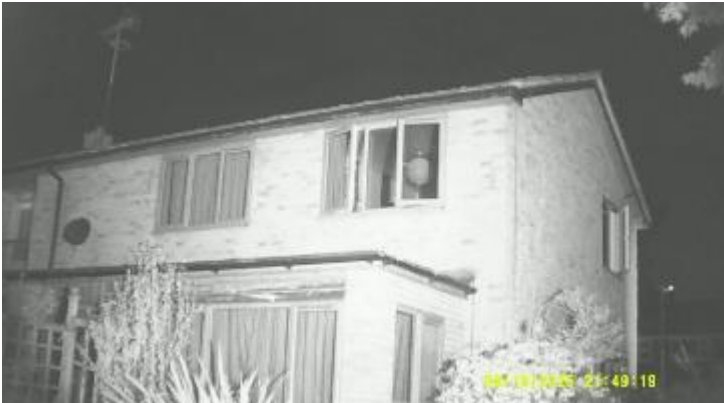
| <i>IR position 4</i><br><i>Unmanned IR</i><br><i>Nightfox Whisker and</i><br><i>Nightfox XB5 PRO</i> | <p>Camera position: observing east elevations of building.</p> <p><b>No emergencies or entries into the building seen upon review.</b></p> <p>Summary of additional observations:<br/> The first activity recorded was a bat seen commuting north in front of the northern corner at 20:34. This was seen again at 20:43. This activity correlates with common pipistrelle calls detected during the survey. From 20:50 till 21:20 there was continuous bat foraging and commuting activity in front of the northeastern elevation. This activity coincides with common pipistrelle calls detected during the survey.</p> | <p>Full elevation photo showing unmanned IR's view.</p> <p>Darkest point full elevation photo showing unmanned IR's view.</p> |

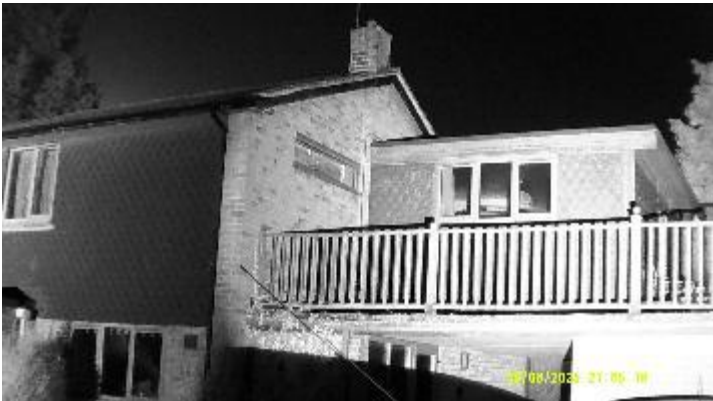
| <p><i>IR position 2</i><br/><i>Nightfox Whisker and</i><br/><i>Nightfox XB5 PRO</i></p> | <p>Camera position: observing west elevations of building.</p> <p><b>No emergences or entries into the building seen upon review.</b></p> <p>No additional observations or bat activity recorded upon review.</p> | <p>Darkest point full elevation photo showing surveyor's view.</p> |

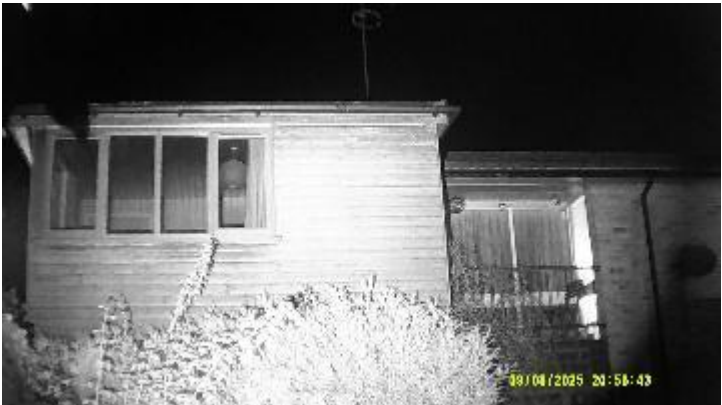
| <p><i>IR position 3</i><br/><i>Nightfox Whisker and</i><br/><i>Nightfox XB5 PRO</i></p> | <p>Camera position: observing south elevation of building.</p> <p><b>No emergences or entries into the building seen upon review.</b></p> <p>No additional observations or bat activity recorded upon review.</p> | <p>Darkest point full elevation photo showing surveyor's view.</p> |

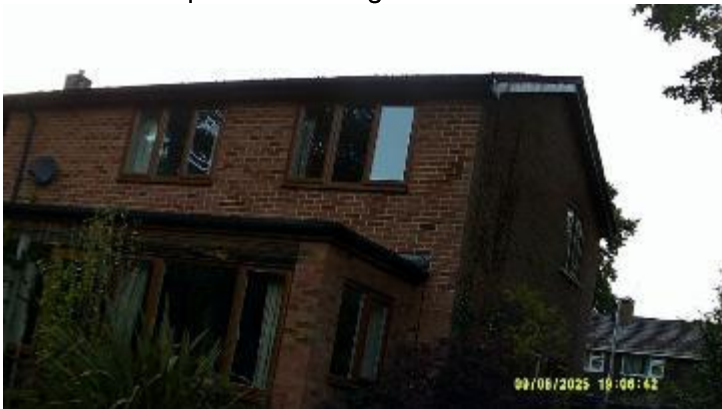
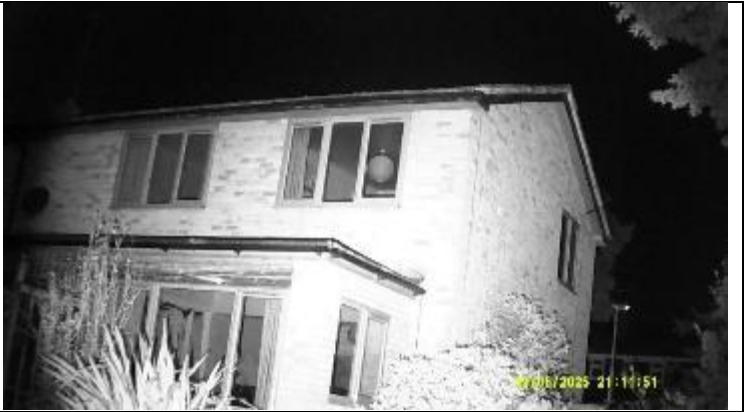
| <p><i>IR position 4</i><br/><i>Unmanned IR</i><br/><i>Nightfox Whisker and</i><br/><i>Nightfox XB5 PRO</i></p> | <p>Camera position: observing east elevations of building.</p> <p><b>No emergences or entries into the building seen upon review.</b></p> <p>Summary of additional observation:<br/>The first bat recorded in the footage was seen foraging in front of the southern elevation. This activity correlates to common pipistrelle calls detected during the survey. This was seen again at 19:57 and 19:59. Common pipistrelles were seen continuously foraging throughout the rear garden and in front of both the southeastern and northeastern elevations from 20:02 till 20:24. Between 20:35 and 20:42 there was another period of continuous common pipistrelle activity. Bats can be seen foraging throughout the rear garden and commuting south in front of the northeastern elevation. This activity can then</p> | <p>Full elevation photo showing unmanned IR's view.</p> <p>Darkest point full elevation photo showing unmanned IR's view.</p> |

| | be seen intermittently from 20:45 till the end of the survey. | |
