36 Luckley Road  
Wokingham  
Berkshire  
RG41 2EN

## Preliminary Roost Assessment

Report ref.: R3061\_PRA\_a

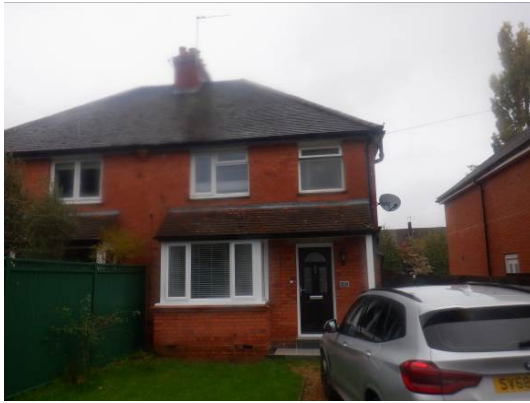
**5.2.2** The property is a semi-detached brick house with a hipped roof, with a sloping roof on the front elevation above the entrance porch and bay window (**Photographs 1 & 2**).

Photograph 1. Front of property viewed from south.

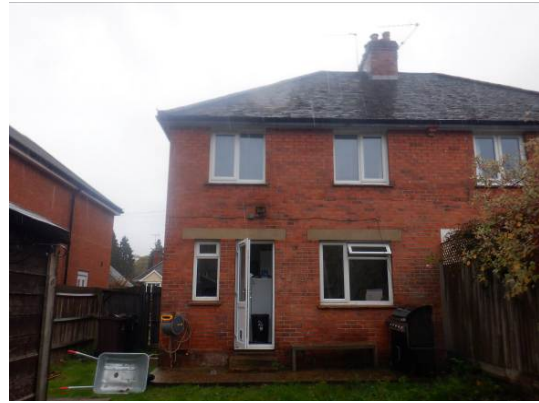
Photograph 2. Rear of property viewed from north.

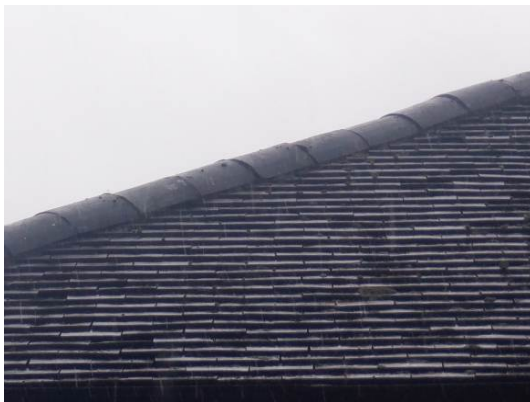
**5.2.3** The roof of the semi-detached house was covered with plain roof tiles that were flat and intact across all elevations of the house (**Photograph 3**). The hip and ridge tiles were tight across the roof, with a small gap in the hip mortar beneath two hip tiles on the eastern elevation (**Photograph 4; Target note 1**). This feature is of a size and type to offer potential roosting opportunities for crevice-dwelling bats, such as the locally recorded pipistrelles (*Pipistrellus* sp.). A close-up inspection was carried out with an endoscope camera and accessed from a cherry picker. The close up inspection showed there to be a suitable gap beneath the hip tiles that could be used by individual crevice-dwelling bats but did not extend into a significant crevice for use by multiple bats, however no evidence of use by bats was found and therefore bats were confirmed as absent (**Photograph 5**).

Photograph 3. Flat plain roof tiles and fully mortared hip (northern elevation).

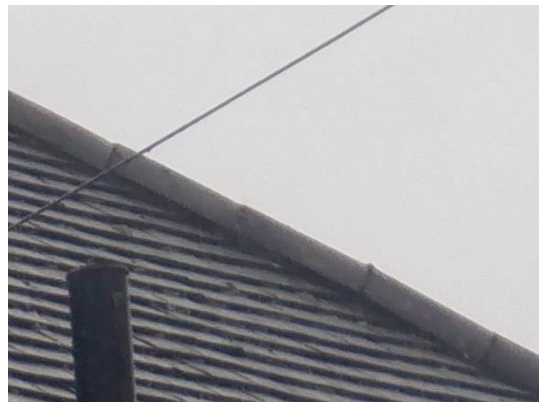
Photograph 4. Small gap in mortar below hip tiles (eastern elevation).

- 6.1.2** The house had the following suitable/potential bat access points and roost features:
- Gap in hip mortar on eastern elevation (**Photograph 4; Target note 1**);

- 6.1.3** The feature associated with the missing hip mortar creating a gap beneath a hip tile on the eastern elevation was inspected with an endoscope during a follow-up visit from a cherry picker, which showed the gap to be of limited extent and was able to be fully inspected and showed no signs of recent or historic use by roosting bats (**Photograph 5**).

- 6.2.1** The development proposals seek consent for a two-storey side extension and a single-storey rear extension. Following the close up endoscope check that confirmed the individual feature beneath the hip tiles located on the eastern elevation of the house that will be removed during the work, had no evidence of current or historic use by crevice-dwelling bats, the survey findings demonstrate that these proposals are highly unlikely to result in the death, injury or disturbance of bats; the damage or destruction of a bat roost; or the obstruction of access to a bat roost in the property's current condition. Therefore, a European Protected Species (EPS) mitigation licence would not be required to allow the development proposals to proceed lawfully.

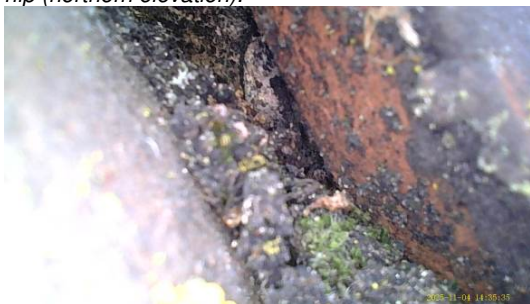
Photograph 5. Close up inspection of hip tile (eastern elevation).

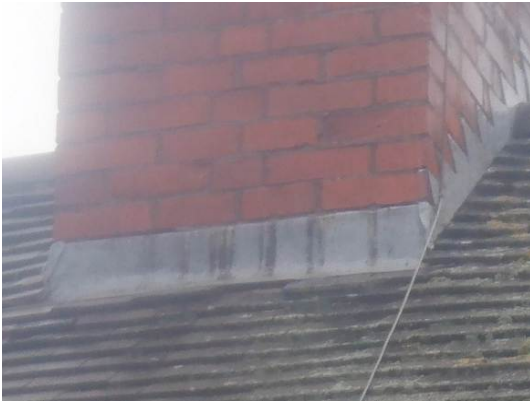
- 5.2.4** The lead flashing around the chimney was flush to the plain roof tiles (**Photograph 6**). The timber soffits and fascia's were intact and sat on top of the brick wall plate of the house (**Photograph 7**).

*Photograph 6. Lead flashing around chimney flush to plain roof tiles (northern elevation).*

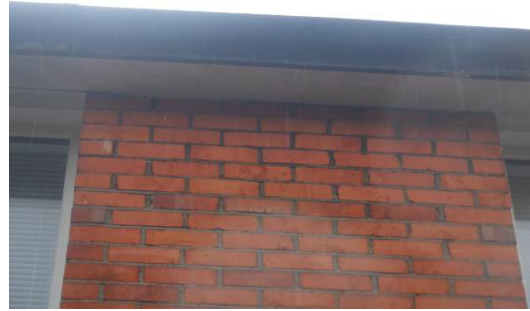
*Photograph 7. Tight timber soffits and fascia's (southern elevation).*

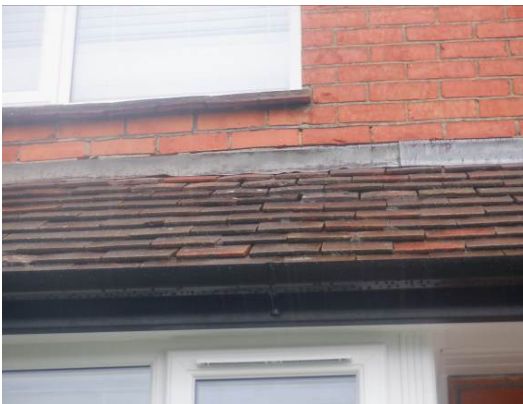
- 5.2.5** The sloping roof of the front porch was covered in overlapping roof tiles that were slightly uneven but offering no roosting opportunities for bats and the lead flashing along the top of the sloping roof was flush to the brickwork (**Photograph 8**). The verge was fully mortared, and the half gable was rendered with pebble-dash that had a crack adjacent to the brickwork, however close inspection with a high-powered torch confirmed the feature to be heavily cobwebbed and of limited extent (**Photograph 9; Target Note 2**).

*Photograph 8. Uneven overlapping roof tiles and flush lead flashing (northern elevation).*

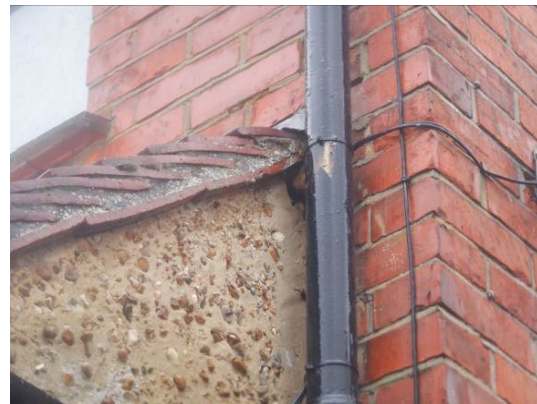
*Photograph 9. Crack in render on front porch (eastern elevation)*

- Gap of limited extent in cracked render on the eastern elevation of the front porch (**Photograph 9; Target note 2**) and;
  - Small gap over the brickwork party wall and timber rafters within loft void (**Photograph 11; Target note 3**).

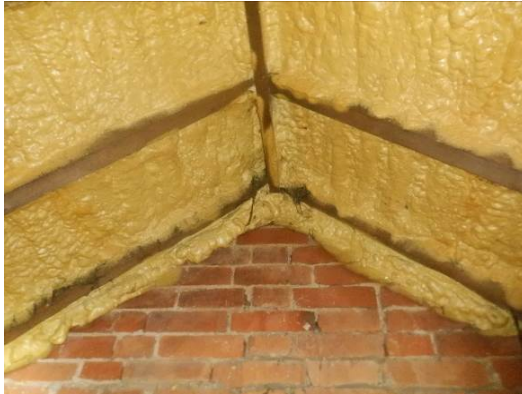
- 5.2.7** There was one roof void that covered the footprint of the property and was accessible via a first floor loft hatch. The void was of 'cut and pitch' construction with an approximate floor-to-ridge height of 2 m, the rafters were heavily cobwebbed throughout and the roof was

covered with spray foam insulation between the rafters, with no daylight visible throughout the roof void (**Photograph 10**).

*Photograph 10. Roof void with roof covered by spray foam insulation.*

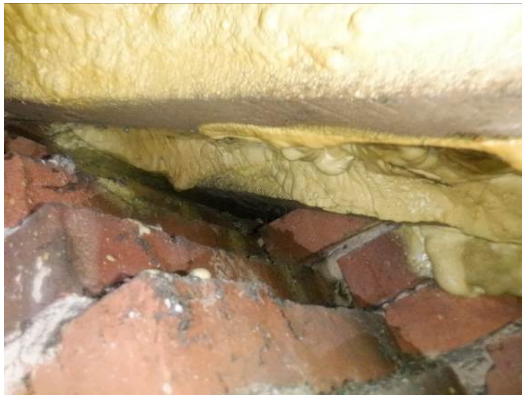
- 5.2.8** The western end of the void featured a brickwork party wall and duel chimney, with a small gap between the brickwork and the timber rafters leading into the neighbouring roof void (**Photograph 11; Target note 3**). The eaves were filled with spray foam insulation throughout the void (**Photograph 12**). The floor of the roof void was partly boarded, with no insulation present and plastic sheeting covering the lathe and plaster between the joists (**Photograph 13**).

*Photograph 11. Small gap between brickwork of party wall and timber rafters (roof void).*

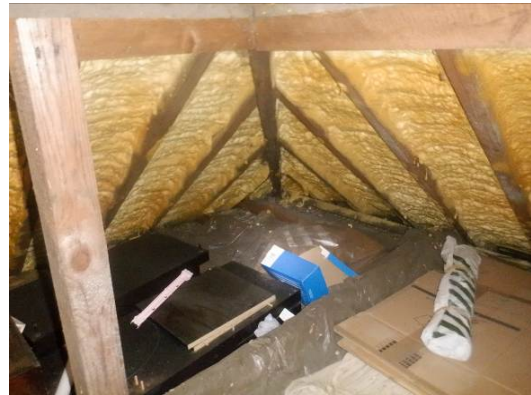
*Photograph 12. Spray foam insulation filling eaves (roof void).*

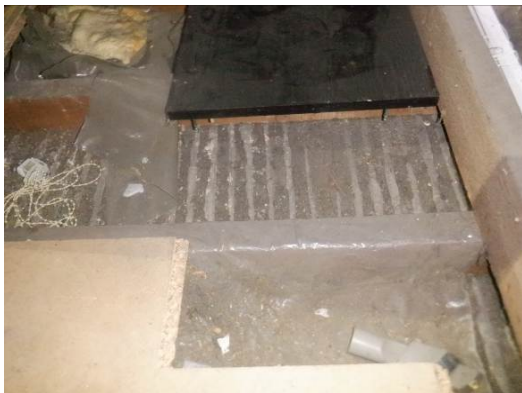
*Photograph 13. Plastic sheeting on floor of roof void covering the joists (roof void).*

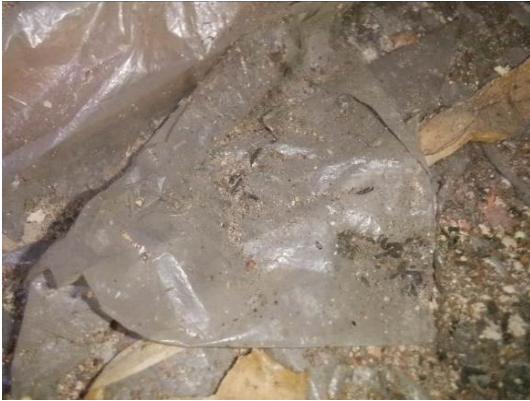
- 5.2.9** A cluster of approximately 20 medium-sized bat droppings, resembling those typically deposited by long-eared species (*Plecotus* spp.), were observed on the plastic sheeting and below the boarding, in front of the brickwork party wall (**Photograph 14**). Due to the intact spray foam insulation lining the roof, which creates no crevices and restricts access points for bats into the roof void and the lack of further evidence observed on the boarding present within the void, it is considered that the droppings are from a roost that is likely historic.

*Photograph 14. Small cluster of medium-sized bat droppings (roof void).*

- 6.1.4** Internally, approximately 20 medium-sized bat droppings were observed during the internal inspection, however the roof void was heavily cobwebbed with no visible access points due to the spray foam for void-dwelling bats, such as brown long-eared (*P. auritus*). Therefore, these droppings were confirmed historic and the roof void was considered to not be in active use by bats.
