## Preliminary Ecological Appraisal and Roost Assessment

171 Victoria Road, Wargrave, Reading, Wokingham, Berkshire, RG10 8AH

18<sup>th</sup> March 2025

The demolition of the existing (single-storey) extension and then the construction of a new (single-storey) on the northern elevation. The development will also include partial demolition and the raising of the southern elevation porch to facilitate the conversion of the garage into a utility room.

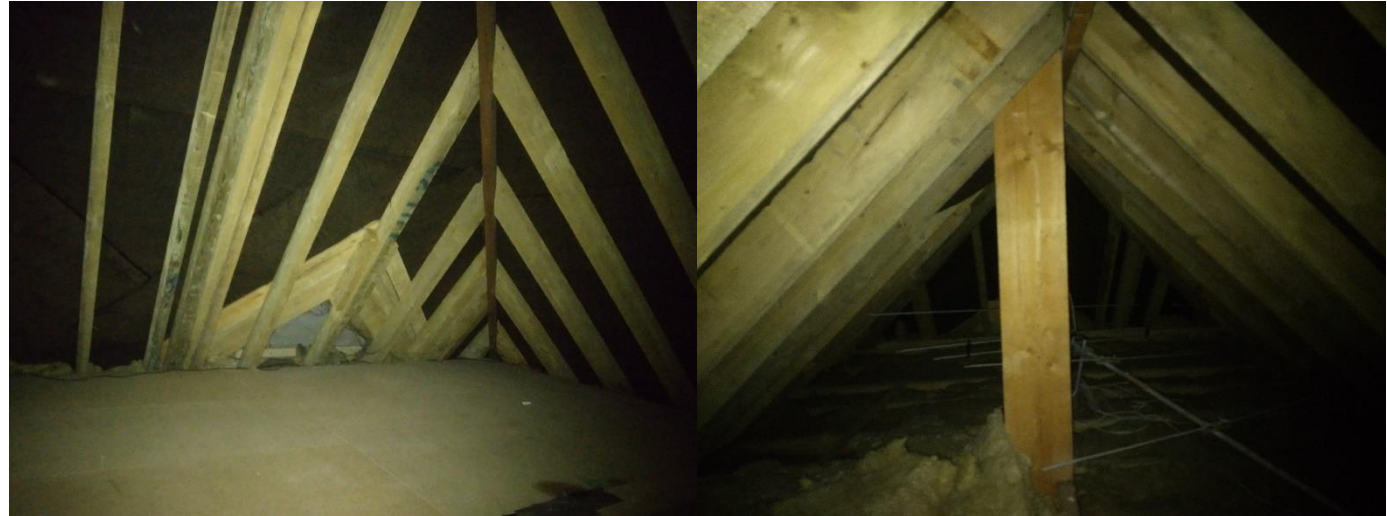
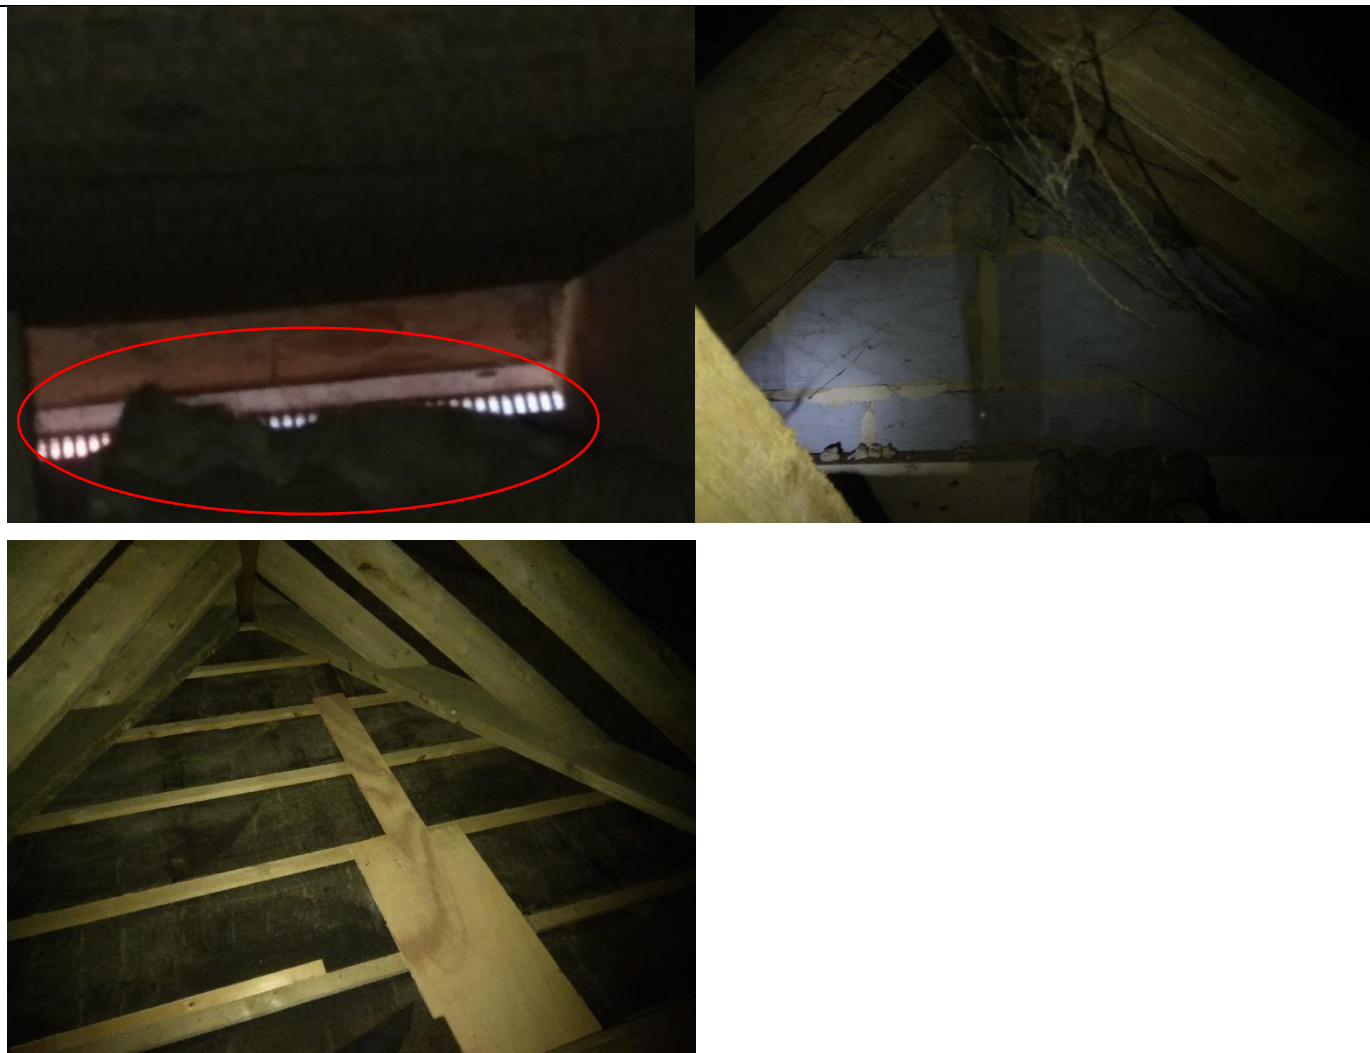
The second loft void (LV2) extended on the western part of the roof. It was 2m in height (at the peak), 5m wide and 6m long. The loft void was lined with excellent-condition Bitumen felt. There were areas of light spill from the ventilation around the edges of the roof (circled in red). The internal temperature of the void was 13°C, and the humidity was 66%.

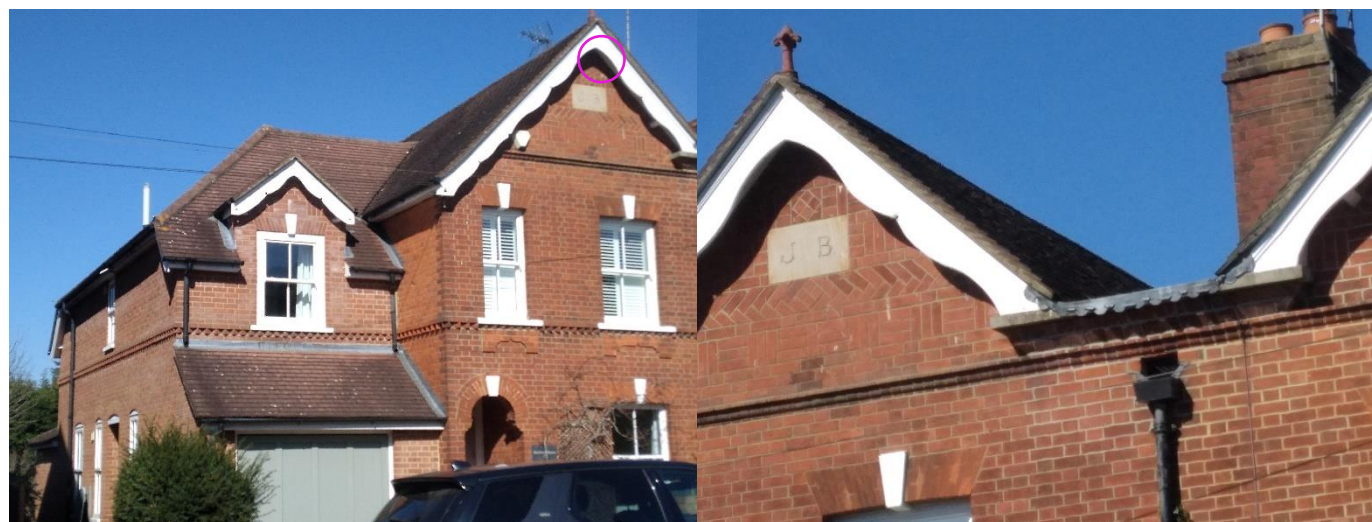
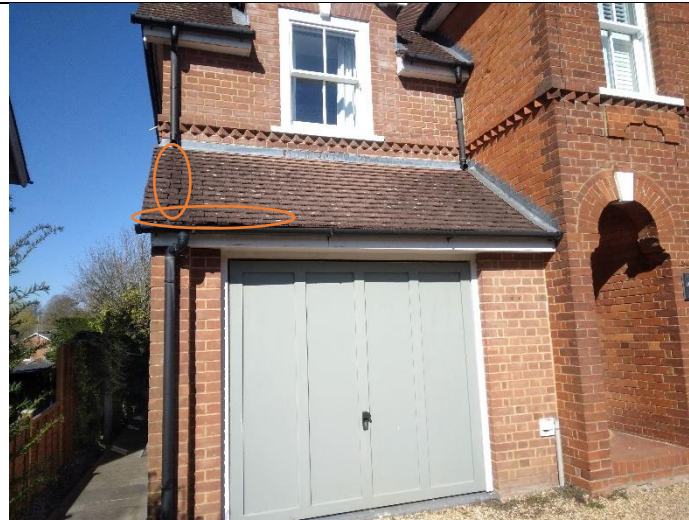
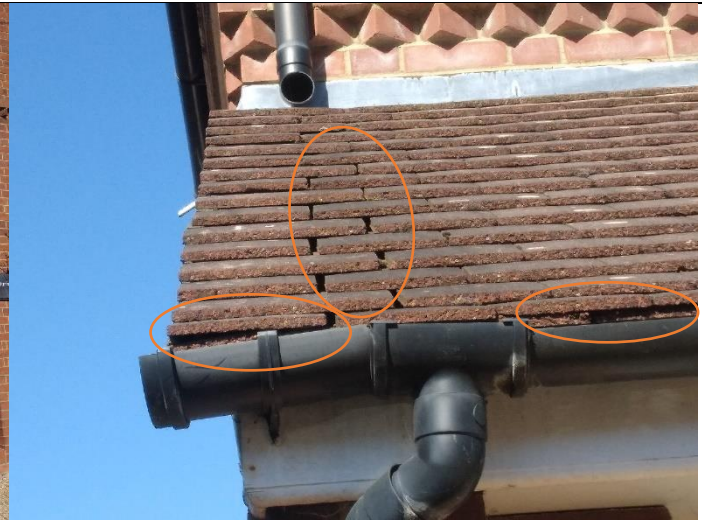
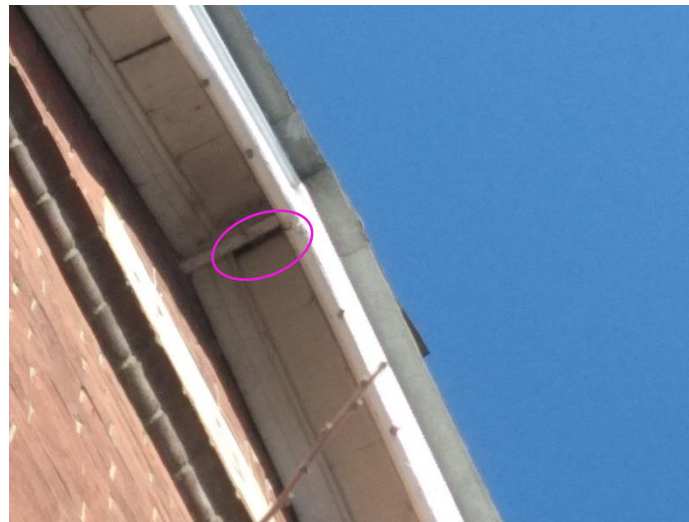
Southern elevation

- Lifted, slipped or missing tiles (circled in orange)
- Gap between the brickwork and soffit box/fascia board (circled in pink)

B1a had low roost suitability due to the presence of a small number of suitable roosting features and access points, as well as the proximity of the traditional orchards in the local area.

| <i>Recommendations</i> | <p><u>Building B1 (B1a and B1b)</u></p> <p>One bat emergence or re-entry survey is required during the active bat season (optimal May to August, suboptimal September) to confirm the presence or likely absence of a bat roost in the building.</p> <p>Infra-red cameras should be used as an aid. Three surveyors are required to provide full coverage of the building (B1).</p> <p>If the absence of a bat roost cannot be determined during the first visit, then further surveys will be required.</p> <p>If bat roosts are confirmed in the building two additional surveys may be required to characterise the roost and to inform an EPSL application to Natural England. Surveys should be a minimum of three weeks apart. The EPSL application requires that surveys have been undertaken within the most recent active bat season and planning permission must have been granted and all relevant wildlife-related conditions have been discharged prior to submission.</p> <p>Lighting mitigation may be required based on the outcome of the night bat survey.</p> <p>Enhancements are dependent on the outcome of further survey.</p> |

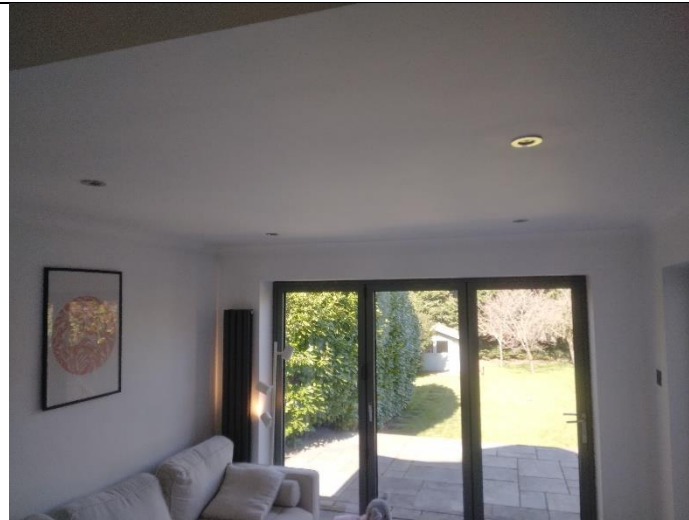
Building B1b is a single-storey (brick-built) extension with a hipped (flat concrete tile) roof. It was attached to the northern elevation of B1a. It had one bi-folding door and two windows. There was no evidence of roosting bats during the survey of B1b (either internally or externally). There was one void within B1b. However, there was no access to the void (sealed off as shown below).

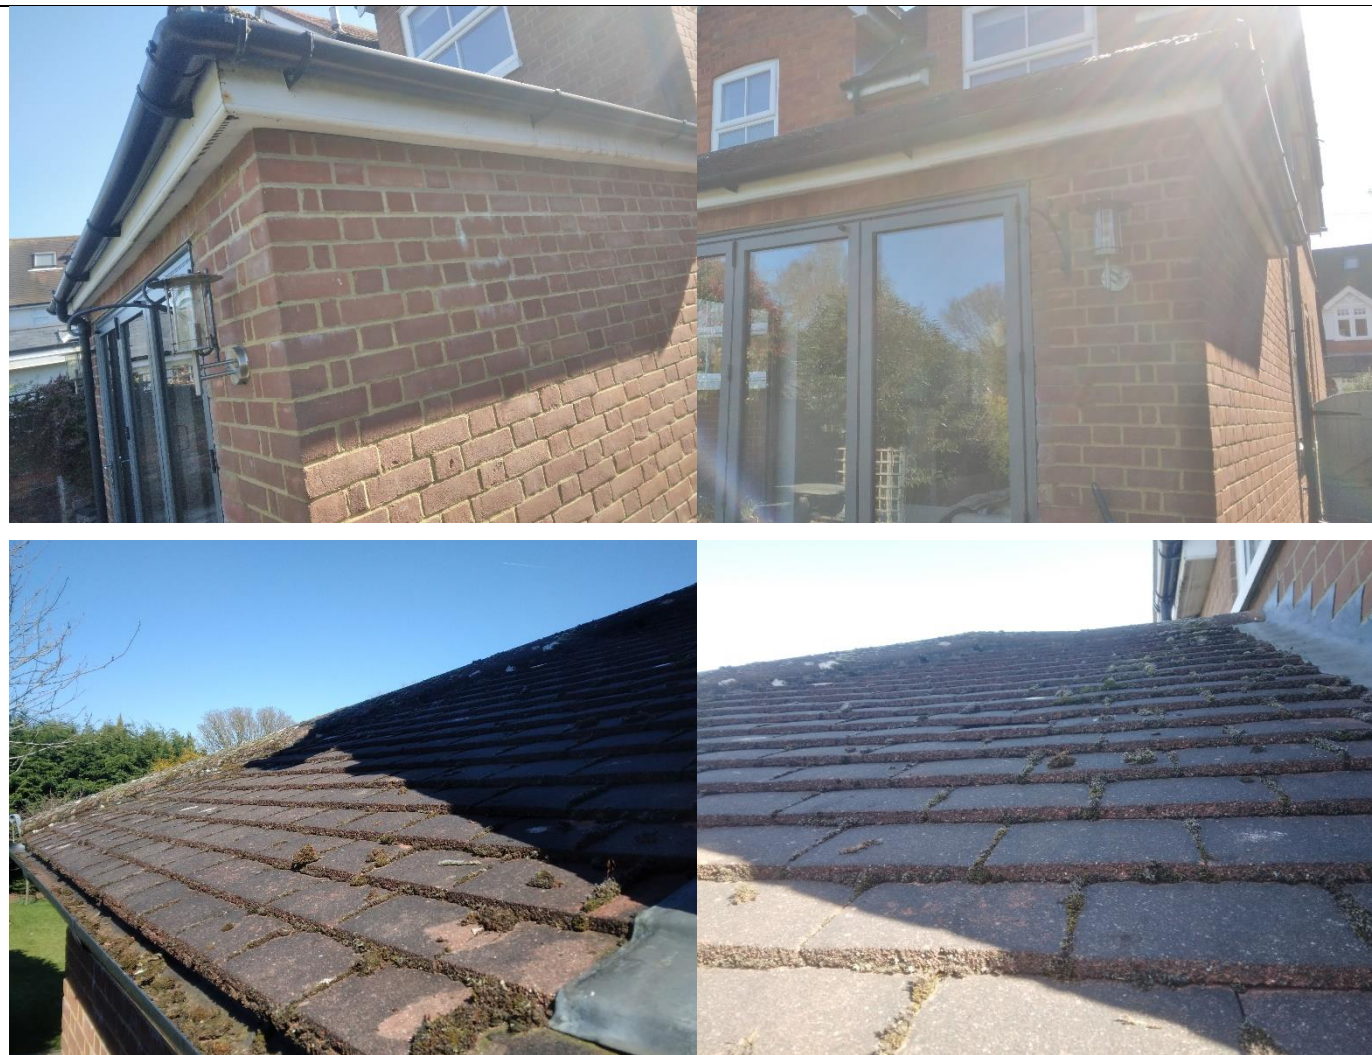
Western elevation

- Lifted, slipped or missing tiles (circled in orange)
- Gap between the brickwork and soffit box/fascia board (circled in pink)

B1b had low roost suitability due to the presence of a small number of suitable roosting features and access points, as well as the proximity of the traditional orchards in the local area.

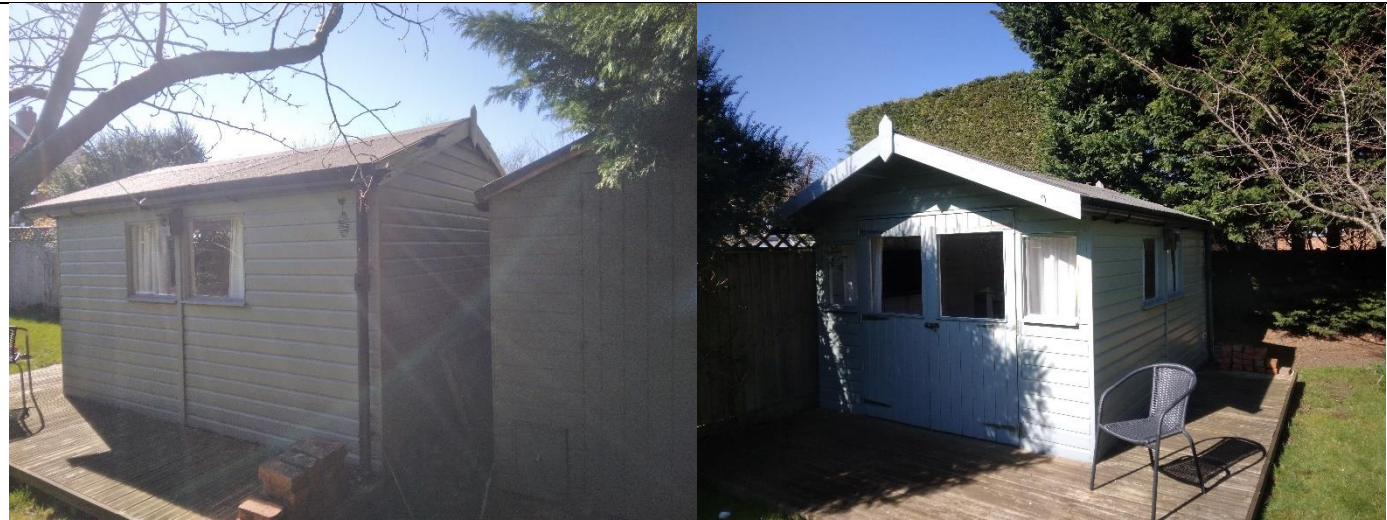
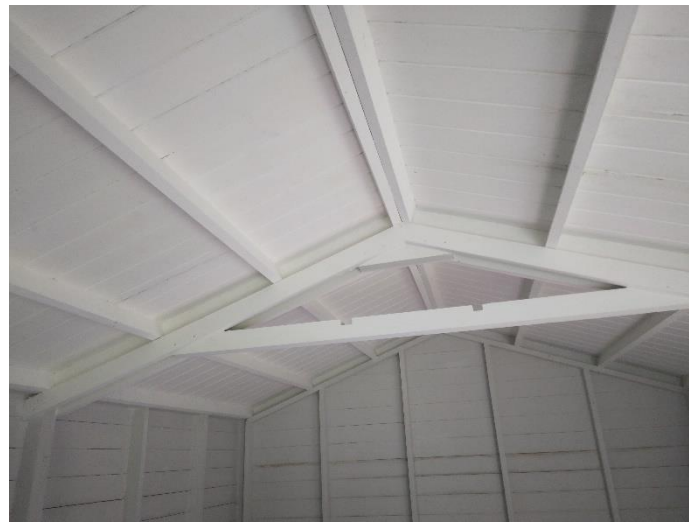
Building B2 (no evidence – negligible roost suitability)

B2 is a small wooden summerhouse with a pitched felt roof. No exterior crevices were noted, and the building was considered negligible as it lacked suitability for crevice and loft-dwelling bats (well-sealed, light spill, and temperature fluctuation). Building B2 is currently not included in the proposed plans.

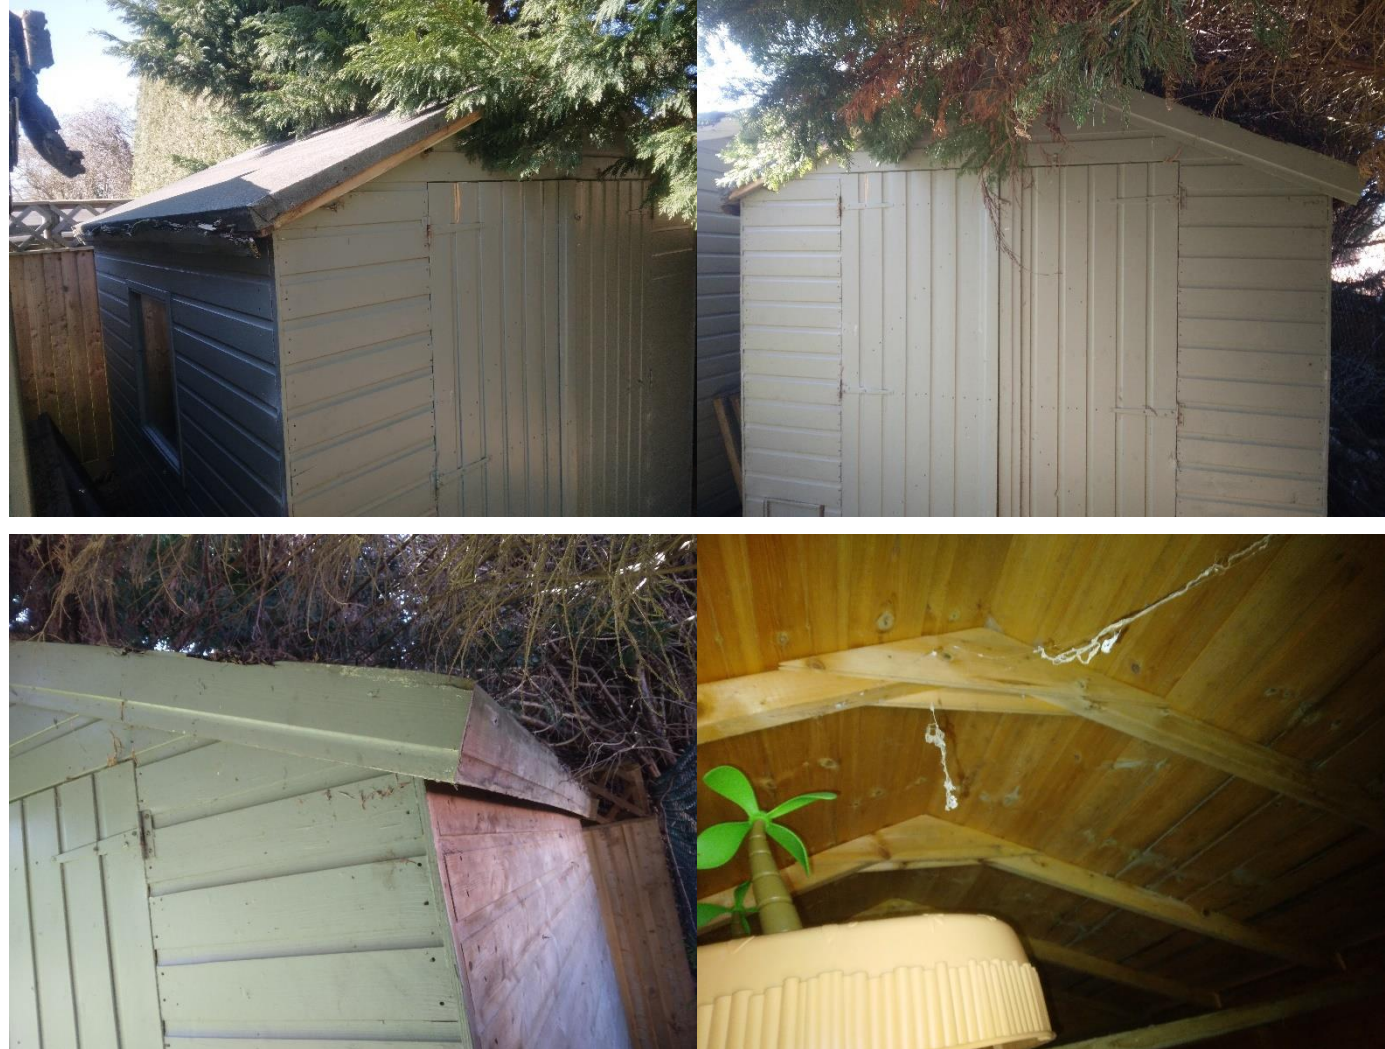
Building B3 (no evidence – negligible roost suitability)

B3 is a small wooden shed with a pitched felt roof. No exterior crevices were noted, and the building was considered negligible as it lacked suitability for crevice and loft-dwelling bats (well-sealed). Building B3 is currently not included in the proposed plans.

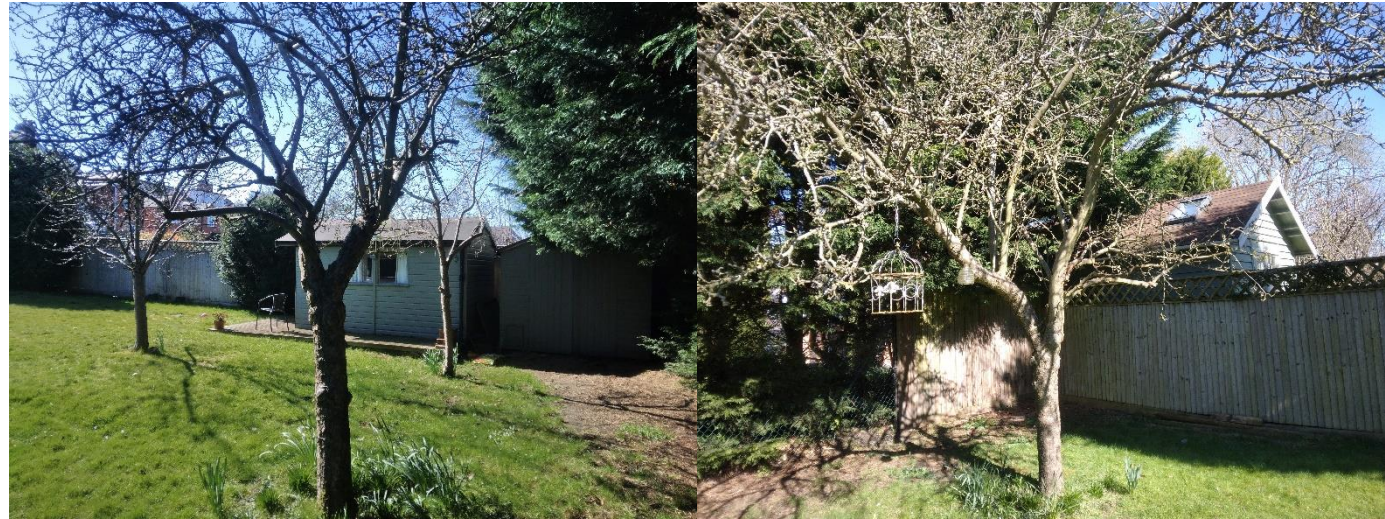
Tree T1 (Potential roosting value - None)

T1 was a semi-mature cherry tree of medium size (~3.5m height and ~40cm DBH) with no ecological niches or evidence of human disturbance. The tree has an excellent natural form and appears in good condition. However, due to its size and age, it does not seem to have suitable roosting features. Tree T1 is currently not included in the proposed plans.

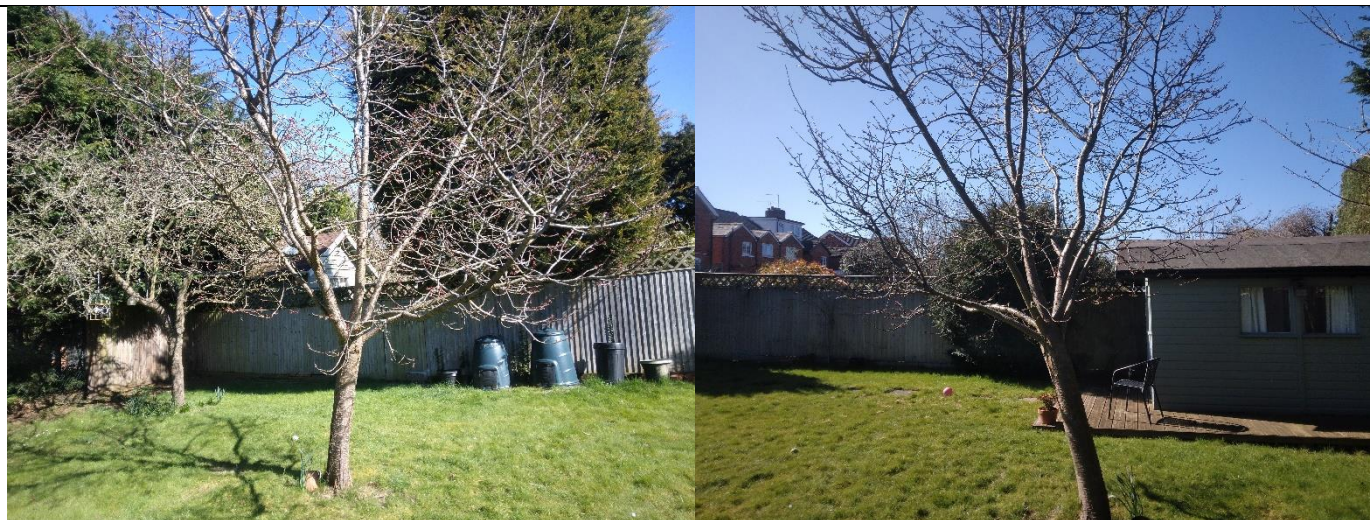
Tree T2 (Potential roosting value - None)

T2 was an immature cherry tree of small size (~3m height and ~25cm DBH) with no ecological niches or evidence of human disturbance. The tree has an excellent natural form and appears in good condition. However, due to its size and age, it does not seem to have suitable roosting features. Tree T2 is currently not included in the proposed plans.

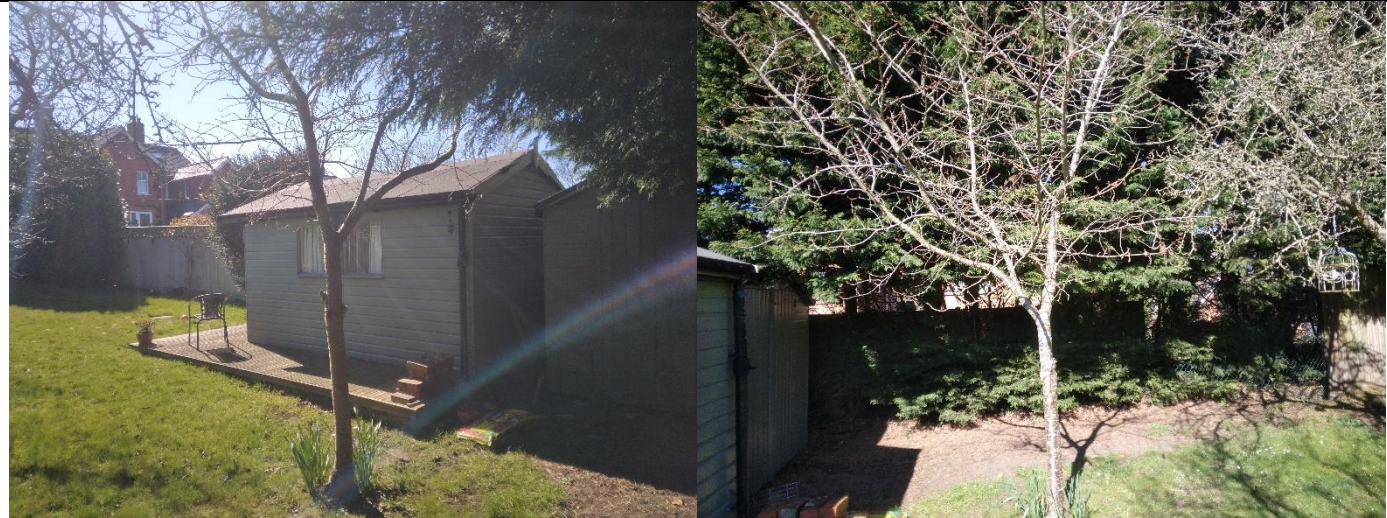
Tree T3 (Potential roosting value - None)

T3 was an immature cherry tree of small size (~3m height and ~15cm DBH) with no ecological niches or evidence of human disturbance. The tree has an excellent natural form and appears in good condition. However, due to its size and age, it does not seem to have suitable roosting features. Tree T3 is currently not included in the proposed plans.

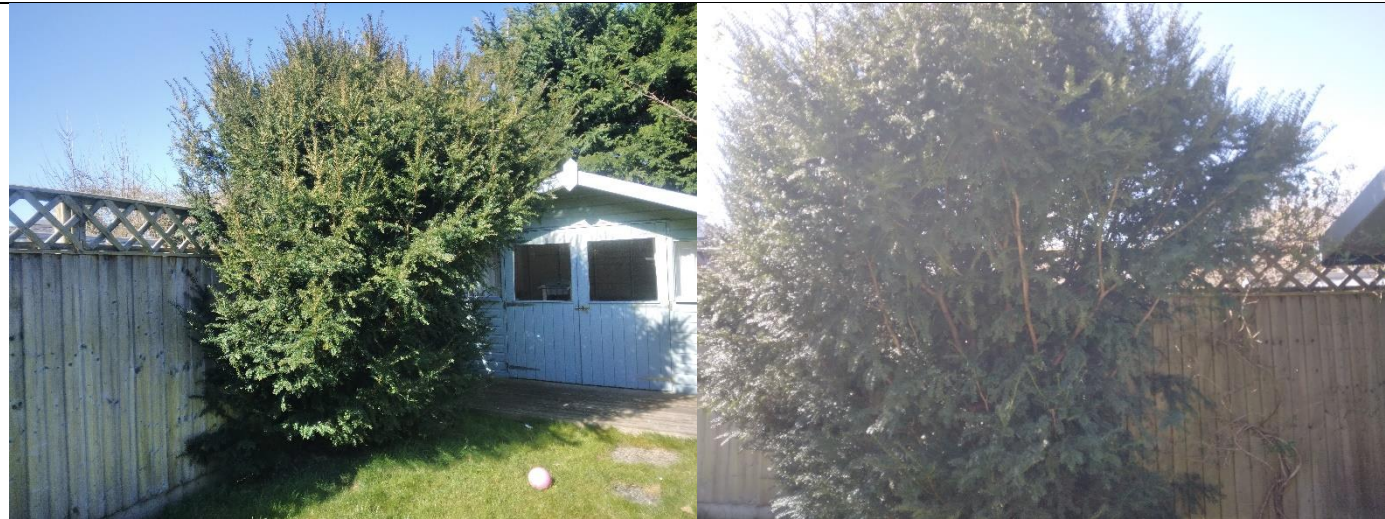
Tree T4 (Potential roosting value - None)

T4 was an immature yew tree of small size (~2.5m height and ~15cm DBH) with no ecological niches or evidence of human disturbance. The tree has an excellent natural form and appears in good condition. However, due to its size and age, it does not seem to have suitable roosting features. Tree T4 is currently not included in the proposed plans.
