**Arboricultural Survey to BS5837:2012**

**42 Pound Lane,  
Sonning,  
Reading,  
Wokingham,  
RG4 6GG**

**26 March 2024**

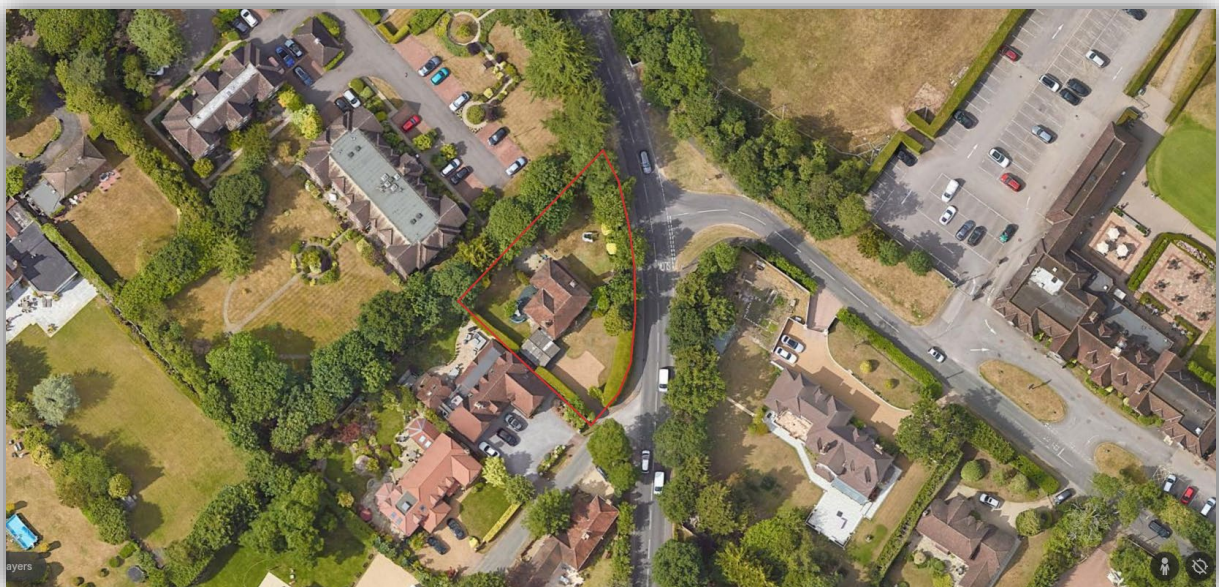
**Figure 2:** Aerial Image of site with approximate red line boundary (Google Earth)

Private domestic detached property with associated off-street parking. The site is relatively flat with minor undulations. Trees and hedges line the perimeter of the property. Site is accessed via Mustard Lane.

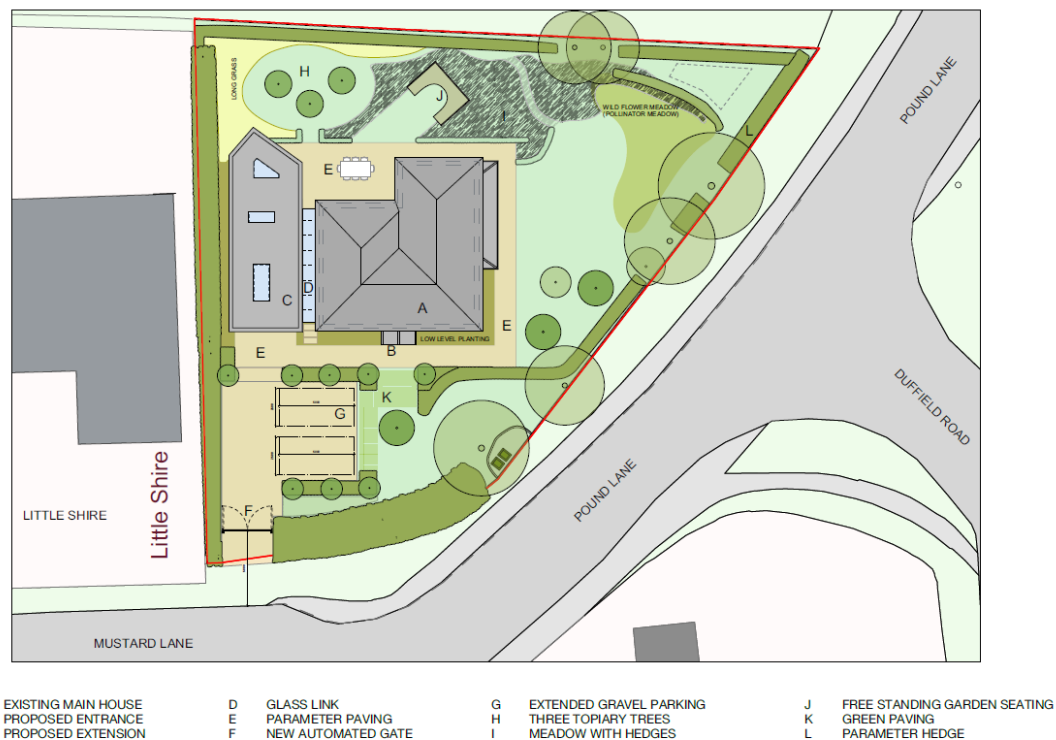
**Figure 3:** Proposed site plan, drawing number: P17 (BDC)

Erection of a single-story side/rear extension following demolition of the existing garage.

It is likely that arboricultural impacts can be addressed with arboricultural methodology or minor amendments to the proposal.
