21 Bayliss Road  
Wargrave  
Reading  
Berkshire  
RG10 8DR

# Preliminary Roost Assessment

Report ref.: R2795\_PRA\_a

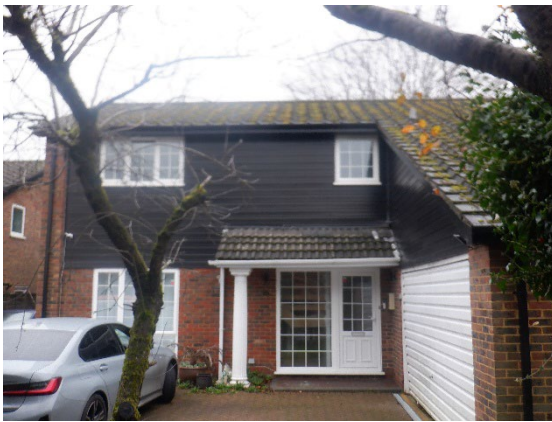
- 5.2.2** The house was a detached dwelling of brick cavity-wall construction with a pitched roof covered in interlocking roof tiles, and a catslide roof on the front elevation over the attached garage (**Photographs 1 & 2**).

*Photograph 1. Front elevation of the house, viewed from the south.*

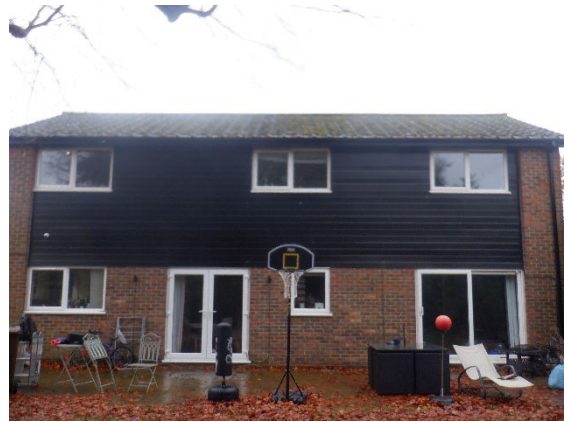
*Photograph 2. Rear elevation of the house, viewed from the north.*

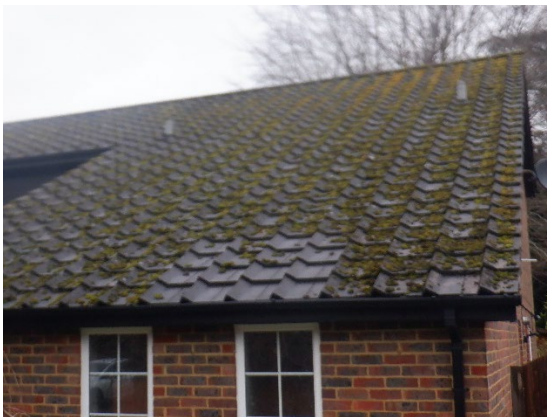
- 5.2.3** The roof was covered with interlocking, machine-made concrete tiles that were in place and flat, and mossy on the front and rear elevations (**Photograph 3**). The ridge tiles were intact across the roof (**Photograph 4**).

*Photograph 3. Tight, mossy interlocking roof tiles (front elevation).*

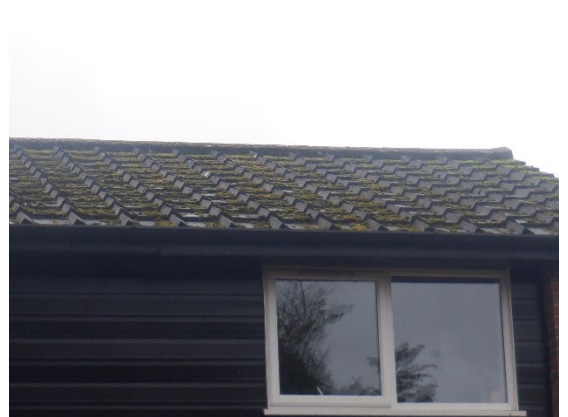
*Photograph 4. Intact ridge tiles (rear elevation).*

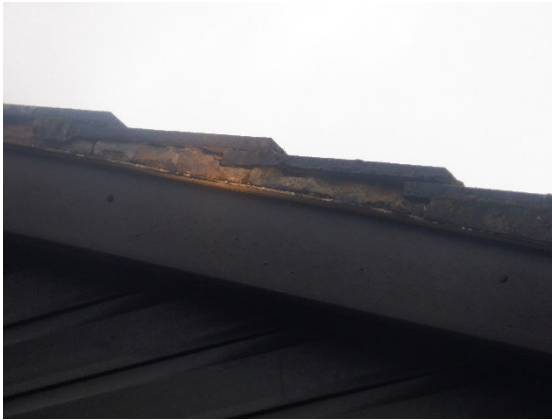
- 5.2.4** The verge mortar was intact along the western and eastern gables, with crumbling sections of verge mortar along the eastern and western sides of the garage (**Photograph 5; Target note 1**) On closer inspection the gaps were of limited extent

*Photograph 5. Crumbling verge mortar above garage (western elevation).*

- Crumbling verge mortar (**Photograph 5; Target note 1**);
- Gap between soffit and brickwork (**Photographs 6; Target note 2**); and
- Lifted uPVC trim (**Photograph 7; Target note 3**).

6.1.3 The gap behind the soffit offers a feature of low suitability for use as bat access and crevice roosting site i.e. only with sufficient space, shelter, protection and conditions for use by individual crevice-dwelling bats, such as the locally recorded common pipistrelle (*P. pipistrellus*) and soprano pipistrelle (*P. pygmaeus*) (see **Appendix 1** for potential suitability categories). The lifted uPVC trim on the front had mortar and blockwork visible underneath and was cobwebbed, showing no evidence of use by bats, and the crumbling mortar was closely inspected and shown to be of limited extent; both features were deemed to be of negligible bat roost potential.

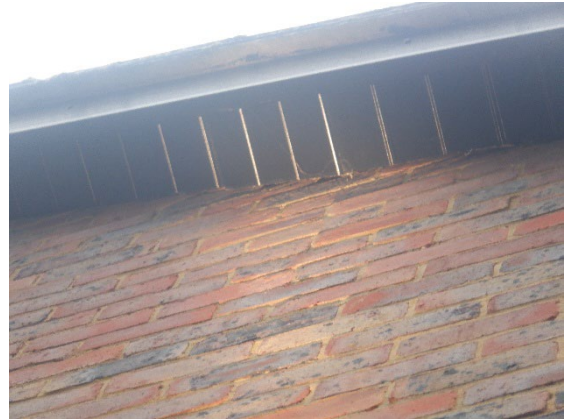
and no evidence of the presence of bats was found. The timber soffit boxes were fitted tightly to the UPVC cladding on the front and rear elevations, with a gap between the soffit and the brickwork on the western gable (**Photograph 6; Target note 2**).

*Photograph 6. Gap under uPVC soffit on western gable.*

- 7.1.2** The proposals, which will involve internal and external alterations, will not affect the soffit box feature of low suitability for bats at the western gable and therefore are unlikely to lead to the damage/destruction of bat roosts, or to the disturbance, injury and/or death of bats.

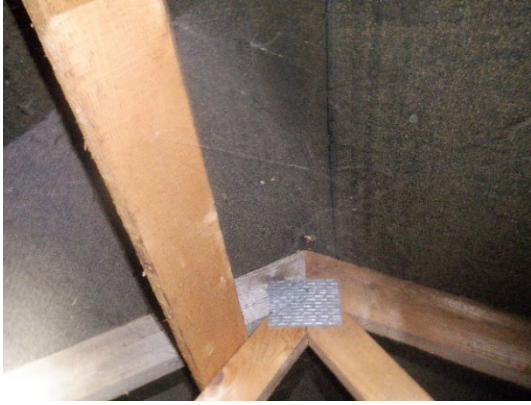
- 5.2.6** There was one loft void that covered the building's second-story footprint, and was accessible via a loft hatch on the first floor. The roof was of pre-trussed rafters that were cobwebbed throughout, with no ridge beam present (**Photograph 8**). The roof was lined with bituminous reinforced bitumen that was intact throughout but had one section of loose overlapping felt on the rear elevation (**Photograph 9; Target note 4**).

*Photograph 8. Cobwebbed rafters with no ridge beam (roof void).*

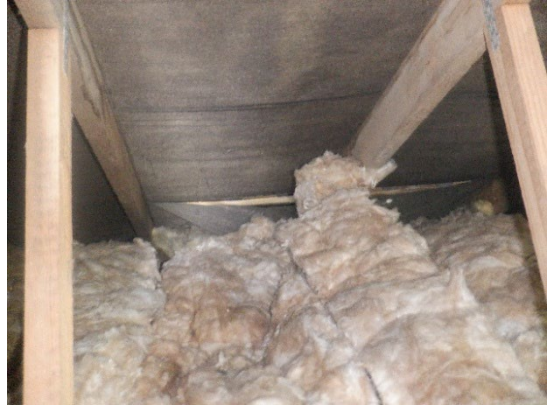
*Photograph 9. Loose overlapping section of felt on the rear elevation (roof void).*

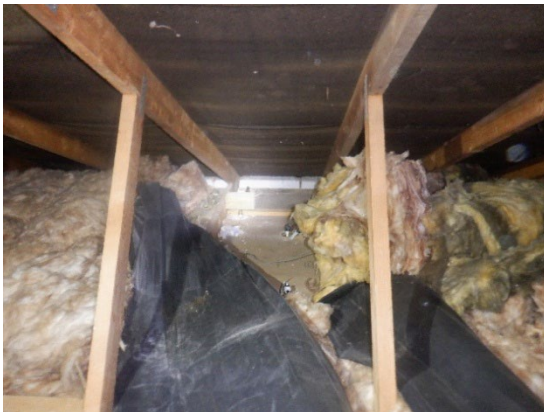
**5.2.7** The floor had a small section of wooden boarding below two empty water tanks to the right of the loft hatch. The rest of the void was covered in fibreglass insulation throughout that went up to the eaves, with the top of the wall plate visible in places (**Photograph 10; Target note 5**). There were scattered mouse and rat droppings present on top of the fibreglass insulation throughout the void (**Photograph 11**).

*Photograph 10. Fibreglass insulation up to open eaves (roof void).*

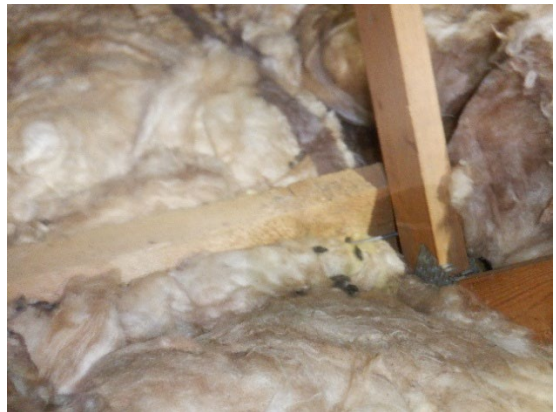
*Photograph 11. Rat droppings on fibreglass insulation (roof void).*

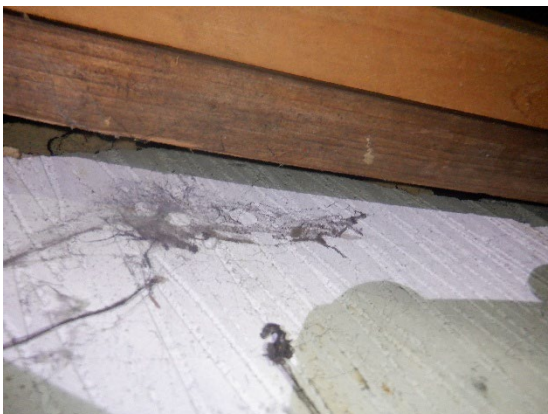
**5.2.8** The gable ends were of blockwork construction, which were tight to the roofing felt, and cobwebbed between the rafters and the blockwork (**Photographs 12 & 13**).

*Photograph 12. Cobwebbed blockwork gable (roof void).*

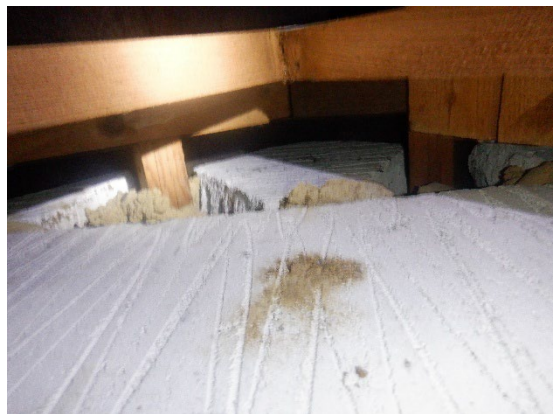
*Photograph 13. Blockwork tight to roof felt (roof void).*
