Technical Note

Holme Park SANG and Gray's Farm SANG,
Easthampstead Road, Wokingham, Berkshire,

Ref: GE23234-TN01-250701

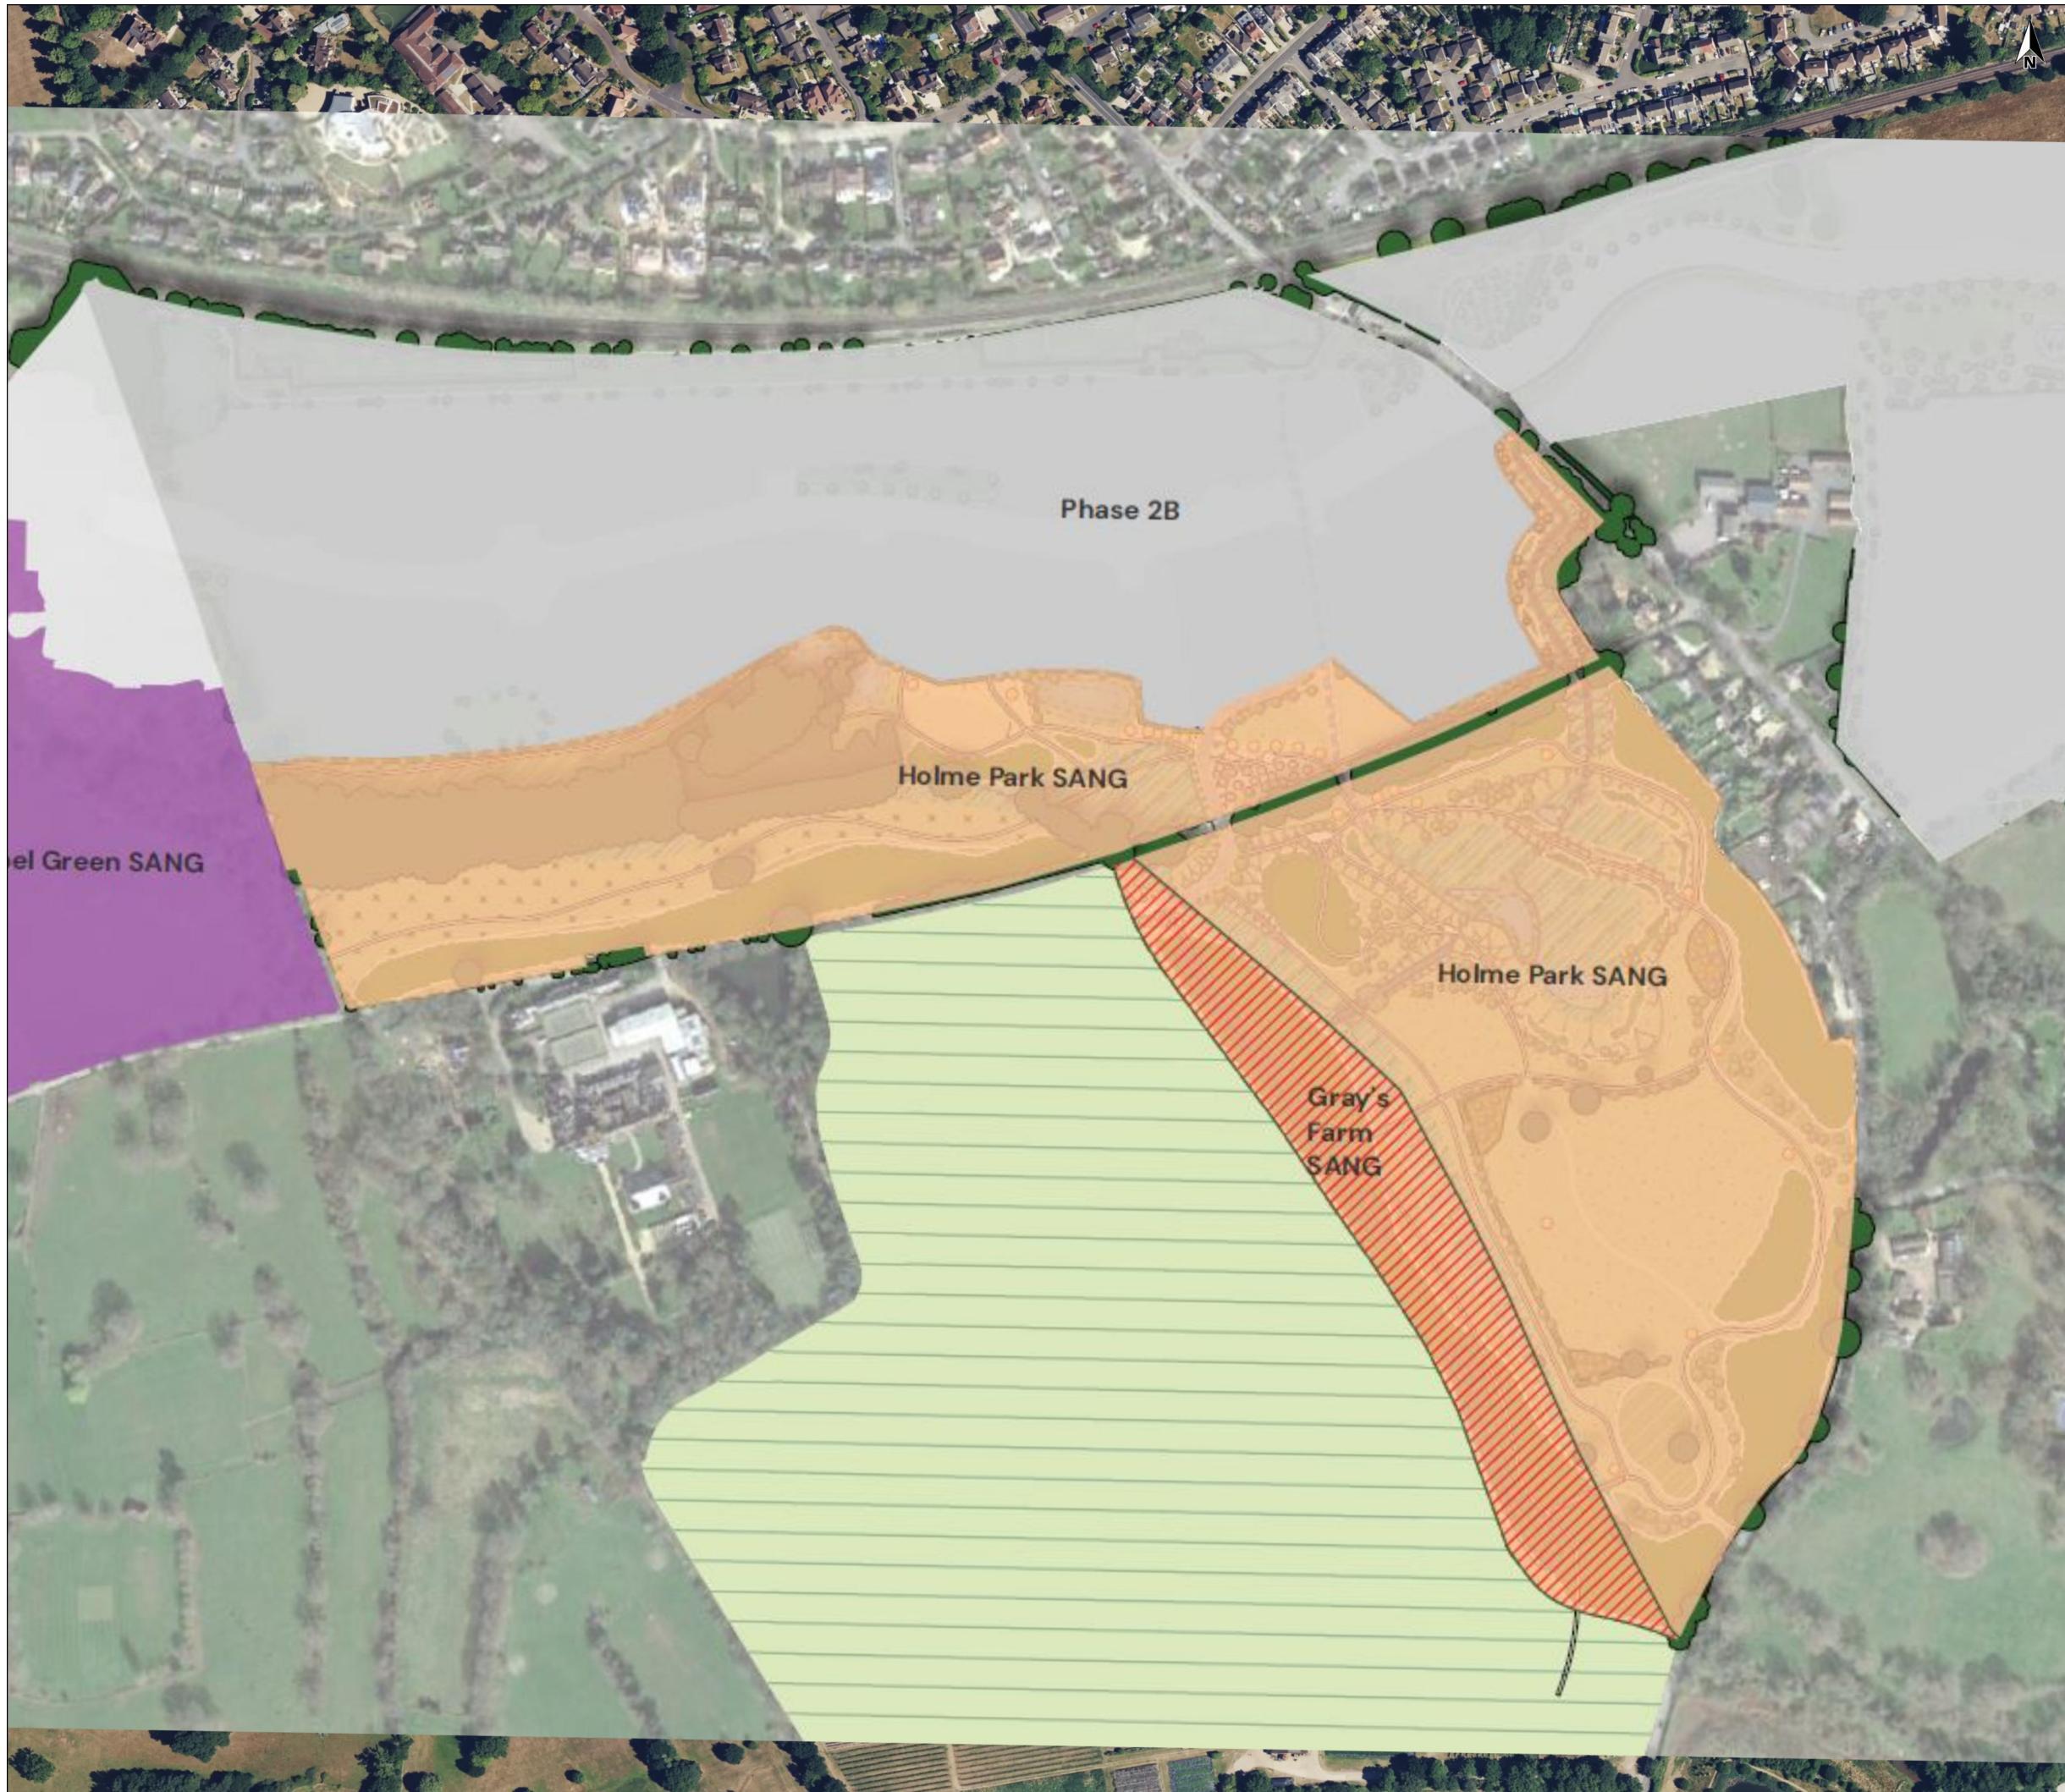
A plan showing the Holme Park SANG and Gray's Farm SANG location is presented in Figure 1.

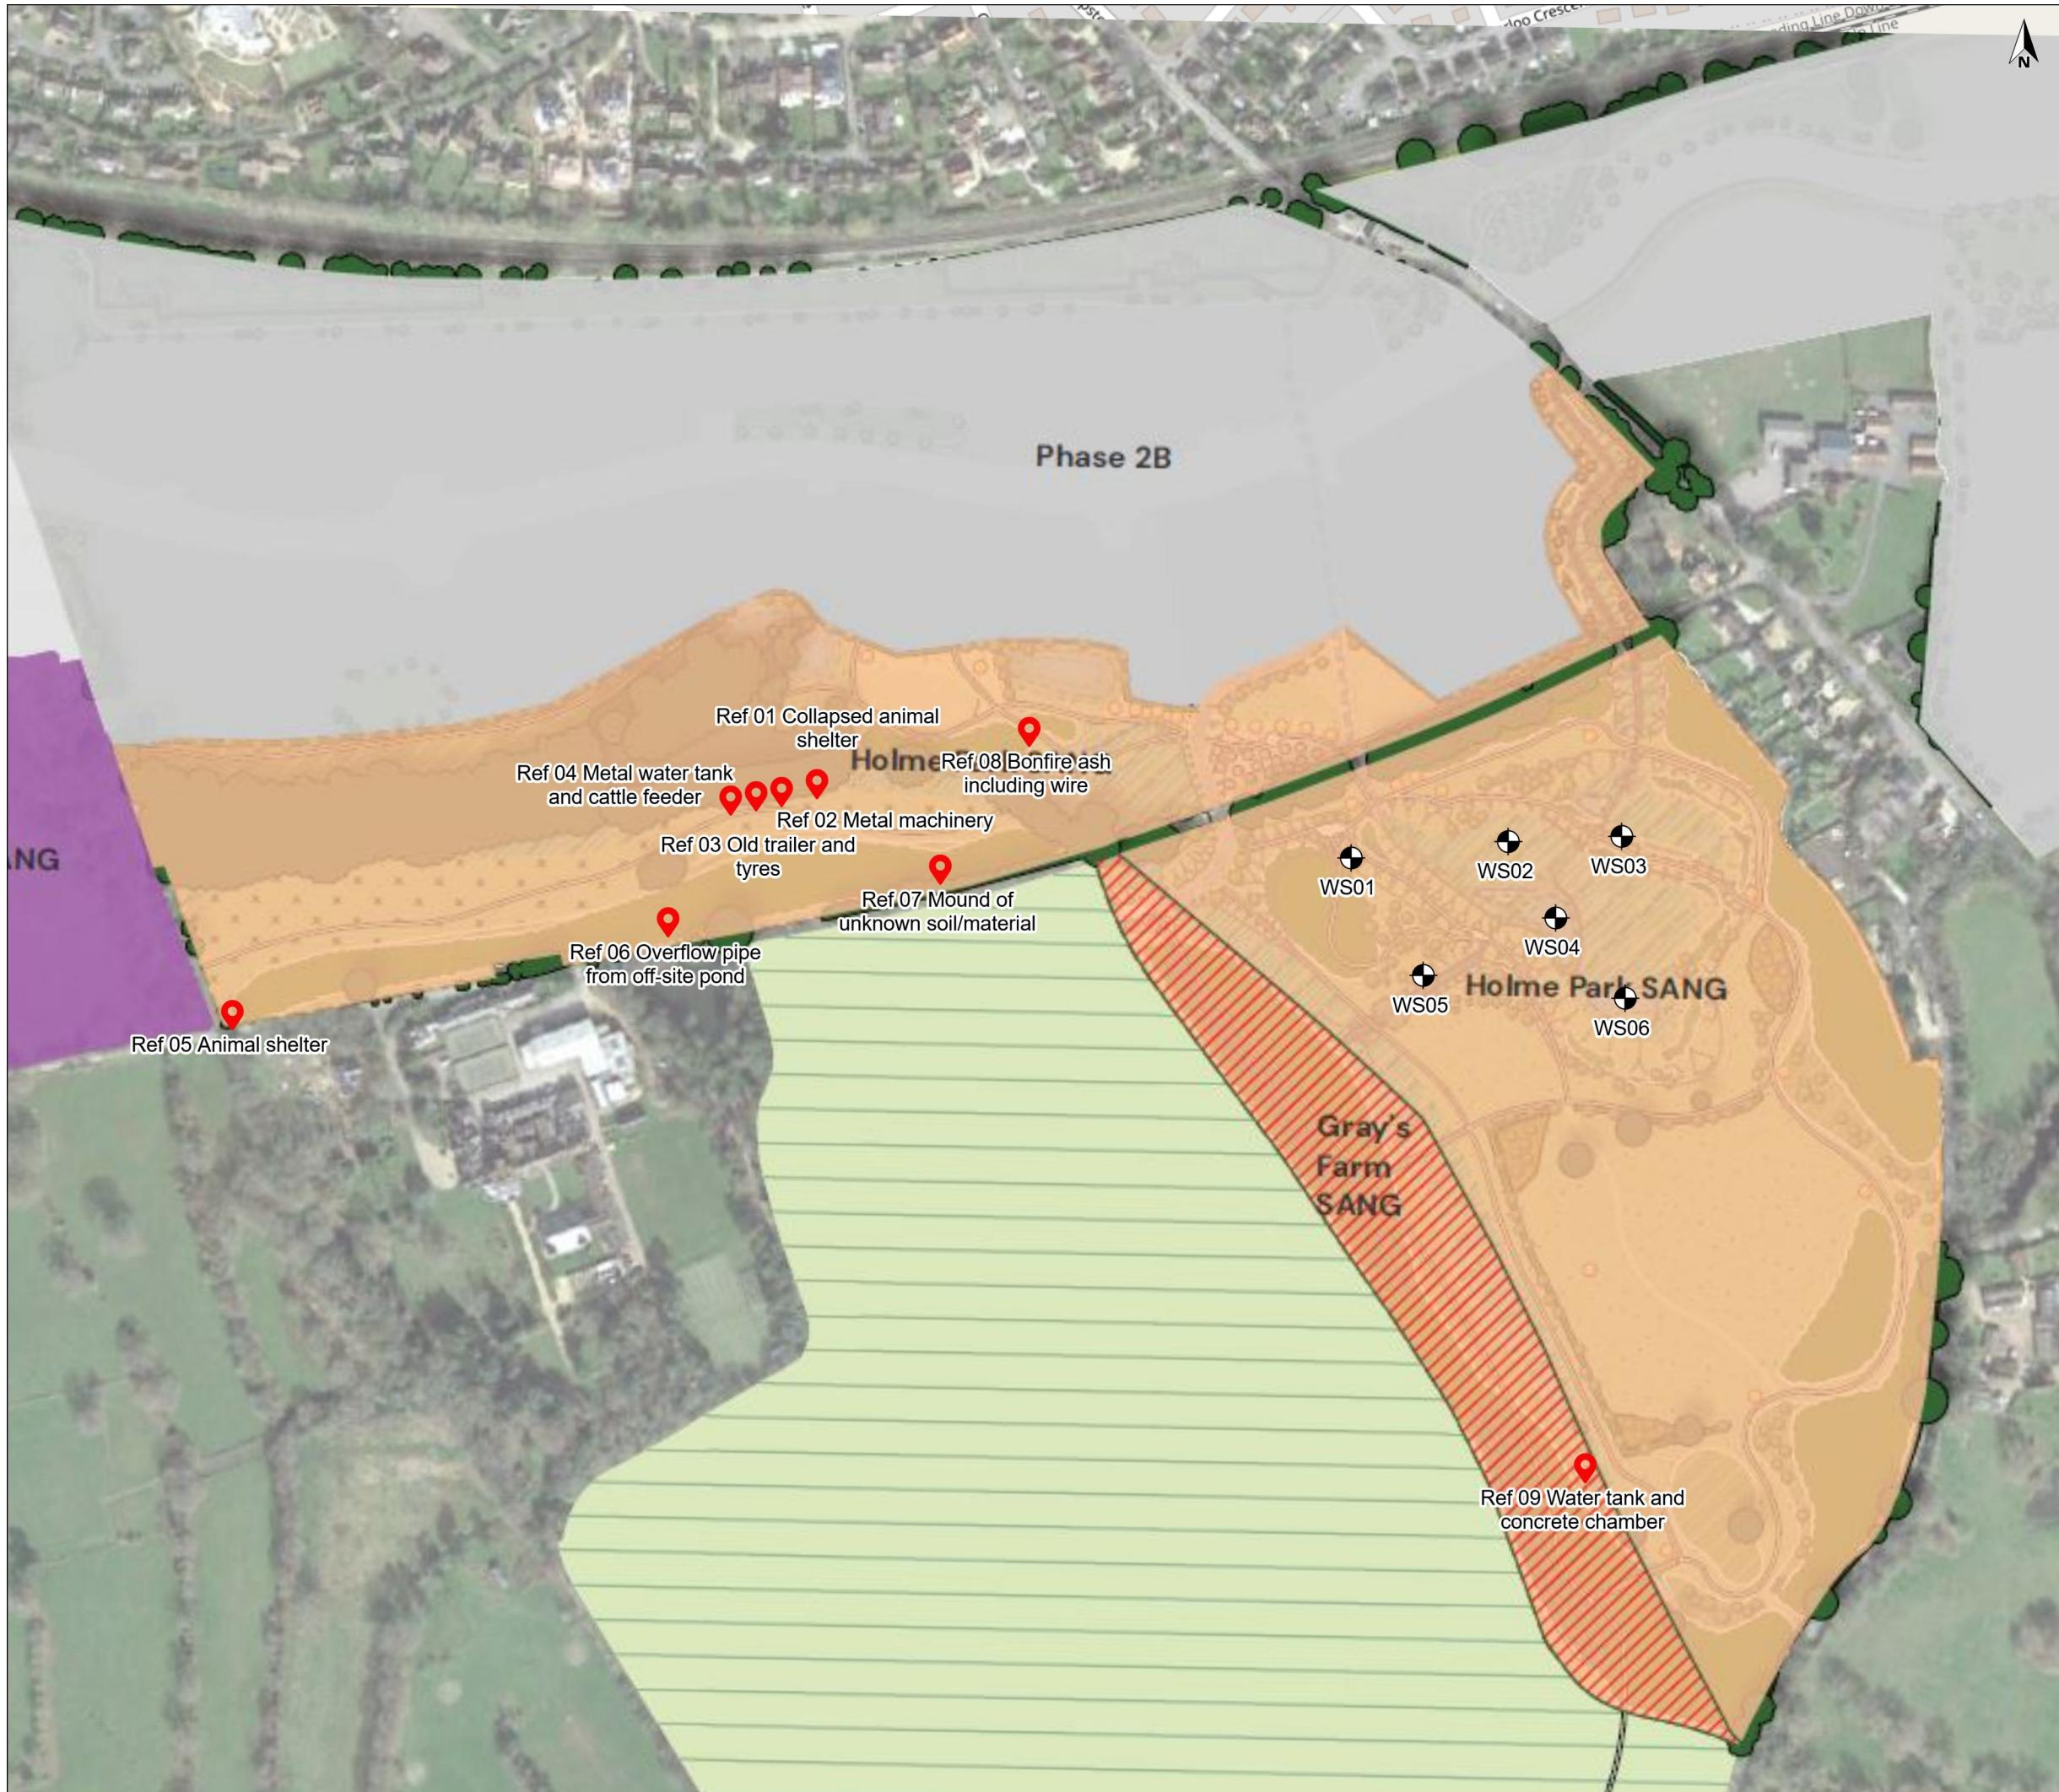
Title: Annotated Site Plan		
Client: Miller Homes Southern & Kier Property Developments	Size: A3	
Project: Holme Park SANG and Gray's Farm SANG, South Wokingham	Drawn: SA	Figure No.: 2
Date: 01-07-2025	Checked: SA	
Proj No: GE23234	Scale: 1:3500	Version: 1

The following features of interest were identified during Geo-Environmental's 2024 inspection and are shown on Figure 2:

- Northern section of Holme Park SANG:
 - Collapsed animal shelter constructed from timber and corrugated metal. No potential asbestos materials noted although structure not safe to enter;
 - Rusted metal machinery in scrub vegetation;
 - Old trailer and tyres in scrub vegetation;
 - Metal water tank and cattle feeder in scrub vegetation;
 - Animal shelter constructed from timber and corrugated metal. No potential asbestos materials noted;
 - Overflow pipe from off-site pond to the south which discharges onto the site surface towards Emm Brook;
 - Mound of unknown soil/material. No potential asbestos materials noted;
 - Bonfire ash including wire.
- Gray's Farm SANG:
 - Water tank and concrete chamber. Chamber may be associated with farm buildings to the west.

The exploratory holes were positioned to provide a general coverage of the proposed basin. Their locations are shown in Figure 2.

Parcel / Area	Feature Reference	Description	Recommendations
Northern section of Holme Park SANG	01	Collapsed animal shelter constructed from timber and corrugated metal. No potential asbestos materials noted although structure not safe to enter.	Suitable R&D asbestos survey by competent person where works to or demolition of building proposed. Secure building to prevent access.
	02	Rusted metal machinery in scrub vegetation.	Consider removal and disposal.
	03	Old trailer and tyres in scrub vegetation.	
	04	Metal water tank and cattle feeder in scrub vegetation.	
	05	Animal shelter constructed from timber and corrugated metal. No potential asbestos materials noted.	Suitable R&D asbestos survey by competent person where works to or demolition of building proposed. Consider securing building to prevent access.

Parcel / Area	Feature Reference	Description	Recommendations
	06	Overflow pipe from off-site pond to the south which discharges onto the site surface towards Emm Brook.	Consider culverting to Emm Brook if this area is to be developed.
	07	Mound of unknown soil/material. No potential asbestos materials noted.	Consider investigation and testing if mound is to be disturbed.
Gray's Farm SANG	08	Bonfire ash including wire	Localised removal and disposal.
	09	Water tank and concrete chamber. Chamber may be associated with farm buildings to the west. No potential asbestos materials noted.	Removal of tank.

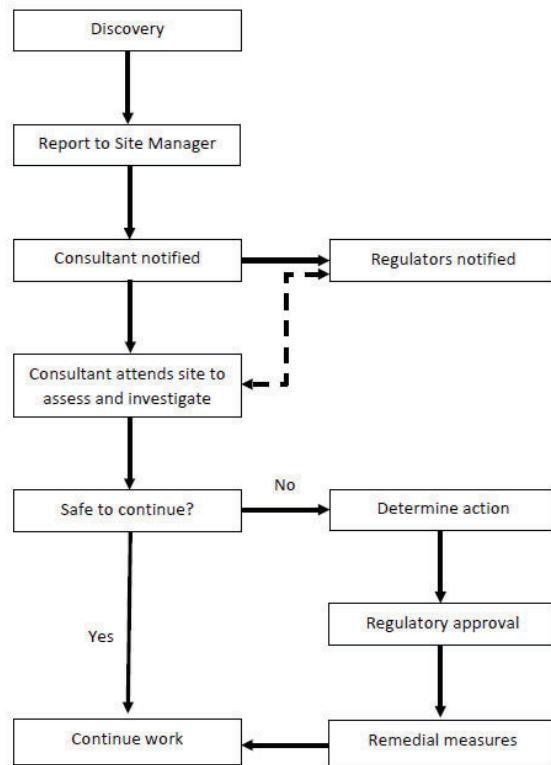
The process is summarised below:

As a general guide, where such unexpected conditions are encountered the following approach is required as a minimum:

- All discoveries are to be reported to the Site Manager immediately and works at that location are to halt until further notice;
- The Site Manager is to report any such discoveries to the Client and the Consultant;

- Following notification from the Site Manager, the Consultant shall discuss the discovery with the Local Authority and/or other relevant parties and if considered necessary, arrange to meet on site to view the discovery;

- The Consultant shall attend the site to record the location, extent and nature of the discovery and implement an appropriate sampling and analysis regime, taking due account of the type and nature of the discovery, known and probable land uses in that area of the site;

- Where remedial action is required, regulatory consultation and approval will be sought;
- A record will be produced by the Consultant and held on site (with copies held by the Consultant, Client and Local Authority/other relevant organisation), detailing the discovery, assessment works undertaken, findings thereof, confirmation either of no action required or detailing the remedial action taken and validation thereof.
