# **Preliminary Roost Assessment**

**11A Belmont Road, Crowthorne, Berkshire, RG45  
6SA**

**Date of Issue: 31/07/2026**

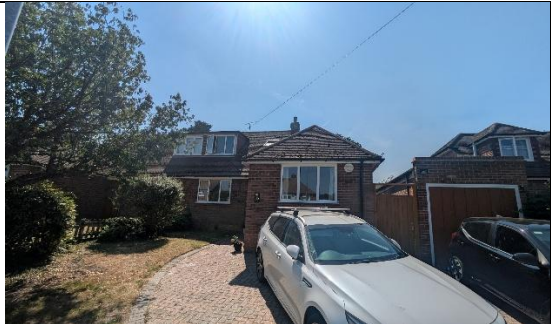
B1 comprised a residential structure which appeared generally well maintained externally; however, several PRFs were identified during the assessment. Photographs of the exterior of B1 and PRFs can be seen in Table 2 below.

| North-westerly facing frontage. | North-easterly facing aspect. |

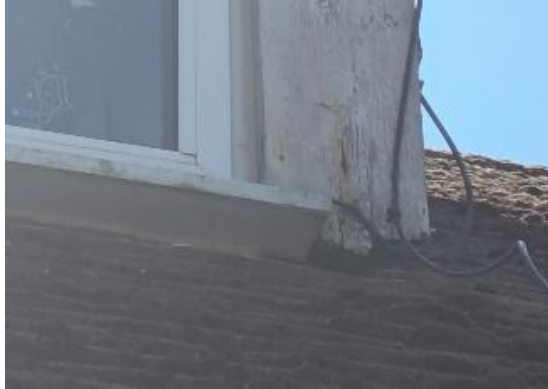
A further PRF was identified beneath the front dormer where areas of rotting timber have created a gap that may provide roosting habitat for bats. Raised tiles were also identified around the dormer feature providing additional opportunities for bats to access concealed areas beneath the roof structure.

PRF: Rotting wood creating a gap under dormer at the front of the property.

Two further bat emergence/re-entry surveys are recommended. The first between May and August and the second between May and September. These surveys must be undertaken at least three weeks apart and are required to determine whether bats are utilising the identified potential roosting features. It is recommended at least two surveyors with night vision aids (NVAs) are placed around B1 to ensure all PRFs are adequately captured. Suggested surveyor locations can be seen in Appendix 1. If bats are confirmed to be present, further roost characterisation surveys may be required to determine the type, extent and conservation status of any roost(s) present.

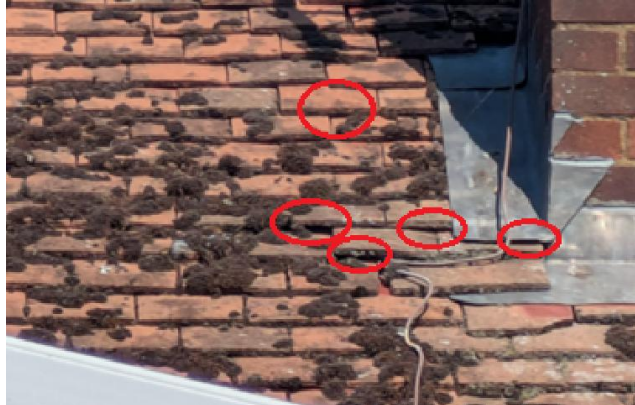
The building consists of a mixture of tiled roof sections and dormer features. A number of PRFs were recorded including areas of raised tiles around the chimney and lead flashing on the south-easterly rear elevation. These features may provide access beneath the roof covering and create potential crevice opportunities suitable for bats.

PRF: Raised tiles around chimney and raised lead flashing at the rear of the property.

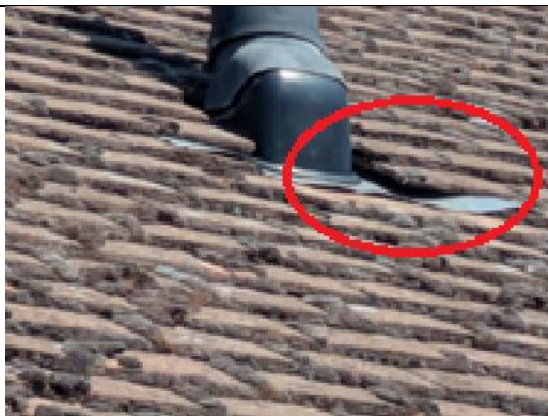
PRF: Raised tiles around the lead flashing at the rear of the property.

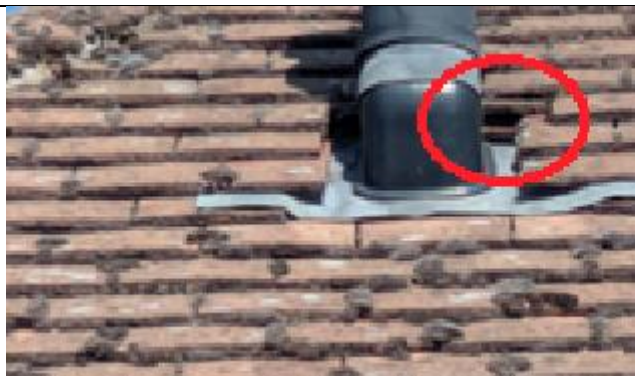
PRF: Raised tiles around the lead flashing at the rear of the property.

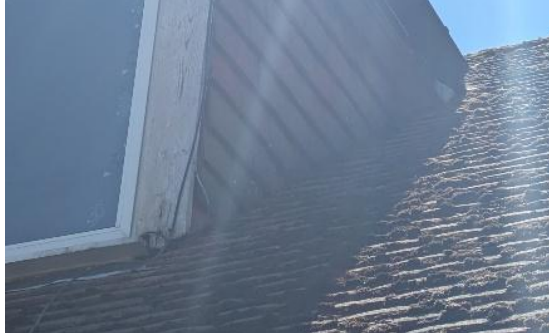
| <p>PRF: Raised tiles on the side of the dormer.</p> | <p>No PRFs on the south westerly roofing.</p> |

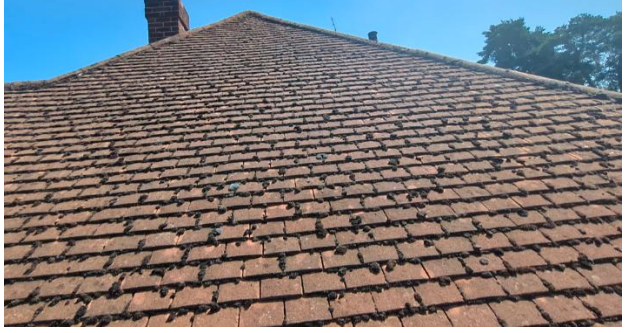
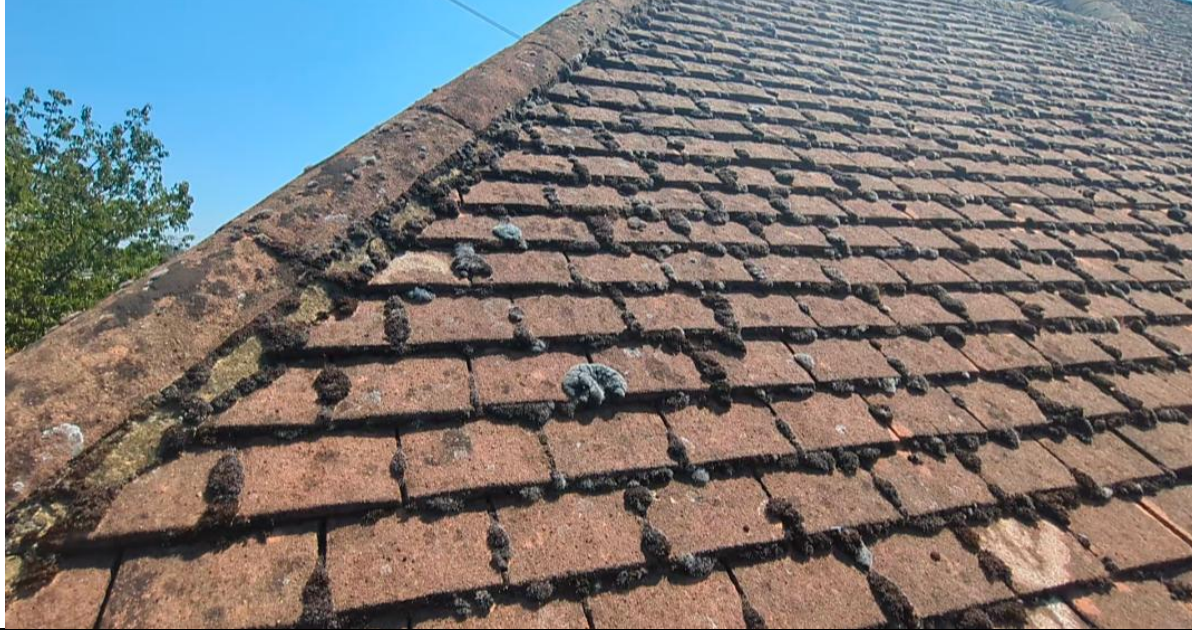
The south-westerly roof slope was inspected and no PRFs were identified in this area with the roof appearing generally well sealed. No obvious gaps or access points were recorded around the remaining visible external areas.

| <p>No PRFs on the south westerly roofing.</p> | |

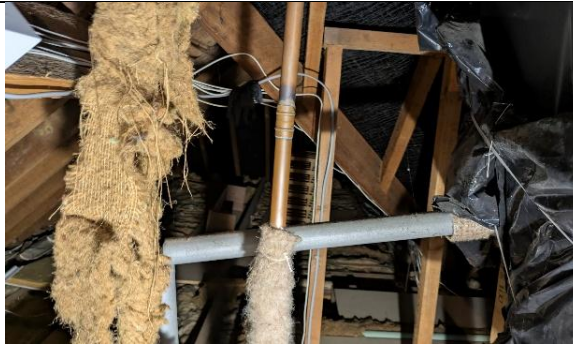
Full access to the loft of B1 was not possible because of plumbing, therefore PRFs and evidence of bats in the inaccessible area could have been missed.

| <p>Plumbing preventing full access to the loft.</p> | <p>Large open cavity running down the property.</p> |

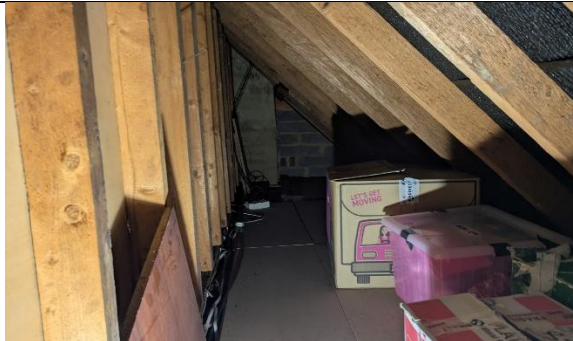
| <p>No entry points for loft access down the side of this building.</p> | <p>Gable end; no signs of bats, droppings or urine.</p> |

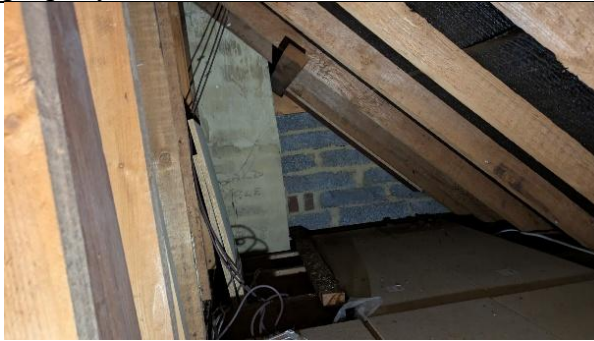
The gable end of the loft was inspected with no evidence of bat activity identified. No bat droppings, staining or urine marks were recorded within the inspected areas.

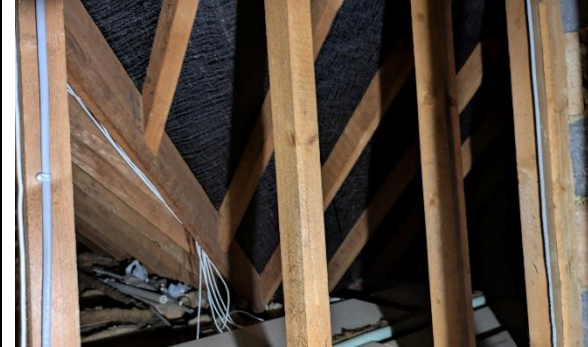
| <p>Rafters and beams tight with no suitable PRFs.</p> | <p>Some droppings were identified and failed the crumble test, however after eDNA analysis, they were confirmed as brown rat.</p> |

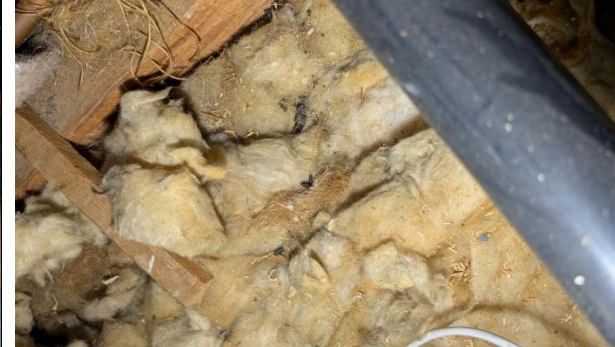
Some mammal droppings were identified within the loft space, which failed the initial crumble test. A few were collected for eDNA analysis and subsequently confirmed as brown rat droppings (see Appendix 2). These were therefore not considered evidence of bat activity.

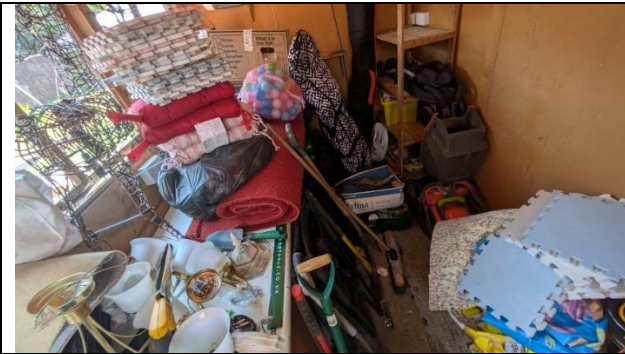
| Interior: no signs of bats, droppings or urine. | Interior: no signs of bats, droppings or urine. |

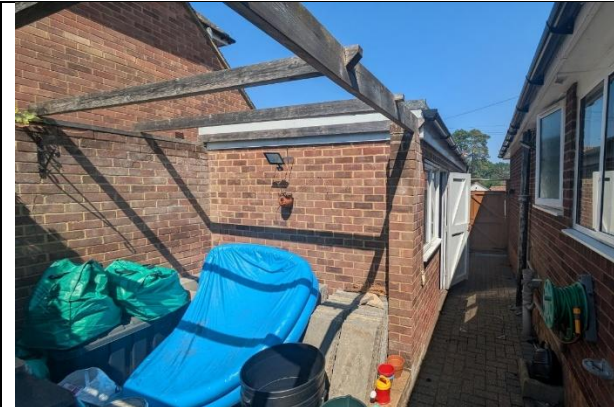
| <p>South easterly rear of the garage, no PRFs.</p> | <p>North westerly frontage of the garage, no PRFs.</p> |

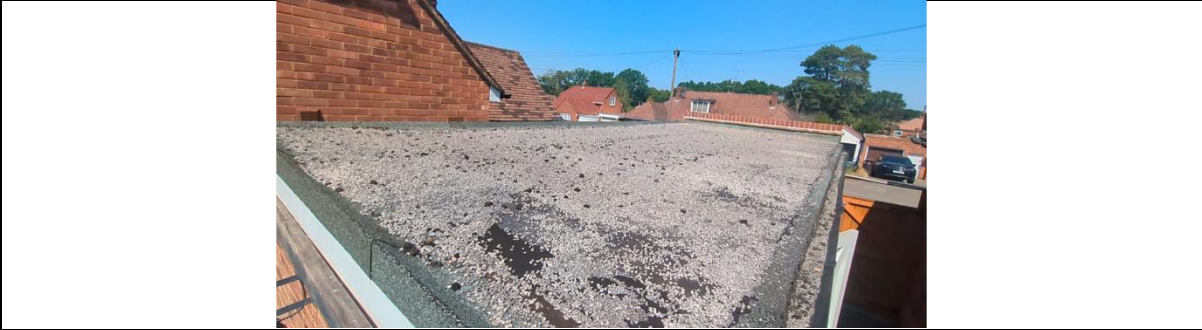
The flat roof was inspected and no defects or features capable of providing roosting opportunities were identified. No suitable features were recorded around the roofline, walls or other external elements.

| <p>Flat roof of the garage, no PRFs.</p> | |

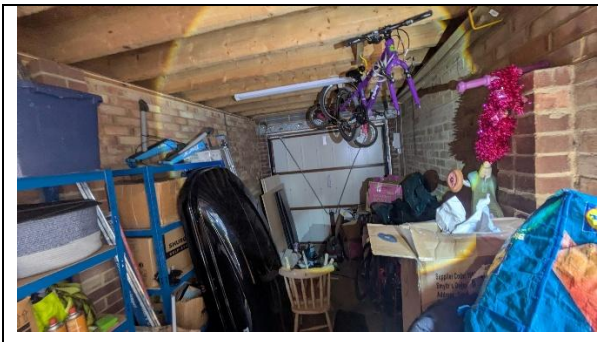
| Interior: no signs of bats, droppings or urine. | Interior: no signs of bats, droppings or urine. |
