# **Preliminary Roost Assessment and Bat Emergence Survey Report**

**SU 76450 70621 - Sindlesham Farm House, Mill Lane, Earley, Wokingham, RG41 5DQ**

**Client:** Mr Marius Iepure

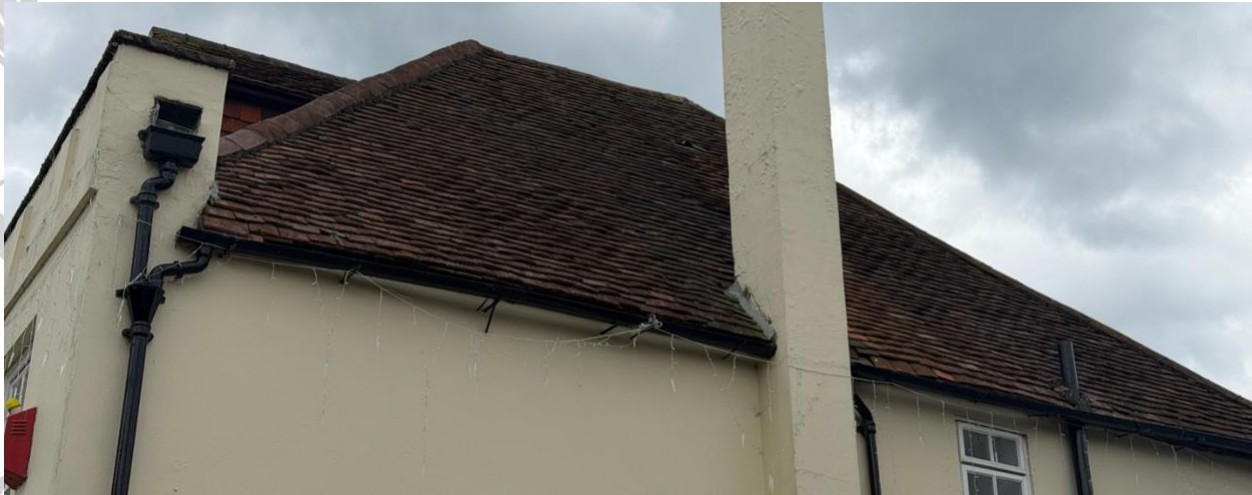
Photograph 1. Clay-tiled roof slope showing multiple raised, uneven and gapped tiles, with potential crevice features beneath tiles and along roof junctions.

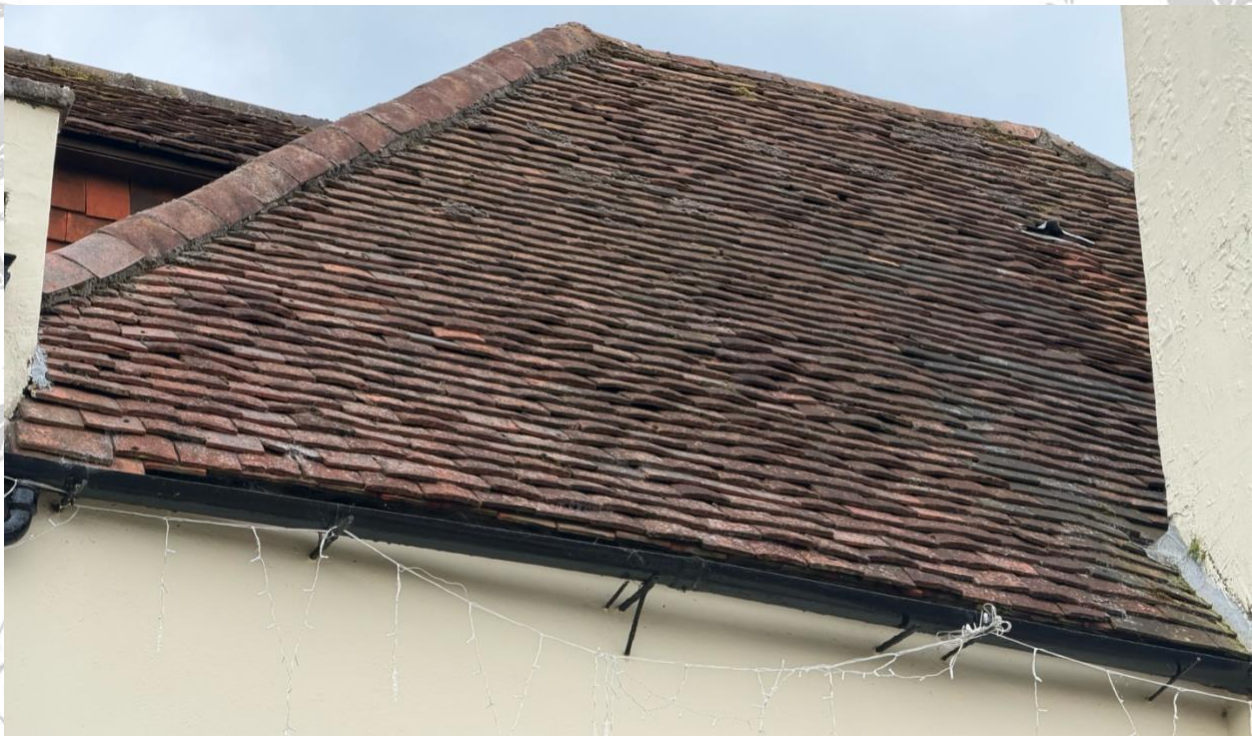
Photograph 2. Roof slope adjacent to chimney structure showing uneven roof tiles, gaps beneath tiles, eaves features and potential access opportunities along the roof edge and gutter line.

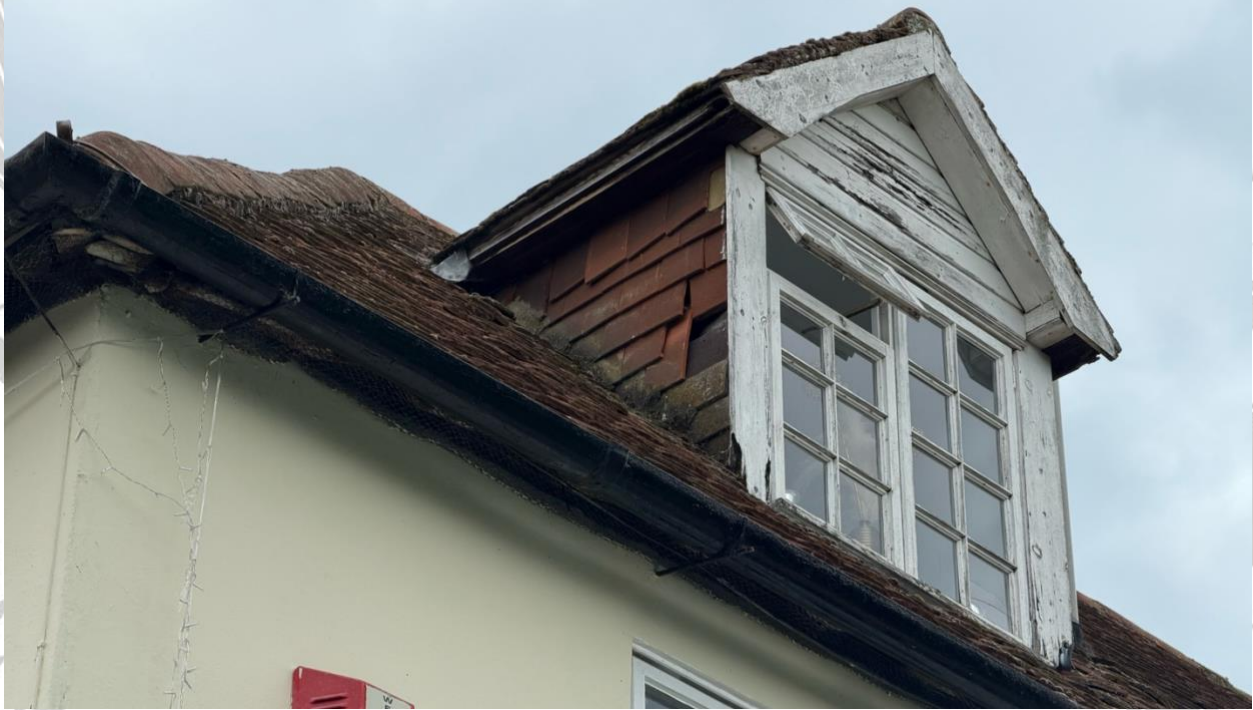
Photograph 3. Dormer window and surrounding roof fabric showing weathered timber, gaps around dormer cheeks, tile gaps and potential crevice features around the dormer interface.

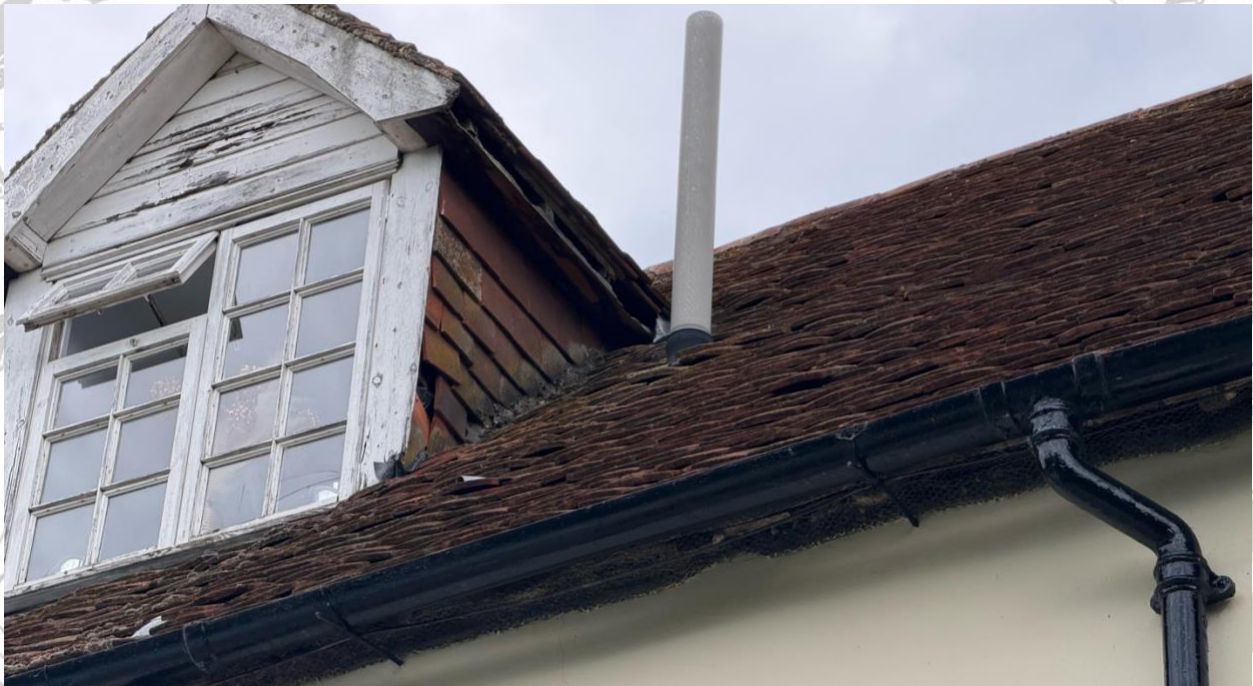
Photograph 4. Dormer and main roof interface showing gaps beneath tiles, weathered timber boarding, and potential roost features around the dormer cheek and roof junction.

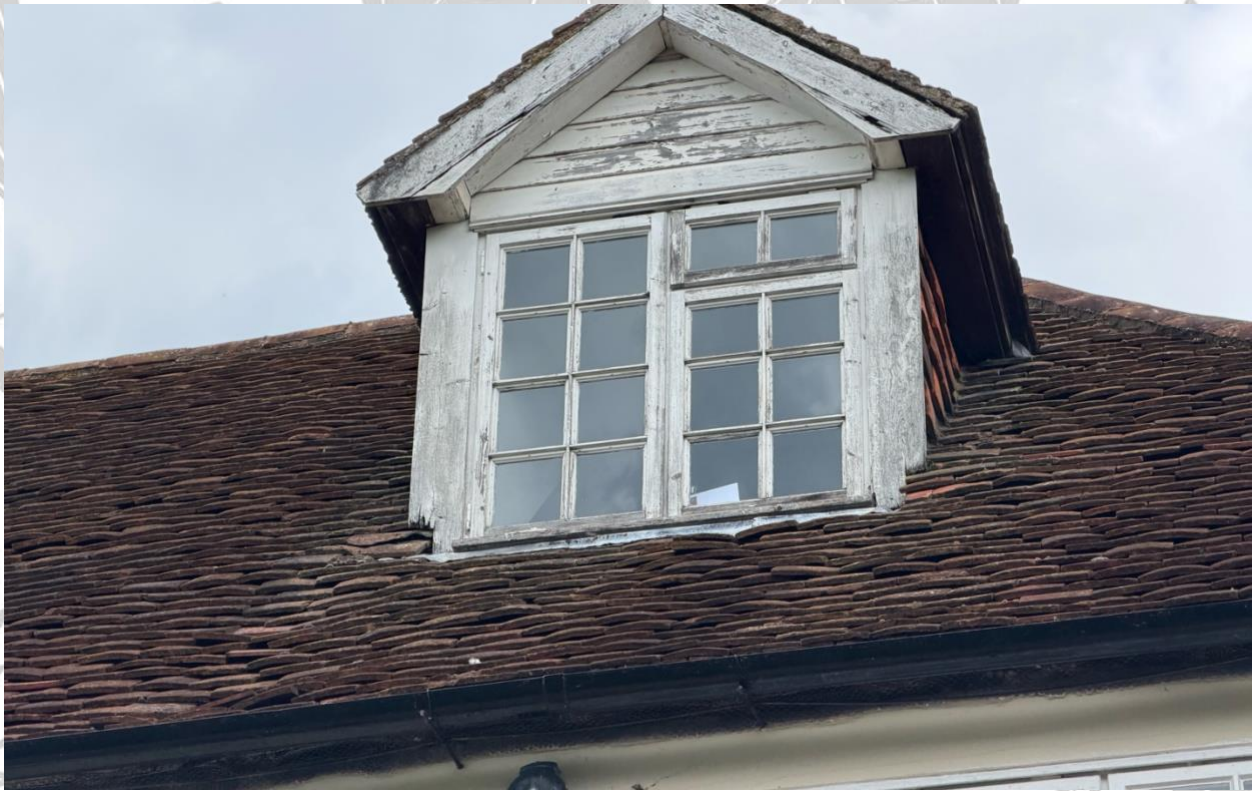
Photograph 5. Dormer window structure showing weathered and deteriorated timber elements, crevices around the window surround, and gaps beneath surrounding roof tiles.

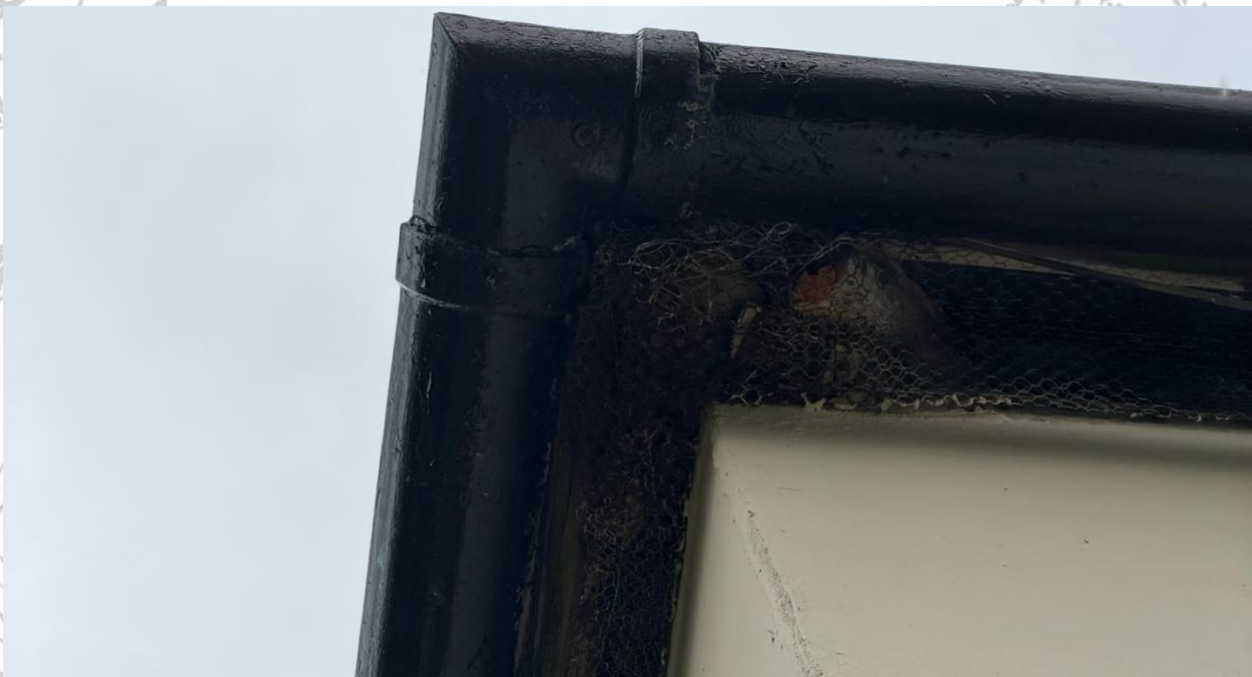
Photograph 6. Eaves and fascia/soffit area showing open and irregular gaps behind the gutter line and beneath the roof edge, suitable for crevice-dwelling bats.

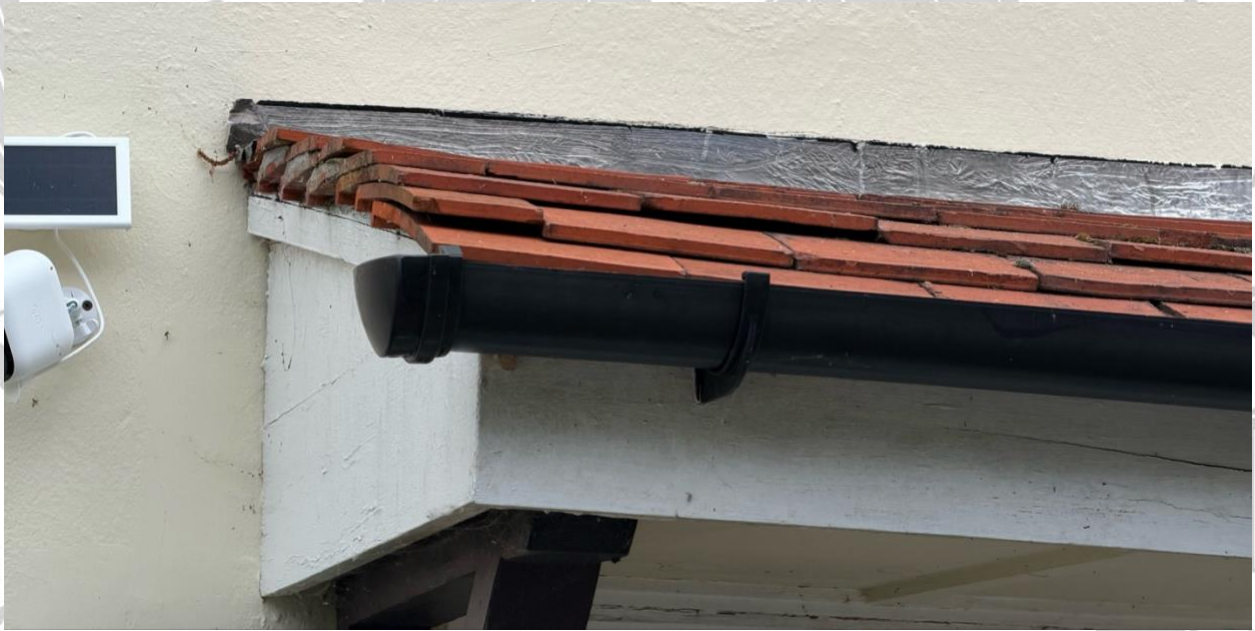
Photograph 7. Lower roof/eaves interface showing raised tiles, gaps beneath tiles and localised access opportunities at the wall and roof junction.

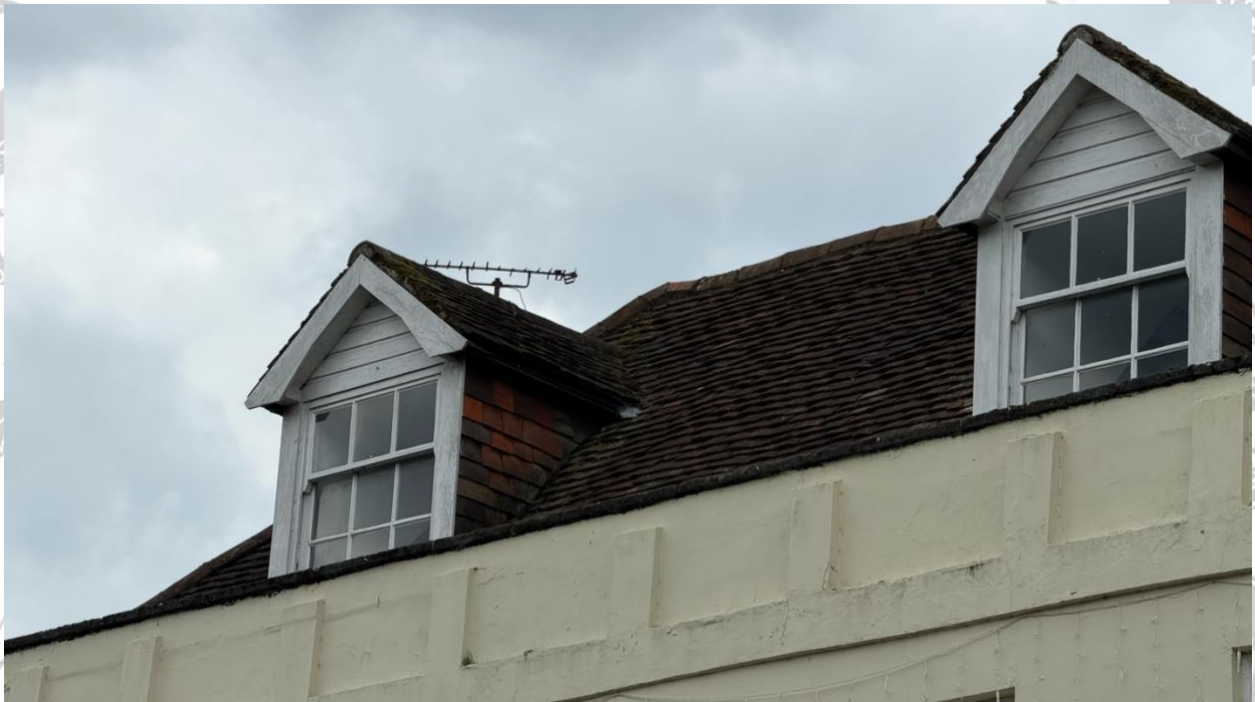
Photograph 8. Wider roof elevation showing multiple dormer structures, clay-tiled roof slopes, ridge and hip features, and widespread potential crevice opportunities.

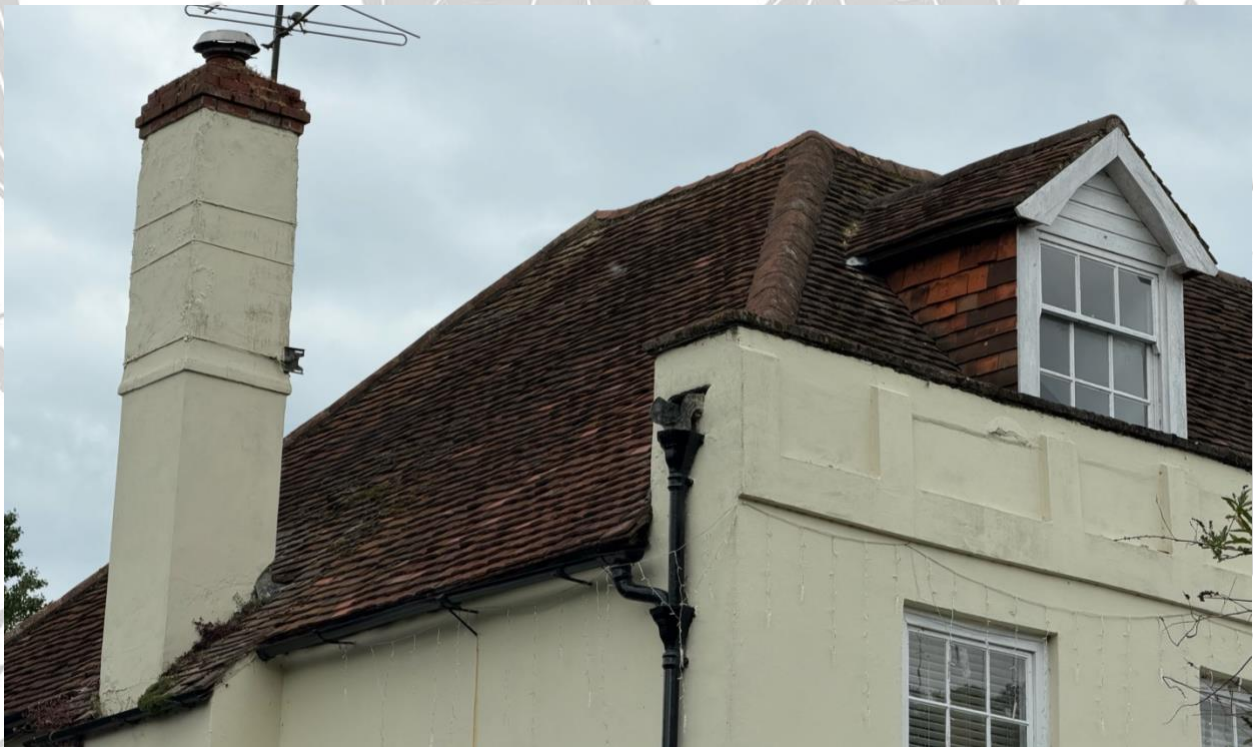
Photograph 9. Chimney and roof slope showing complex roof junctions, ridge and hip tiles, weathered roof covering and potential crevices around roof and chimney interfaces.

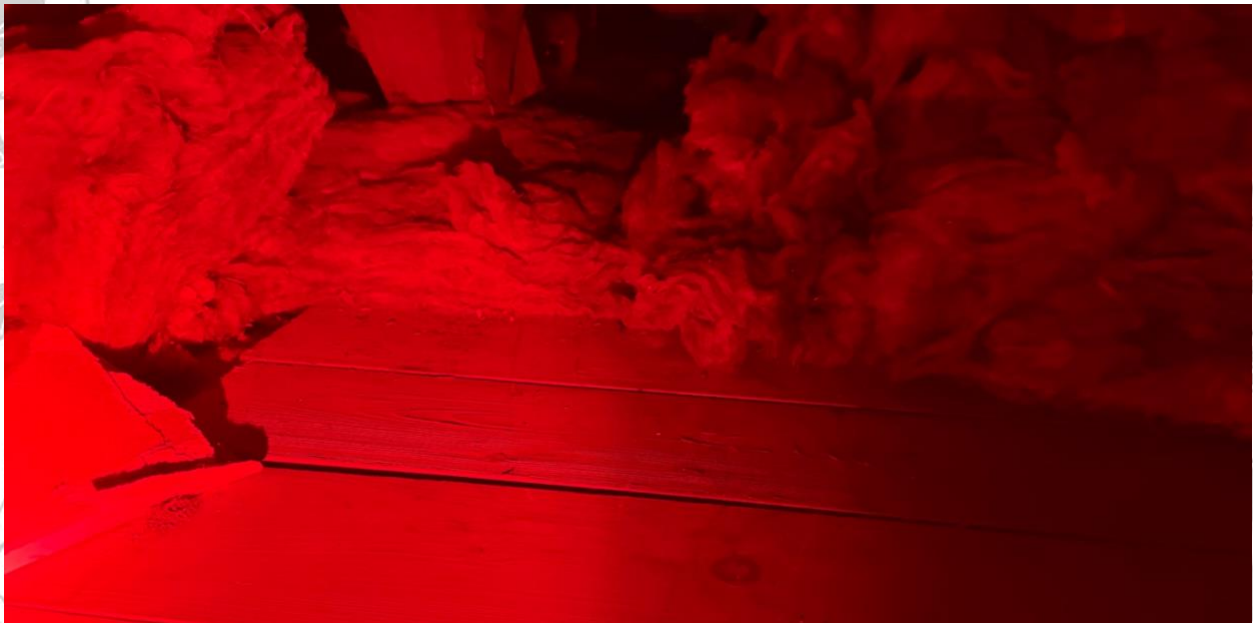
Photograph 10. Internal loft inspection area showing timber boarding, insulation and concealed roof void spaces. No visible evidence of bat use was recorded in the accessible inspection area, including no bat droppings, feeding remains, staining, live bats or dead bats.

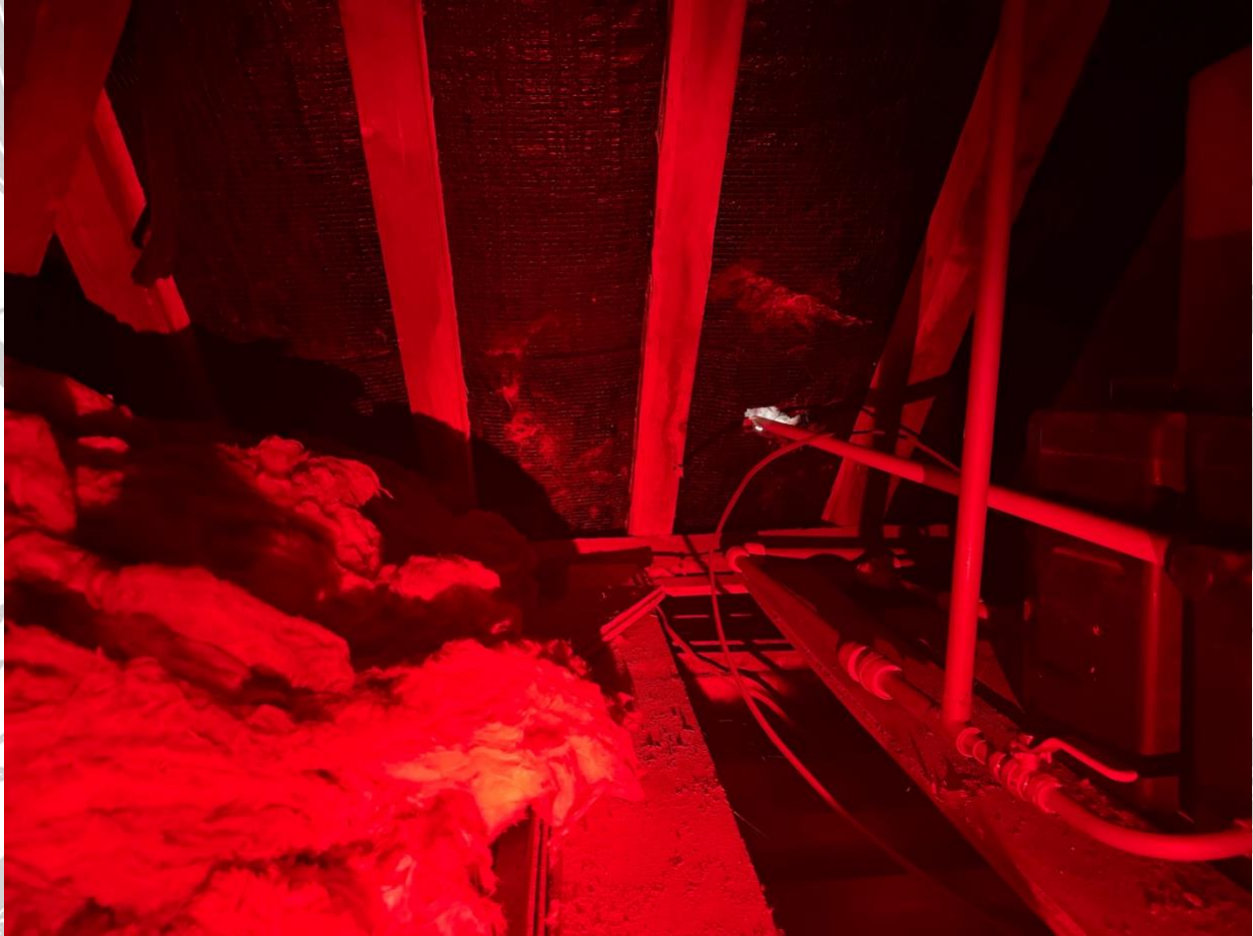
Photograph 11. Internal loft void showing exposed roof timbers, underlay, insulation, pipework and services. The inspection identified no visible evidence of roosting bats within the accessible area; however, concealed voids behind insulation, underlay, roof tiles and inaccessible roof interfaces could not be fully inspected without intrusive works.
