**KP HOLDING GROUP LTD**

**LAND SOUTH OF SCHOOL ROAD, HURST, BERKSHIRE RG10 0DB**

**INFILTRATION TEST REPORT  
STATUS FINAL**

**Reference: 1753/IR**

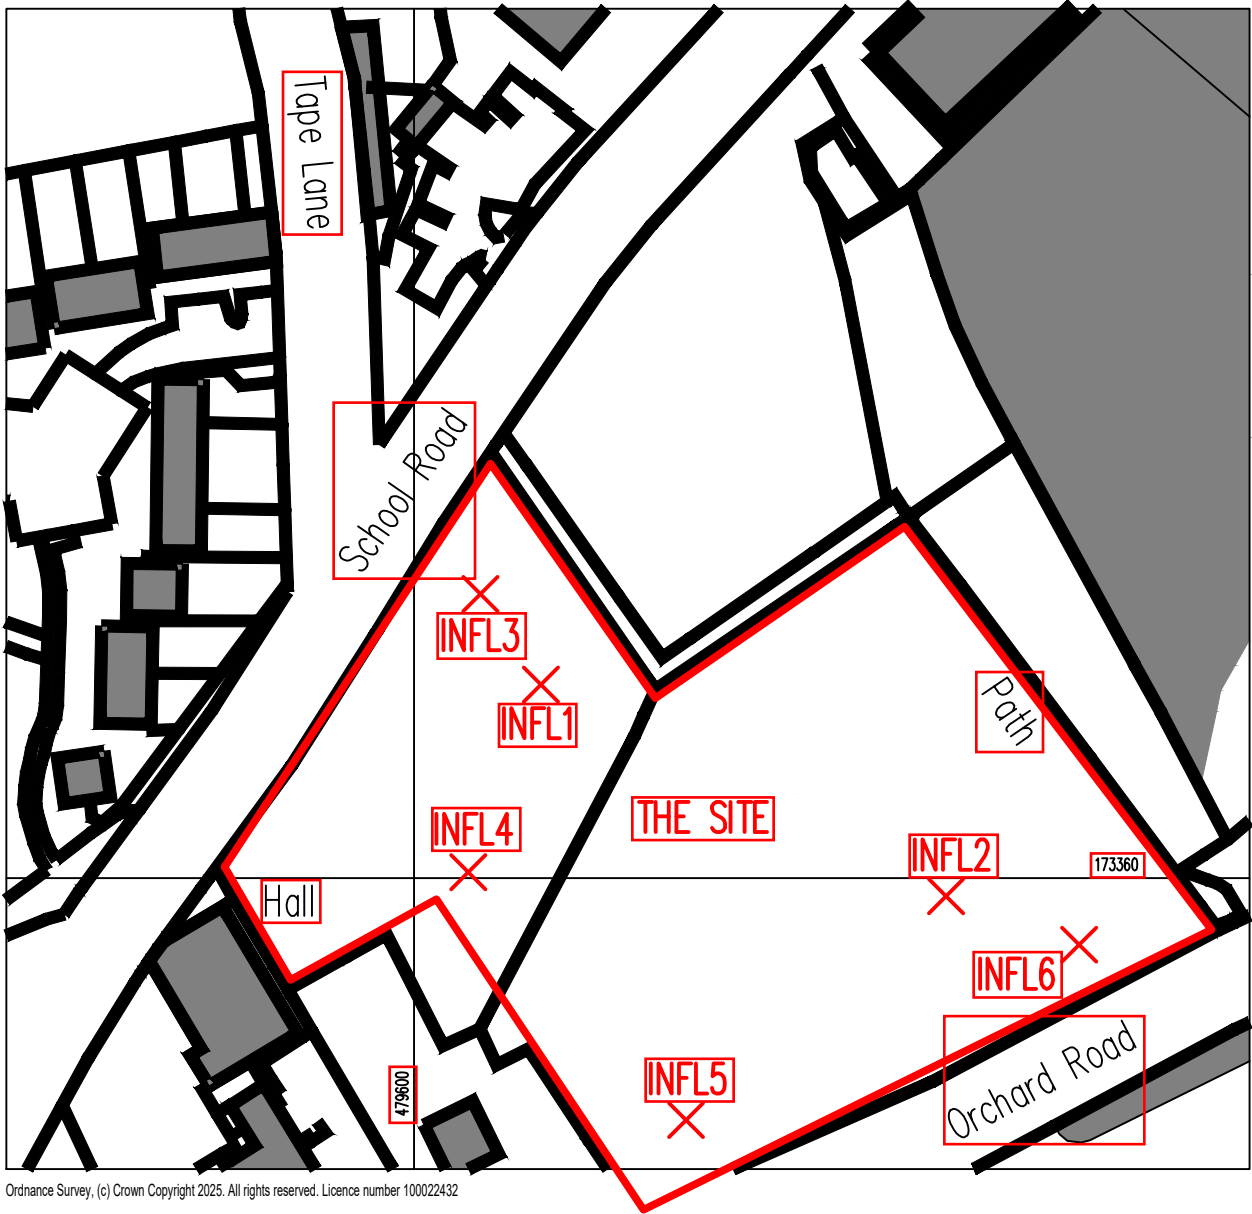
**Figure 1 Test Locations**

Trial pits locations were specified by the Client's advisers. The subsoils was found to be a clayey sand and a gravely sand, which was consistent with geological maps of the Site. The test locations are shown in Figure 1, and the pits logs are presented in Appendix B1.

| Location | Easting | Northing |
| INFL1 | 479621 | 173392 |
| INFL2 | 479688 | 173357 |
| INFL3 | 479611 | 173407 |
| INFL4 | 479609 | 173361 |
| INFL5 | 479645 | 173320 |
| INFL6 | 479710 | 173349 |

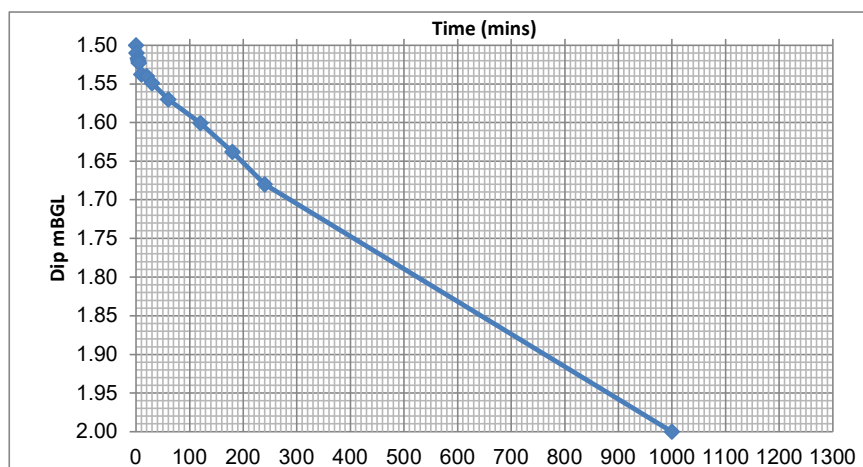
**Soakaway Test Cycle 2**

Location: INFL1

| <u>Trial Pit Details</u> | Depth<br>(m) | Length<br>(m) | Width<br>(m) | Effective Storage Volume<br>2.41617 | | |
| Dimensions | 2.00 | 1.30 | 0.30 | 0.20 | | |
| Mean surface Area | 1.19 | | | 0<br>1<br>3<br>4<br>5<br>10<br>20<br>30<br>60<br>120<br>180<br>240<br>extrapolated<br>1000<br>1.50<br>1.51<br>1.52<br>1.52<br>1.52<br>1.54<br>1.54<br>1.55<br>1.57<br>1.60<br>1.64<br>1.68<br>2.00 | | |

Soil Infiltration Rate F (m/s)

**2.4E-06**

| Reference | Test depth (m) | Infiltration rates | | |
|---|---|---|---|---|
| INFL01 | 2 | $1.8 \times 10^{-6}$ | $2.4 \times 10^{-6}$ | - |

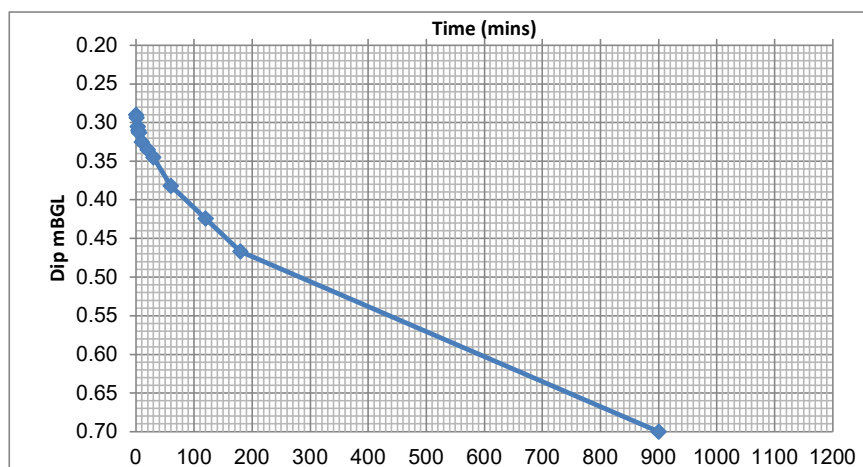
**Soakaway Test Cycle 1**

Location: INFL3

| <u>Trial Pit Details</u> | Depth<br>(m) | Length<br>(m) | Width<br>(m) | Effective Storage Volume<br>2.41617 | | |
| Dimensions | 0.70 | 1.30 | 0.30 | 0.16 | | |
| Mean surface Area | 1.046 | | | 0<br>1<br>3<br>4<br>5<br>10<br>20<br>30<br>60<br>120<br>180<br>extrapolated<br>900<br>0.29<br>0.29<br>0.31<br>0.31<br>0.31<br>0.33<br>0.34<br>0.35<br>0.38<br>0.42<br>0.47<br>0.70 | | |

Soil Infiltration Rate F (m/s)

2.4E-06

| Reference | Test depth (m) | Infiltration rates | | |
|---|---|---|---|---|
| INFL03 | 0.7 | $2.4 \times 10^{-6}$ | - | - |

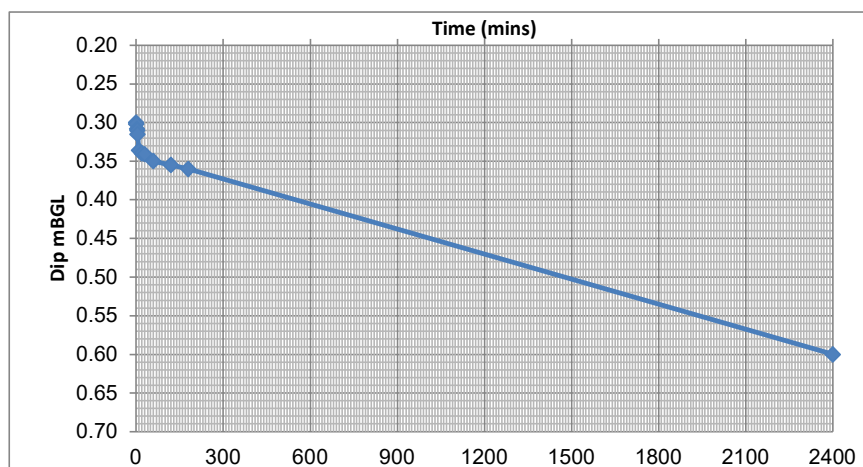
**Soakaway Test Cycle 1**

Location: INFL4

| <u>Trial Pit Details</u> | Depth<br>(m) | Length<br>(m) | Width<br>(m) | Effective Storage Volume<br>2.41617 | | |
| Dimensions | 0.65 | 1.50 | 0.30 | 0.16 | | |

Soil Infiltration Rate F (m/s)

7.8E-07

| Reference | Test depth (m) | Infiltration rates | | |
|---|---|---|---|---|
| INFL04 | 0.65 | $7.8 \times 10^{-7}$ | - | - |

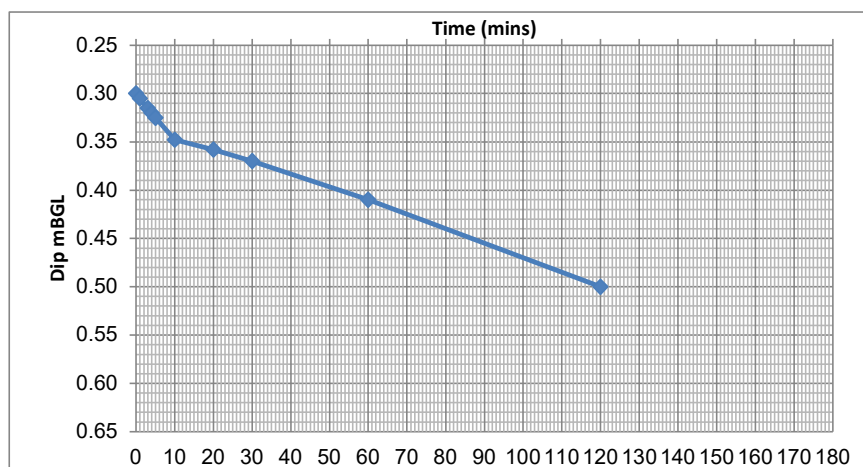
Soil Infiltration Rate F (m/s)

1.2E-05

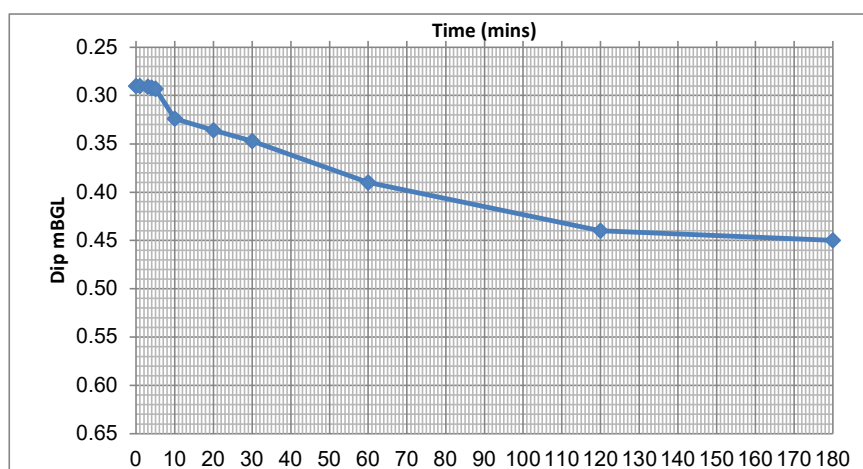
Soil Infiltration Rate F (m/s)

5.9E-06

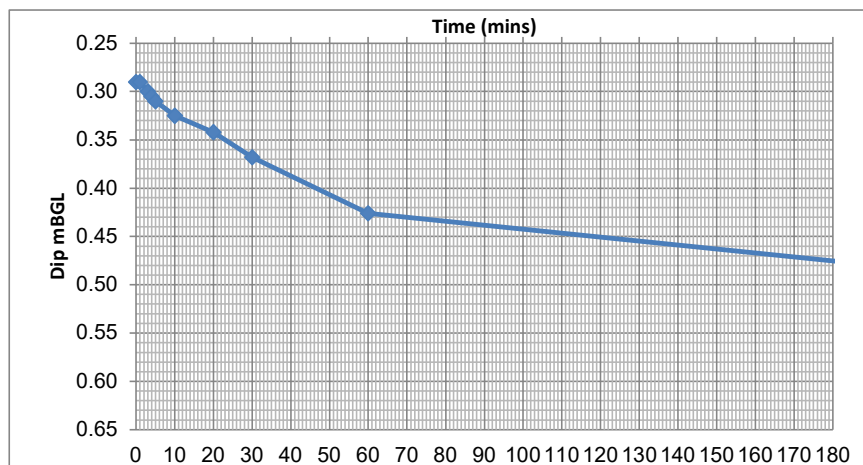
Soil Infiltration Rate F (m/s)

**9.9E-06**

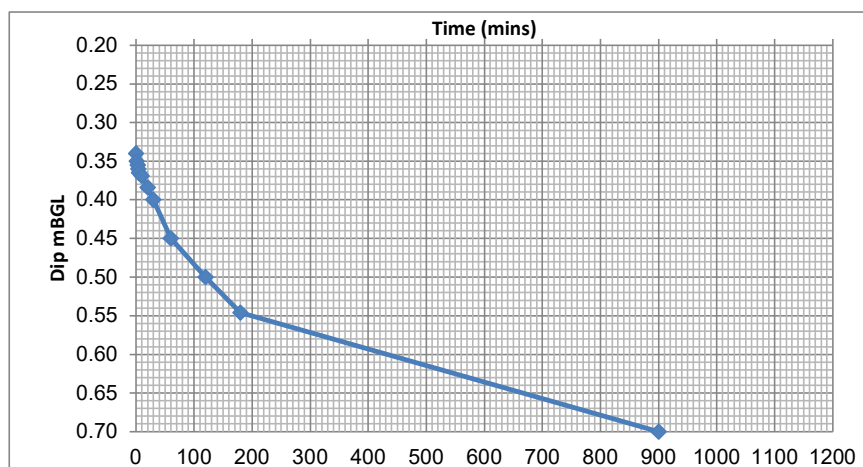
Soil Infiltration Rate F (m/s)

2.1E-06

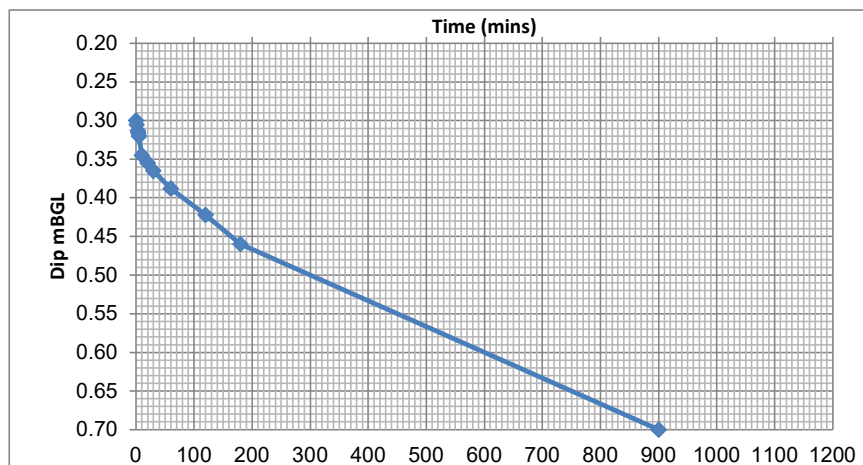
Soil Infiltration Rate F (m/s)

2.1E-06

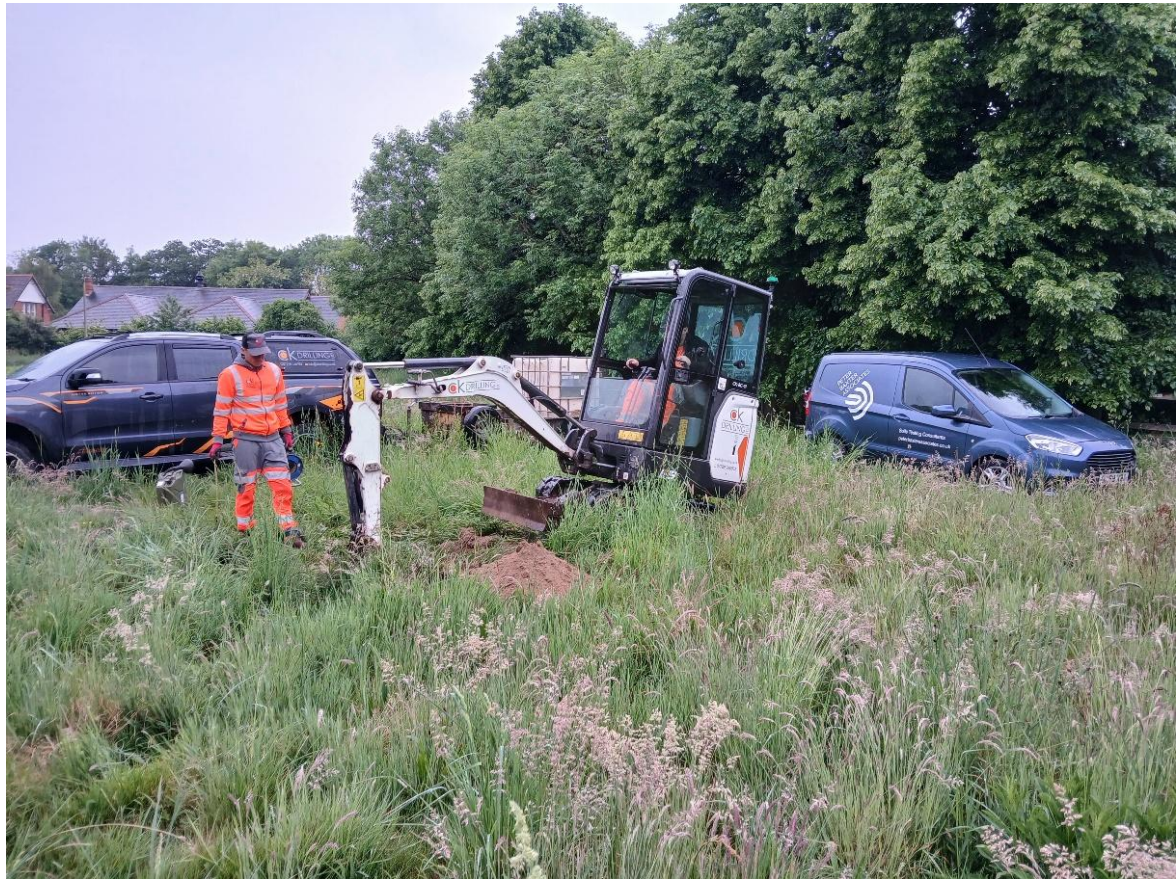
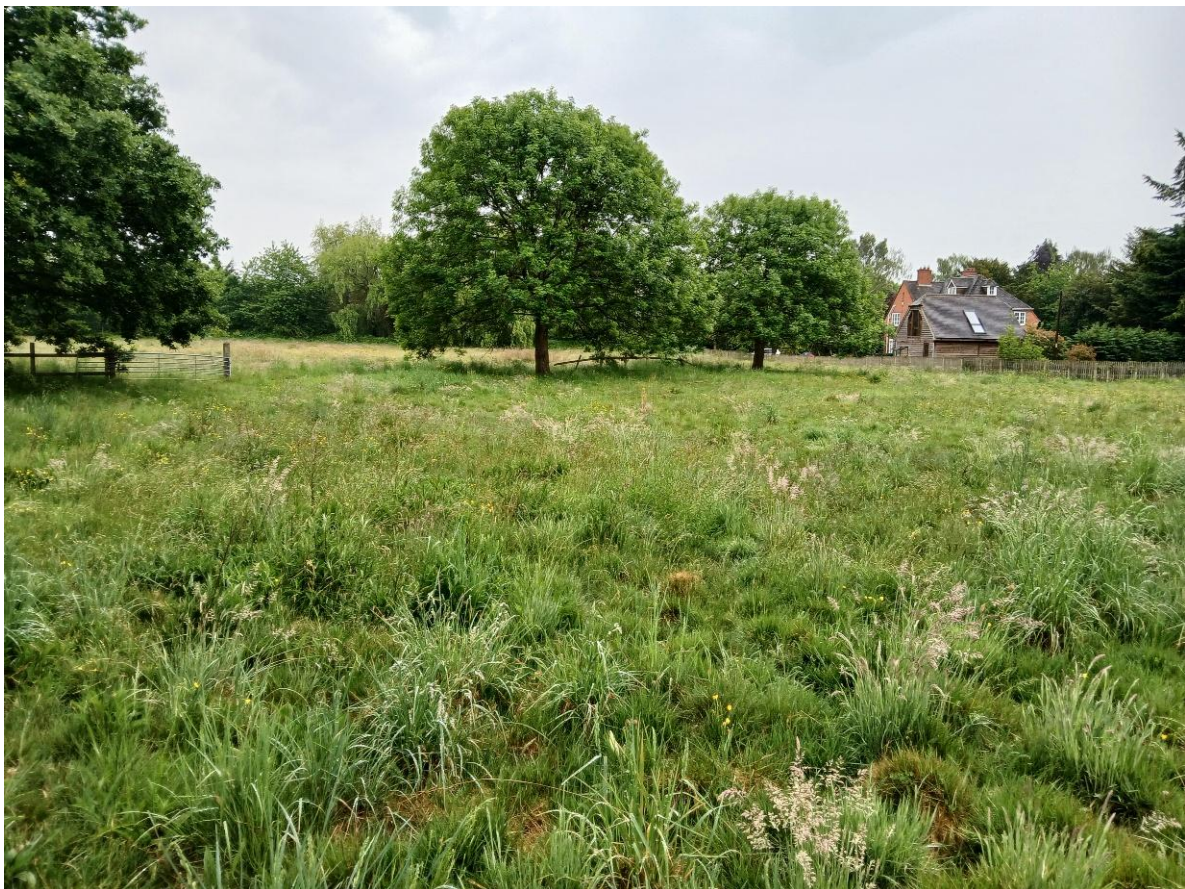
**Excavation INFL1, top, view south to INFL5 bottom**

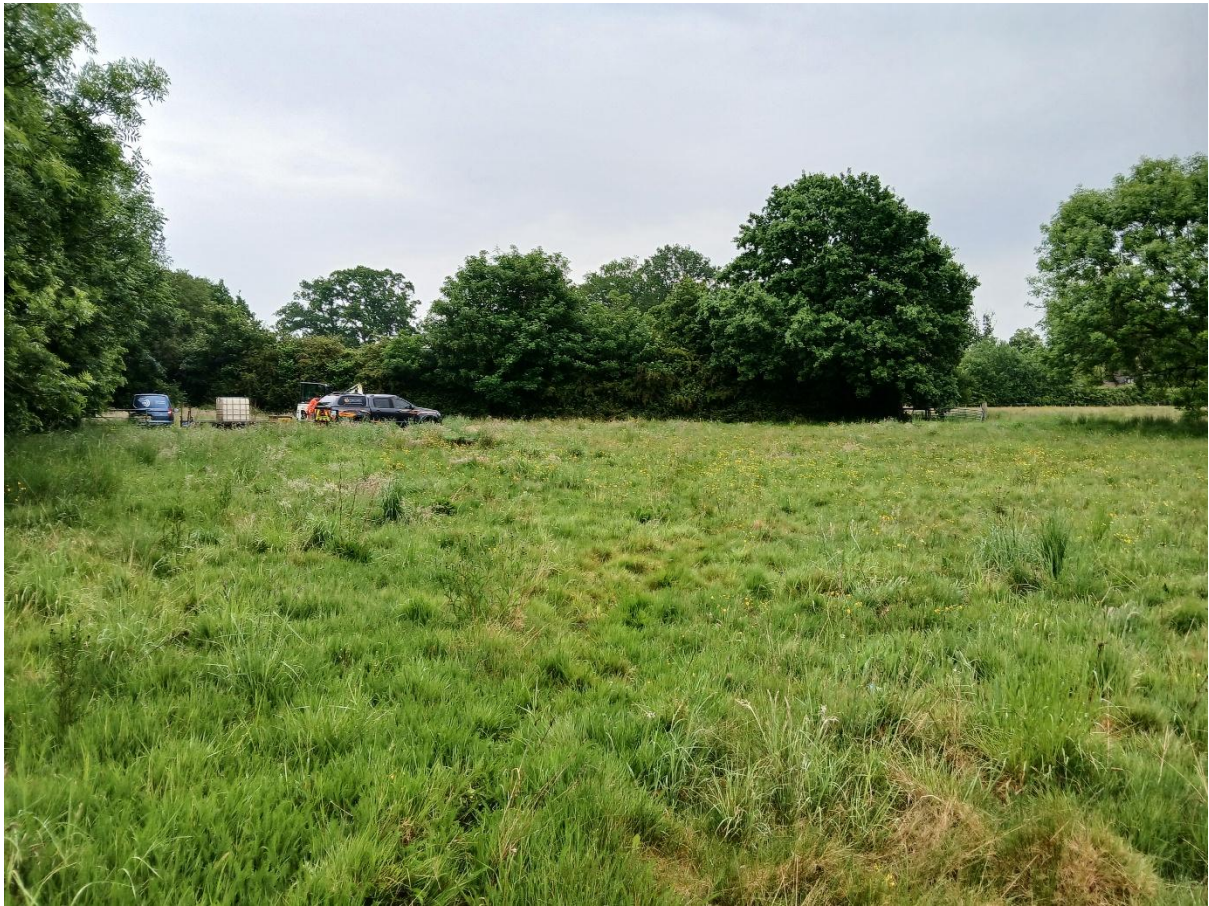
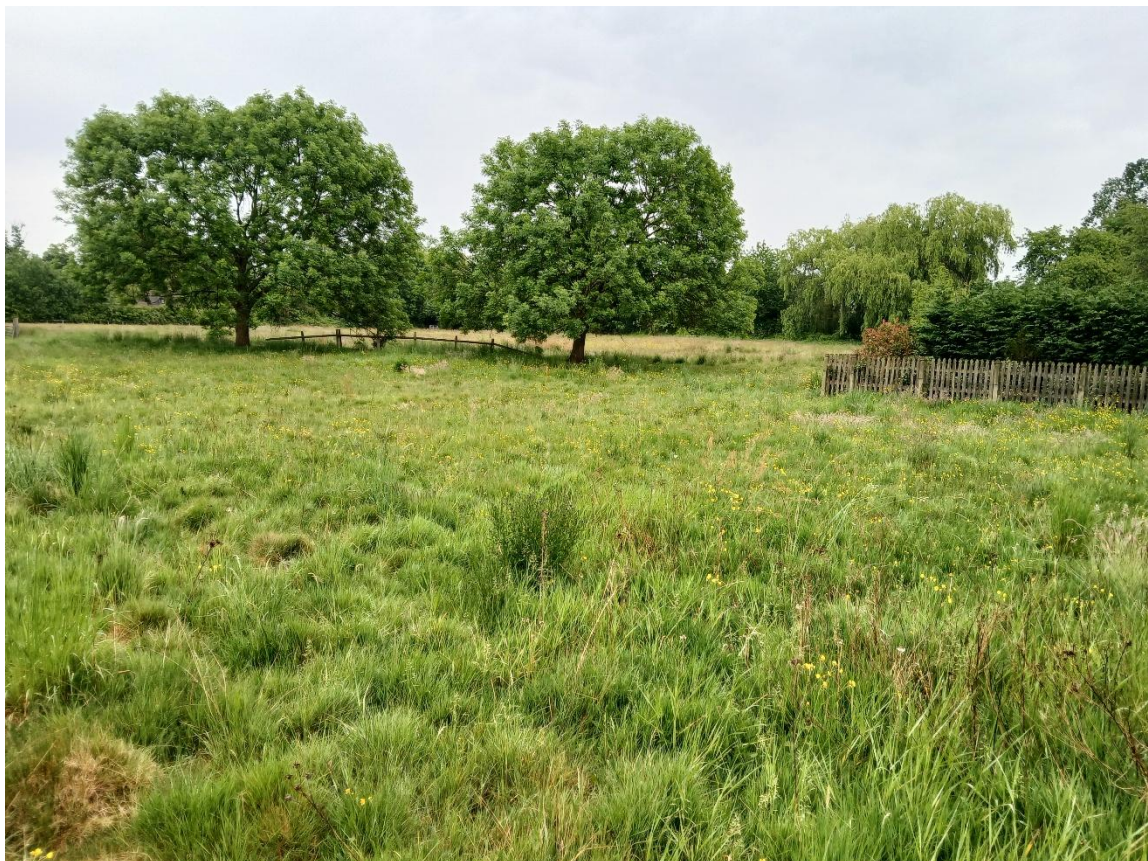
**View northeast to INFL1 top, view east to INFL2 bottom**
