# PRA, NESTING BIRDS AND BAT ACTIVITY SURVEY REPORT

8<sup>th</sup> January 2025

Graiswold, Sandhurst Road, Wokingham,  
RG40 3JQ

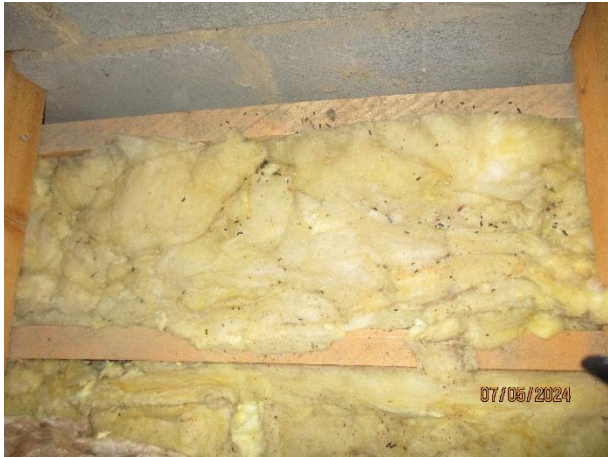
| | - Approximately 200 brown long-eared bat droppings found scattered under the ridge beam in the main loft void under the fibre glass insulation. |

**Photo 19:** Bat droppings within Main Void.

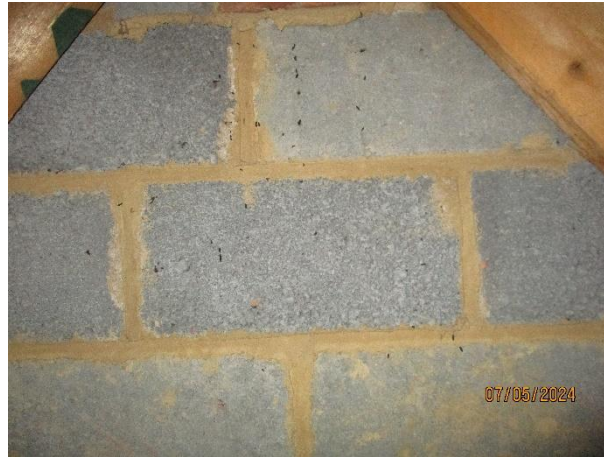
**Photo 20:** Bat droppings within Main Void.

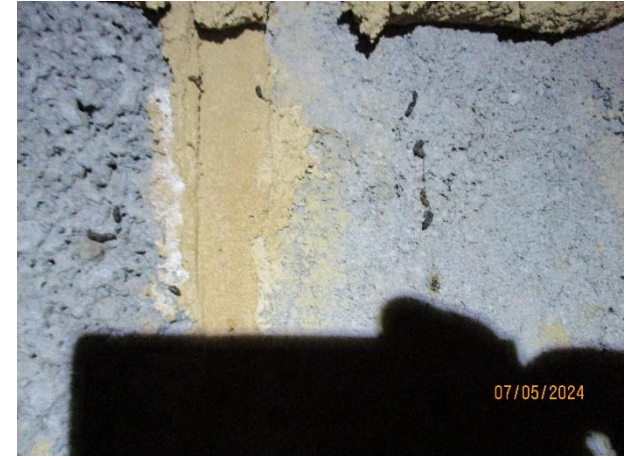
- Approximately 20 brown long-eared bat droppings were found stuck to the southwest gable wall within the main loft void.

**Photo 21:** Bat droppings within Main Void.

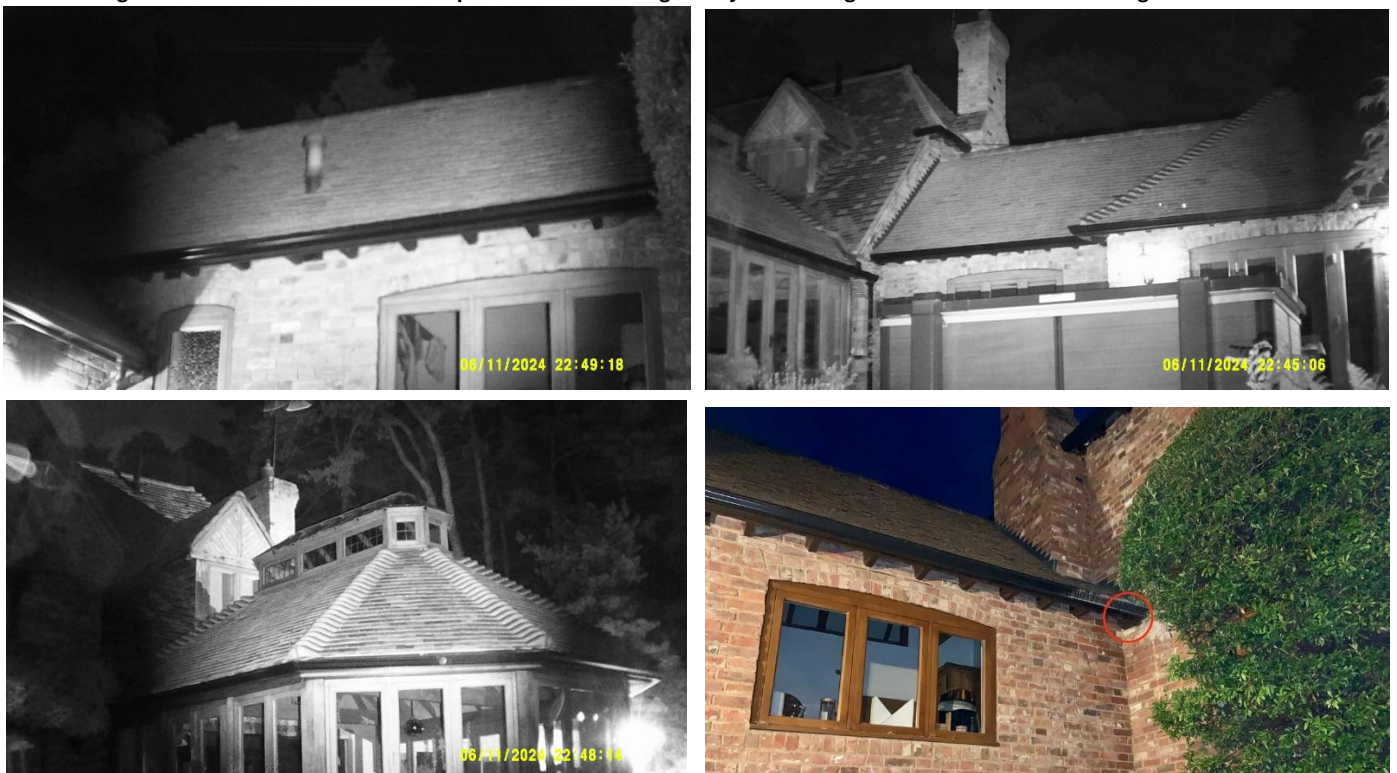
Figure 2: Screenshots of the darkest point recorded during survey for NVA Nightfox Whiskers and bat emergence

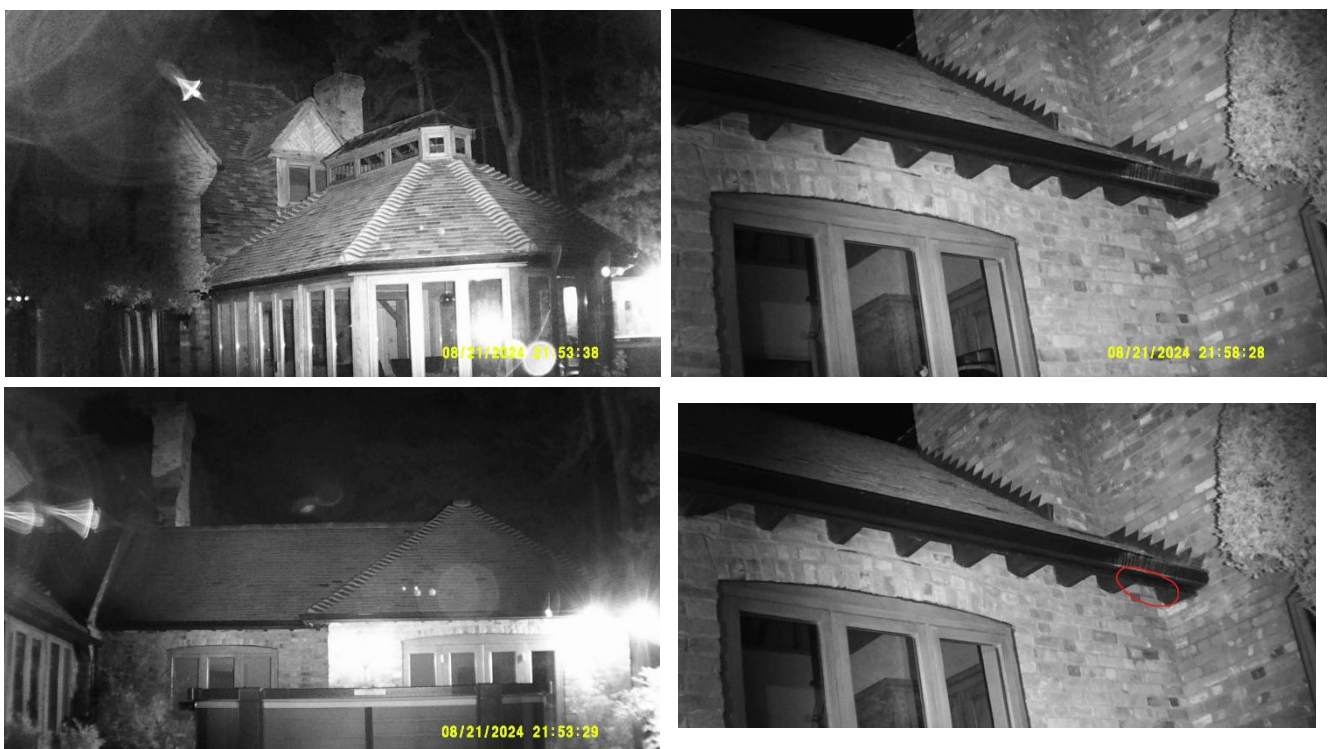
Figure 4: Screenshot of the darkest point recorded during survey for NVA Nightfox Whiskers and bat emergence

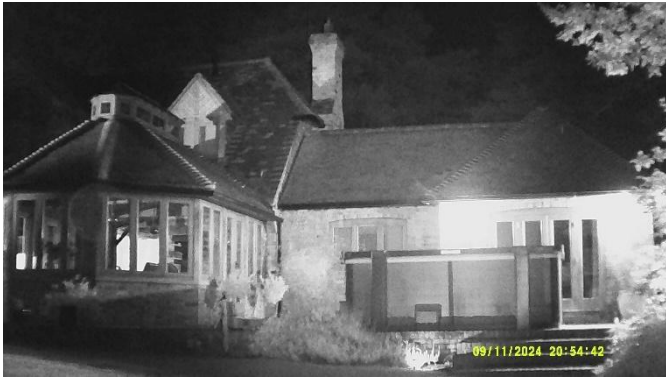
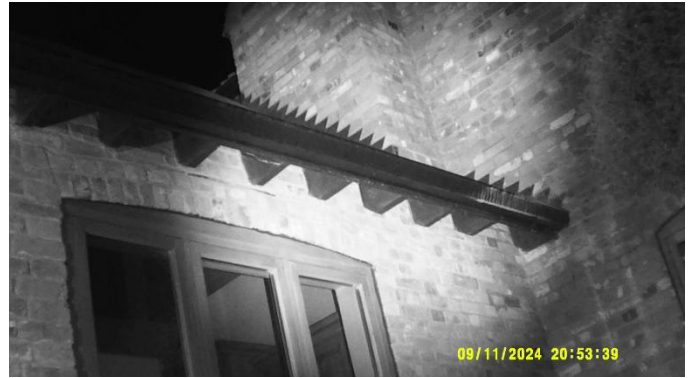
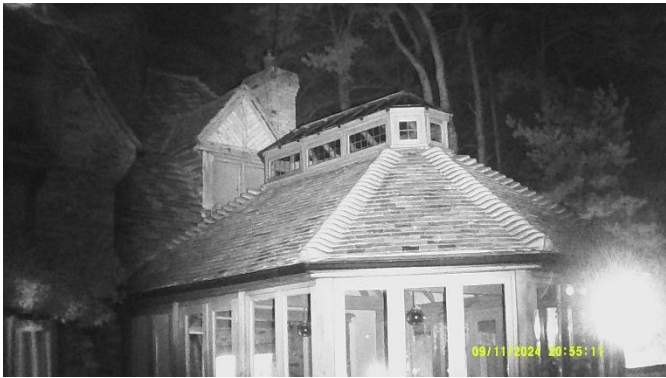
**Figure 6: Screenshot of the darkest point recorded during survey for NVA Nightfox Whiskers**

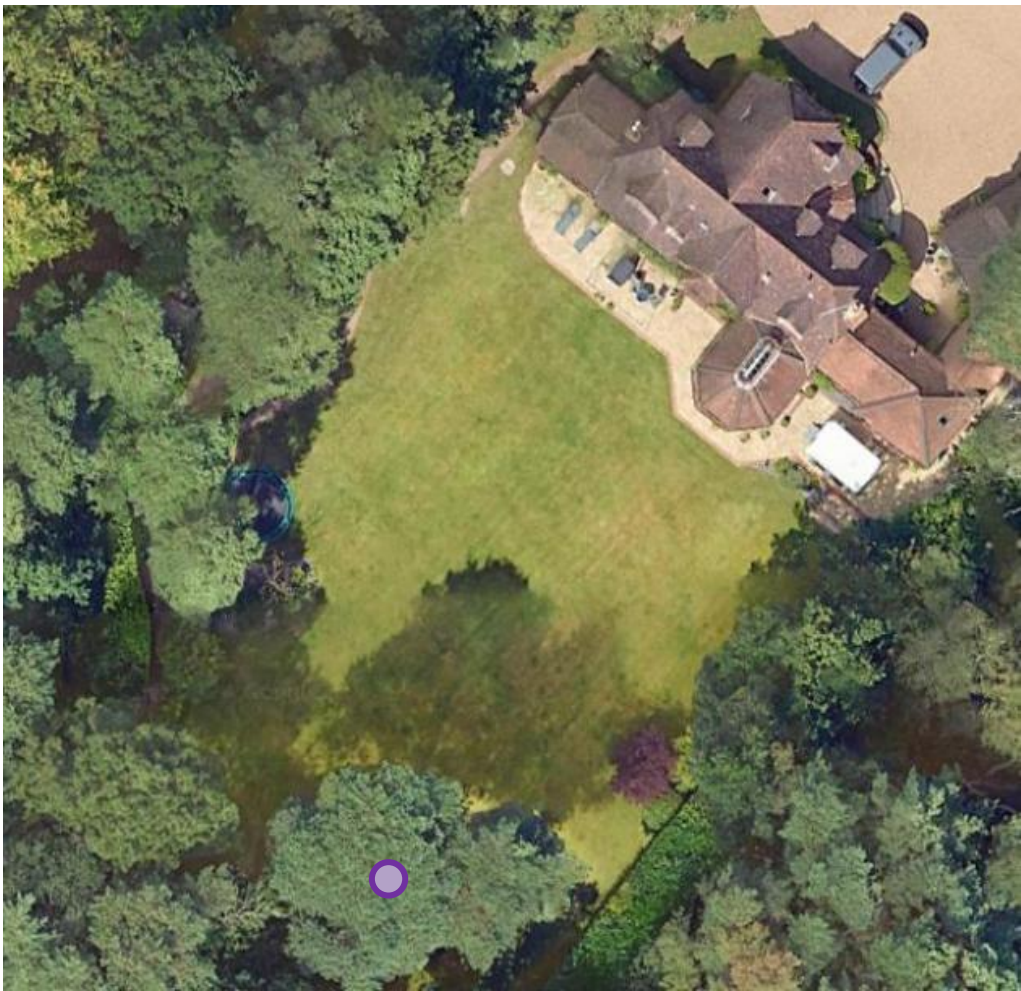
Figure 7: Aerial image to show possible location of the temporary bat box.

| LEGEND: | |
|---|---|
| | <p>One '2F Schwegler Bat Box' must be erected on a suitable mature tree within the applicant's ownership.</p> <p>The box must be erected at a minimum of 3.5 metres (m) from ground level on a sunny aspect. Any limbs/branches must be pruned back around the entrance and below the bat box to ground level to ensure the entrance to the box is unobstructed and allows for a clear flightpath.</p> |

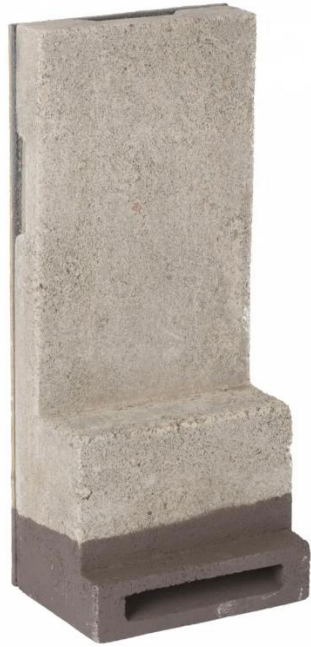
**Figure 8: *Vivara Pro Build-in WoodStone Bat Box (x2 required)***

| Phase of works | Action | Description | Notes to applicant: |
|---|---|---|---|
| | 6. Permanent replacement bat roost and enhancement bat roosting features to be constructed (refer to Appendix I for full details and list of figures). | <b>Replacement bat roost to be created:</b> | <ul style="list-style-type: none"> <li>NOTE: photographic evidence of the installed bat box must be supplied to the ecologist by the applicant for the bat licence return. The applicant is advised to speak to their contractors in advance of these works to ensure photographs can be taken in advance; failure to supply this evidence will result in a breach of the EPS licence.</li> <li>No external light fixtures must be erected within at least 5m of the installed bat box (see 'Artificial Lighting at Night (ALAN)' below for full strategy).</li> <li>The 'Vivara Pro Build-in WoodStone Bat Box' can be purchased by the applicant from <a href="https://www.nhbs.com/vivara-pro-build-in-woodstone-bat-box">https://www.nhbs.com/vivara-pro-build-in-woodstone-bat-box</a>.</li> </ul> |
