## **Bat Emergence and Re-Entry Surveys (BERS)**

Brunninghams Farm, Heath Ride, Finchampstead, Wokingham, RG40 3QJ

*“Proposed erection of 8 no. detached dwellings with associated access, parking and landscaping, following demolition of the existing buildings.”*

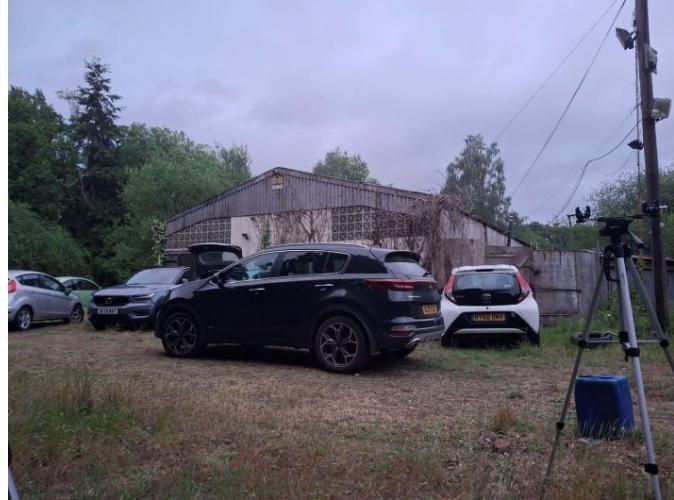
Figure 1: Elevation viewed by Surveyor 1.

<p><i>IR position 1</i>  <i>Nightfox Whisker +</i>  <i>Nightfox XB5 Pro</i>  <i>(850nm)</i></p>	<p>Camera position: observing N &amp; W elevation of B1.  Emergences observed: None.  No additional observations or bat activity recorded upon review.  The activity on the IR footage confirmed the observations of the surveyor.</p>

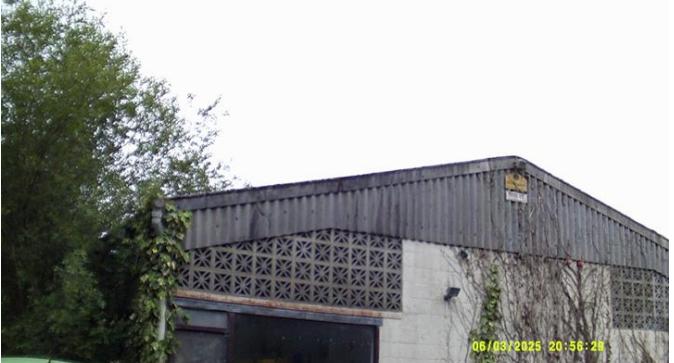
<p><i>Surveyor 2</i></p>	<p><b>Emergences observed - none</b></p> <p>Summary of general activity:  Species – CP, soprano pipistrelle (SP), myotis sp.  Flight paths – The first bat activity recorded was an SP at 21.28, foraging the northeast corner of the site along the treeline. CP was seen foraging along the northern elevation, west to east at 21.54.  Foraging areas – Treeline at northeast corner of the site above surveyor position. In front of north elevation of building.  Other activity - There were five occurrences of bats that were heard but not seen. CP at 21:52, 22:07 and 22:15, Myotis sp. at 22:01 and SP at 22:37.</p>

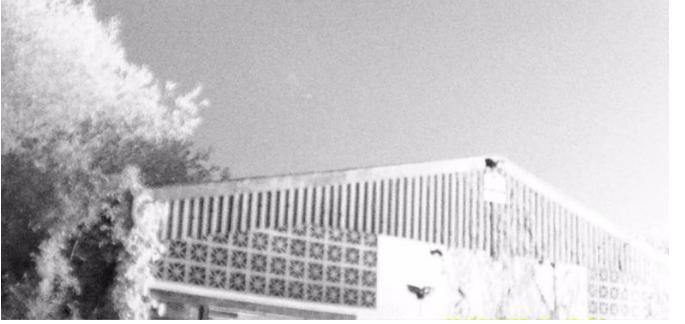
<p>Figure 4: Darkest point of IR position 2.</p>
<p><b>Surveyor 3</b></p>	<p><b>Emergences observed - none</b></p> <p>Summary of general activity:  Species – CP, SP, myotis sp.  Flight paths – SP seen foraging around the trees adjacent to the eastern elevation of B1 from 21:42-21:44 and again at 21:59. CP seen passing the southwest of B1 at 21:55, 22:08 and 22:15.</p> <p>Foraging areas – Trees adjacent to the eastern elevation of B1.</p> <p>Other activity - There were three occurrences of bats that were heard but not seen. CP at 22:26, myotis sp. at 22:01 and SP at 22:38.</p>

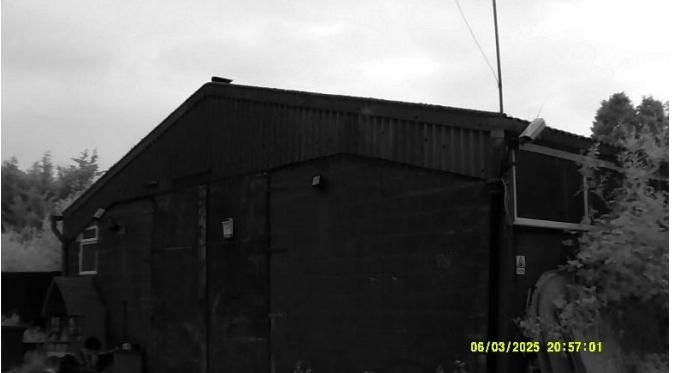
<p>Figure 5: Elevation viewed by Surveyor 3.</p>

<p><i>IR position 3</i>  <i>Nightfox Whisker +</i>  <i>Nightfox XB5 Pro</i>  <i>(850nm)</i></p>	<p>Camera position: observing S &amp; E elevation of B1.  Emergences observed: None.    No additional observations or bat activity recorded upon review.  The activity on the IR footage confirmed the observations of the surveyor.</p>

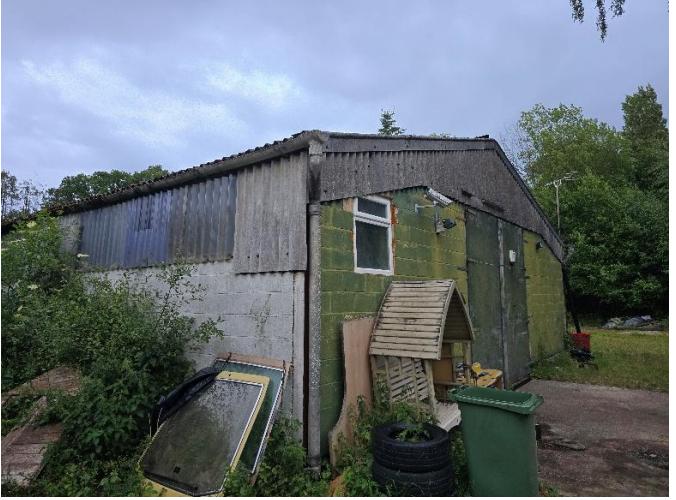
<p><b>Surveyor 4</b></p>	<p><b>Emergences observed - none</b></p> <p>Summary of general activity:  Species – SP, CP.  Flight paths – Two passes by SP, one at 21:41 along the western and then southern elevations of B1 and at 21:43 from east to west along the southern elevation. At 22:07 a CP passed east to west along the southern elevation. At 22:15 a CP was observed foraging from east to west along southern elevation.  Foraging areas – Along southern elevation and above B1.  Other activity - Two occurrences of bats that were heard but not seen, SP at 21:50 and CP at 21:53.</p>

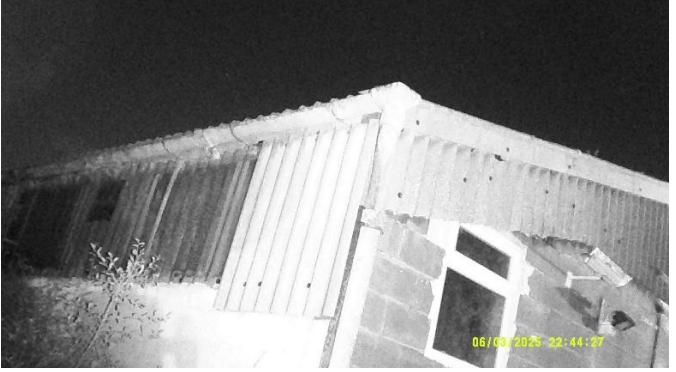
<p><i>IR position 4</i>  <i>Nightfox Whisker +</i>  <i>Nightfox XB5 Pro</i>  <i>(850nm)</i></p>	<p>Camera position: observing S &amp; W elevation of B1.  Emergences observed: None.  At 22:09 and 22:37 pipistrelle sp. were observed foraging above B1.  The activity on the IR footage confirmed the observations of the surveyor.</p>

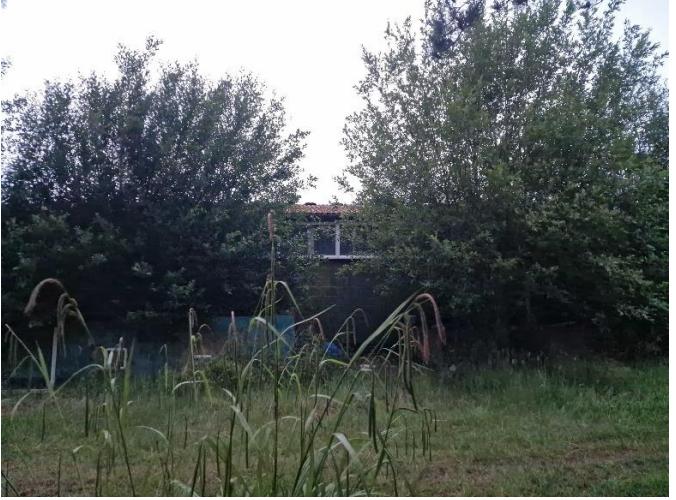
<p><i>Surveyor 5</i></p>	<p><b>Emergences observed - none</b></p> <p>Summary of general activity:  Species – CP, SP, myotis sp.  Flight paths – Two passes by a CP at 21:55 and 22:08 from south to east. SP foraging along the eastern elevation at 21:42.  Foraging areas – Foraging of the vegetation along the eastern elevation of B1.  Other activity - Three occurrences of bats that were heard but not seen, myotis sp. at 22:01, CP at 22:15 and SP at 22:38.</p>

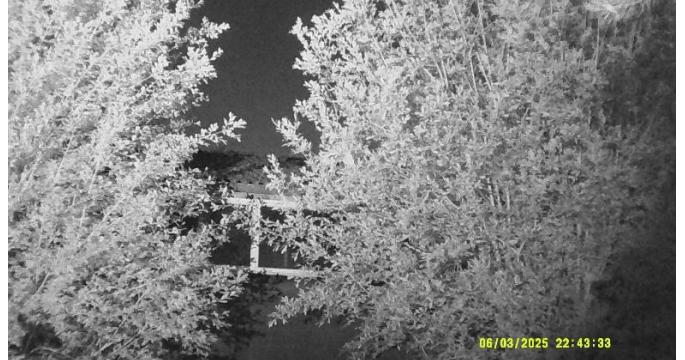
Figure 10: Darkest point of IR position 5.

<p>IR position 5 Nightfox Whisker + Nightfox XB5 Pro (850nm)</p>	<p>Camera position: observing E elevation of B1. Emergences observed: None.  No additional observations or bat activity recorded upon review. The activity on the IR footage confirmed the observations of the surveyor.</p>

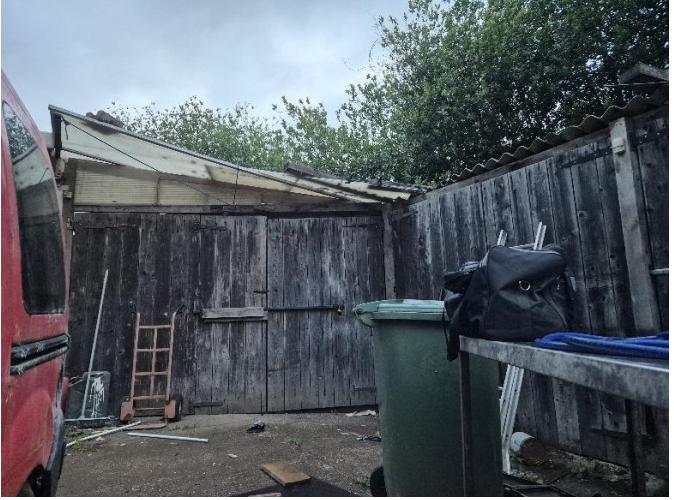
<p><b>Surveyor 2</b></p>	<p><b>Emergences observed - none</b>    Summary of general activity:  Species – None.  Flight paths – No bat activity was observed during the survey.  Foraging areas – None</p>

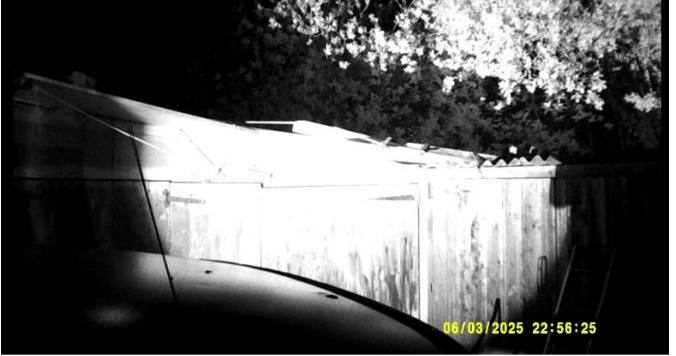
<p><i>IR position 2</i>  <i>Nightfox Whisker +</i>  <i>Nightfox XB5 Pro</i>  <i>(850nm)</i></p>	<p>Camera position: observing N&amp;E elevation of B3 from within small courtyard.  Emergences observed: None.  No additional observations or bat activity recorded upon review.  The activity on the IR footage confirmed the observations of the surveyor.</p>

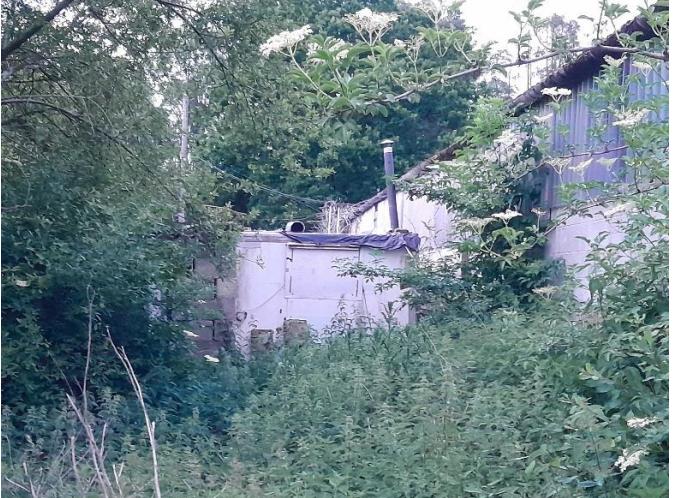
<p><i>Surveyor 3</i></p>	<p><b>Emergences observed - none</b>  Summary of general activity:  Species – SP, CP.  Flight paths – No bat activity was observed during the survey.  Foraging areas – None.  Other activity - There were 4 occurrences of bats that were heard but not seen. SP at 21:45 and CP at 21:55, 22:08 and 22:16.</p>

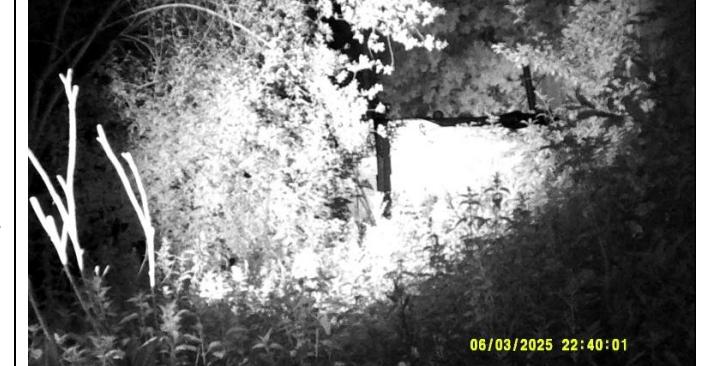
<p>Figure 16: Darkest point of IR position 3.</p>

<p>IR position 3 Nightfox Whisker + Nightfox XB5 Pro (850nm)</p>	<p>Camera position: observing S elevation of B3. Emergences observed: None.  No additional observations or bat activity recorded upon review. The activity on the IR footage confirmed the observations of the surveyor.</p>

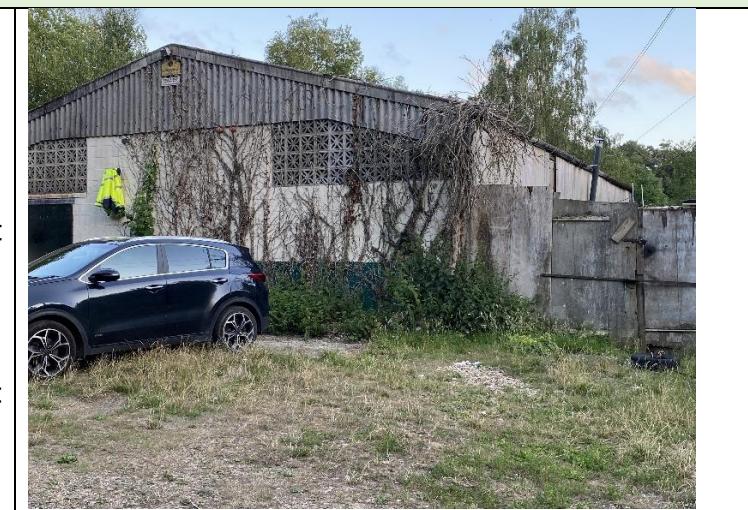
Figure 17: Elevation viewed by Surveyor 1.

<p><i>IR position 1</i>  <i>Nightfox Whisker +</i>  <i>Nightfox XB5 Pro</i>  <i>(850nm)</i></p>	<p>Camera position: observing N &amp; W elevation of B1.  Emergences observed: None.  No additional observations or bat activity recorded upon review.  The activity on the IR footage confirmed the observations of the surveyor.</p>

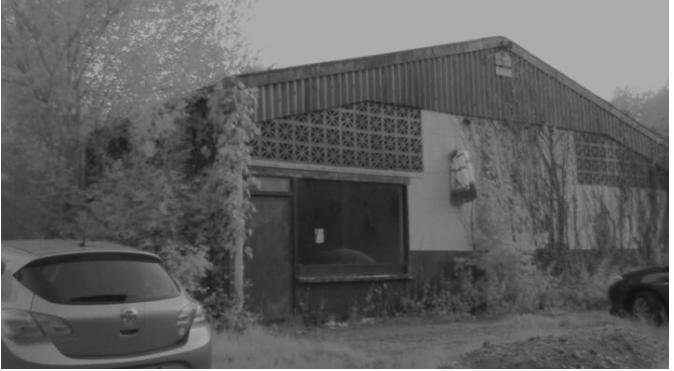
<p><i>Surveyor 2</i></p>	<p><b>Emergences observed - none</b></p> <p>Summary of general activity:  Species – CP, SP, noctule, serotine.  Flight paths – SP and CP observed foraging along the treeline at the northern and eastern edge of the site between 21:51 and 22:32.  Foraging areas – Constant foraging along the treeline at the northern and eastern edge of the site.  Other activity - Five occurrences of bats that were heard but not seen. SP at 21:37, noctule at 21:38 and 22:09, CP at 22:11 and serotine at 22:46.</p>

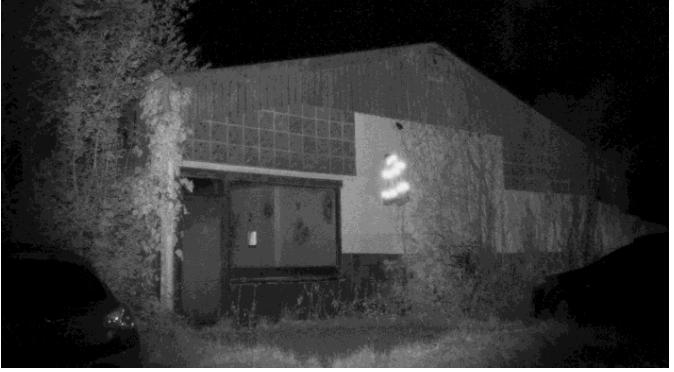
<p><i>IR position 2</i>  <i>Nightfox Whisker +</i>  <i>Nightfox XB5 Pro</i>  <i>(850nm)</i></p>	<p>Camera position: observing N &amp; E elevation of B1.  Emergences observed: None.    No additional observations or bat activity recorded upon review.  The activity on the IR footage confirmed the observations of the surveyor.</p>

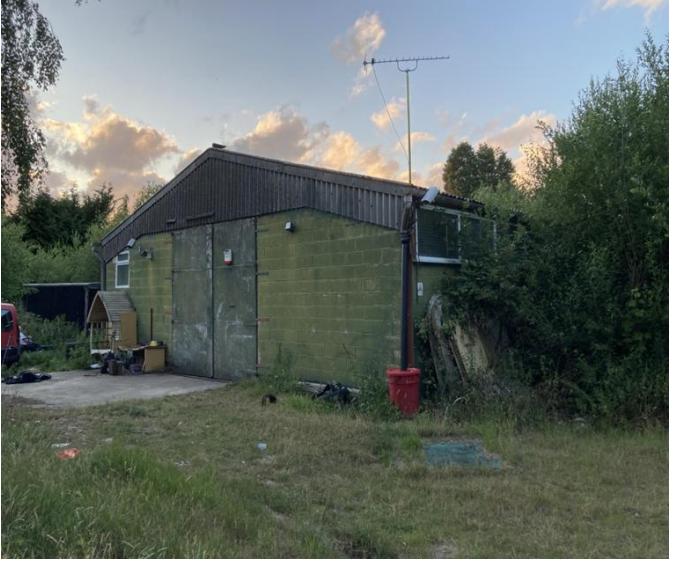
<p><i>Surveyor 3</i></p>	<p><b>Emergences observed - none</b>    Summary of general activity:  Species – CP, SP, noctule, serotine.  Flight paths – SP and CP multiple passes over surveyor position heading west along southern elevation of B1 between 22:00 and 22:30. SP foraging at tree to south of B1 at 22:04 and 22:26. CP foraging around vegetation adjacent to eastern elevation at 22:17.  Foraging areas – Tree to south of B1 and adjacent to eastern elevation.  Other activity - Four occurrences of bats that were heard but not seen. CP at 21:11 and 22:37, noctule at 22:10 and serotine at 22:45.</p>

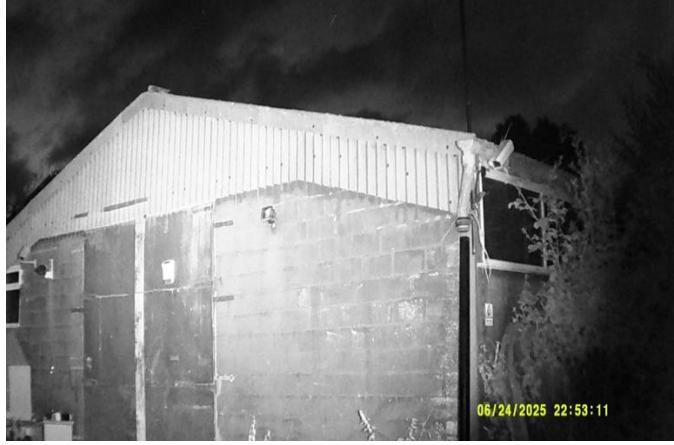
<p><i>IR position 3</i>  <i>Nightfox Whisker +</i>  <i>Nightfox XB5 Pro</i>  <i>(850nm)</i></p>	<p>Camera position: observing S &amp; E elevation of B1.  Emergences observed: None.    No additional observations or bat activity recorded upon review.  The activity on the IR footage confirmed the observations of the surveyor.</p>

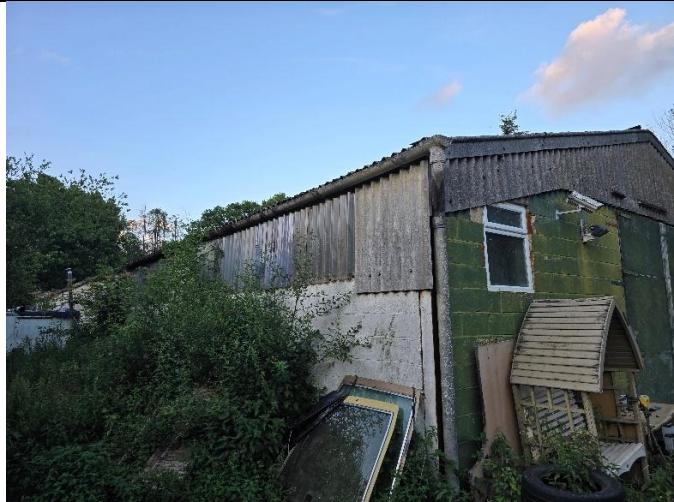
<p>Figure 23: Elevation viewed by Surveyor 4.</p>

<p><i>IR position 4</i>  <i>Nightfox Whisker +</i>  <i>Nightfox XB5 Pro</i>  <i>(850nm)</i></p>	<p>Camera position: observing S &amp; W elevation of B1.  Emergences observed: None.  No additional observations or bat activity recorded upon review.  The activity on the IR footage confirmed the observations of the surveyor.</p>
