Sonning Court
Thames Street
Sonning-on-Thames
Berkshire
RG4 6UR

Preliminary Roost Assessment

Report ref.: R3096_PRA_a

December 2025

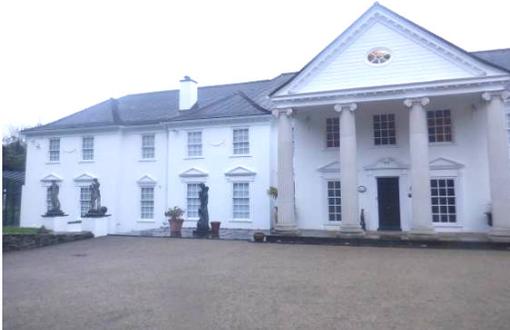
- 5.2.2 The property is a detached house of brick and render construction, with a complex hipped roof and front pitched gable. There was a glass-roofed conservatory and glass flat-roofed extensions on the rear and western elevations (**Photographs 1 - 4**).

Photograph 1. Front of the property viewed from the south.

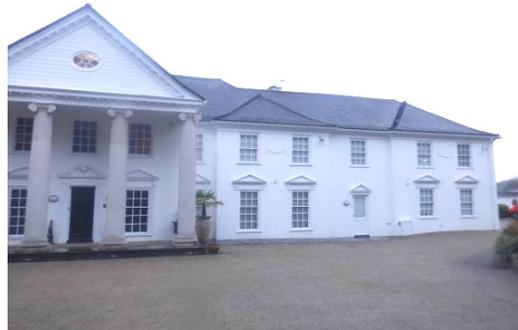
Photograph 2. Front of the property viewed from the south.

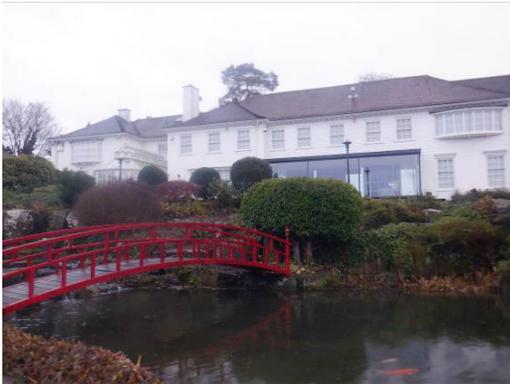
Photograph 3. Rear of the property, viewed from the north.

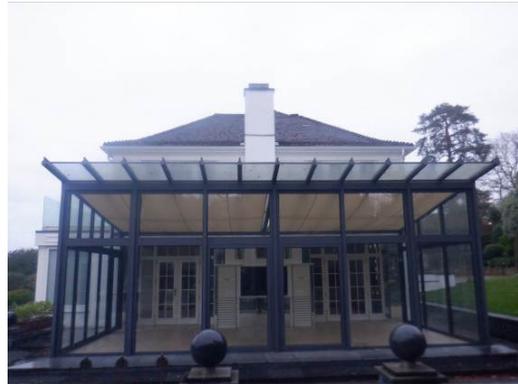
Photograph 4. Flat-roofed glass side extension, viewed from the west.

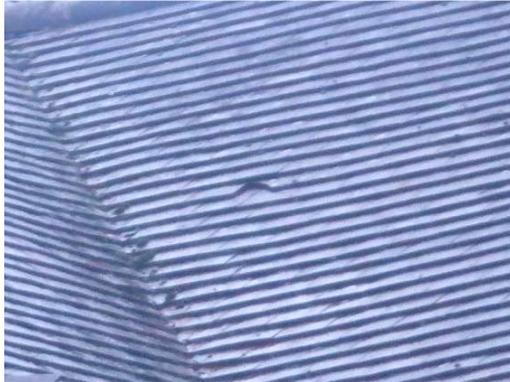
- 5.2.3 The main roof was covered with overlapping plain tiles that were mostly intact across all elevations, with the exception of occasional broken roof tiles on the eastern elevation of the front gable (**Photographs 5 & 6**). However, the tiles remained in place thus did not create a suitable roosting feature for bats. There were a few lifted and slipped tiles beside the chimney on the front elevation of the property, offering potential roosting features for crevice-dwelling bats such as pipistrelle species (*Pipistrellus* spp.) (**Photograph 7; Target note 1**). There was a slight gap below a lifted roof tile beside

Photograph 5. Tight plain roof tiles and broken roof tile (front elevation).

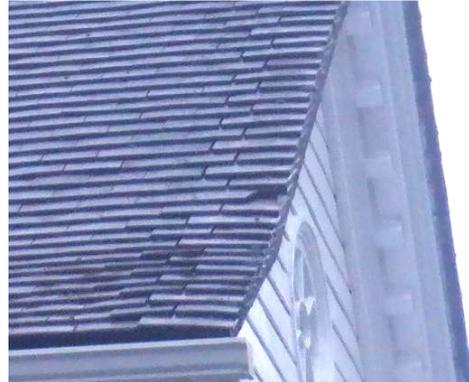
Photograph 6. Broken verge tile (front elevation).

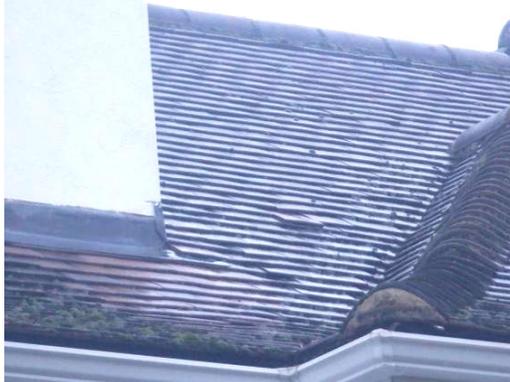
Photograph 7. Lifted and slipped roof tiles beside chimney (front elevation).

6.1.2 Externally, the occasional gaps beneath slipped and lifted plain roof tiles beside the chimney on the front elevation were the only potential crevice roosting features observed during the inspection, that were suitable for species such as common pipistrelle and soprano pipistrelle that have been recorded locally.

6.2.2 The identified potential roost features below slipped and lifted roof tiles on the front elevation will be unaffected by the proposals and retained long-term. The survey findings demonstrate that these proposals are highly unlikely to result in the death, injury or disturbance of bats; the damage or destruction of a bat roost; or the obstruction of access to a bat roost. Therefore, a European Protected Species (EPS) mitigation licence would not be required to allow the development proposals to proceed lawfully.

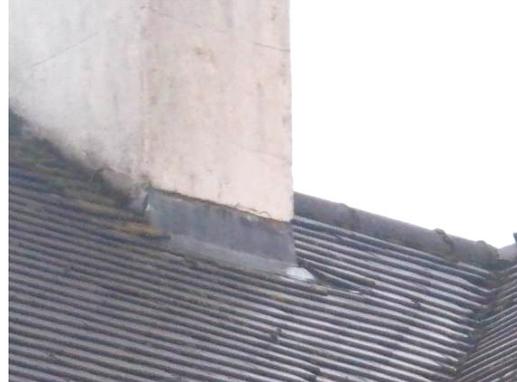
the chimney at the eastern end of the roof, but it was deemed to be of limited extent (**Photograph 8**).

Photograph 8. Gap of limited extent below lifted roof tile at base of chimney (eastern elevation).

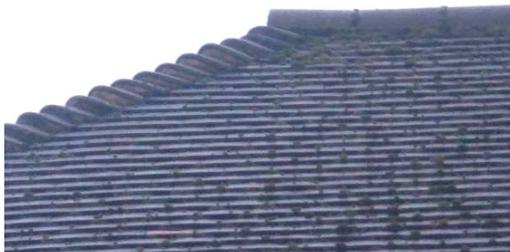
- 5.2.4** The ridge and hip mortar was intact across all elevations of the house (**Photograph 9**). The lead flashing around all chimneys and connecting the conservatory to the main house, was flush to the plain roof tiles and brickwork (**Photograph 10**).

Photograph 9. Intact ridge and hip mortar (western elevation).

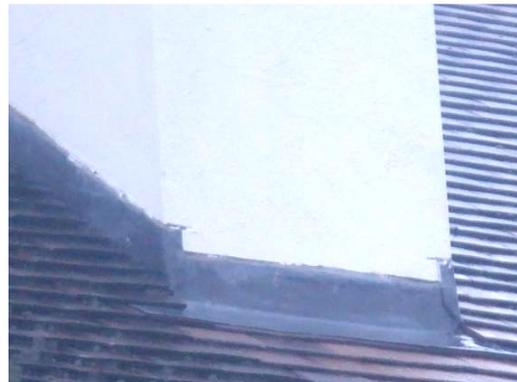
Photograph 10. Lead flashing flush to plain roof tiles (front elevation).

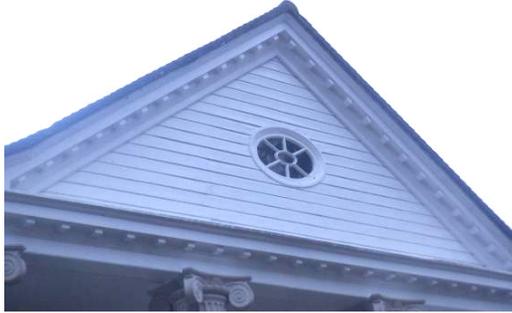
- 5.2.5** The verge mortar on the gable end located on the front elevation of the house was intact with no visible gaps (**Photograph 11**). The timber soffits and bargeboards were

Photograph 11. Intact verge mortar across gable end (front elevation).

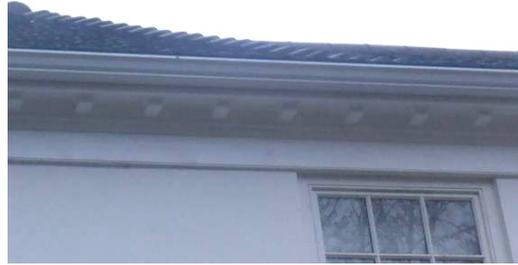
intact and tight to the brickwork on all elevations of the house (**Photograph 12**).

Photograph 12. Intact timber soffits and bargeboards tight to the brickwork (front elevation).

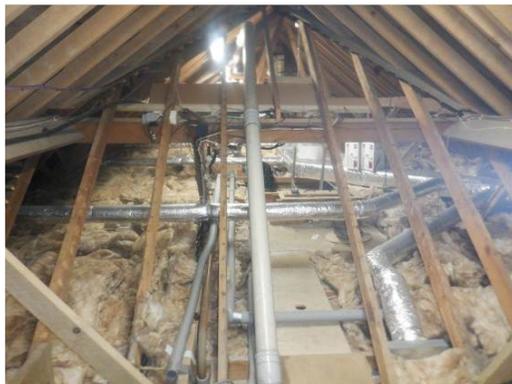
- 5.2.7** The property had one continuous roof void that covered the second storey footprint of the house and that was accessible via two loft hatches on the first floor. The void had a floor-to-ridge height of approximately 4 metres at the highest point and was of 'cut and pitch' rafter construction at the eastern end and pre-trussed rafter construction at the western end (**Photograph 13**). The majority of the roof was lined with bitumen felting that was mostly intact, but with occasional small tears (**Photographs 14 & 15; Target note 2**). The roof void at the western side of the house was of newer construction and was lined with intact breathable membrane (**Photograph 16**).

Photograph 13. Roof void (eastern elevation).

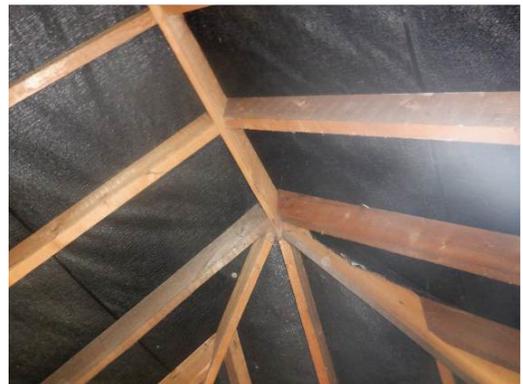
Photograph 14. Eastern side of roof void lined with bitumen felting (roof void).

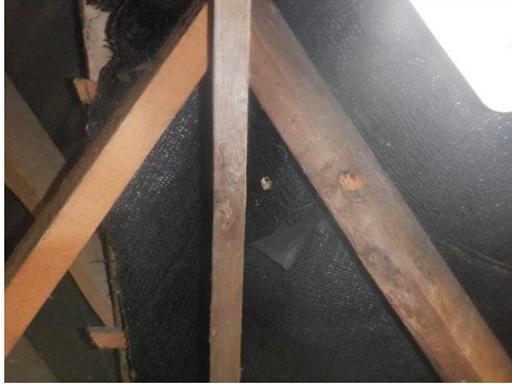
Photograph 15. Small gaps between timber rafters and bitumen felting at the ridge of the hipped roof (roof void).

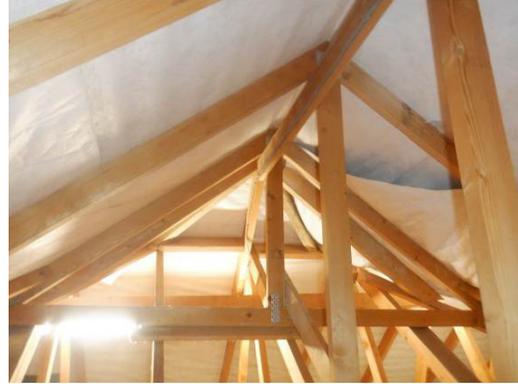
Photograph 16. Western side of roof void lined with breathable membrane (roof void).

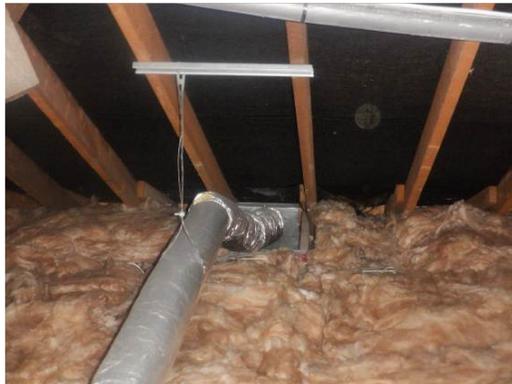
5.2.8 The floor was centrally boarded with thick fibreglass insulation between the joists (**Photograph 17**). The eaves were blocked by fibreglass along the eastern side of the loft void and open into the soffits along the western side (**Photographs 18 & 19; Target note 3**). There was a small amount of expanding foam filling a section of the eaves on the eastern side of the loft void (**Photograph 20**).

Photograph 17. Thick fibreglass insulation between joists (roof void).

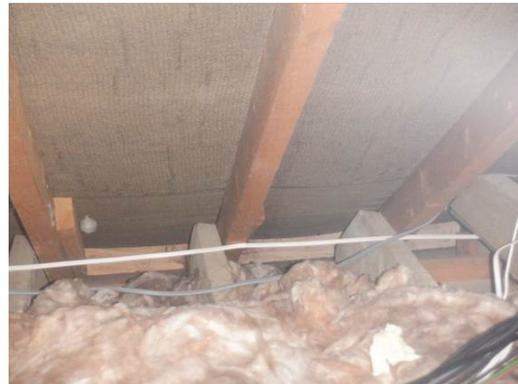
Photograph 18. Eaves blocked by fibreglass insulation along eastern side (roof void).

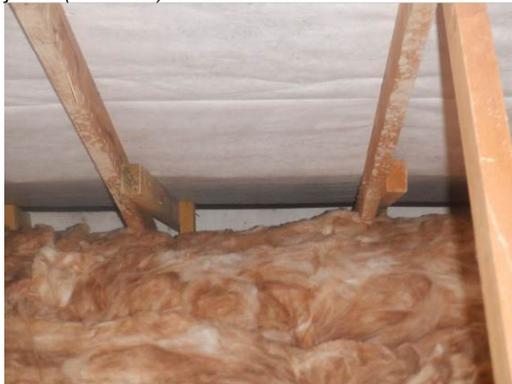
Photograph 19. Eaves open into soffits along western side (roof void).

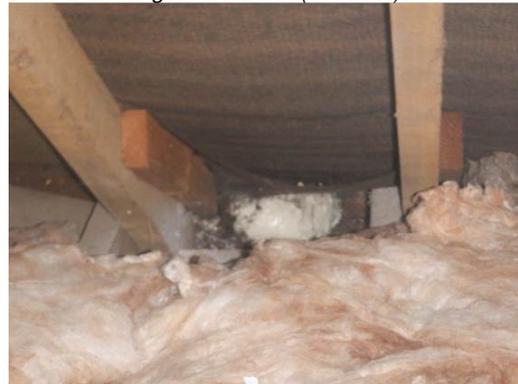
Photograph 20. Small section of expanding foam in eaves on eastern side (roof void).

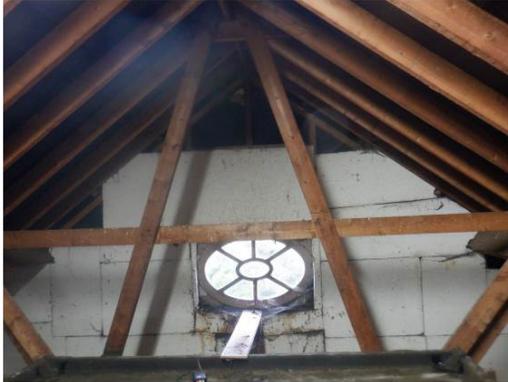
5.2.9 The pitched gable end on the front elevation of the house was lined with bitumen roofing felt that was tight to the rafters, with polystyrene insulation present on top

Photograph 21. Front gable end with circular window, lined with polystyrene and bitumen felt (roof void).

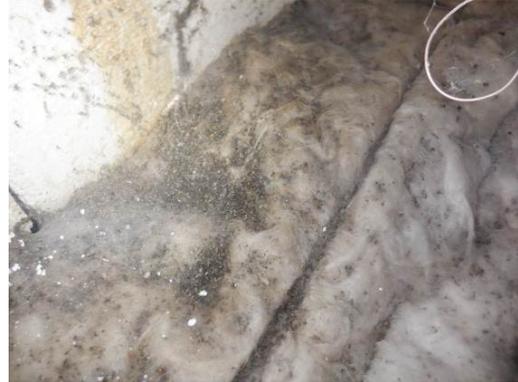
(**Photograph 21**). There was a small circular window in the wall and a large accumulation of cluster flies around the window and on the fibreglass below (**Photograph 22**). There was a large raised platform in the centre of the gable where a water tank had likely been previously removed and one likely medium-sized bat dropping, typical of those deposited by void-dwelling bats such as long-eared species (**Photographs 23 & 24**). Due to a lack of visible entrance points and a lack of any further evidence within the void, this dropping is assumed to be from an historic roost.

Photograph 22. Accumulation of cluster flies at gable end wall (roof void).

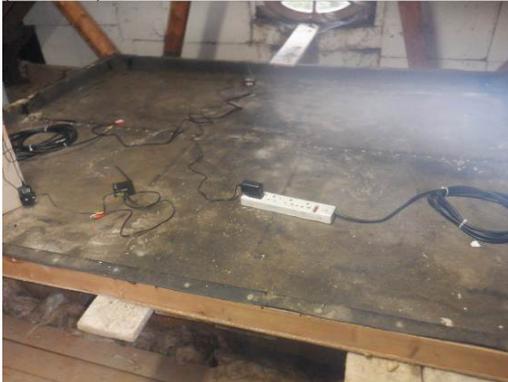
Photograph 23. Raised platform in front of pitched gable (roof void).

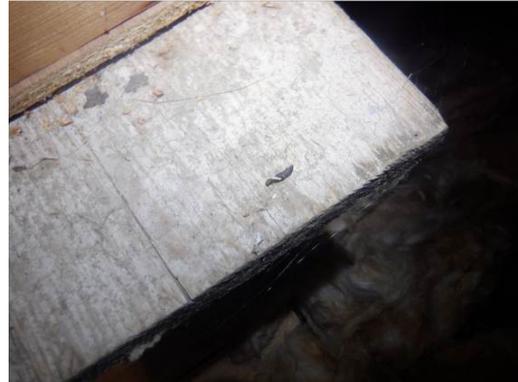
Photograph 24. Possible medium-sized bat dropping (loft void).

6.1.3 During the internal inspection, one medium-sized bat dropping, typical of those deposited by void-dwelling species, such as the locally recorded brown long-eared bat (*Plecotus auritus*), was found beneath the front gable. The loft space was of a size that was suitable for internal flight and the ridge was only lightly cobwebbed throughout; however there was a lack of evidence found within the rest of the void and the void lacked visible access points, therefore this dropping has been classified as being from a likely historic roost.

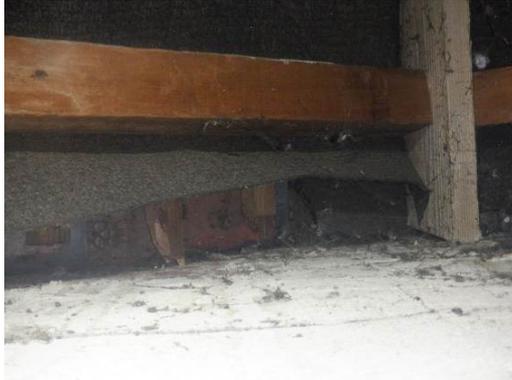
5.2.10 Towards the eastern side of the roof void, there was a heavily cobwebbed brickwork and render chimney with lead flashing around the base and a small gap between the bitumen felting and rendered brickwork, exposing the external plain roof tiles (**Photograph 25; Target note 4**). A second chimney was visible at the eaves on the rear elevation of the void, which was cobwebbed and tight to the rafters. This gap was heavily cobwebbed with no daylight visible. A second chimney was partly visible at the eaves on the rear elevation, which was cobwebbed and tight to the rafters (**Photograph 26**). The enclosed skylights were both tight to the breathable membrane felting and timber rafters (**Photograph 27**).

Photograph 25. Cobwebbed gap between the roof felt and chimney at the eastern end (roof void).

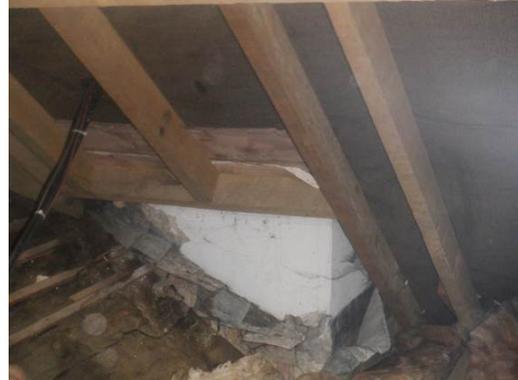
Photograph 26. Heavily cobwebbed gap between bitumen felting and enclosed skylight (roof void).

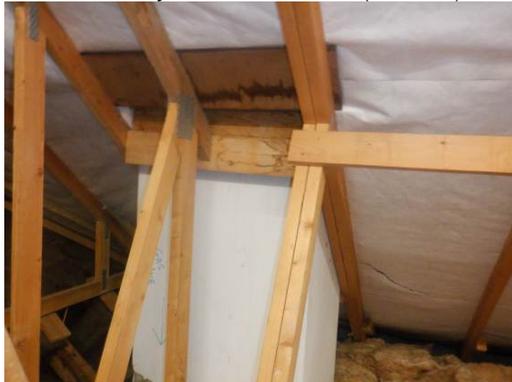
Photograph 27. Roof membrane and timbers tight to light box surrounding a skylight on the western side (roof void).

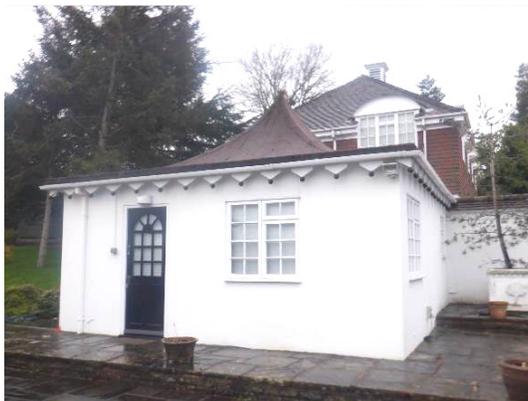
5.2.11 The detached pool house was a single-storey building, which featured a sloping hipped roof covered in bitumen felt (**Photograph 30**). The soffit was tight to the rendered wall on all elevations of the building (**Photograph 31**). There was no internal roof void to survey within the building.

Photograph 30. Detached pool house (northern elevation).

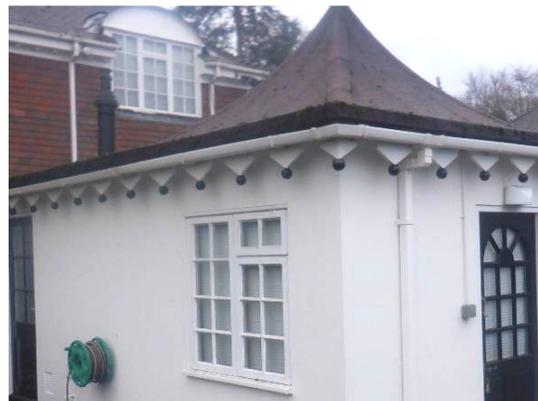
Photograph 31. Soffit tight to the rendered walls (eastern elevation).

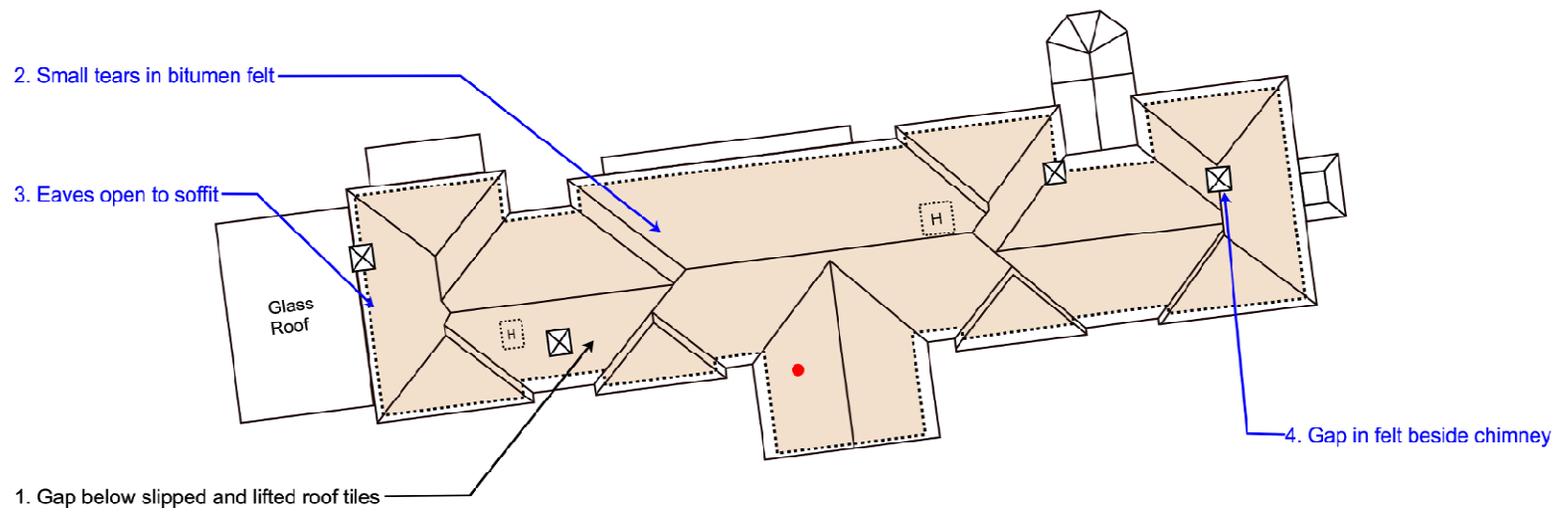
Figure 1. Plan of the Preliminary Roost Assessment findings.

- 5.2.1 The findings from the external inspection carried out for the property are described with photographs and are annotated in a plan, as follows:
