**12 Oatlands,  
Shinfield,  
Reading  
RG2 9DW**

**PHASE 1 BAT SURVEY  
(Provisional roost assessment)**

**November 2024**

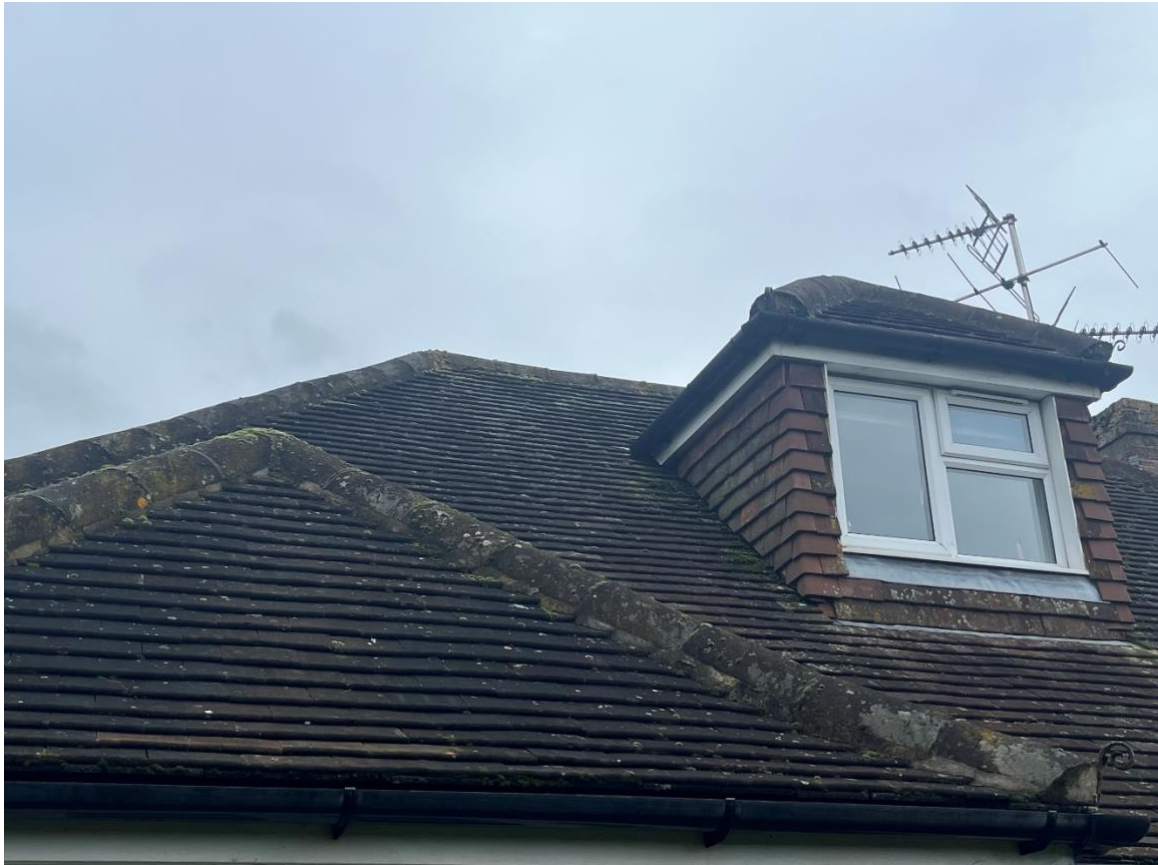
The bungalow is brick faced block walls with a pitched roof of clay tiles which are close fitting with no gaps and the ridge tiles and soffits are all in excellent order with no gaps (See figures 2, 3 & 5). However, the dormer off the west face and the flat roofed south facing dormer have hang tile faced sides with potential openings (See figures 4 & 6).

**Figure 2. Western elevations northern half looking southeast.**

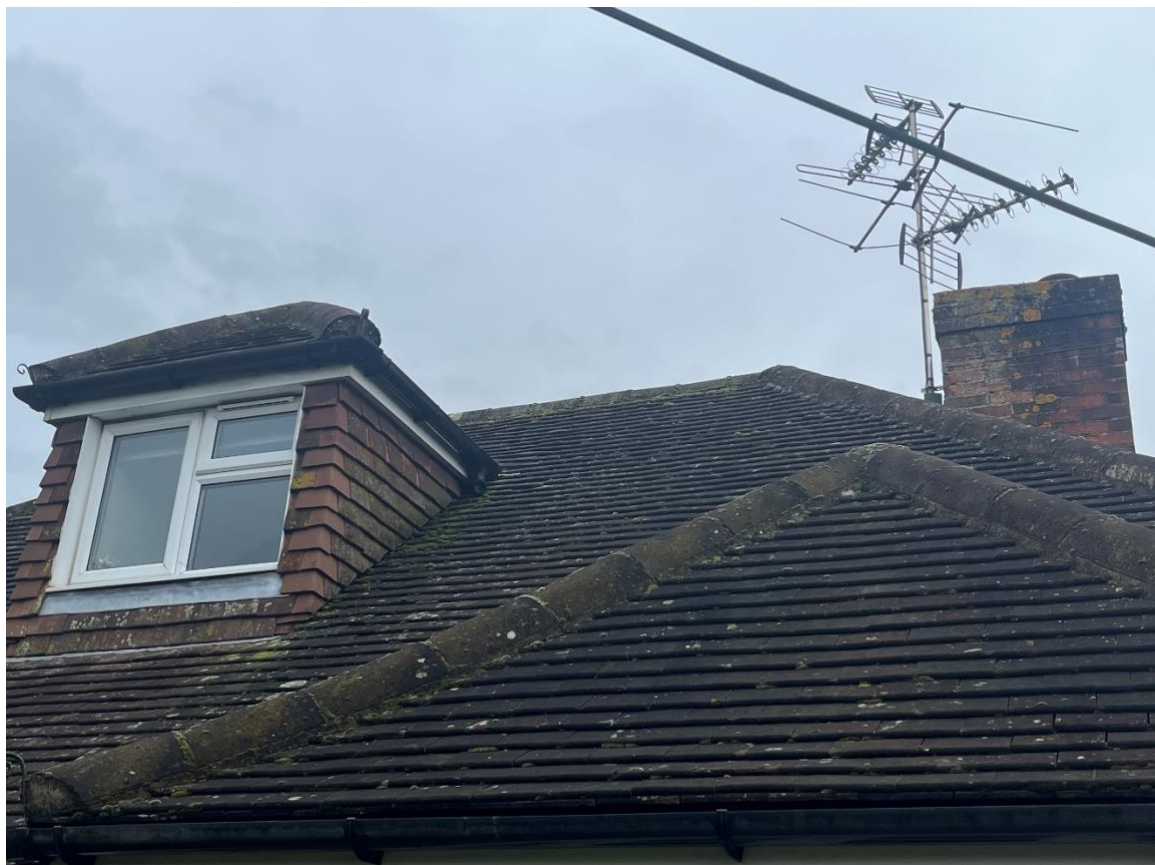
**Figure 3. Western elevations southern half looking northeast.**

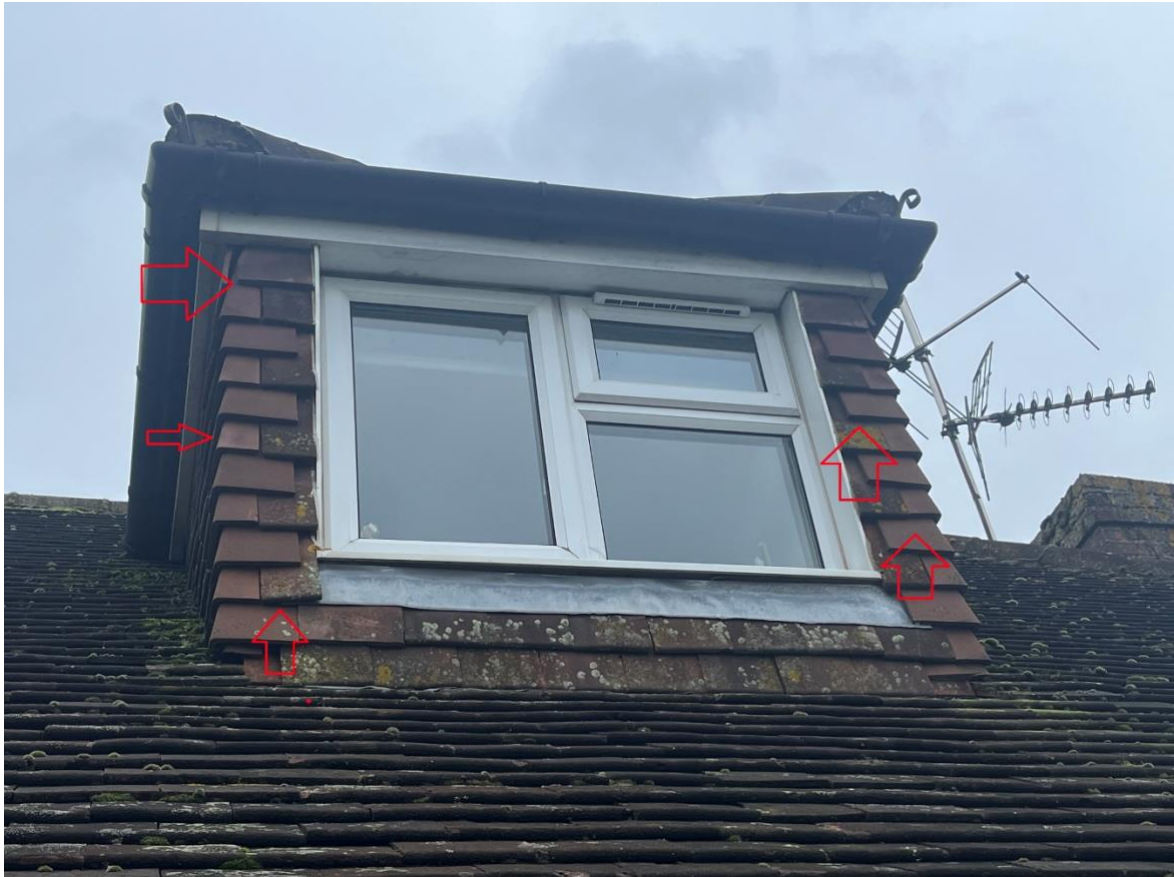
**Figure 4. Wet dormer looking east: Red arrows indicate potential openings for crevice roosting bats.**

There was no sign of any activity in the loft. However, the hang-tile faced dormers do have some potential openings, and if these would be directly impacted by the proposals, they have low potential, and a phase 2 emergence survey is recommended.

A dusk emergence survey is recommended to identify whether bats are utilising the property. These can be carried out in suitable weather between May and the end of September.

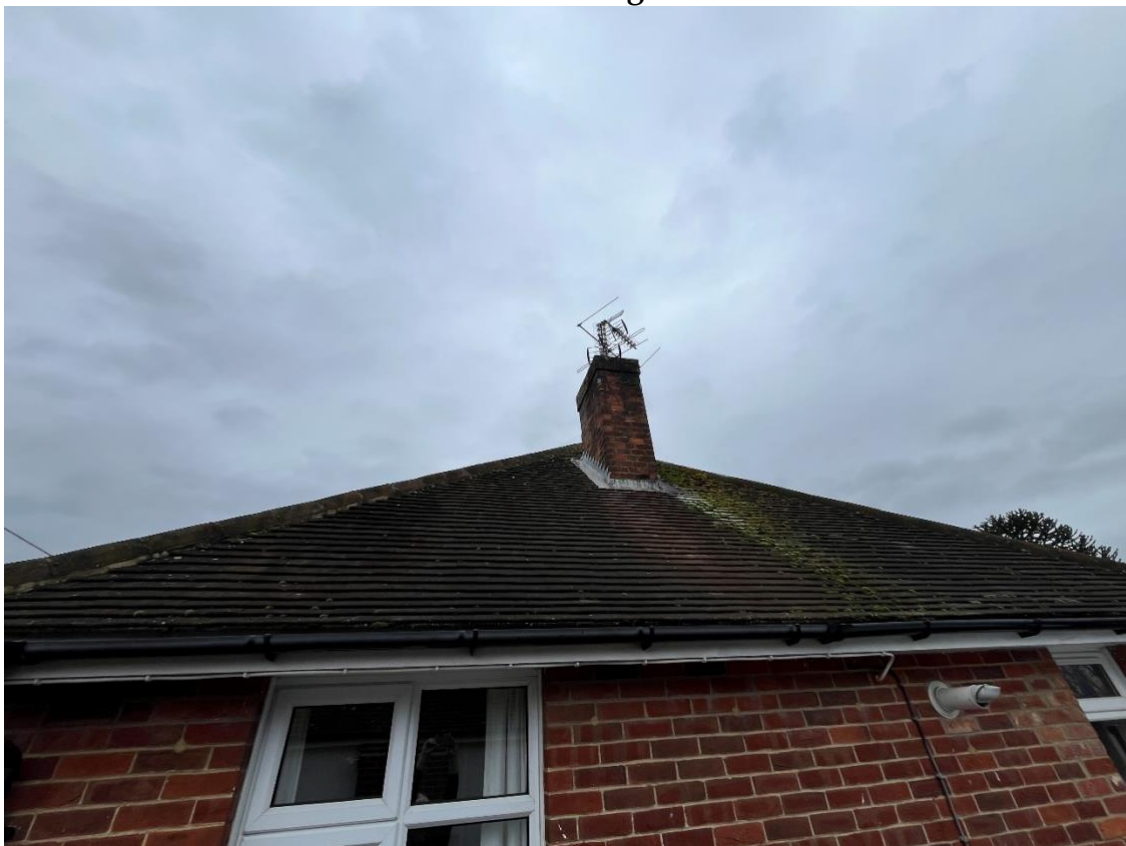
**Figure 5. South hip looking north.**

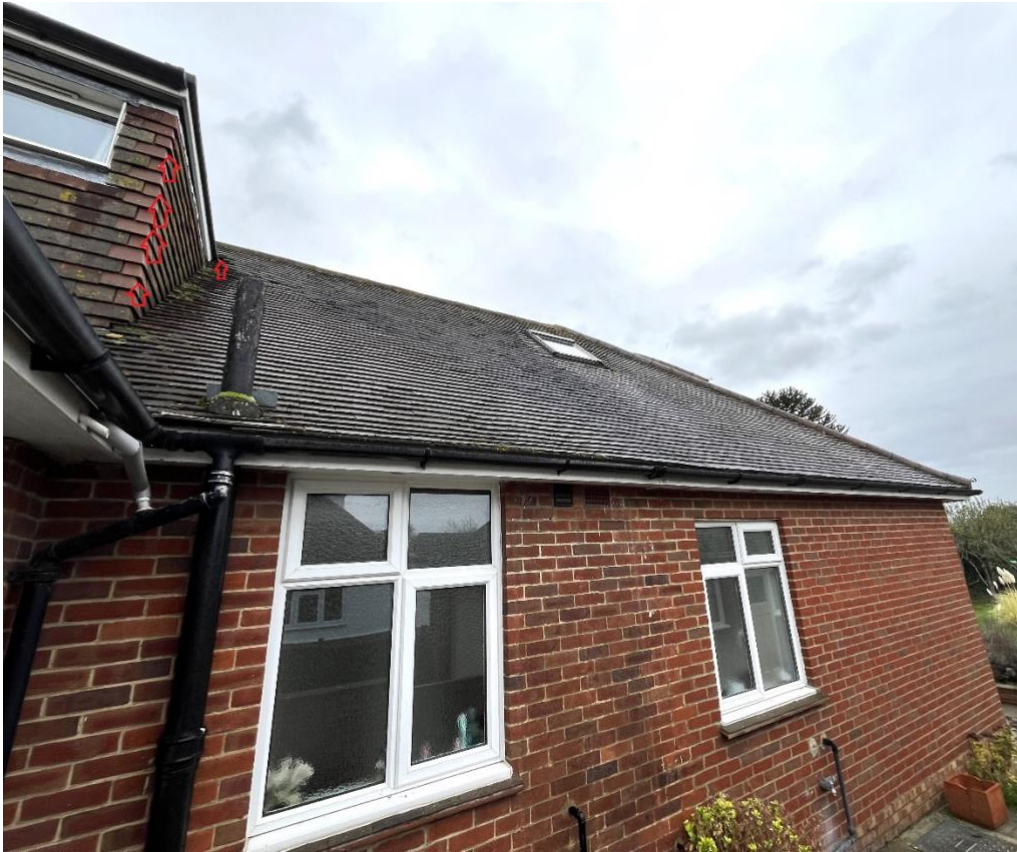
**Figure 6. South face of rear extension looking northeast. Red arrows indicate potential openings for crevice roosting bats.**

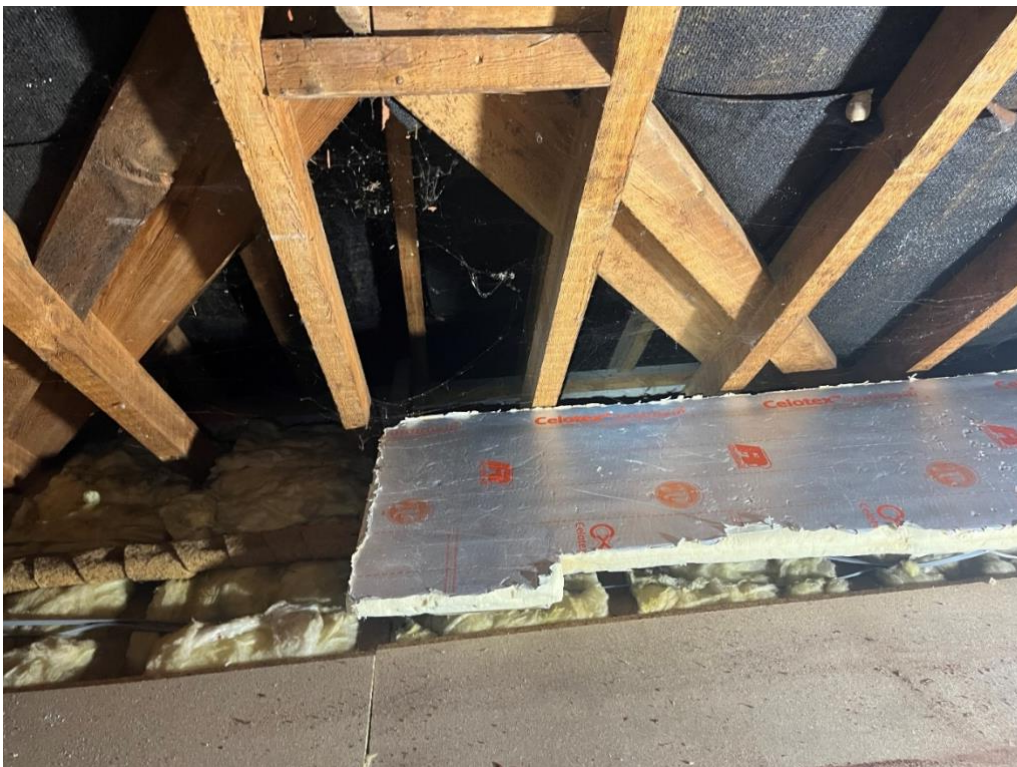
The loft is partly boarded out and used for storage. The roof is lined with felting which is in very good order with no external daylight visible from within (see figures 6 & 7) and there was no sign of any bat activity within.

**Figure 6. Loft looking west.**
