# BASS ECOLOGY

## Preliminary Roost Assessment

| Document Version/REF | | Date | Author |
|---|---|---|---|
| V.1.2 | AA259WM | 14/05/25 | Leon Lambert (Senior Ecologist) |

Bass Ecology have been commissioned to undertake a preliminary roost assessment on 57 Western Avenue, Woodley, Wokingham, RG5 3BL, henceforth referred to as the site.

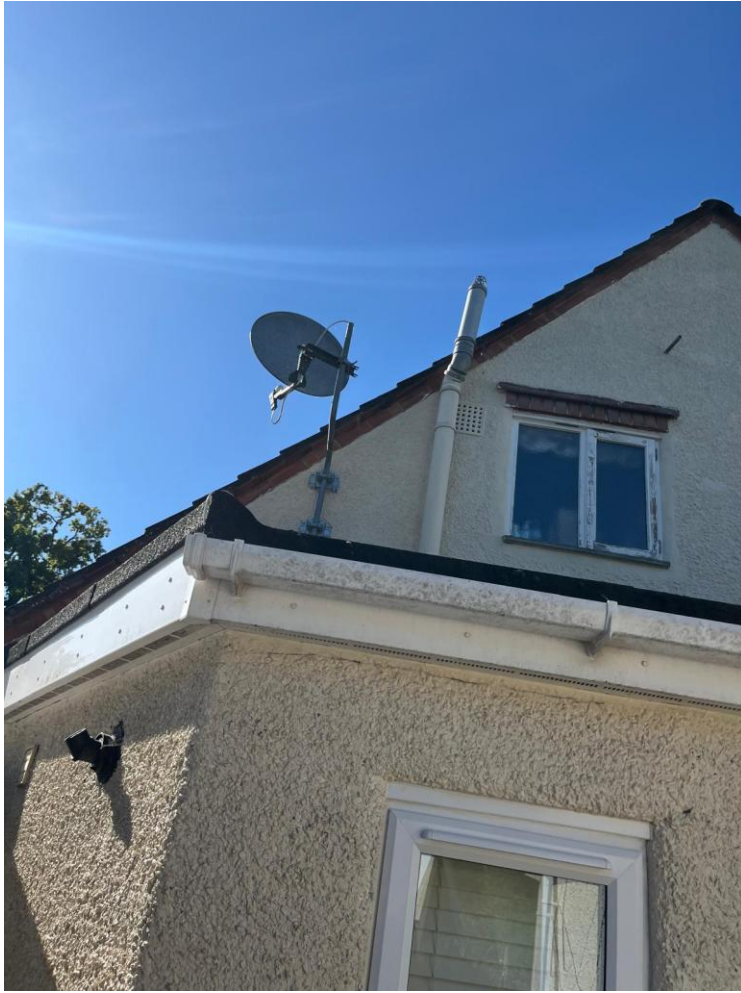
Firstly, a walkaround of the house was conducted, looking for any features that could support roosting bats, of which none were found, this included getting up close to the ends and gutters.

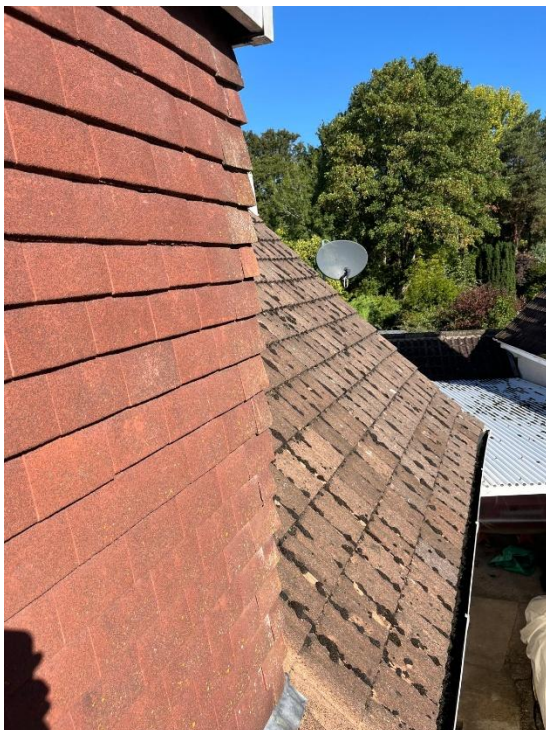
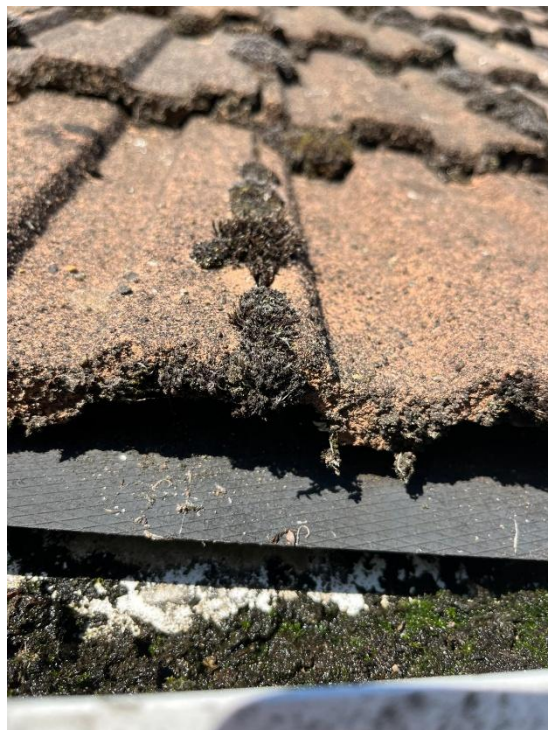
An up-close survey was then conducted of the tiles where the dormer was to be built. There were gaps between the tiles, however none of them exceeded 10mm, and most were covered in moss.

The conclusion from this survey indicates that the potential for roosting bats is minimal, given the size of the gaps are less than 10mm from the outside. Pipistrelle bats are found in Wokingham and the wider Berkshire area, and have been known on occasion to squeeze between gaps of 8-10mm, however this is not widely accepted as the case.

Due to the extremely low potential, I would recommend a single emergence survey prior to any works commencing. A precautionary method of works with a bat licenced ecologist present would be recommended for the initial tile strip (to be done by hand).

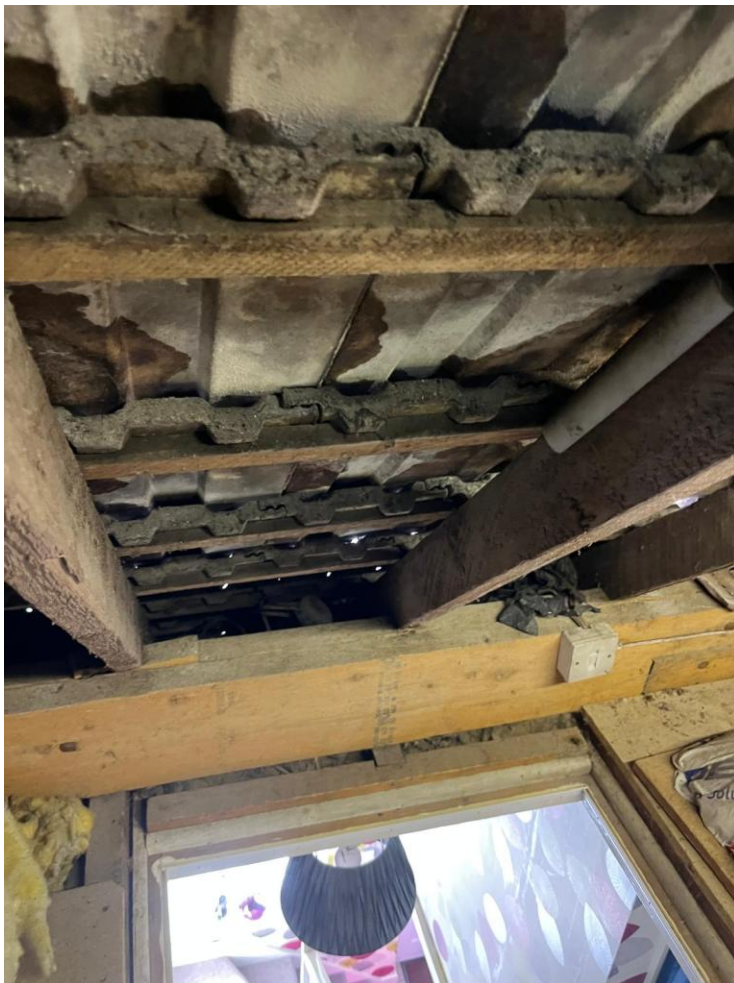
Then the loft area and behind the tiles were then inspected. The surveyor entered the loft space, where you can see behind the tiles and all of the batons. No guano or signs of roosting bats were found, however a large amount of light was entering through the tiles suggesting the gaps went all the way into the loft space and to the batons.
