Flood Risk Assessment

GTO House, Floral Mile, Hare Hatch

Ref: 10946B

Flood Risk Assessment: GTO House, Floral Mile, Hare Hatch

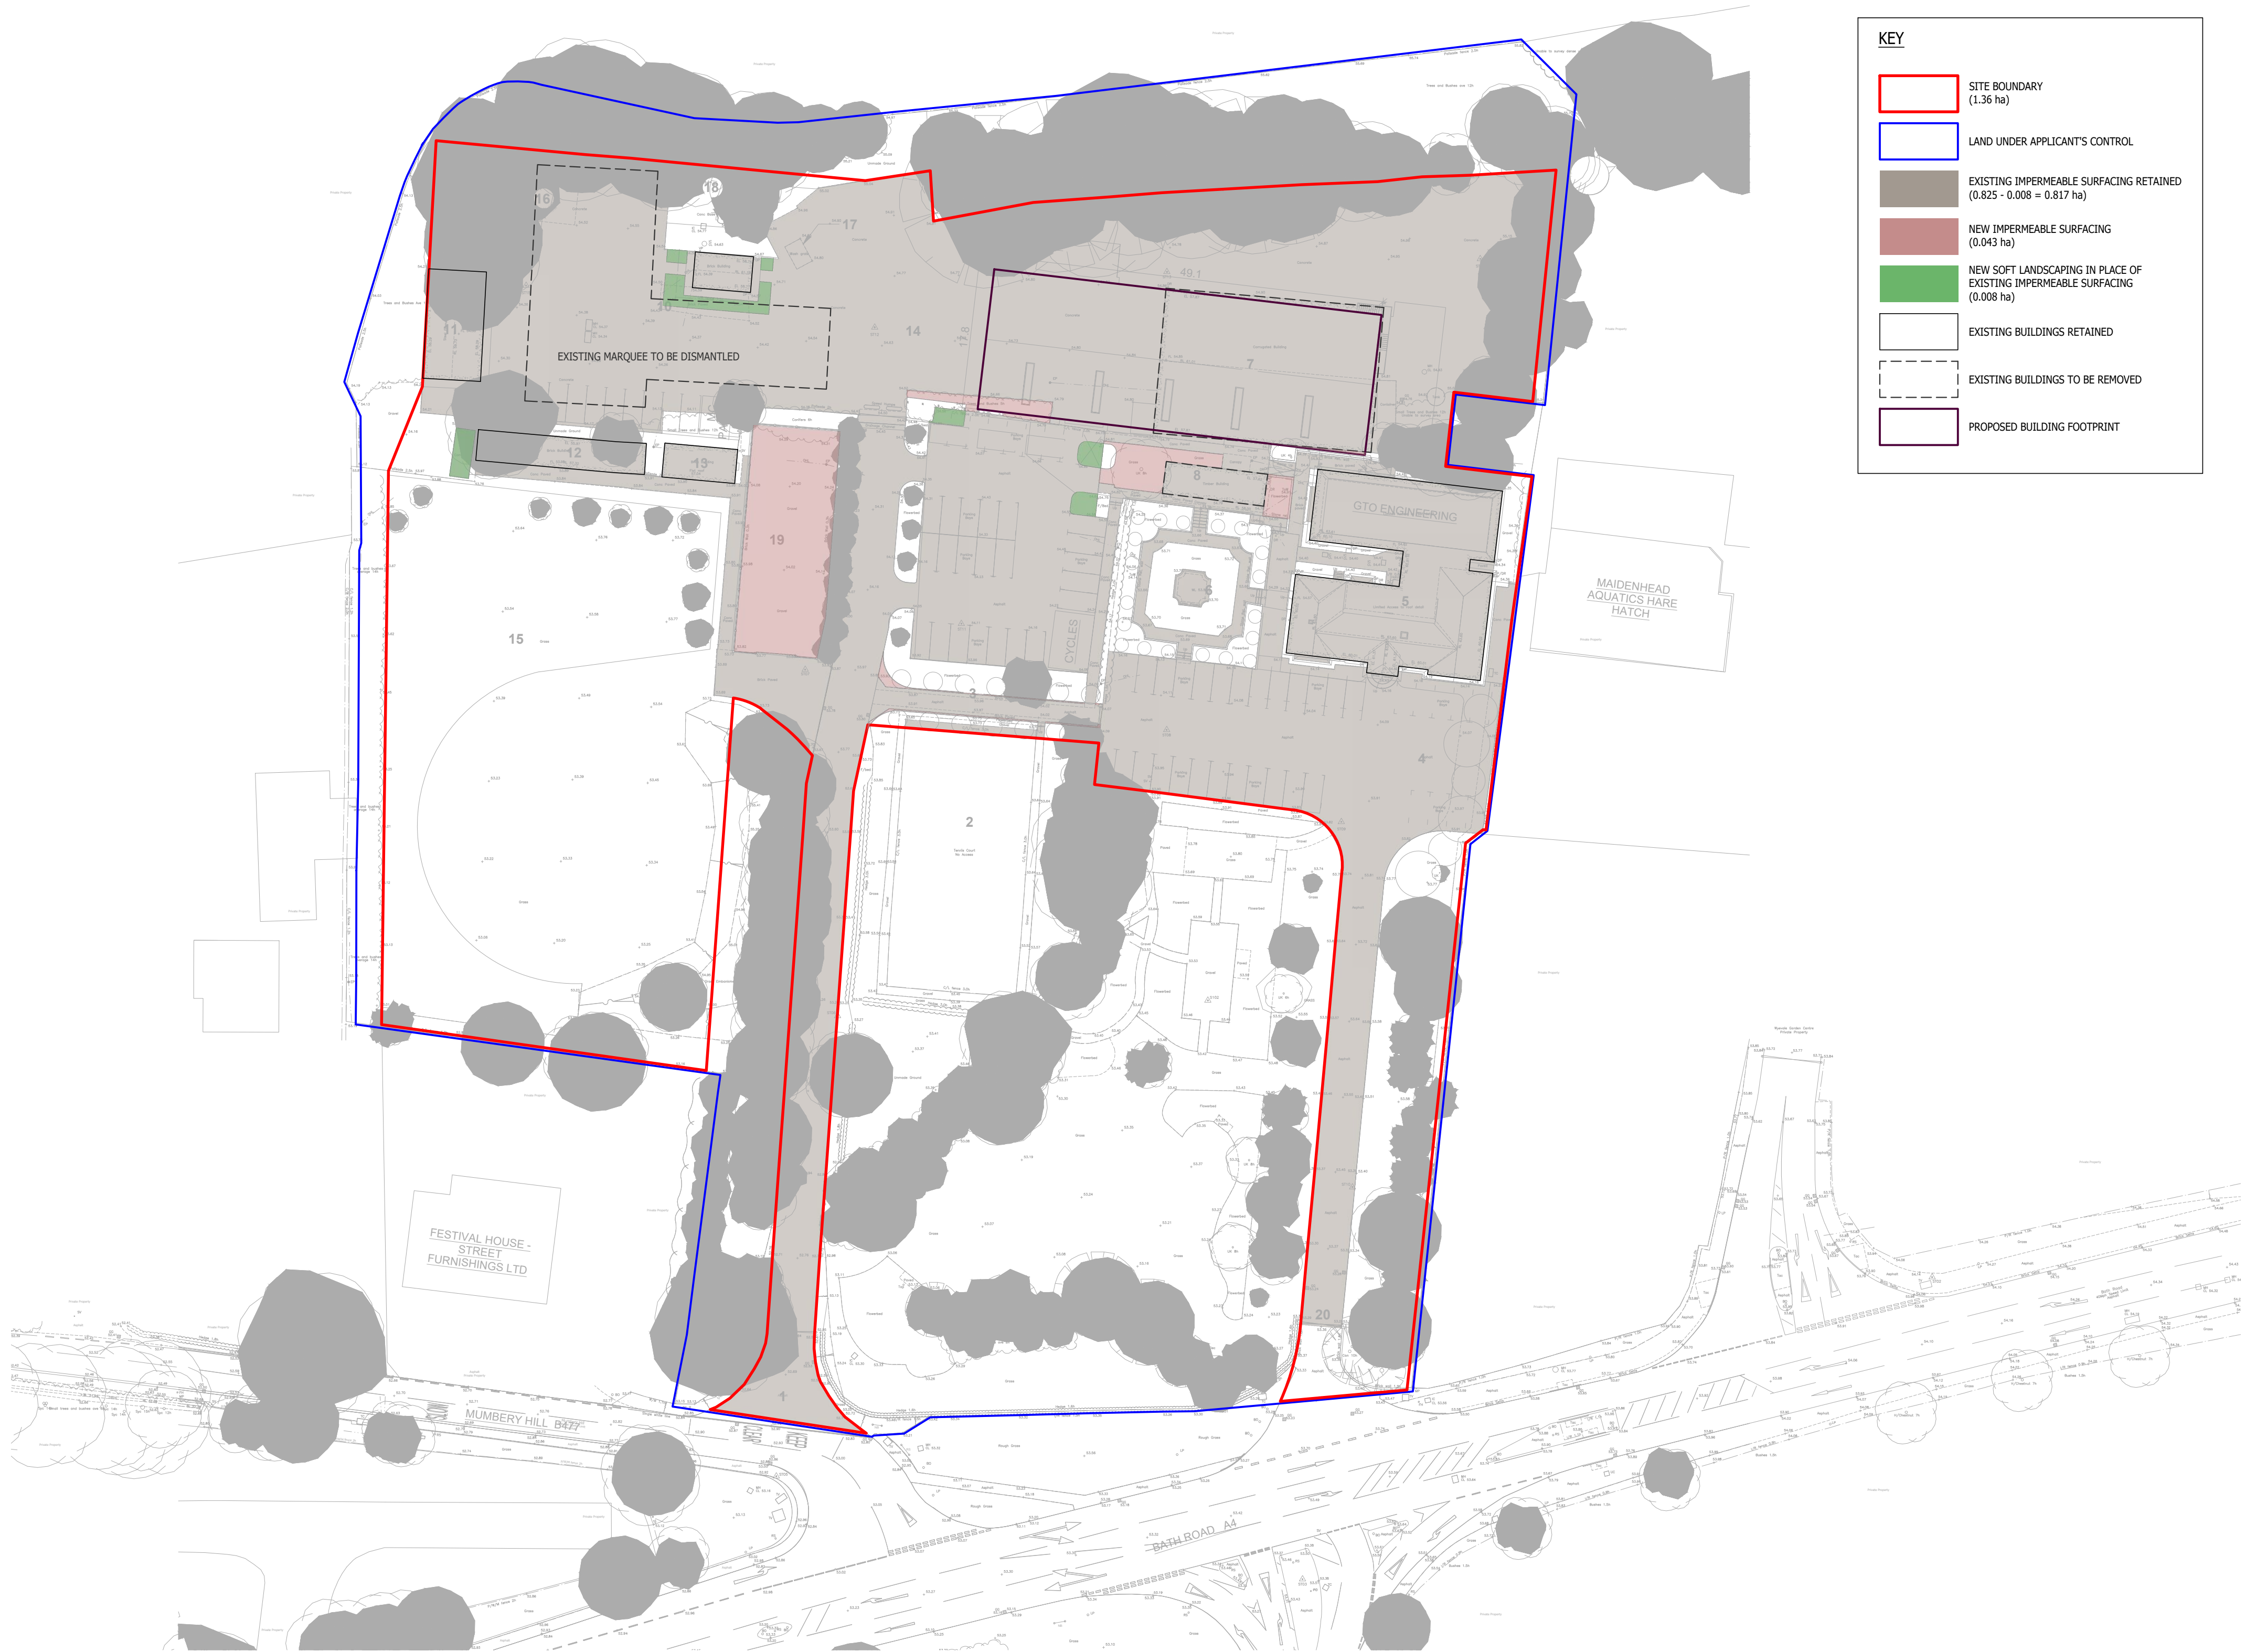
KEY	
<div></div>	SITE BOUNDARY (1.36 ha)
<div></div>	LAND UNDER APPLICANTS CONTROL
<div></div>	EXISTING IMPERMEABLE SURFACING RETAINED (0.825 - 0.008 = 0.817 ha)
<div></div>	NEW IMPERMEABLE SURFACING (0.043 ha)
<div></div>	NEW SOFT LANDSCAPING IN PLACE OF EXISTING IMPERMEABLE SURFACING (0.008 ha)
<div></div>	EXISTING BUILDINGS RETAINED
<div></div>	EXISTING BUILDINGS TO BE REMOVED
<div></div>	PROPOSED BUILDING FOOTPRINT
