# Bat Close-out Report

1<sup>st</sup> September 2025

## Roof Repairs

**Castlemans Cottage, Bath Road, Knowl Hill, Berks. RG10 9UT**

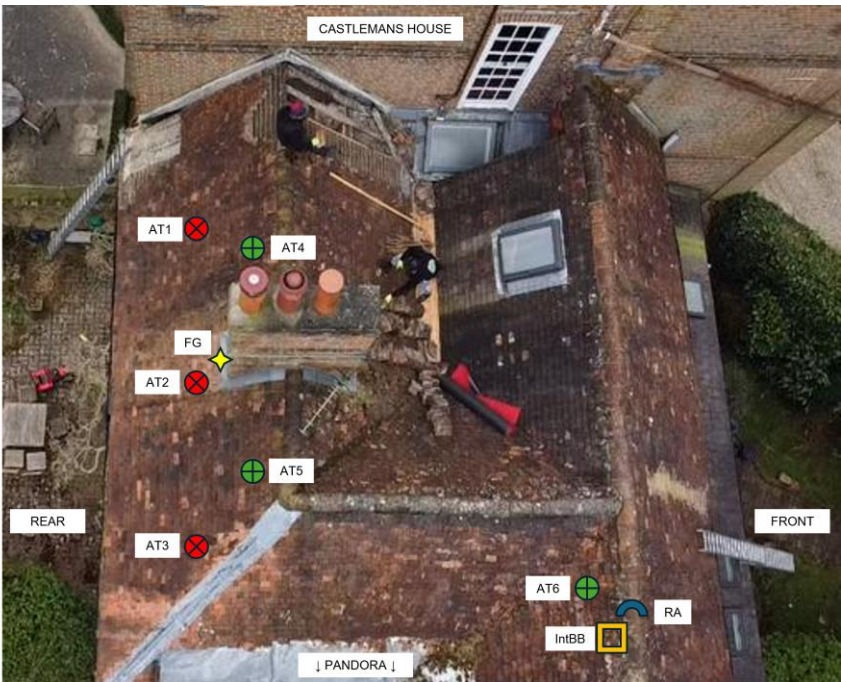
Figure 2 - Map of Bat Access Provisions

2.6.1. Figure 2 indicates the locations of each of the mitigation features on the roof. Bat access points have been positioned on the flanks facing southeast to take advantage of the sunnier aspects. There are no artificial light sources that will illuminate these locations. The rear garden is bordered by two prominent mature hedgerows which will aid navigation to the roosting sites.

ACCESS TILE (AT)  
WITH ACCESS THROUGH FELT  
(75mm X 30mm)
-

ACCESS TILE (AT)  
WITHOUT ACCESS THROUGH FELT
-

ACCESS POINT (FG)  
(FLASHING GAP 20mm X 30mm)
-

RIDGE ACCESS POINT (RA)  
(20mm X 100mm)
-

CREVICE-DWELLING MATERNITY  
BAT BOX WITHIN LOFT SPACE (IntBB)

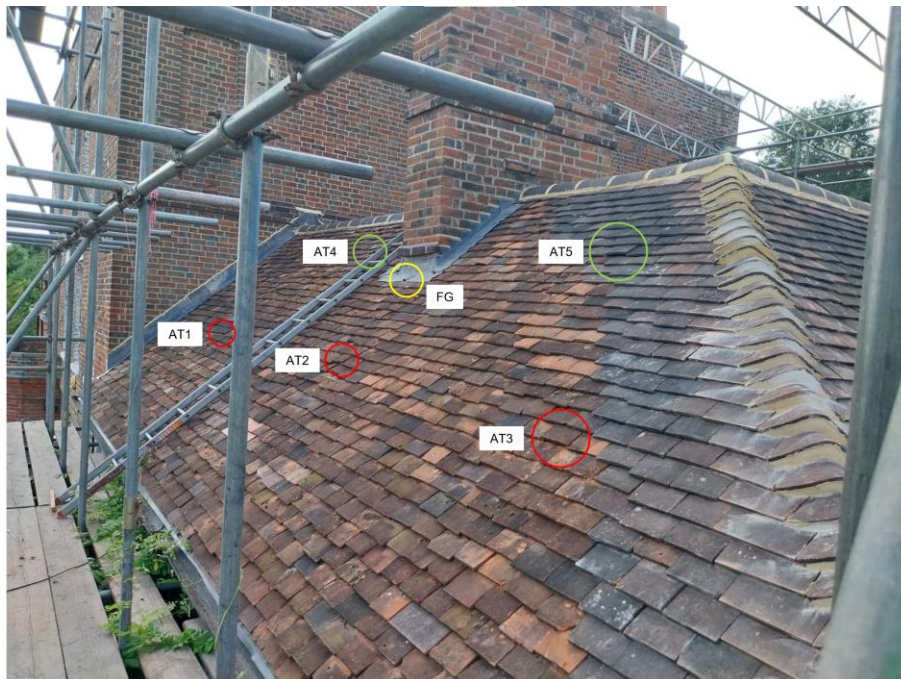
*Figure 3 - Bat Access Provisions on Rear Flank*

- i. 6x Bat Access Tiles – formed with tile fragments to raise roof tiles. Identified as ‘AT1’ to ‘AT6’ in the following figures. (3x without access hole (AT1 to AT3), and 3x with access hole through felt (AT4 to AT6)).
- ii. 1x Access point on Chimney Flashing (formed in lead flashing, 20mm high x 30mm wide). Identified as ‘FG’ in the following figures.
- iii. 1x Access point under ridge tiles (20mm high x 100mm wide). Identified as ‘RA’ in the following figures.
- iv. 1x Crevice-dwelling Maternity Bat Box installed in loft space (Supplier: nestbox.co.uk). Identified as ‘IntBB’ in the following figures.

- Wet ridge system has been installed. (No breathable membrane has been used.) See figures 3, 4, 6, 8 and 11.

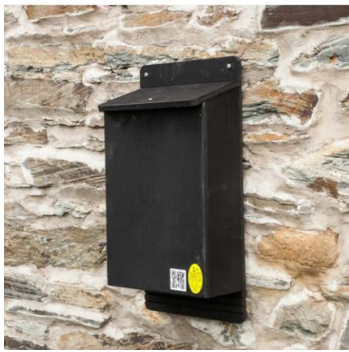
*Figure 10 - Specification of Crevice-dwelling Roost Maternity Bat Box (IntBB) from nestbox.co.uk*

- Designed for larger roosts or maternity colonies of crevice dwelling bats especially pipistrelles.
- External surfaces black to increase heat absorption.
- Internal ceramic heat sinks to retain and stabilise box temperature.
- Grooved landing ladder continues internally.
- Precision cut FSC certified panels for dry, draught free, long-lasting box.

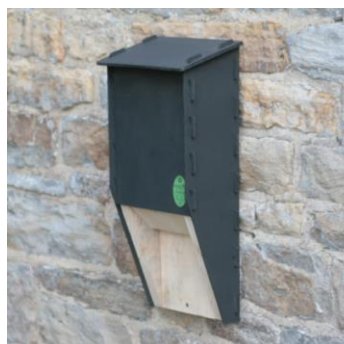
Figure 16 - Specification of external bat box from nestbox.co.uk

- Recycled plastic weatherproof shell to provide long lasting protection.
- UK grown, locally sourced FSC wooden internal roost chamber to create attractive roosting space for bats.
- Available with two different roost chambers designed for either crevice or cavity roosting bats.
- Self-cleaning design requires no maintenance.
- Improved updated design for 2023
