227A Nine Mile Ride  
Finchampstead  
Wokingham  
Berkshire  
RG40 3QA

## Preliminary Roost Assessment

Report ref.: R2931\_PRA\_a

**May 2025**

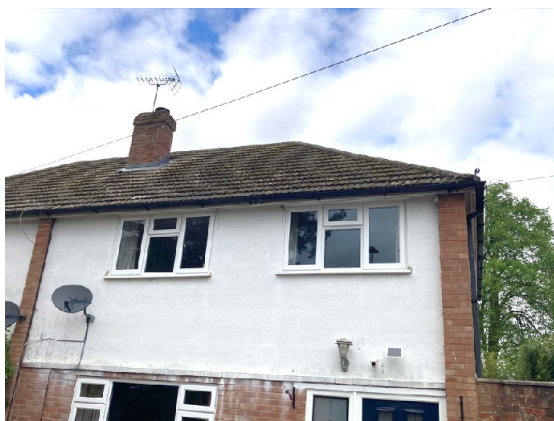
5.2.2 The semi-detached two-storey house had an existing single-storey rear extension to form a conservatory. There was a single storey detached garage to the east of the building (**Photographs 1 & 2**).

Photograph 1. Front elevation, viewed from the front.

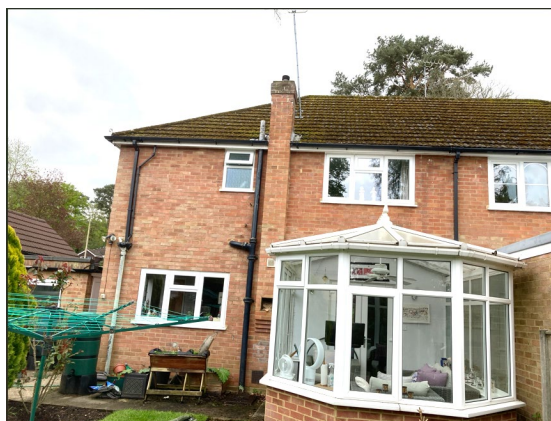
Photograph 2. Rear elevation, viewed from the rear.

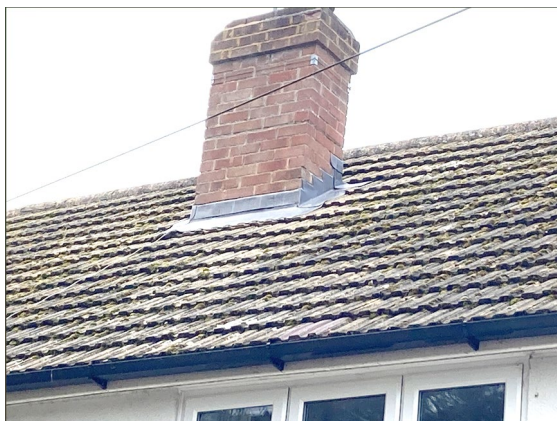
5.2.3 The house's pitched roof was covered by interlocking concrete tiles that were in place and tightly interlocking (**Photograph 2 & 3**). The mortar along the ridge and hip was intact (**Photographs 4**).

*Photograph 3. Tight fitting interlocking concrete tiles (Front elevation)*

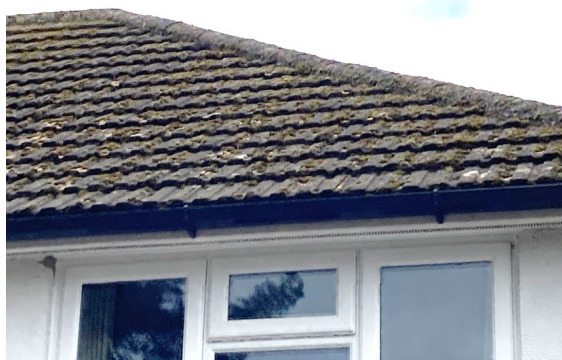
*Photograph 4. Ridge and hip mortar fully intact (front elevation).*

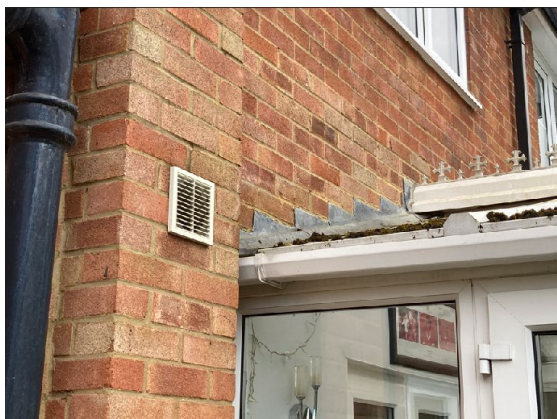
- 5.2.4** The lead flashing at the junction of the conservatory and house on the rear elevation was fitted tightly, and whilst the lead flashing was well fitted around the western chimney, there were slight gaps around the margin but these were of limited extent (**Photographs 5 & 6**).

*Photograph 5. Lead flashing sealed to the brickwork wall (rear elevation).*

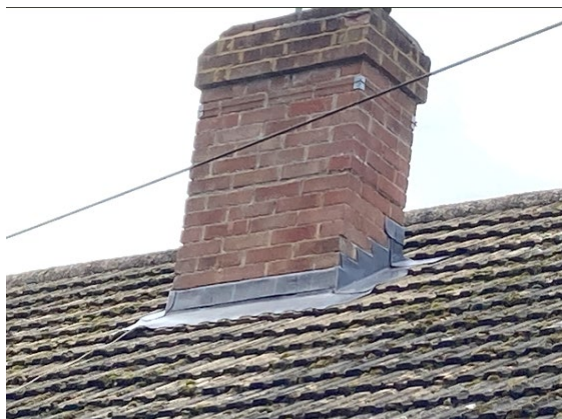
*Photograph 6. Lead flashing well fitted but slightly raised around western chimney (front elevation).*

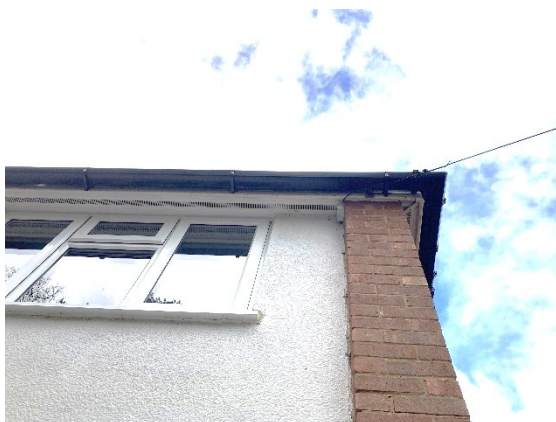
- 5.2.5** The vented uPVC soffits on all three sides of the house were fully sealed to the walls (**Photographs 7 & 8**).

*Photograph 7. Vented uPVC soffit tightly fit against the brickwork (front elevation).*

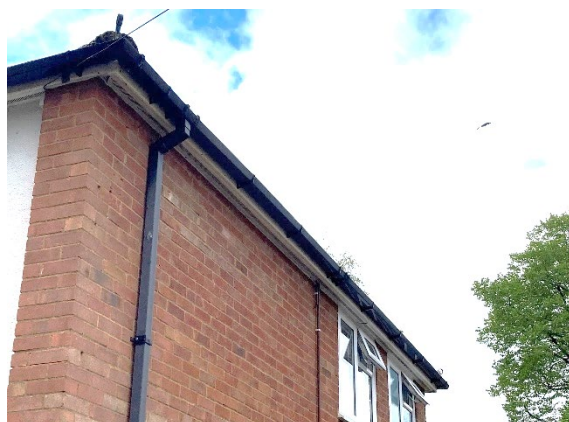
*Photograph 8. uPVC soffit sealed to the brickwork wall (corner of eastern side and rear elevation).*

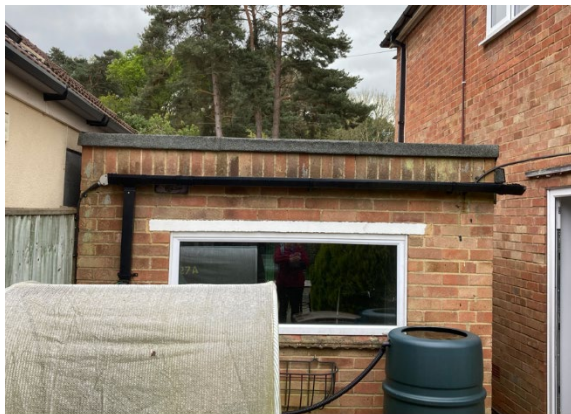
- 5.2.6** The garage had a timber lined, flat roof covered with bitumen felt (**Photographs 9 & 10**). There was an opening between the flat roof and brickwork (**Photograph 11; Target Note 1**); however, this low suitability feature when closely investigated with a high powered torch of showed no evidence of use by bats. The garage had tightly fitted barge boards (**Photograph 12**).

*Photograph 9. Timber constructed roof with bitumen roofing felt (rear elevation)*

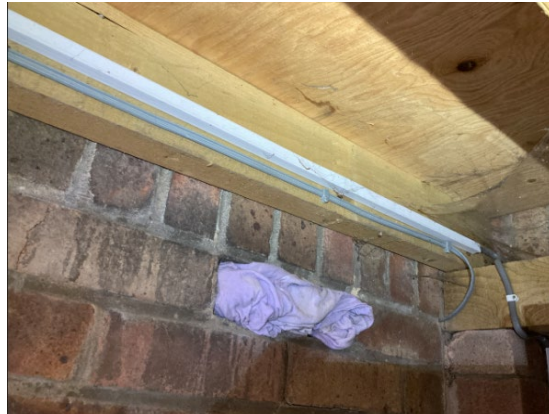
*Photograph 10. Tightly fitted timber lining within the garage (eastern elevation).*

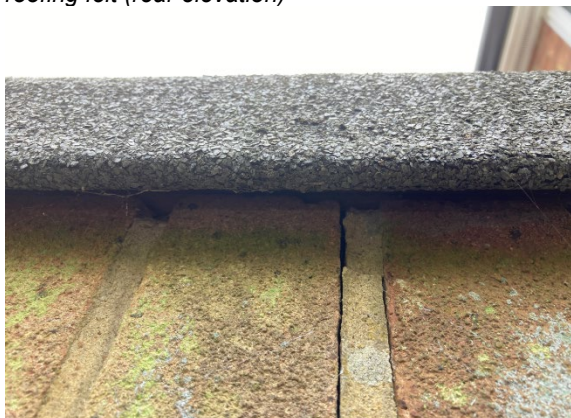
*Photograph 11. Gap between flat roof and garage wall*

- 6.1.1 The detached property had the following suitable/potential bat access points and roost features:
- Opening between roof and brickwork on the garage (**Photograph 11; Target note 1**);

- 6.1.3 The gap between the flat roof and brickwork on the garage roof was a feature of low suitability (see **Appendix 1** for potential suitability categories) for crevice dwelling bats, such as the locally recorded common pipistrelle (*Pipistrellus pipistrellus*) and soprano pipistrelle (*Pipistrellus pygmaeus*); however, during a close inspection it is of limited extent and showed no evidence of use, and as such is considered unlikely to support roosting bats.

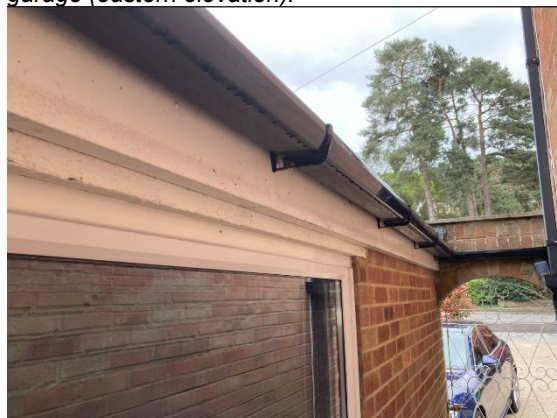
*Photograph 12. Tightly fitted timber barge boards*

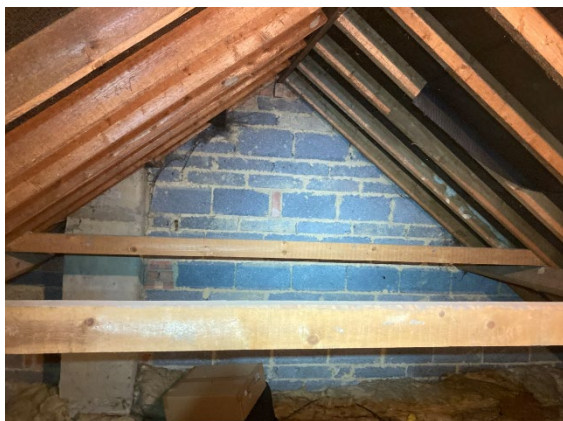
- 5.2.7** The building had one roof void that covered its second-storey footprint and was accessible via a first-floor loft hatch. The void was of 'cut and pitch' construction with a ridge beam, rafters and supporting trusses, and had an approximate floor-to-ridge height of 2.5 metres (**Photograph 13**).

*Photograph 13. Roof void showing 'cut and pitch' construction.*

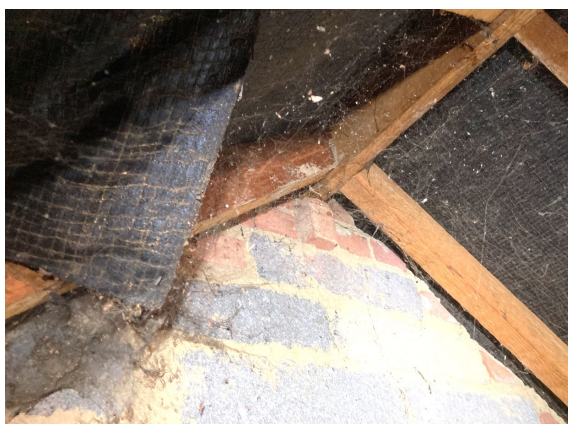
- 5.2.8** The roof was lined by a hessian-reinforced bitumen felt. It was mostly intact with occasional tears and was loosely fitting in places (**Photograph 14 & 15; Target note 2**). The floor was partly boarded and partly insulated with fibreglass, which mostly filled the eaves (**Photograph 16**).

*Photograph 14. Loosely fitted bitumen felt (western elevation)*

- Torn and loose fitting bitumen felt roof lining (**Photograph 14 & 15; Target note 2**); and
  - Gap along the edge of the blockwork party wall (**Photographs 17 & 18; Target notes 3**).

- 6.1.2 No droppings were observed within the house's roof void of the building, which had features such as loose felt that could allow bats in, therefore it is unlikely to support principally void dwelling species, such as the locally recorded brown long-eared (*Plecotus auritus*).

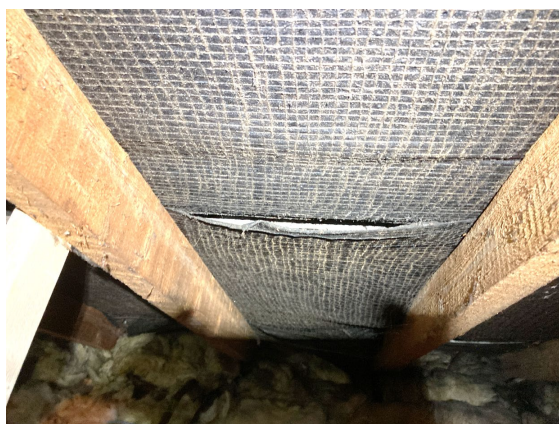
*Photograph 15. Loosely fitted bitumen felt (eastern elevation)*

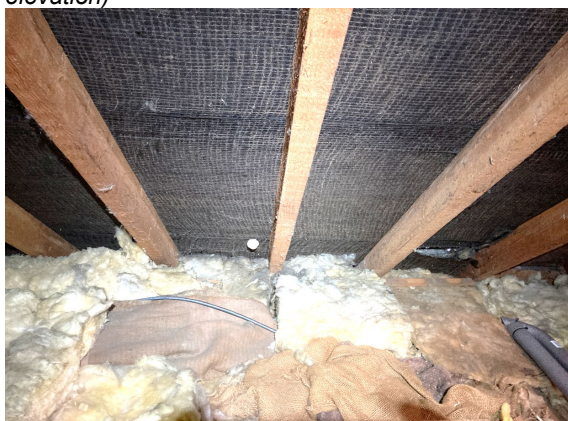
*Photograph 16. Fibreglass filled eaves and torn bitumen felt*

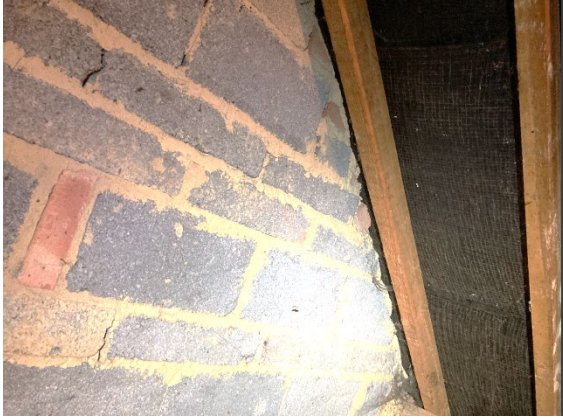
- 5.2.9** There was a small gap between the blockwork and the felt on the party wall and some missing blockwork, which had been filled with fibreglass (**Photographs 17 & 18; Target notes 3**). The western chimney was cement covered, tightly fitted and highly cobwebbed (**Photograph 19**).

*Photograph 17. Cobwebbed gap along the edge of the western blockwork party wall.*

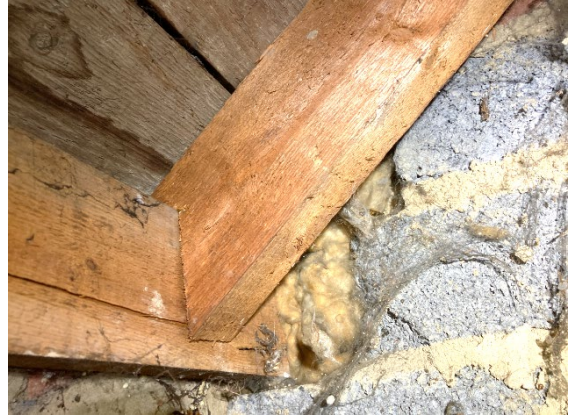
*Photograph 18. Gaps in blockwork, filled with fibreglass insulation on the party wall.*

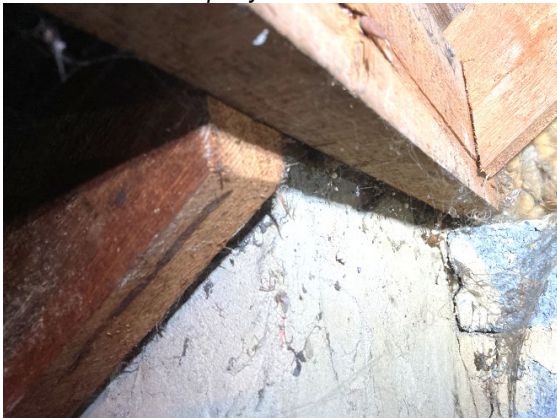
*Photograph 19. Tightly fitted cemented chimney with cobwebs (western elevation)*
