Client  
TAYLOR WIMPEY WEST LONDON

Project  
PHASE 1, LAND OFF WATMORE LANE,  
WINNERSH

Title  
TREE PROTECTION PLAN

Drawing Number  
1894-KC-PH1-YTREE-TPP02RevA

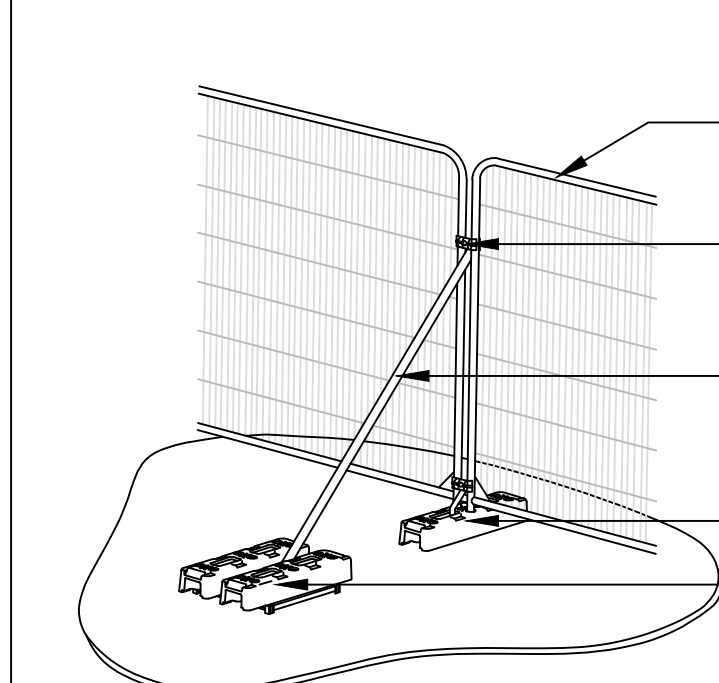
Figure 1: Example of a protective barrier

- Steel mesh panel
- Connectors fitted to secure panels
- Diagonal strut
- Block feet to avoid driven scaffold poles
- Block tray weighted with blocks

- Existing ground
- Geotextile membrane e.g. Terram 1000 or similar
- Compression-resistant layer (e.g. 100mm depth of woodchip)
- Robust sheets (timber, steel, recycled plastic) overlying Terram 1000 or similar
- 2.0m high barrier as detail in Figure 1 (Temporary, for the duration of works)

- KEY
- Existing site features
  - Proposed layout
  - Trees retained (Green-coloured line indicates extent of canopy)
  - Trees for removal (Red-coloured dash line indicates extent of canopy)
  - 2.0m high barrier as detail in Figure 1 (Temporary, for the duration of works)
  - Area of ground protection as detail in Figure 2
  - Tree Preservation Order (TPO) woodland
  - Tree Preservation Order (TPO) area
  - Tree Preservation Order (TPO) group
  - Veteran trees
  - Natural England's recommended 15m stem diameter buffer
  - Minimum intervention zone to allow area around 'veteran' tree to naturalise
  - Ancient and Semi-Natural Woodland
  - 15m buffer to Ancient Woodland
