**Arboricultural Implications  
Assessment  
for a proposed development  
at  
Meadowside  
83 London Road  
Twyford  
RG10 9EL  
Rev A**

**Client: Emma McCormack  
Meadowside  
83 London Road  
Twyford  
RG10 9EL**

**Date**  
16/01/2026

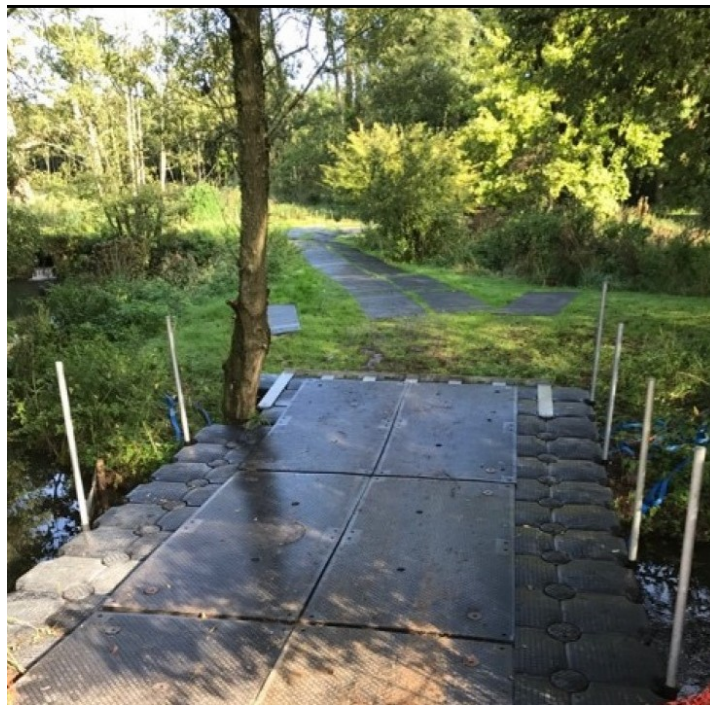
Fig. 3 Ground Guards – MultiMatts Euro Trak is ideal for the ground protection required here.

- 3.4.3 The tree protection plan – (appendix 1) shows the position of the ground protection measures do be put into place prior to any other works taking place on site.
- 3.4.4 The areas illustrated will be covered by ground protection matting (such as Ground Guards – MultiMatts Euro Trak), suited to supporting the weight of construction traffic (recommended load bearing 5t – maximum 10t).
- 3.4.5 The separate mats are joined together using joiner kits to lock the panels together and will be reinforced using a layer of woodchips to provide cushioning under the mats themselves (see AMS).

The installation of ground protection is addressed by the Arboricultural Method Statement at section 3.3
