## HERITAGE STATEMENT

**Document No: 1312-HR-A-HS-XX-01**  
**Rev 01**

- 1.1 This Heritage Statement is submitted as part of the Listed Building application for a proposed log burner to 'Peacocks', School Road, Hurst. The document is written to assist greater understanding of the impact of the proposals upon the historic significance of the listed building.

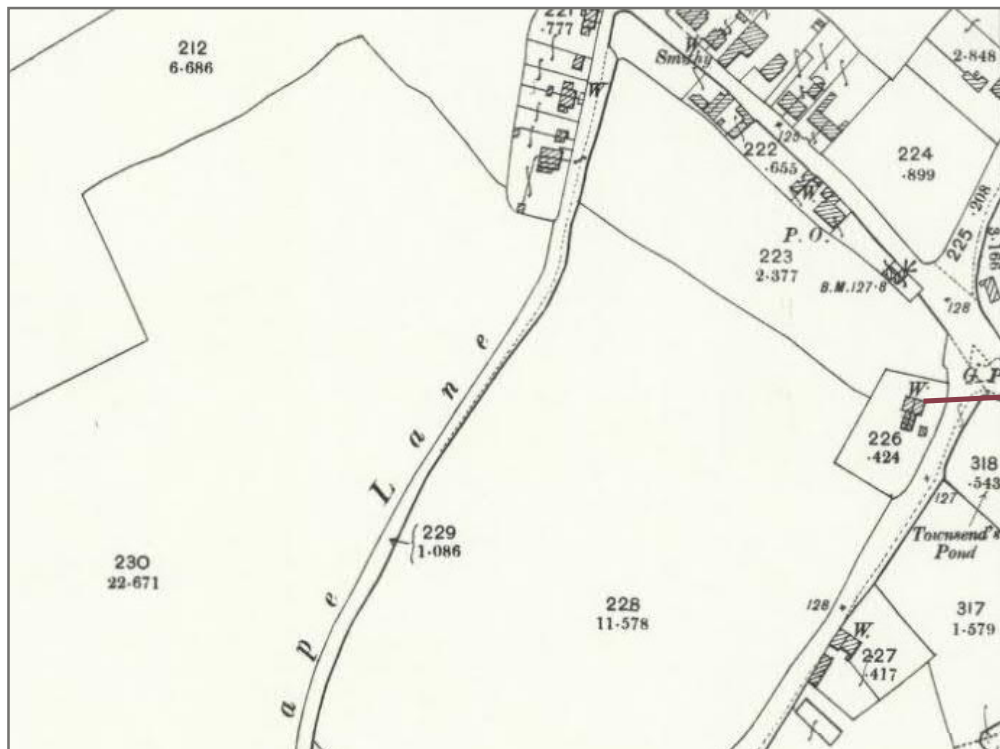
Image 1: Extract from Ordnance Survey map of 1899, surveyed 1898, (Berkshire XXXV111.2, National Library of Scotland, 2024).

Peacocks - indicated to be two residences

Addition of modern light weight timber framed extension to form Utility/WC function. Central stairs possibly added in early C20 as OS map indicates property as two cottages in 1898 (refer to Image 1).

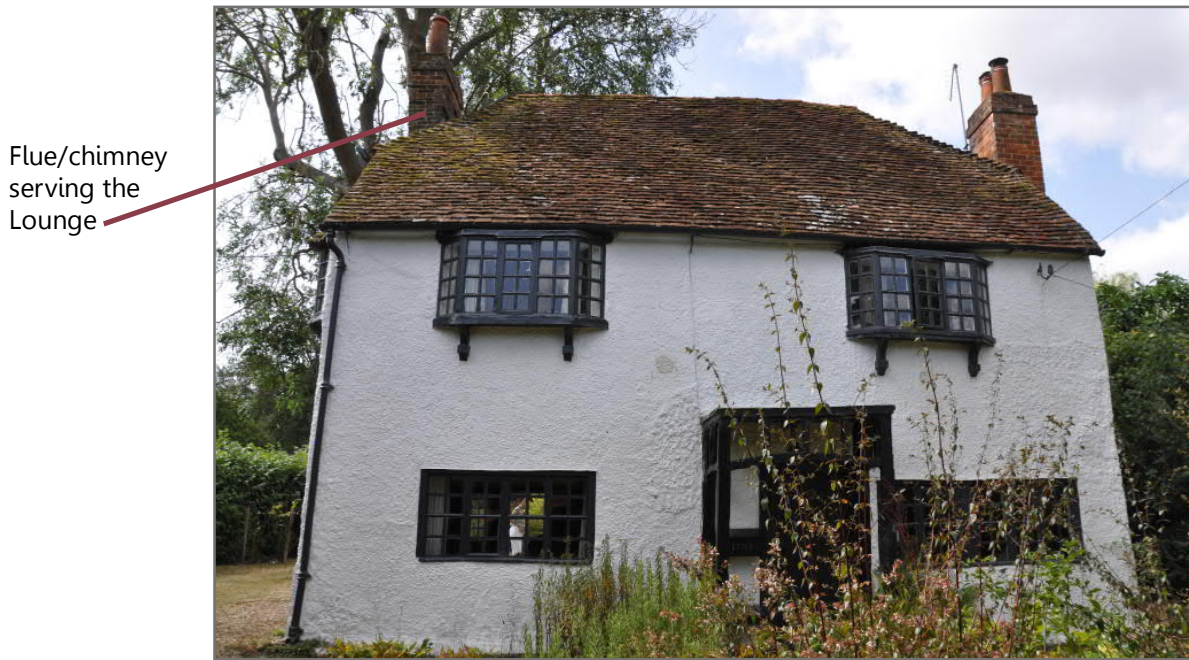
Image 2: East elevation (Phase 1 construction)

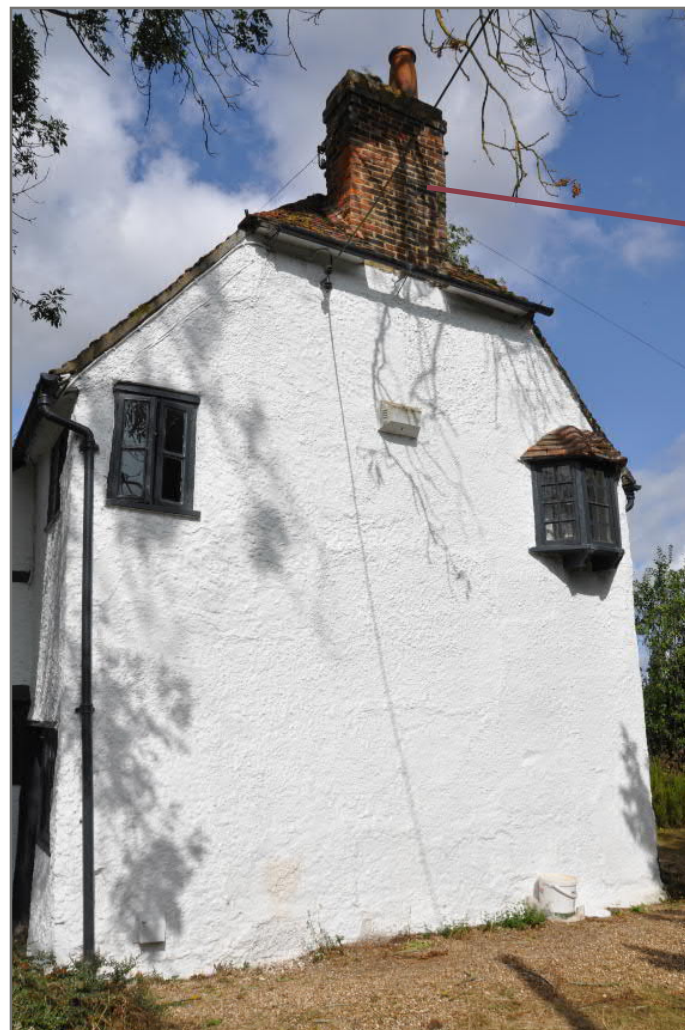
Image 3: South elevation (Phase 1 construction)

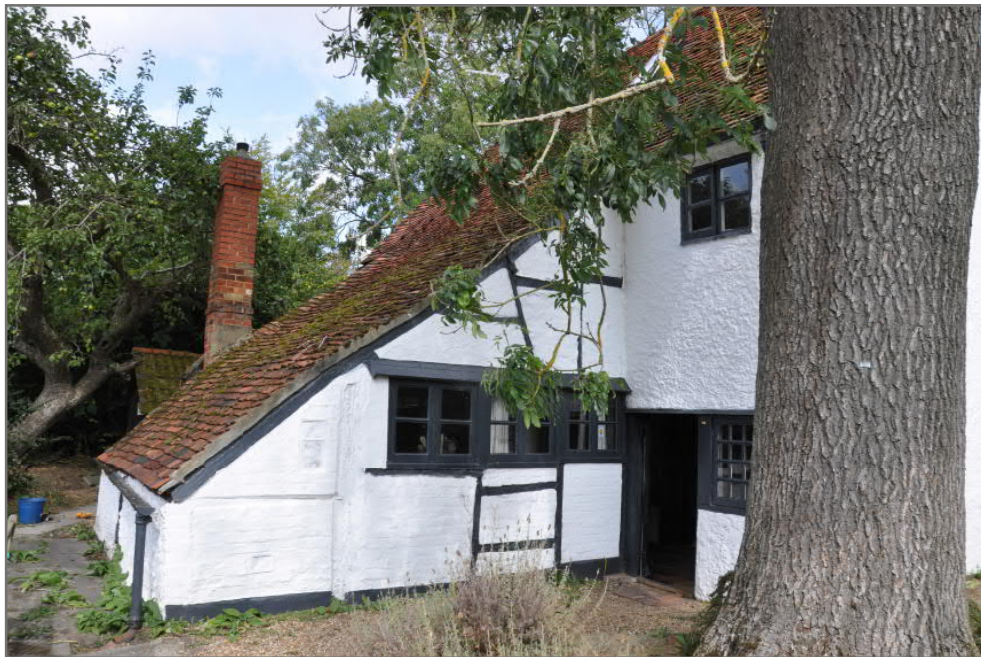
Image 4: South elevation of outshut and catslide roof (Phase 2 construction)

Possible era when catside outshut was added, possibly in two phases, or reconstructed.

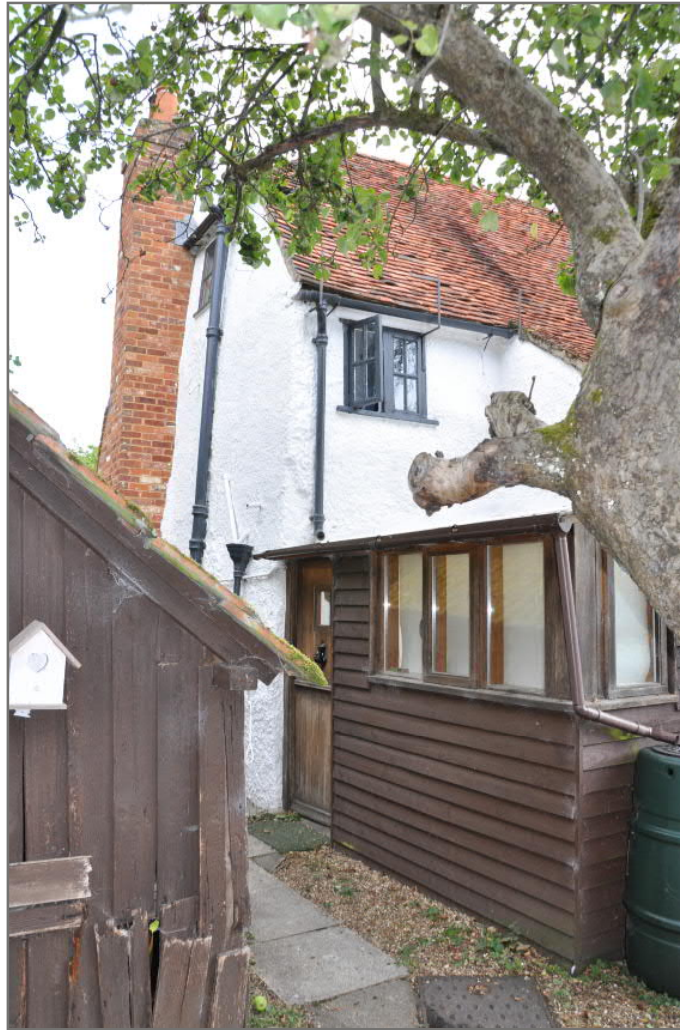
Image 6: View of north west corner - modern extension

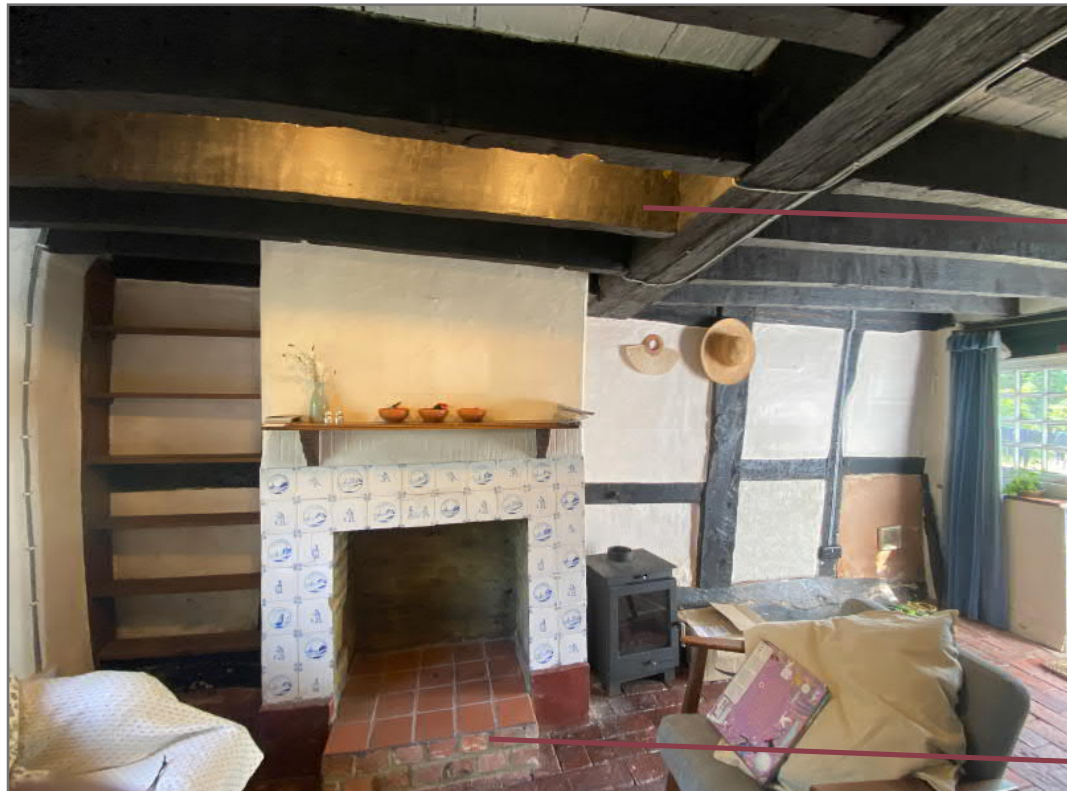
Carpenters' marks visible to each joist

Modern brick plinth

Image 7: View of existing south fireplace in Lounge

- The original timber frame, evident in the Lounge, Dining Room and First Floor is of architectural interest
- The complete set of carpenters' marks to both the Lounge and Dining Room are of architectural interest.

The previous gas fire had been identified in a pre-purchase survey of the property to not meet safety guidelines (refer to Image 8). This has been removed and has therefore removed the inherent fire risk associated with the fitting. The current modern brick hearth is insufficient in size to provide the requisite fire retardant surround to a source of solid heating ie: 300mm in front of the log burner and 150mm to each side of the log burner.

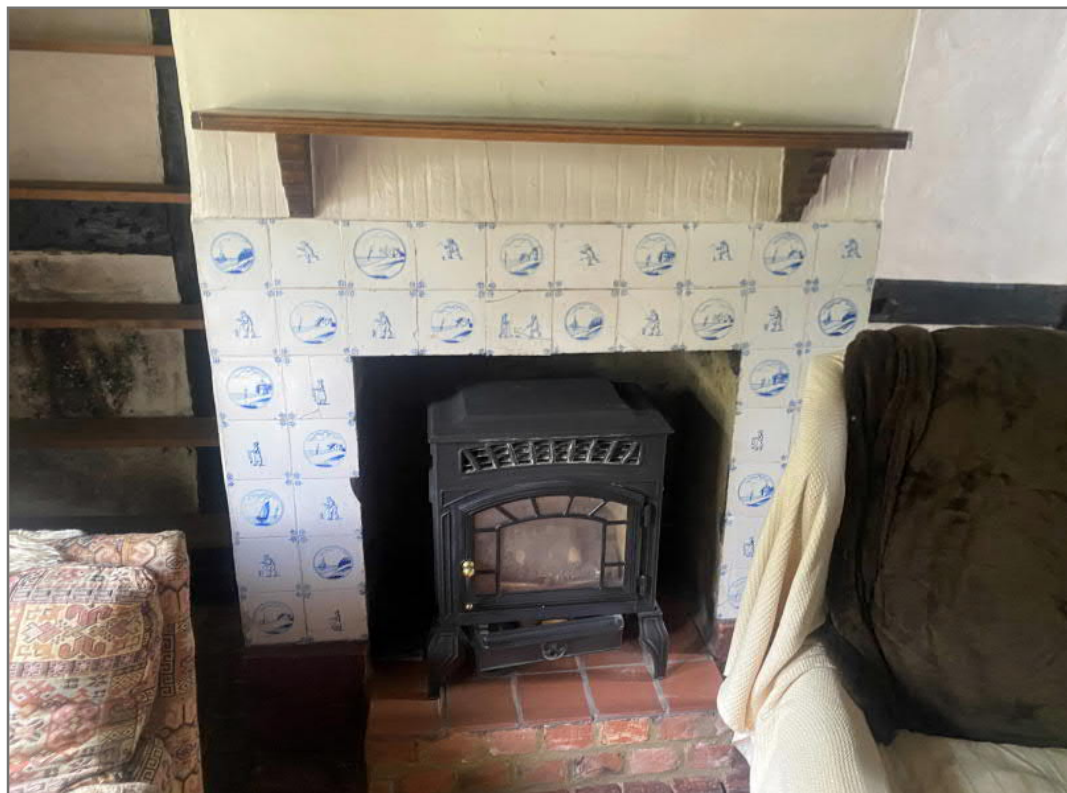
Image 8: View of previous gas stove removed in August 2024 after found unsafe

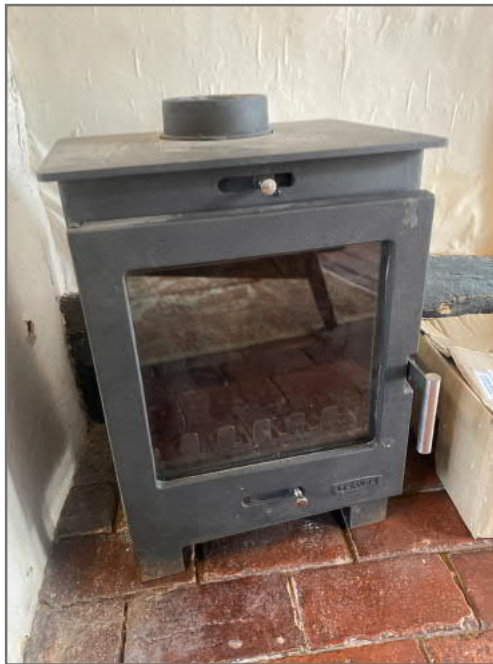
Image 10: Proposed log burner

Together with the Aga in the kitchen, the property relies upon this source of heating in the Lounge to heat the whole property as central heating is not installed. A log burner is proposed to be installed as a replacement - refer to Image 10 - and the existing brick hearth is proposed to be removed and replaced with two flagstones - refer to Image 11 - to provide the requisite fire retardant zone, to be placed upon the non-combustible sub-floor.

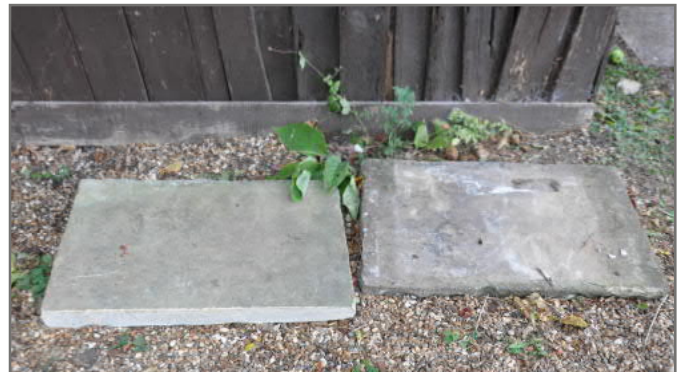
Image 11: Proposed stone to form hearth

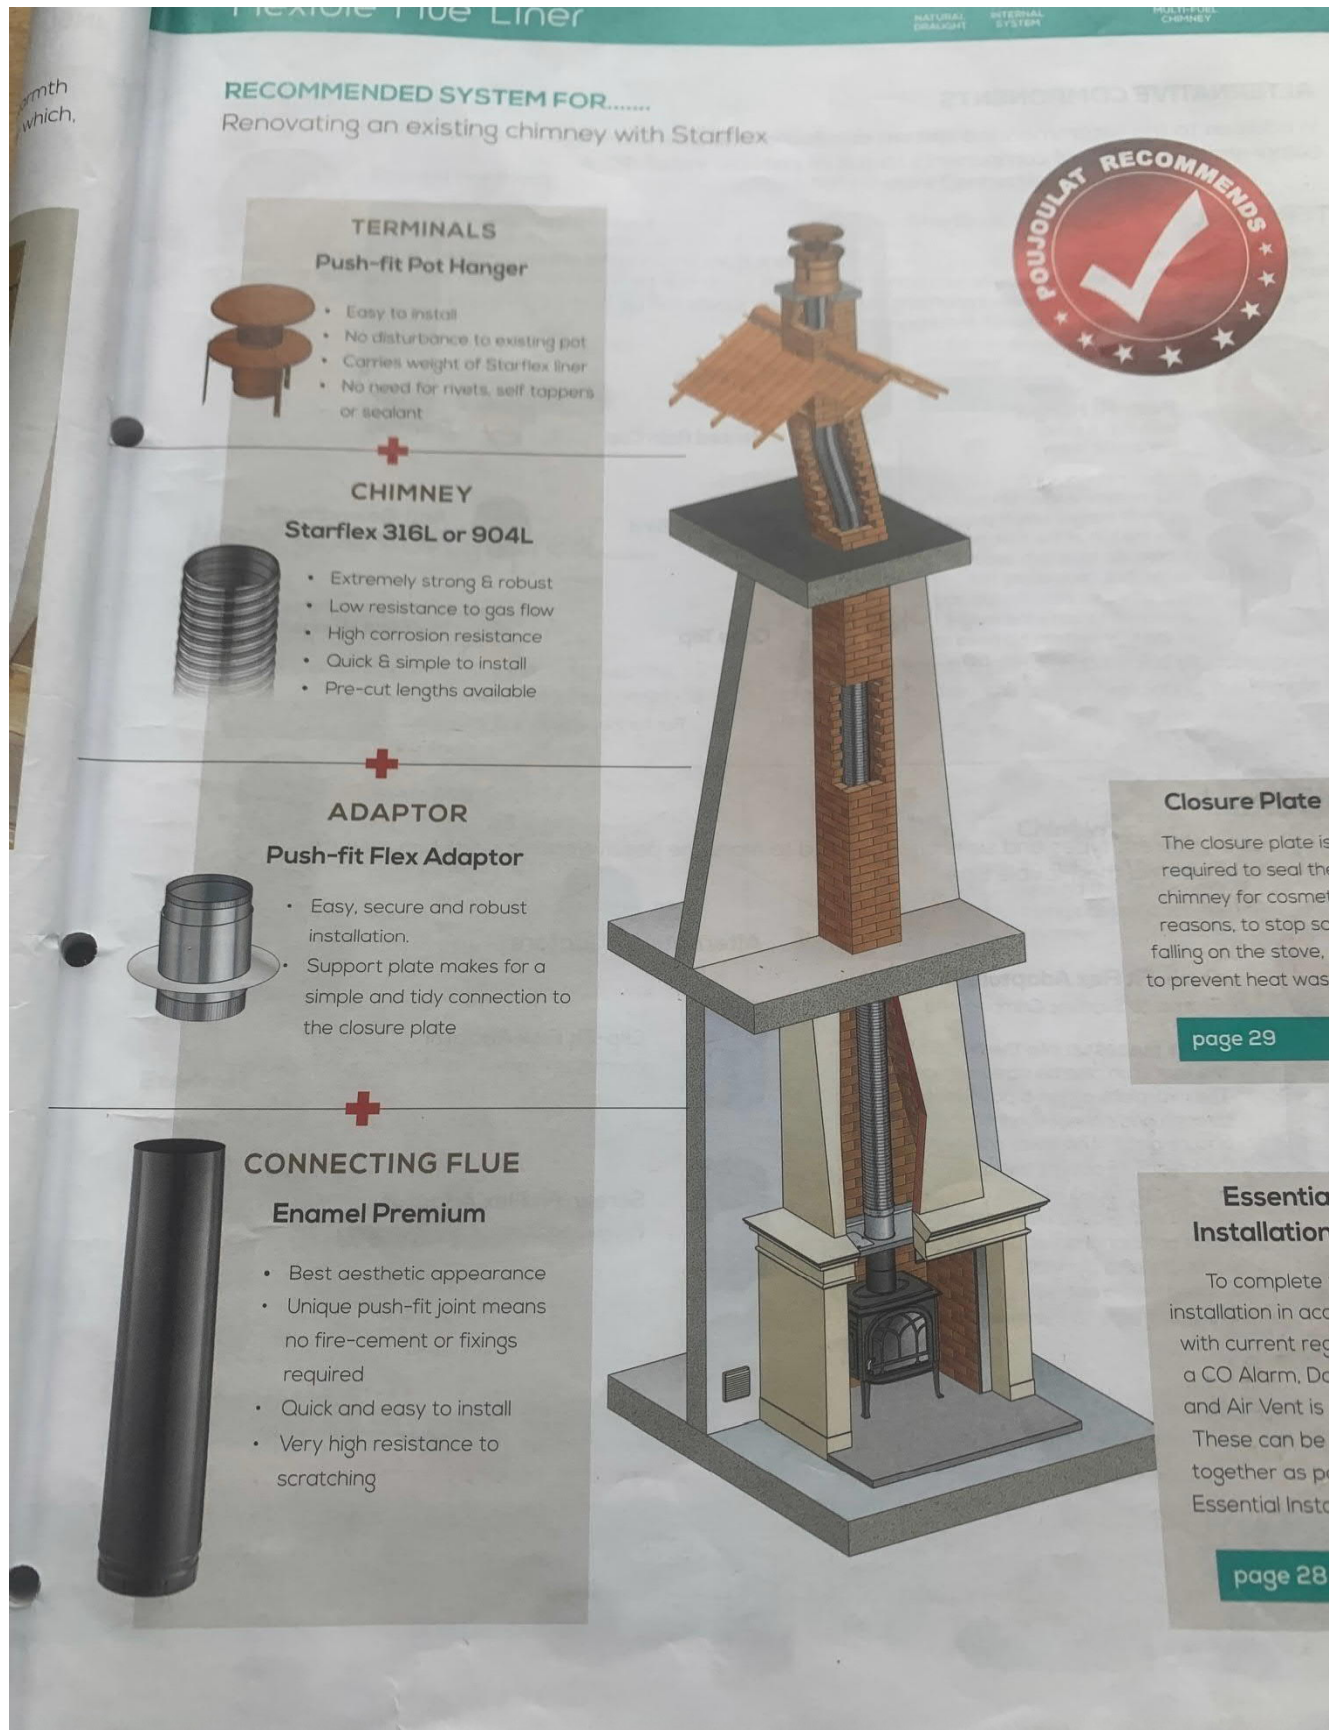
Image 13: Image of proposed installation

The method statement for its installation is to install a 316 grade stainless steel flue liner with a terracotta painted cowl which is clipped to the liner; no mechanical fixings are proposed to be used to fix the liner to the existing flue. The flue liner does not require to be back-filled, for example, vermiculite is not proposed to be installed as it has potential to trap moisture within the flue, and to hold the vermiculite in place the front of the hearth would require to be opened up above the register and would require the masonry to be deconstructed and reconstructed which is unnecessary and would disturb the original fabric. Refer to the Appendix for detail of the proposed installation.

- Install wood burner to provide adequate heating
- Erect scaffold tower to safe working height next to chimney (no fixings to the building to be used)
- Inspect and sweep existing chimney/flue (certificate provided)
- Install 316 stainless steel liner using support cowl (no mechanical fixings to building are used to install the liner or cowl)
- Install closure plate as per HETAS guidelines
- Remove existing hearth (this has been installed in recent years by another party and unfortunately it does not meet HETAS requirements)
- Install superimposed hearth (stone supplied by customer) this is not fixed to the floor.
- Install wood burner as per install instructions
- Install Co alarm
- Test heating appliance as per HETAS requirements
- Register appliance with HETAS
