10 Danywern Drive  
Winnersh  
Wokingham  
Berkshire  
RG41 5NR

# Preliminary Roost Assessment

Report ref.: R2632\_PRA\_a

March 2024

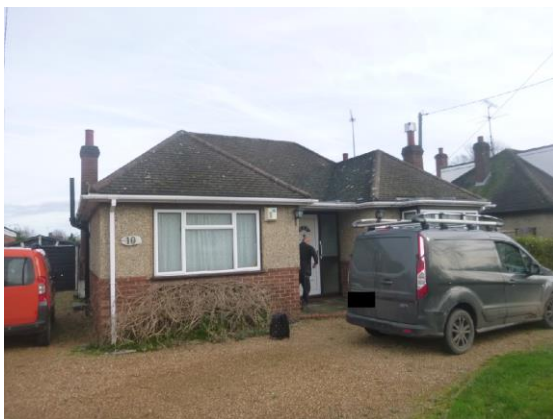
- 5.2.2** The detached bungalow had a hipped roof with a flat roof section over the front porch and glass-roofed conservatory at the rear (**Photographs 1 & 2**).

*Photograph 1. Front of property viewed from southwest.*

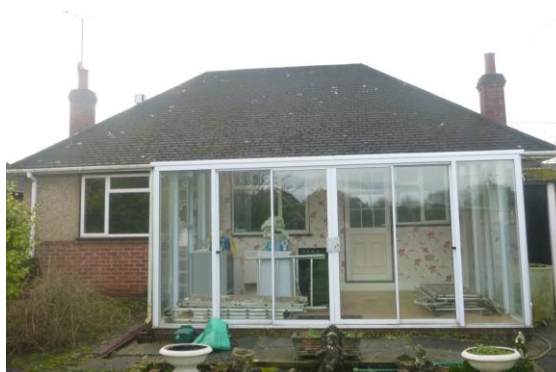
*Photograph 2. Rear of property viewed from northeast.*

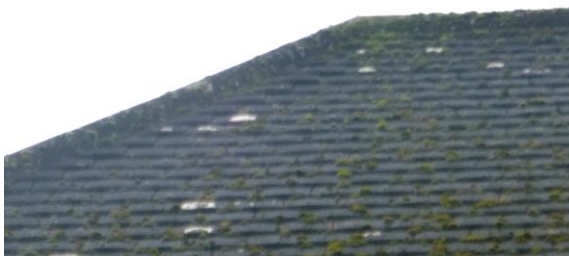
- 5.2.3** The hipped roof was covered in clay tiles that were mostly flat and intact other than occasional lifted tiles along the hip on the rear elevation and southwest elevation (**Photograph 3; Target note 1**). The ridge and hip mortar was intact on all elevations (**Photograph 4**).

*Photograph 3. Lifted clay roof tiles along the hips (rear elevation).*

- Lifted clay roof tiles along the rear hips of the property (**Target note 1**); and
- A gap between the uPVC soffit and brickwork on the front elevation (**Target note 2**).

- 8.1.1** Further survey is recommended to determine the presence or likely absence of bat roosts in the property, in order to be able to assess fully whether the development proposals will have an adverse effect on bats.

- 8.1.2** A minimum of one dusk emergence survey visit should be undertaken in the period of May to August. This survey visit will form the roost characterisation necessary to inform an impact assessment and mitigation strategy.

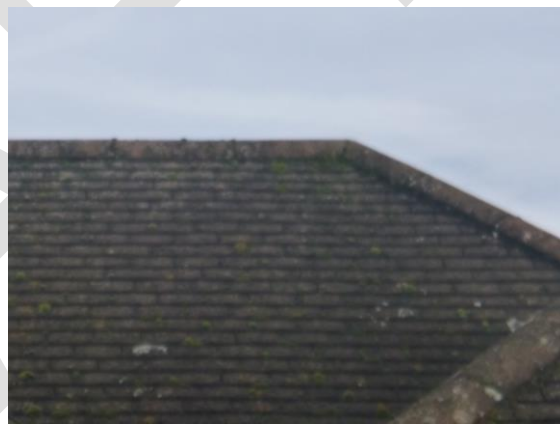
*Photograph 4. Ridge and hip mortar fully intact (front elevation).*

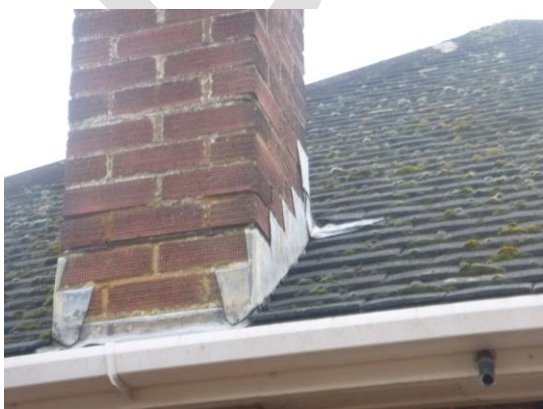
- 5.2.4** The lead flashing situated at the base of the chimneys was sealed to the clay roof tiles and brickwork (**Photographs 5 & 6**). The roof tiles were cut behind the western chimney and the gaps were closely inspected and confirmed to be superficial (**Photograph 7**).

*Photograph 5. Lead flashing sealed to brickwork and roof tiles (northwest elevation).*

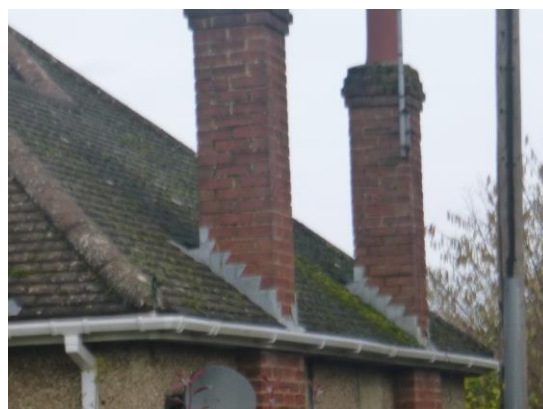
*Photograph 6. Lead flashing sealed to brickwork and roof tiles (southeast elevation).*

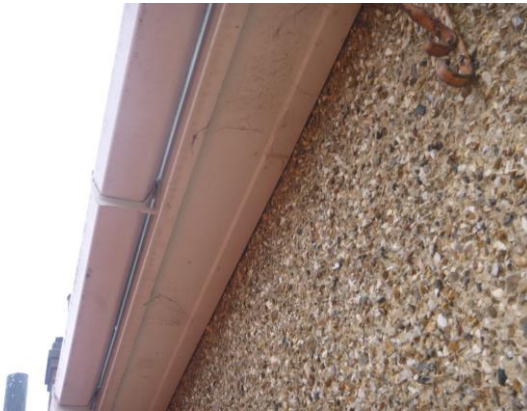
- 5.2.5** The uPVC soffit was sealed to the wall of the property, with a gap situated between the soffit and wall on the front elevation (**Photographs 8 & 9; Target note 2**).

*Photograph 8. uPVC soffit sealed to the rendered wall (northwest elevation).*

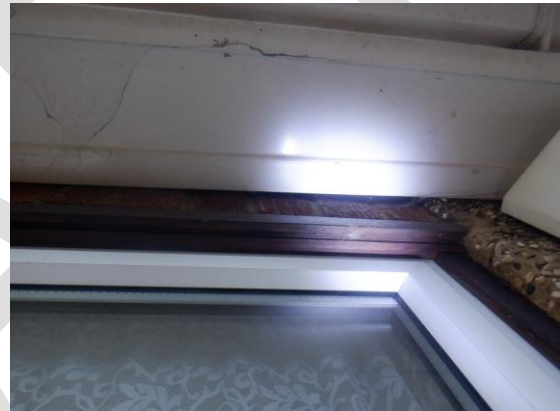
*Photograph 9. Gap between uPVC soffit & brickwork (front elevation).*

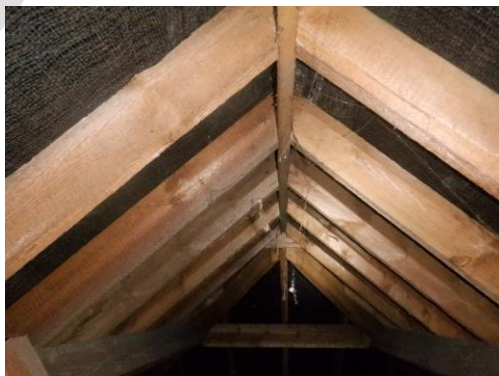
- 5.2.6** The roof void was of cut & pitch construction, accessible via a ladder and had an approximate floor-to-ridge height of 1.75 metres in which the ridge was cobwebbed throughout (**Photograph 10**).

*Photograph 10. Ridge cobwebbed throughout the void.*

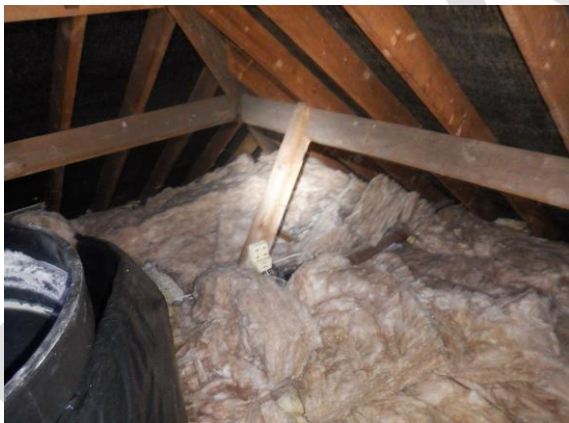
- 5.2.8** The floor was covered by fibreglass insulation that was installed in 2011 over a previously existing layer of vermiculite. The fibreglass filled the eaves, preventing access to the uPVC soffit (**Photograph 13**). A small, inactive wasp nest was situated within the southwest corner of the void (**Photograph 14**).

*Photograph 13. Eaves blocked by fibreglass insulation.*

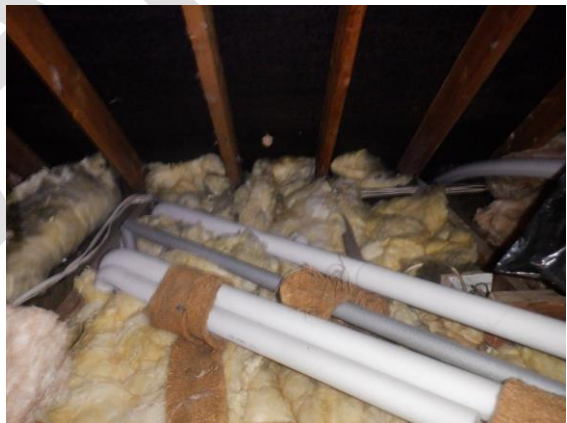
*Photograph 14. Small in-active wasp nest within southwest corner of the void.*

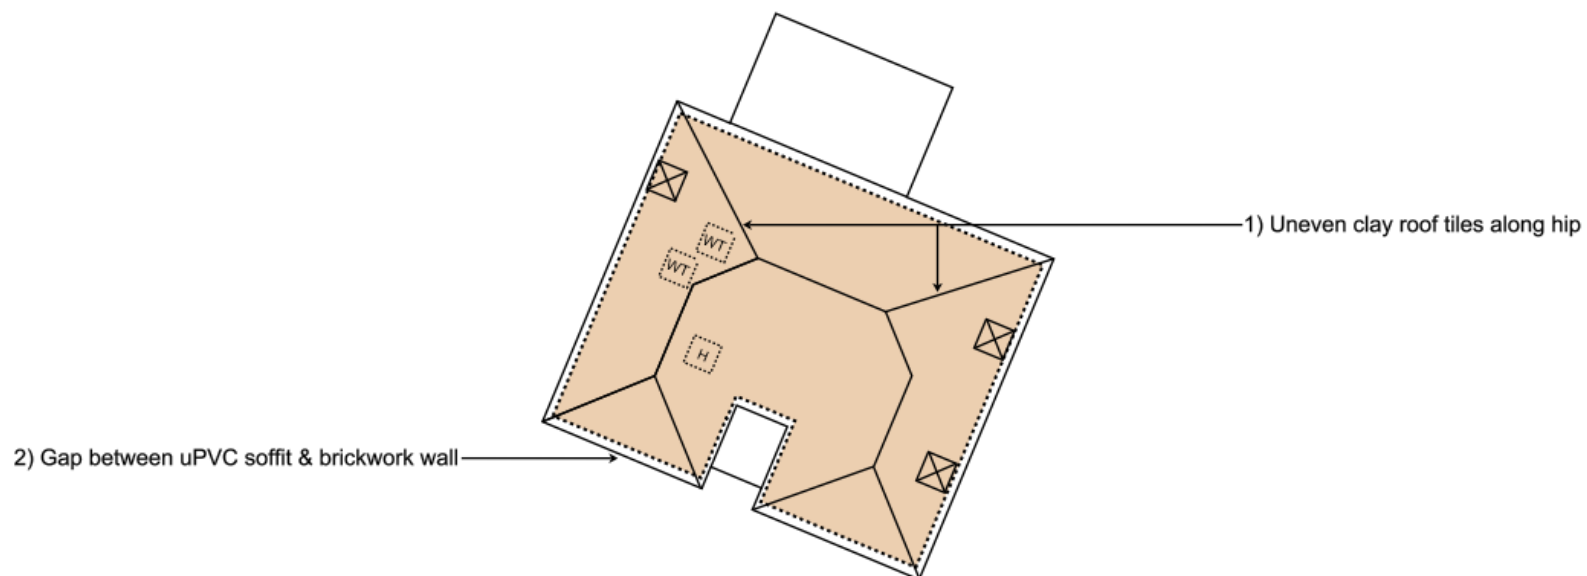
| JM | March 2024 | Not to scale | Preliminary Roost Assessment Plan | |

- 5.2.1** The findings from the external and internal inspections carried out for the property are described with photographs, and annotated in a plan, as follows:
