Heritage Assessment- Bathrooms

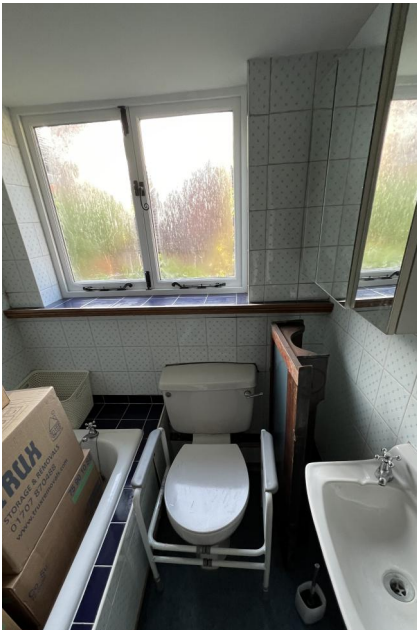
Right bathroom

There are two bathrooms in the first floor which are part of the existing late addition flat roof extension, they are both at lower level than the rest of the first floor and require stepping down in order to access them. The ceilings are very low and both feature a bath tub. The external wall is presumed to be a thin layer of brick.

**Bathroom:** We propose to merge the two existing bathrooms into one larger bathroom, allowing for a spacious walk-in shower. Additionally, we will rebuild the external wall, which is currently an uninsulate thin layer of brick, of poor qaulity, to create an insulated wall and straighten it to match the angle of the new extension. This adjustment will cause the wall to shift slightly from its original alignment, but only by a small amount.

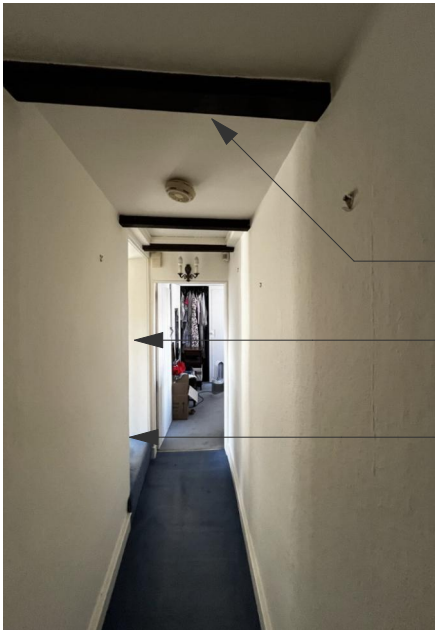
Corridor

Presumed original beams  
Presumed late 20th century opening to extension  
Steep step into right bathroom and rear bedroom

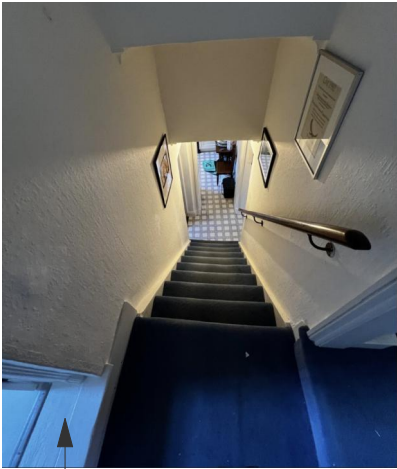
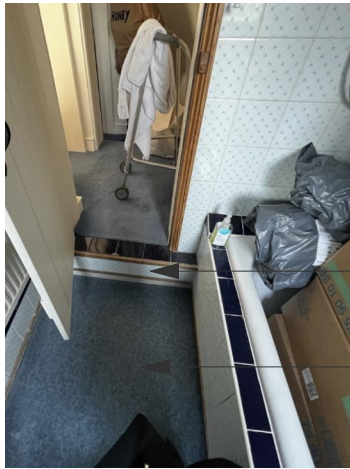
Existing 250mm rise step to access rear bathroom  
Existing floor deck to be raised to match rear bedroom level and eliminate step  
Existing step to access left bathroom from staircase. Proposed partition to close this doorway and make sure the stair lift chair can rest against it.

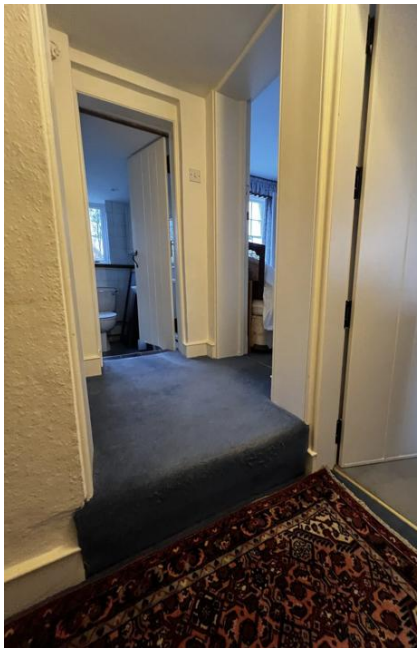
Proposed large bathroom with walk-in shower and raised ceiling

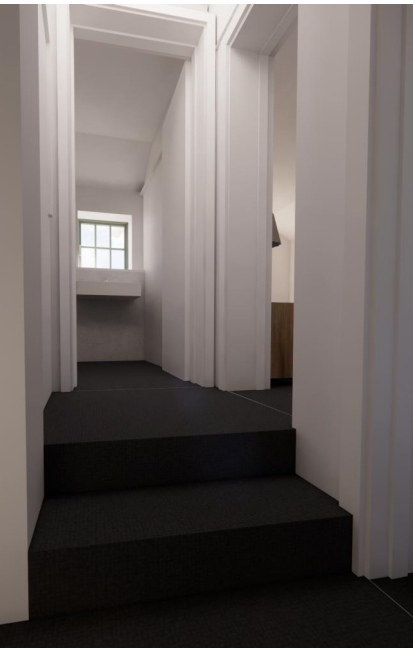
Existing steep step into rear bedroom and bathroom

Proposed adjusted step and flush floor finish
