## **PRELIMINARY ECOLOGICAL APPRAISAL (DBW) AT 10 RUSSELL WAY WINNERSH**

**Prepared for:  
Mr & Mrs G Rutter  
10 Russell Way  
Winnersh  
Wokingham  
RG41 5SN**

**19 September 2024**

**Ref: SPH/NP/PEA-24/10.09**

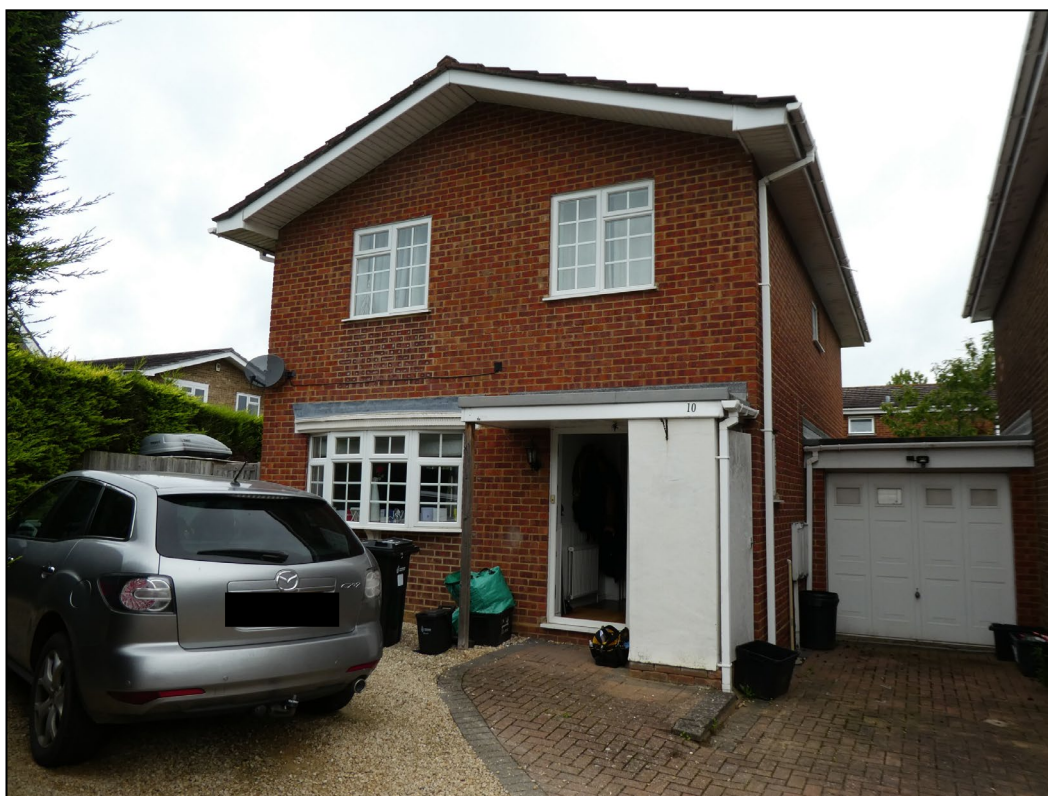
The link attached garage was also inspected externally. The garage is brick built and in good condition, see cover photograph. The flat roof of the garage is also covered in close fitted bitumen felt and the flashing affixing it to the property and the neighbouring property has no gaps, see Figure 9 on page 11. The uPVC fascias are well fitted with no gaps, see Figure 10 on page 11.

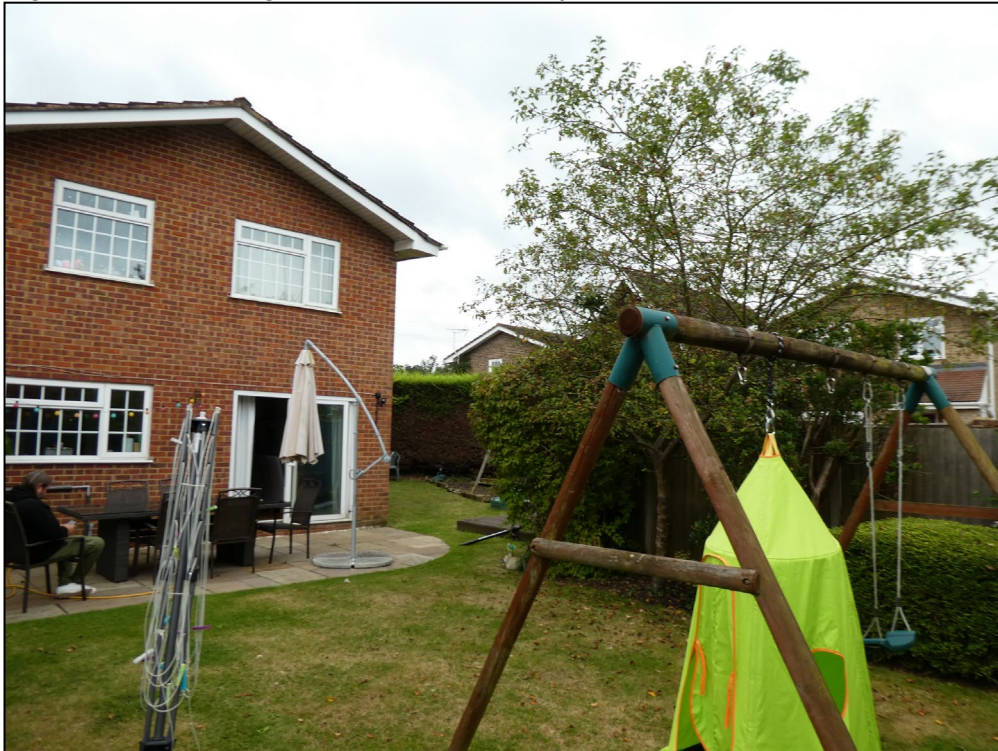
Figure 3. Rear/side garden. 10 Russell Way, Winnersh. 10.09.24

The application site comprises a detached, brick-built property with a link attached garage. The remainder of the site comprises a paved and gravelled driveway/parking area surrounded by hedges. The side and rear garden is mainly laid to lawn, with patio area and trees, shrubs and hedgerows around the boundaries, see Figure 3 below. The site itself offers limited foraging and commuting habitat for bats and there is limited ecological connectivity to bat foraging or commuting habitat in the wider landscape.

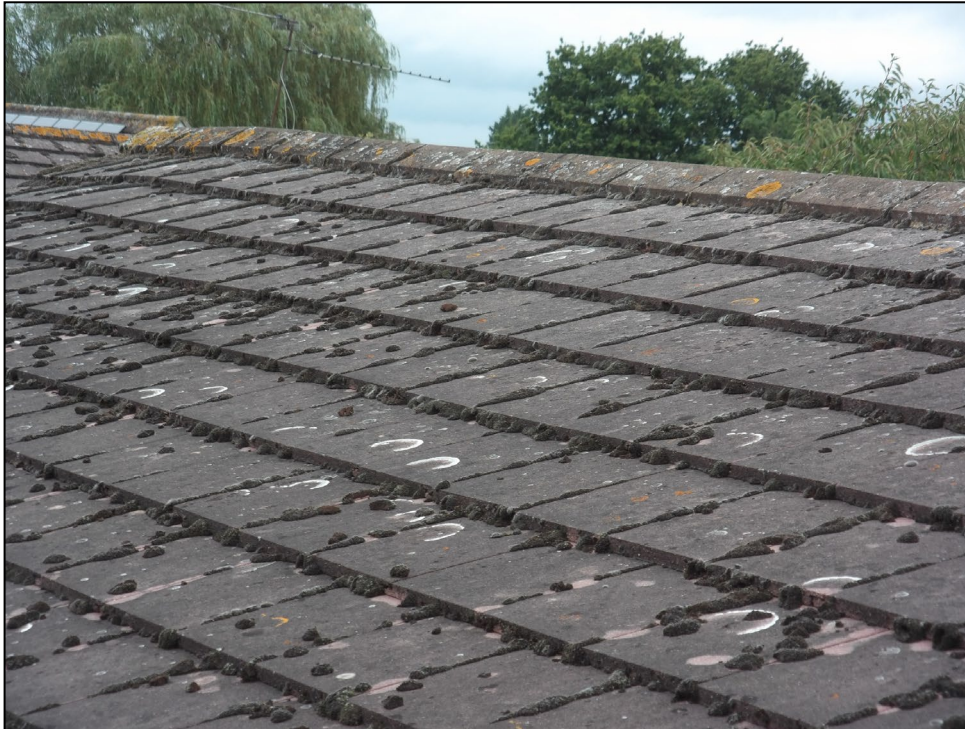
Figure 4. Example of roof tiles. 10 Russell Way, Winnersh. 10.09.24

The property is a detached, brick-built building with a link attached garage, all of which are in a good condition externally. The pitched roof of the property is covered in closely fitted tiles, none of which are missing or broken, see Figure 4 below. The ridge tiles are all tightly fitted with no gaps which could be used by roosting bats (see Figure 5 on page 9) and the verges are all fully sealed with no gaps in which roosting bats could exploit, see Figure 6 on page 9. The uPVC soffits and fascias are all tightly fitted to the walls and had no cracks or splits in which bats could use to roost, see Figure 7 on page 10. The bitumen felt covering the flat front of the front porch is well fitted with no splits or tears that could be exploited, see Figure 8 on page 10.

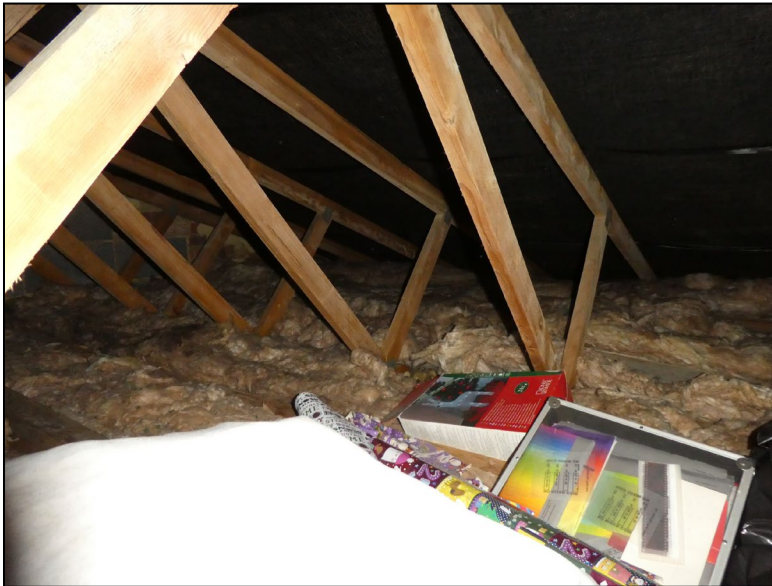
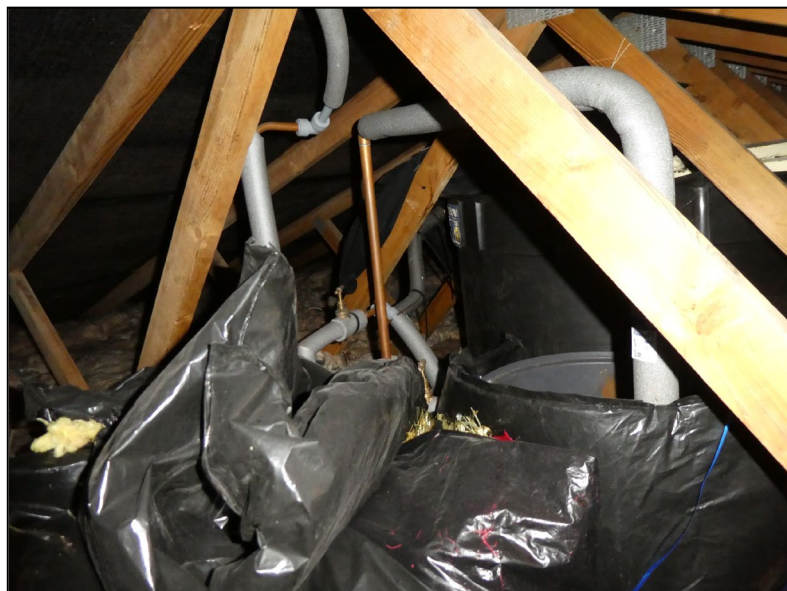
Figure 11. Example of loft space. 10 Russell Way, Winnersh. 10.09.24

The loft space was accessed via steps, through a hatch and is in a good condition. The loft space is not lit, not boarded and deeply insulated and the inspection took place from the hatch only, see Figure 11 below. The roof tiles that could be seen were lined with bitumen felt, all of which appeared to be in a good condition, see Figure 12 on page 13.

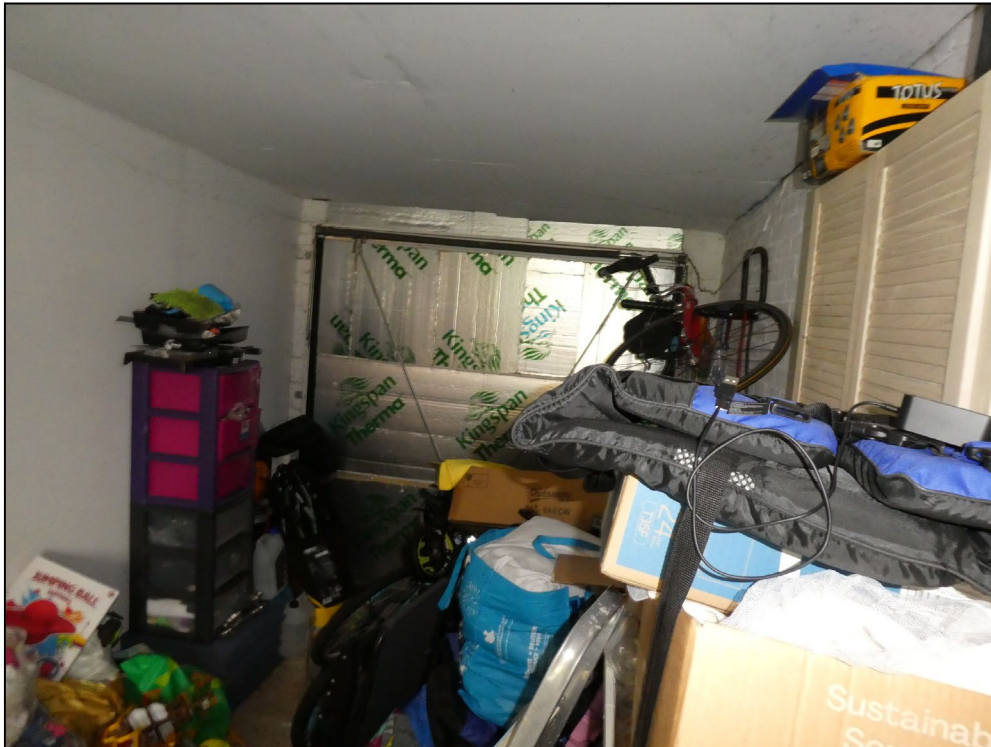
Figure 13. Internal view of garage and boarded roof. 10 Russell Way, Winnersh. 10.09.24

The attached garage was also inspected internally, although there is no loft space. The garage is used for storage and is cluttered but in a good condition. Internally the flat roof has been boarded and contained no cracks or splits in which roosting bats could exploit, see Figure 13 on page 13.
