# Bat Survey Report

83 Wilderness Road, Reading, RG6 7RF

**Ref:** 241852

**Client:** Ribina Mustafa

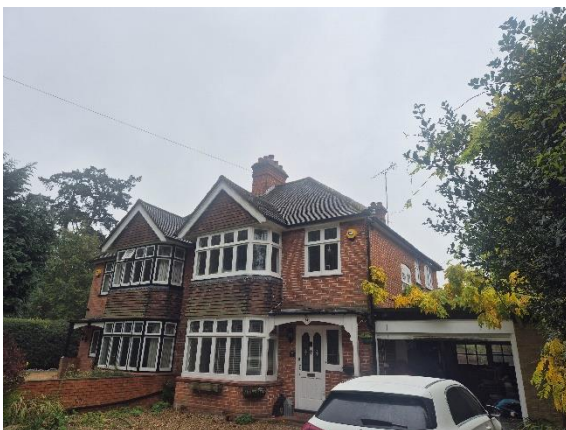
**Photograph 1:** Northern elevation of B1.

B1 is a semi-detached brick-built house c. 7m in height with a hipped roof and clay tiles. There is an attached garage on the western elevation with a flat felt roof and a pitched section with bay windows on the northern elevation. There is a single-storey lean to extension and a conservatory on the southern elevation.

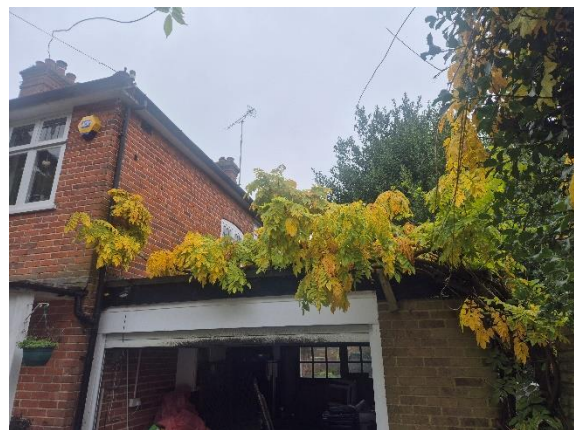
**Photograph 2:** Northern elevation of the attached garage of B1.

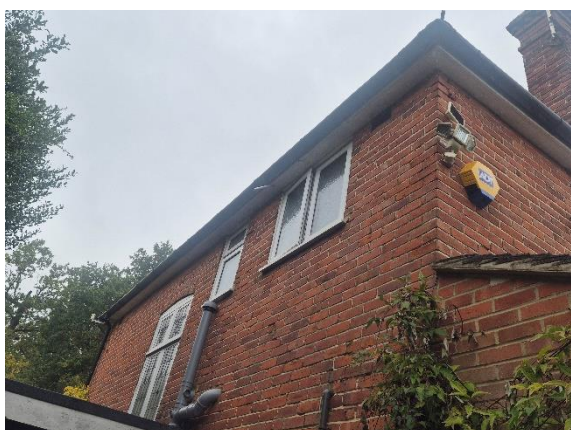
**Photograph 3:** Western elevation of B1.

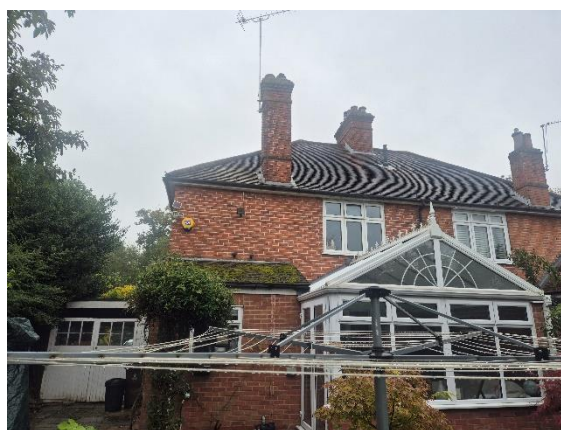
**Photograph 4:** Southern elevation of B1.

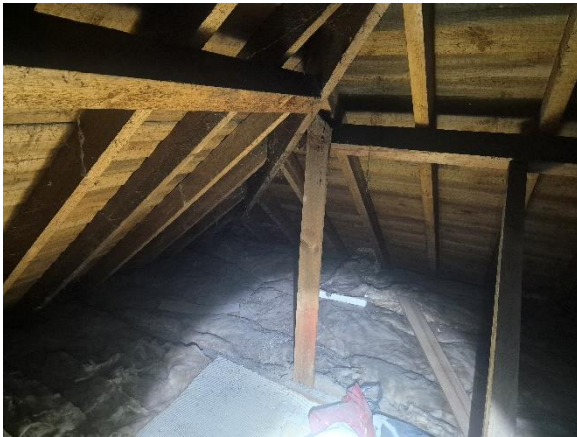
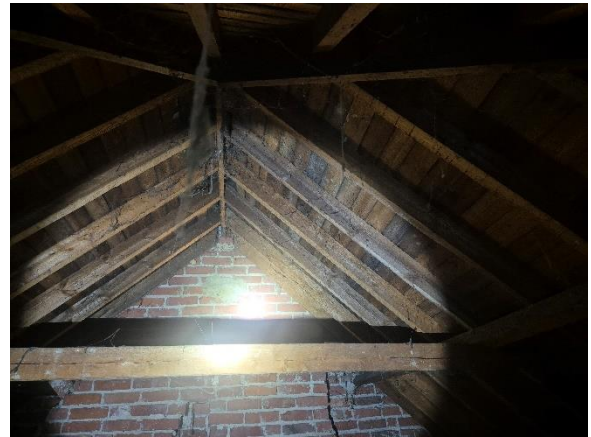
The loft void has a timber frame and is c. 2.5-3m in height to the apex (Photographs 7 and 8). It is lined with wooden sarking and has a small area of boarding; it was possible to view most areas from the centre. There is heavy cobwebbing across the entire loft. There is light ingress caused by a gap at the ridge, which is covered by cobwebbing (Photograph 9). No draughts or other light ingress was recorded. No evidence of bats was recorded.

**Photograph 7:** Loft void of B1.

**Photograph 8:** Loft void of B1.

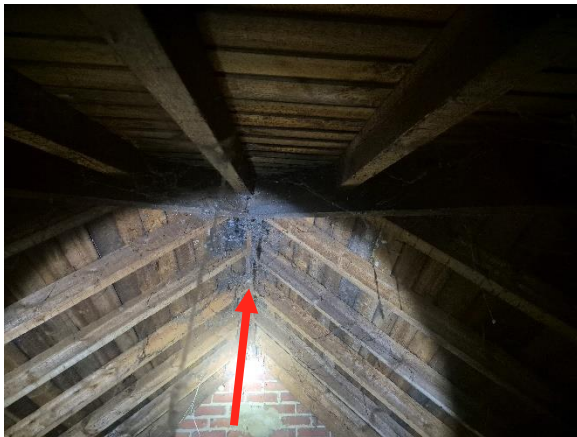
**Photograph 9:** Location of light ingress within the loft void of B1.

Due to a lack of evidence of bats within the loft and heavy cobwebbing, it is considered highly unlikely that bats are entering the void to roost. There are potential roost features on the roof on the northern and southern elevations which will not be impacted under the proposals. No potential roost features were identified on the western elevation or on the garage (which will be removed under the proposals). There are no potential roost features on the lean-to or conservatory on the southern elevation which are also proposed for removal.

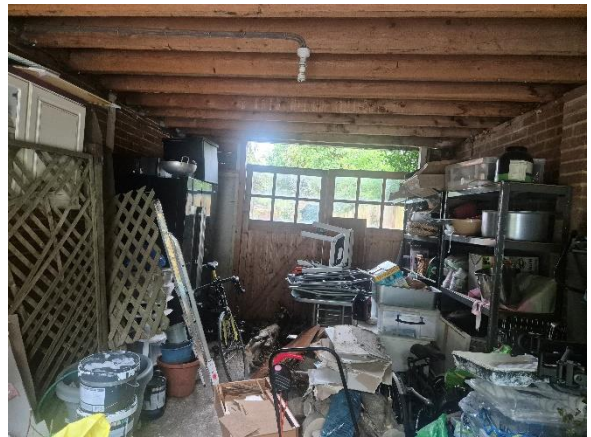
The interior of the garage was inspected, no evidence of bats was recorded (Photograph 10). The building is in good condition with well-sealed soffits. There are missing and lifted tiles on the northern elevation (Photograph 11) and gaps beneath the hanging tiles under the first-floor window (Photograph 12). There are missing tiles and a gap beneath the lead flashing next to the chimney on the southern elevation (Photograph 13). The lean-to extension on the southern elevation has a flush roof with no potential roost features. The western roof was inspected from

**Photograph 10:** Interior of the garage of B1.

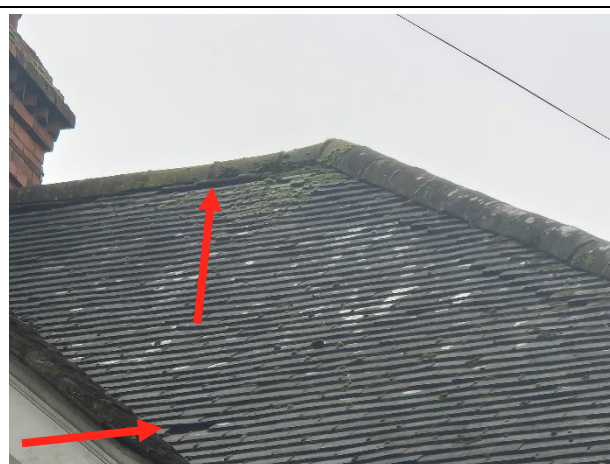
**Photograph 11:** Missing/ lifted tiles on the northern elevation of B1.

The areas of B1 to be impacted have negligible suitability for roosting bats, due to a lack of evidence and potential roost features. No evidence of bats was recorded in the loft void, which the proposed extension will be connected to. There are potential roost features with moderate suitability in the form of lifted hanging tiles and missing/ lifted roof tiles on the northern elevation and missing roof tiles and lifted flashing on the southern elevation. None of these features will be impacted under the proposals. If the proposals change to include works to the northern and southern elevations, two further bat surveys will be required. If the scaffolding for the proposed extensions is to be installed in front of the roof tiles on the northern and southern elevations, the works should be undertaken in winter (and not exceed the end of March) to ensure that access to the potential roost features is retained during the active season for bats, if this is not possible further surveys will be required. Construction works should take place during daylight hours only, with no illumination at night. The surrounding habitats provide moderate foraging opportunities for bats.

No evidence of bats was recorded within the loft void, and no potential roost features were identified within the areas to be impacted under the proposals therefore no further surveys are required. Potential roost features were identified on the northern and southern elevations, which will not be impacted. If plans change to include any works to the roof on the northern and southern elevations, further bat surveys will be required. If the scaffolding for the proposed extensions is to be installed in front of the roof tiles on the northern and southern elevations, the works should be undertaken in winter (and not exceed the end of March) to ensure that access to the potential roost features is retained during the active season for bats, if this is not possible further surveys will be required. Construction works should take place during daylight hours only, with no illumination at night.

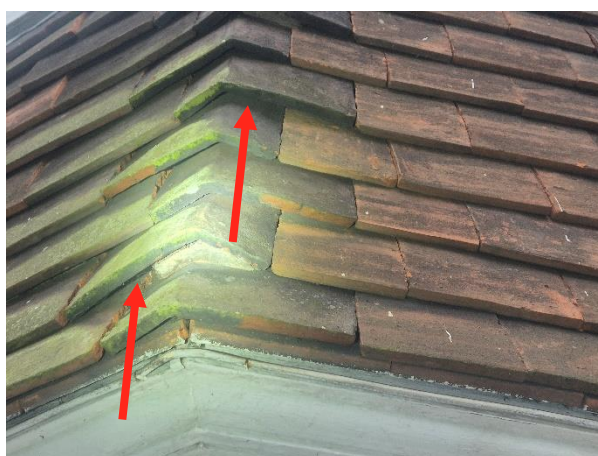
**Photograph 12:** Gaps beneath the hanging tiles on the northern elevation of B1.

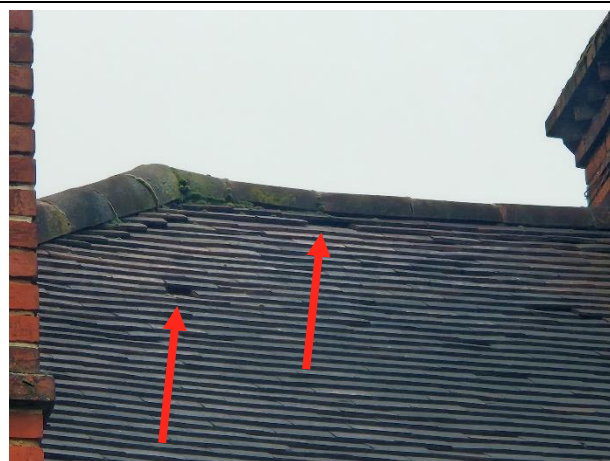
**Photograph 13:** Missing tiles on the southern elevation of B1.

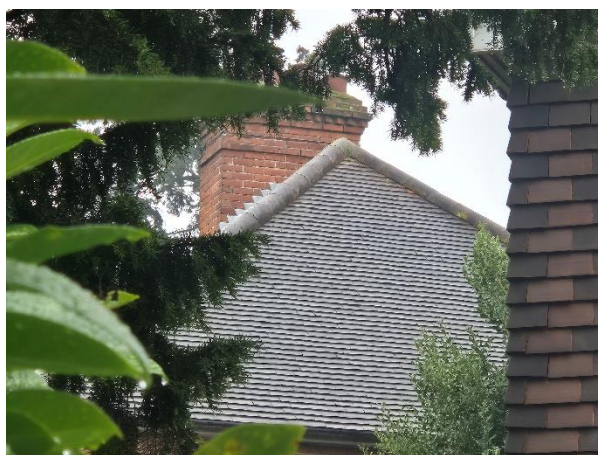
the road with binoculars due to visibility issues, no potential roost features were identified (Photograph 14).

**Photograph 14:** Roof on the western elevation of B1.
