## Bat Emergence and Re-Entry Surveys (BERS)

Springfield Barn Hatch Gate Lane, Wargrave, RG10 8QD

Magrun Ltd

This report is prepared to inform a planning application for the proposal described as:  
“The construction of a partial demolition and re-build of the eastern half of the building”

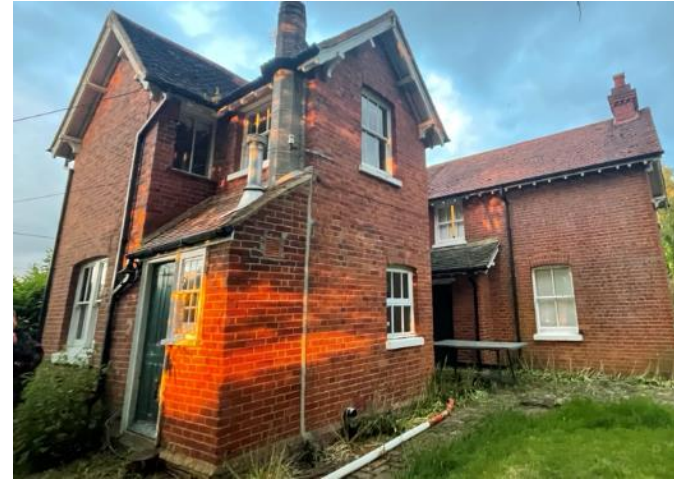
*Figure 3: the north-western and south-western elevations of B2*

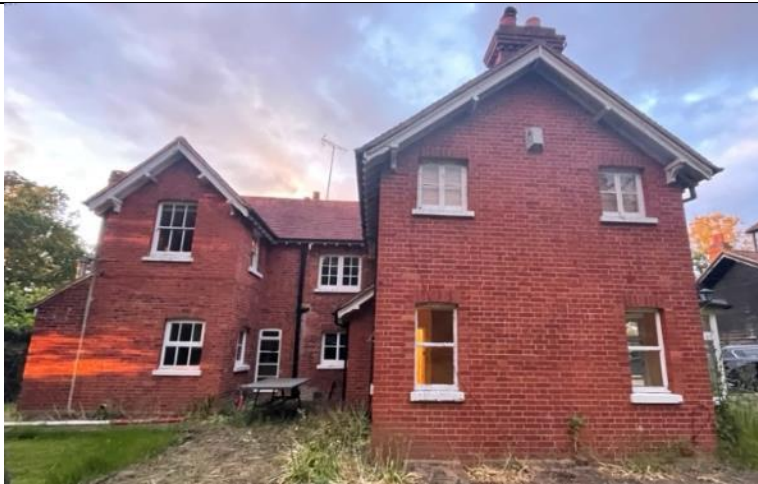
*Figure 4: the south-western elevation of B2*

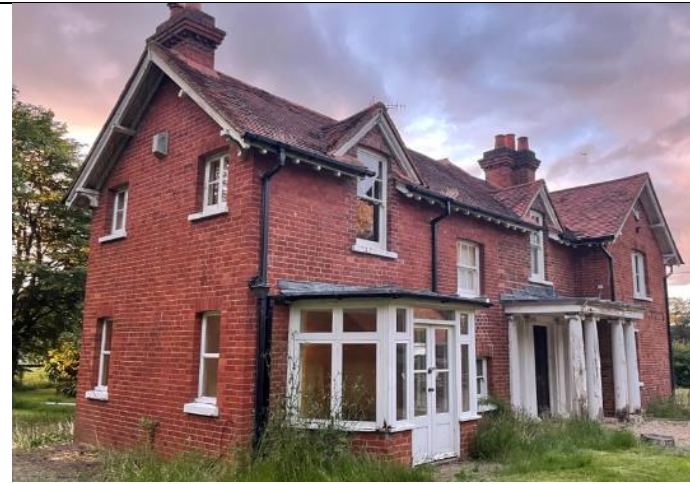
*Figure 5: the south-eastern elevation of B2*

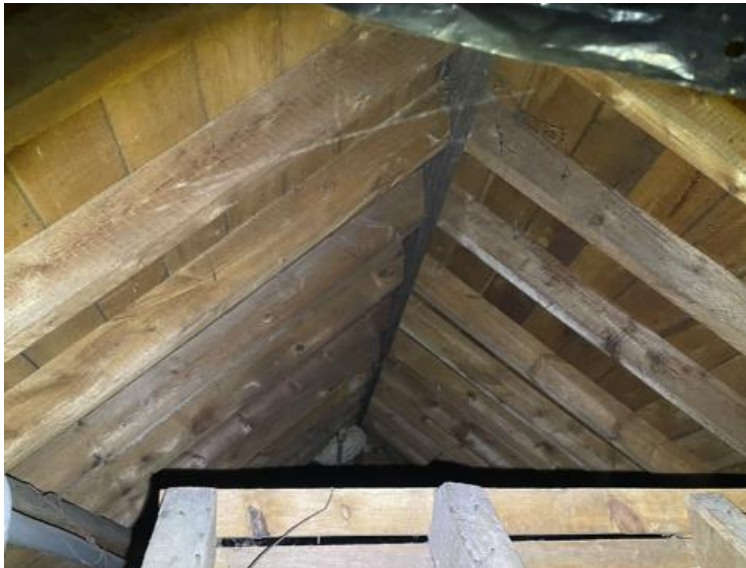
*Figure 6: the loft space within B2*

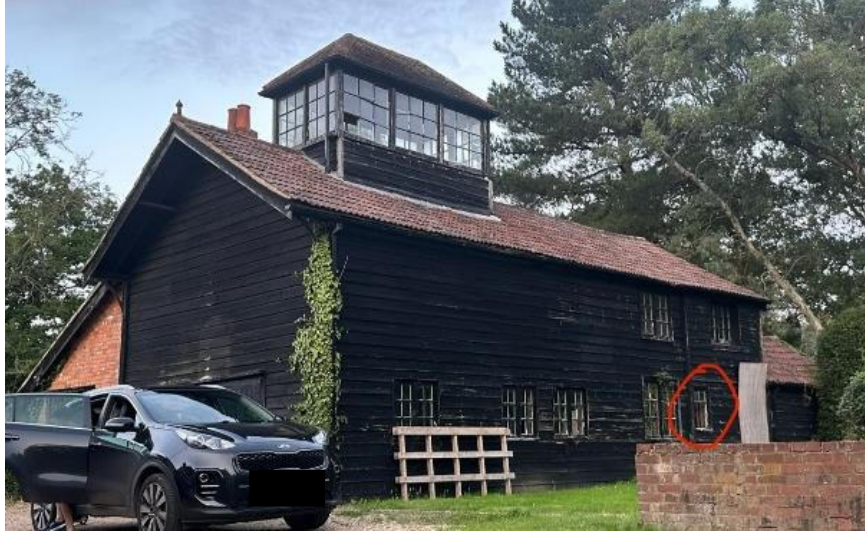
| <i>Surveyor 1</i> | <p><b>One emergence at 21:45 and one re-entry at 22:07, from a brown long eared bat. The bat emerged from the window on the bottom right side of the south-western elevation and re-entering at the same point.</b> First bat activity noted of the night were two noctules seen flying overhead in a north-east to south-west direction, the from then until 22:43, noctules continued to be heard intermittently. At 21:31 the first soprano pipistrelle was heard, along with a common pipistrelle, these could then be seen passing and foraging around the surveyor's position, as well as some being heard but not seen until 22:43. A brown long eared bat could be heard and seen foraging until 22:27. A serotine was heard at 21:44. the last bat of the evening was a common pipistrelle at 22:43.</p> | |
| <i>IR position 1</i> | <p>The footage reflected the view of surveyor 1. <b>The recording confirmed the emergence and re-entry of a brown long eared bat identified by the surveyor at 21:45 and 22:07.</b></p> | |

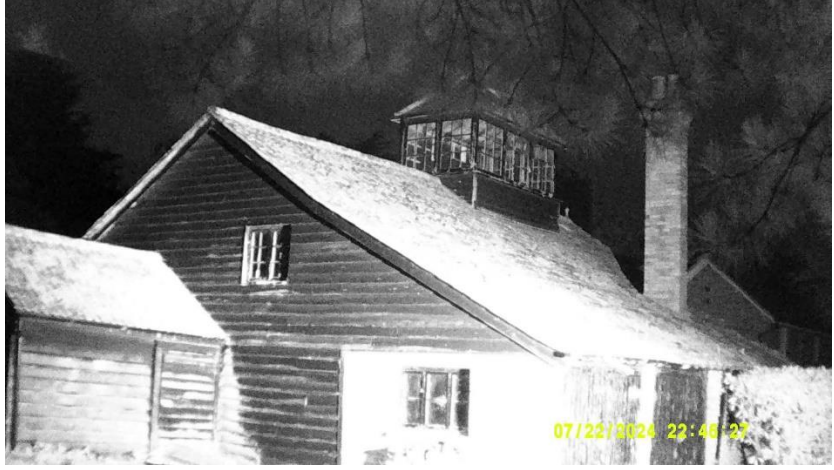
| <i>IR position 2</i> | <p>The footage reflected the view of surveyor 2. <b>The recording confirmed the emergences and re-entries of soprano pipistrelles identified by the surveyor. The emergences were at 21:32, 21:41, 21:43, 21:44, 21:57, 22:13, 22:15 and 22:32. The re-entries were at 21:39, 21:42, 21:48, 21:53, 22:15 and 22:35.</b></p> | |
