## Bat Emergence and Re-Entry Surveys (BERS)

Springfield Barn Hatch Gate Lane, Wargrave, RG10 8QD

This report is prepared to inform a planning application for the proposal described as:  
“The construction of a partial demolition and re-build of the eastern half of the building”

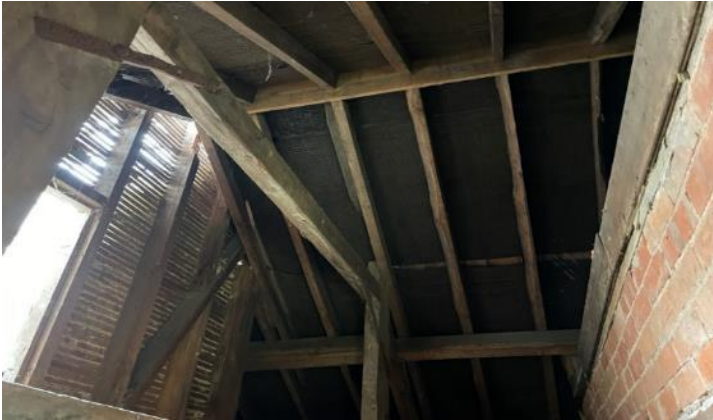
| Field Survey | |
|---|---|
| Building inspection prior to survey | <div><p>Internal check on B1</p><p>Externally, the building is in the same condition as when the previous PRA (Arbtech Consulting Ltd, May 2024) was undertaken. This included raised roof tiles, broken windowpanes, open eaves and warped wooden weatherboarding. The loft space was also in the same condition; however, the brown long eared bat was not observed within the loft during this inspection.</p><p>Figure 1: the loft space within B1</p><p>PRA on B2</p><p>B2 is a detached two-storey brick-built building with a cross-pitched and gabled roof clad in clay roof tiles. The roof tiles are in relatively good condition with a few raised tiles on all elevations under which bats could roost. The doors and windows are wooden framed and appear in excellent condition with no suitable bat roosting sites. The brickwork around the building appears in excellent condition with no gaps or cracks within which crevice-dwelling bats could roost. There are no soffits or bargeboards around the building as the eaves are open. with no gaps between the brickwork and roof. There are four chimneys located on the roof of the building. The brickwork on the chimneys appears in good condition. There is lead flashing around the bases of the chimney which is flat and without gaps. The brick gable ends are in good condition with no gaps around</p></div> |

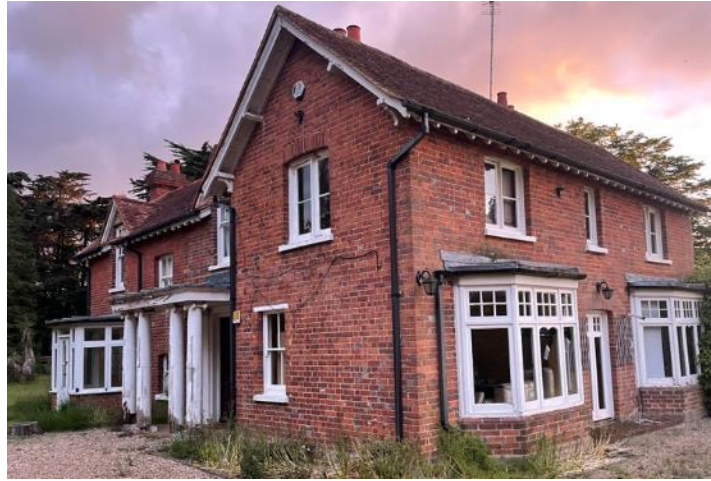
*Figure 2: the north-eastern and south-eastern elevations of B2*

the tops of the gable ends. There is one loft space within the main roof void of B2. The roof structure is built from modern timber beams including the ridge beam. The roof is lined with wooden sarking which appears in good condition with no gaps. The floor of the loft space is lined with mineral wool insulation and there are timber boards in places. There are cobwebs around the ridge beam and roof to floor cobwebs which could indicate a lack of internal flying activity by void dwelling bats, such as brown long-eared bats. No daylight enters the loft space which indicates that it is well sealed. B2 has moderate habitat value for roosting bats.

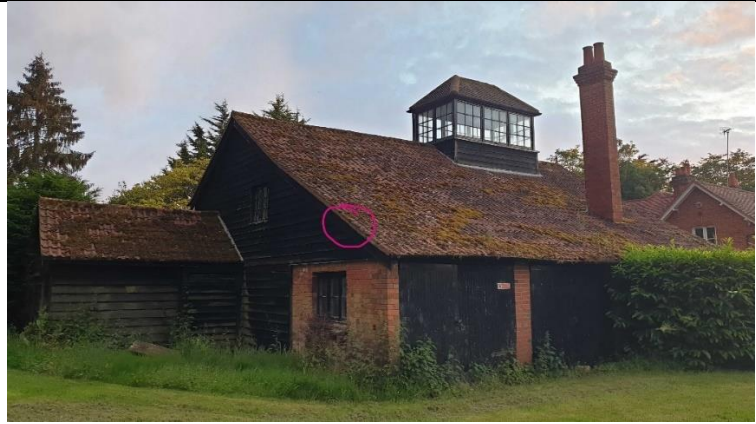
| 07/06/2024 | Sunset 21:17<br>21:02 – 23:17 | CPx1 | Day | B1 | SE elevation | Barge board | Under the barge board on the south-eastern elevation |

| Surveyor 2 | <p><b>One emergence from a common pipistrelle observed at 21:48 from underneath the barge board.</b> The bat then flew south-east. The first bat was a noctule heard not seen at 21:28. Common pipistrelles were heard not seen between 21:31 and 22:20. Another noctule was heard not seen at 22:39. The last bat observed was a common pipistrelle heard not seen at 22:45.</p> | |

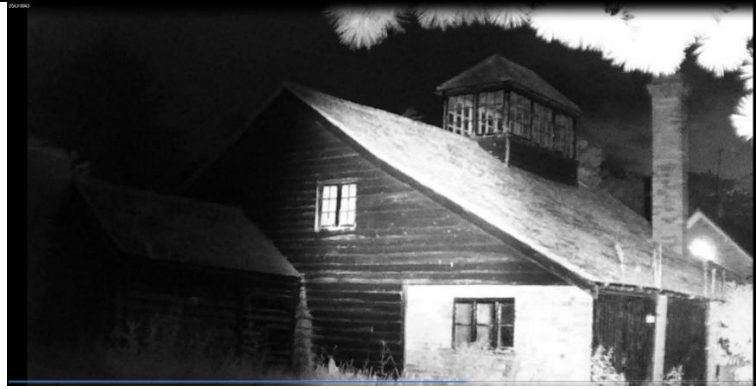
| IR position 2 | <p>The footage reflected the view of surveyor 2. <b>The recording confirmed the emergence of a common pipistrelle identified by the surveyor at 21:48.</b></p> | |

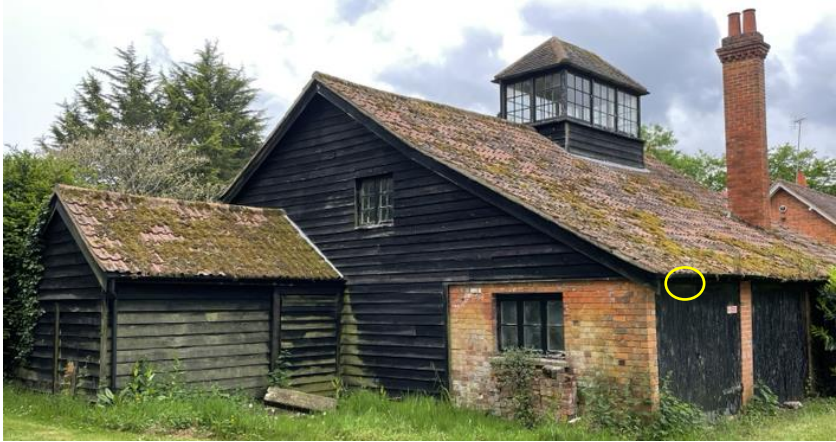
| Field Survey | | | | | | | |
|---|---|---|---|---|---|---|---|
| 01/07/2024 | Sunset<br><br>21:23<br><br>21:08 –<br><br>23:23 | SPx2 | Maternity Roost.<br><br>(Please see results<br><br>from subsequent<br><br>survey, when 8 SP<br><br>were observed to | B1 | NE elevation | Eaves | Under the eaves on the north-east elevation of B1 |

| <p><i>Surveyor 2</i></p> | <p>An emergence from a soprano pipistrelle was observed from under the eaves on the north-east elevation at 21:32. A re-entry from a soprano pipistrelle into the same location was observed at 21:43 and an emergence from a soprano pipistrelle as the same location was observed at 21:48. The bat flew south-east after emerging and began feeding south to north along the property border (trees and hedgerow). This was continuous activity throughout the survey. Common pipistrelles were heard not seen at 21:52 and then from 22:02 feeding from north to northwest, with continuous activity until the last heard not seen at 22:17. A brown long-eared bat was heard not seen at 22:21 and again at 23:15. A noctule was heard not seen at 23:02.</p> | |

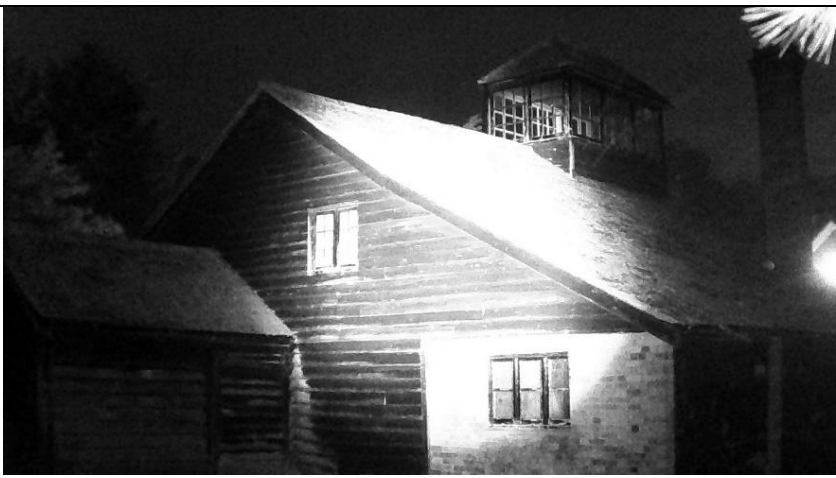
| <p><i>IR position 2</i></p> | <p>The footage reflected the view of surveyor 2. <b>The recording confirmed the emergence, re-entry and second emergence of a soprano pipistrelle identified by the surveyor at 21:32, 21:43 and 21:48.</b></p> | |

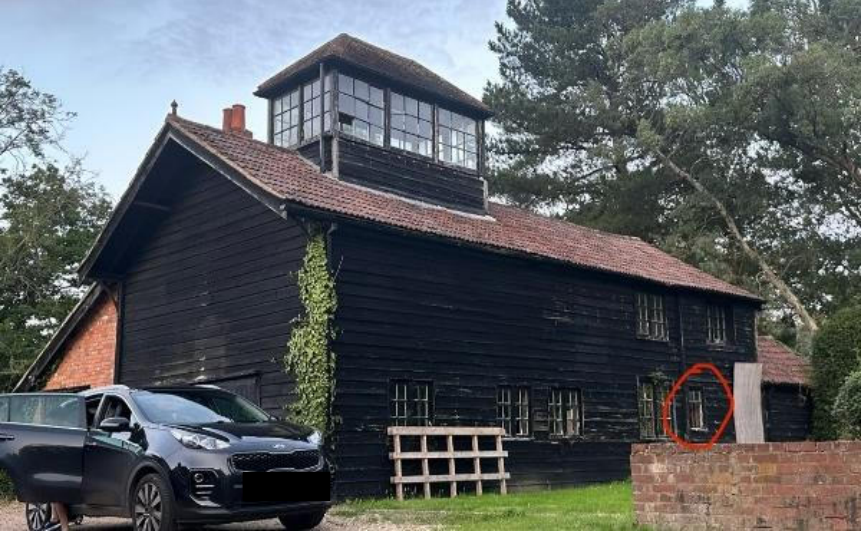
| <b>Field Survey</b> | | | | | | | |
|---|---|---|---|---|---|---|---|
| | 20:50 –<br>23:05 | BLEx1 | Day | B1 | Loft | Window on the bottom right of the south-western elevation | Loft dimensions<br>L – 12m<br>W – 5m<br>H – 3m |

| <p><i>Surveyor 1</i></p> | <p><b>One emergence at 21:45 and one re-entry at 22:07, from a brown long eared bat. The bat emerged from the window on the bottom right side of the south-western elevation and re-entering at the same point.</b> First bat activity noted of the night were two noctules seen flying overhead in a north-east to south-west direction, the from then until 22:43, noctules continued to be heard intermittently. At 21:31 the first soprano pipistrelle was heard, along with a common pipistrelle, these could then be seen passing and foraging around the surveyor's position, as well as some being heard but not seen until 22:43. A brown long eared bat could be heard and seen foraging until 22:27. A serotine was heard at 21:44. the last bat of the evening was a common pipistrelle at 22:43.</p> | |

| <i>Impact Assessment</i> | <p>The proposed development will include the partial demolition and re-build of the eastern half of B1, re-fitting of the external cladding and re-roofing of B1.</p> <p>All three roosts will be destroyed during the proposed development. Bats could be injured or killed during the proposed development of B1.</p> <p>The proposed plans for B2 are yet to be determined.</p> <p>An increase or change in the artificial lighting to the east, south and west of B1 could disturb bat foraging and commuting behaviour in those areas.</p> |
| <i>Recommendations</i> | <p>An EPSL application to Natural England will be required to legally permit the proposed works. The EPSL application requires that surveys be undertaken within the most recent active bat season (optimal May to August, suboptimal September). Planning permission must have been granted and all relevant wildlife-related conditions have been discharged prior to submission, where possible to do so. The survey effort should include at least one survey between May and June when the detection rate of bat roosts is highest.</p> <p>A Material Changes Check will be required within three months of the EPSL submission, if no survey work has been undertaken within that period.</p> <p>The EPSL will detail any mitigation and compensation measures that will be required for the proposed development to comply with the standing advice and will be designed to reduce any impacts to an acceptably low level so as to maintain (or enhance) the Favourable Conservation Status (FCS) of the local bat population.</p> |

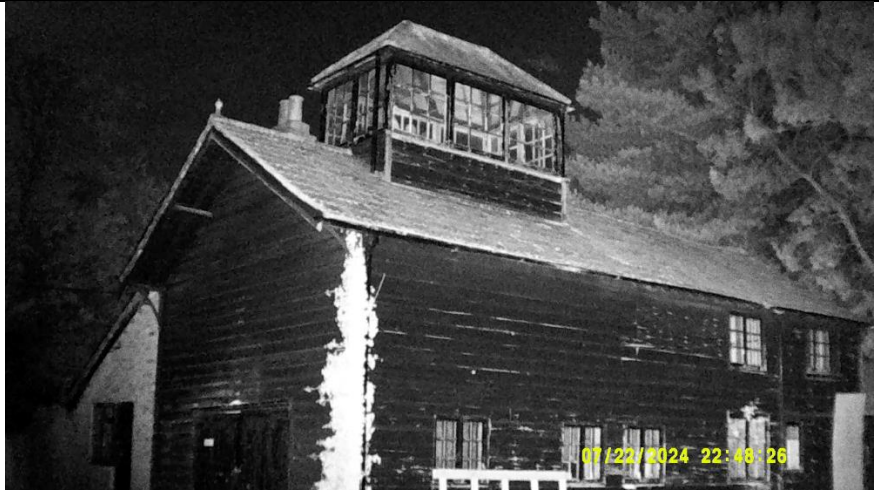
| <p><i>IR position 1</i></p> | <p>The footage reflected the view of surveyor 1. <b>The recording confirmed the emergence and re-entry of a brown long eared bat identified by the surveyor at 21:45 and 22:07.</b></p> | |

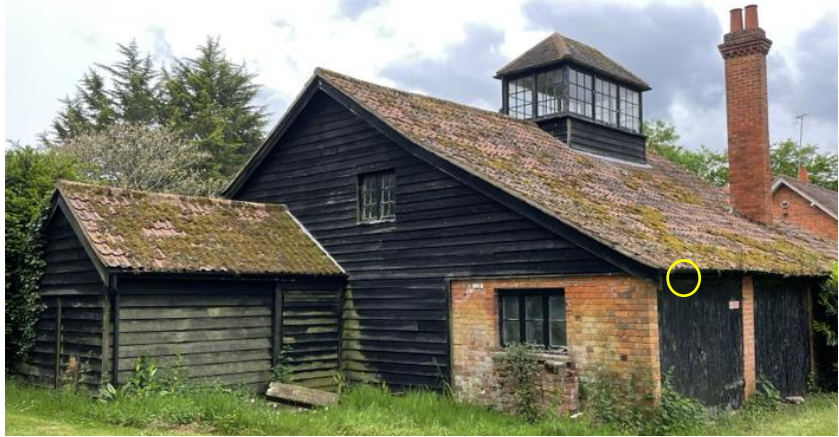
| <b>Field Survey</b> | | | | | | | |
|---|---|---|---|---|---|---|---|
| 22/07/2024 | Sunset<br>21:05 | SPx8 | Maternity | B1 | NE elevation | Eaves | Under the eaves on the north-eastern elevation of B1 |

| Surveyor 2 | <p>8 emergences and 6 re-entries from soprano pipistrelles were observed from under the eaves on the north-east elevation. The emergences were at 21:32, 21:41, 21:43, 21:44, 21:57, 22:13, 22:15 and 22:32. The re-entries were at 21:39, 21:42, 21:48, 21:53, 22:15 and 22:35. First bat heard was a Noctule at 21:18 heard not seen. At 21:40 a brown long eared bat can be seen flying around inside the light box on top of the roof. A brown long eared bat could be heard but not seen at 21:45, 21:57, 22:14 and 22:38. A noctule could be heard but not seen at 22:04.</p> | |

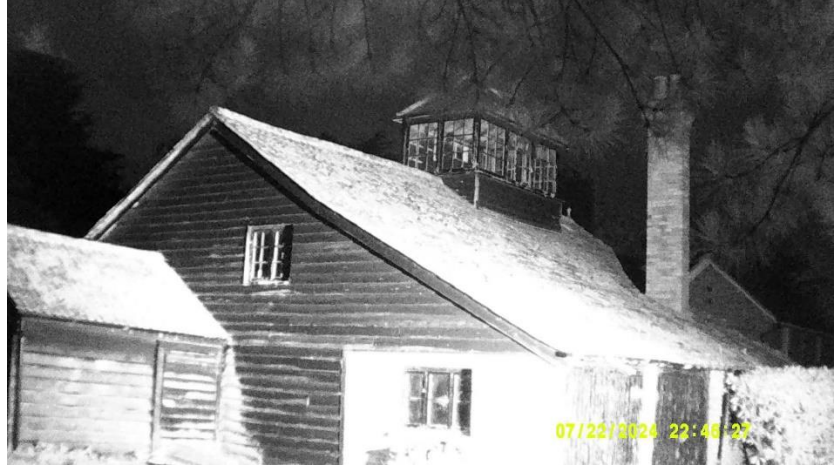
| <i>IR position 2</i> | <p>The footage reflected the view of surveyor 2. <b>The recording confirmed the emergences and re-entries of soprano pipistrelles identified by the surveyor. The emergences were at 21:32, 21:41, 21:43, 21:44, 21:57, 22:13, 22:15 and 22:32. The re-entries were at 21:39, 21:42, 21:48, 21:53, 22:15 and 22:35.</b></p> | |

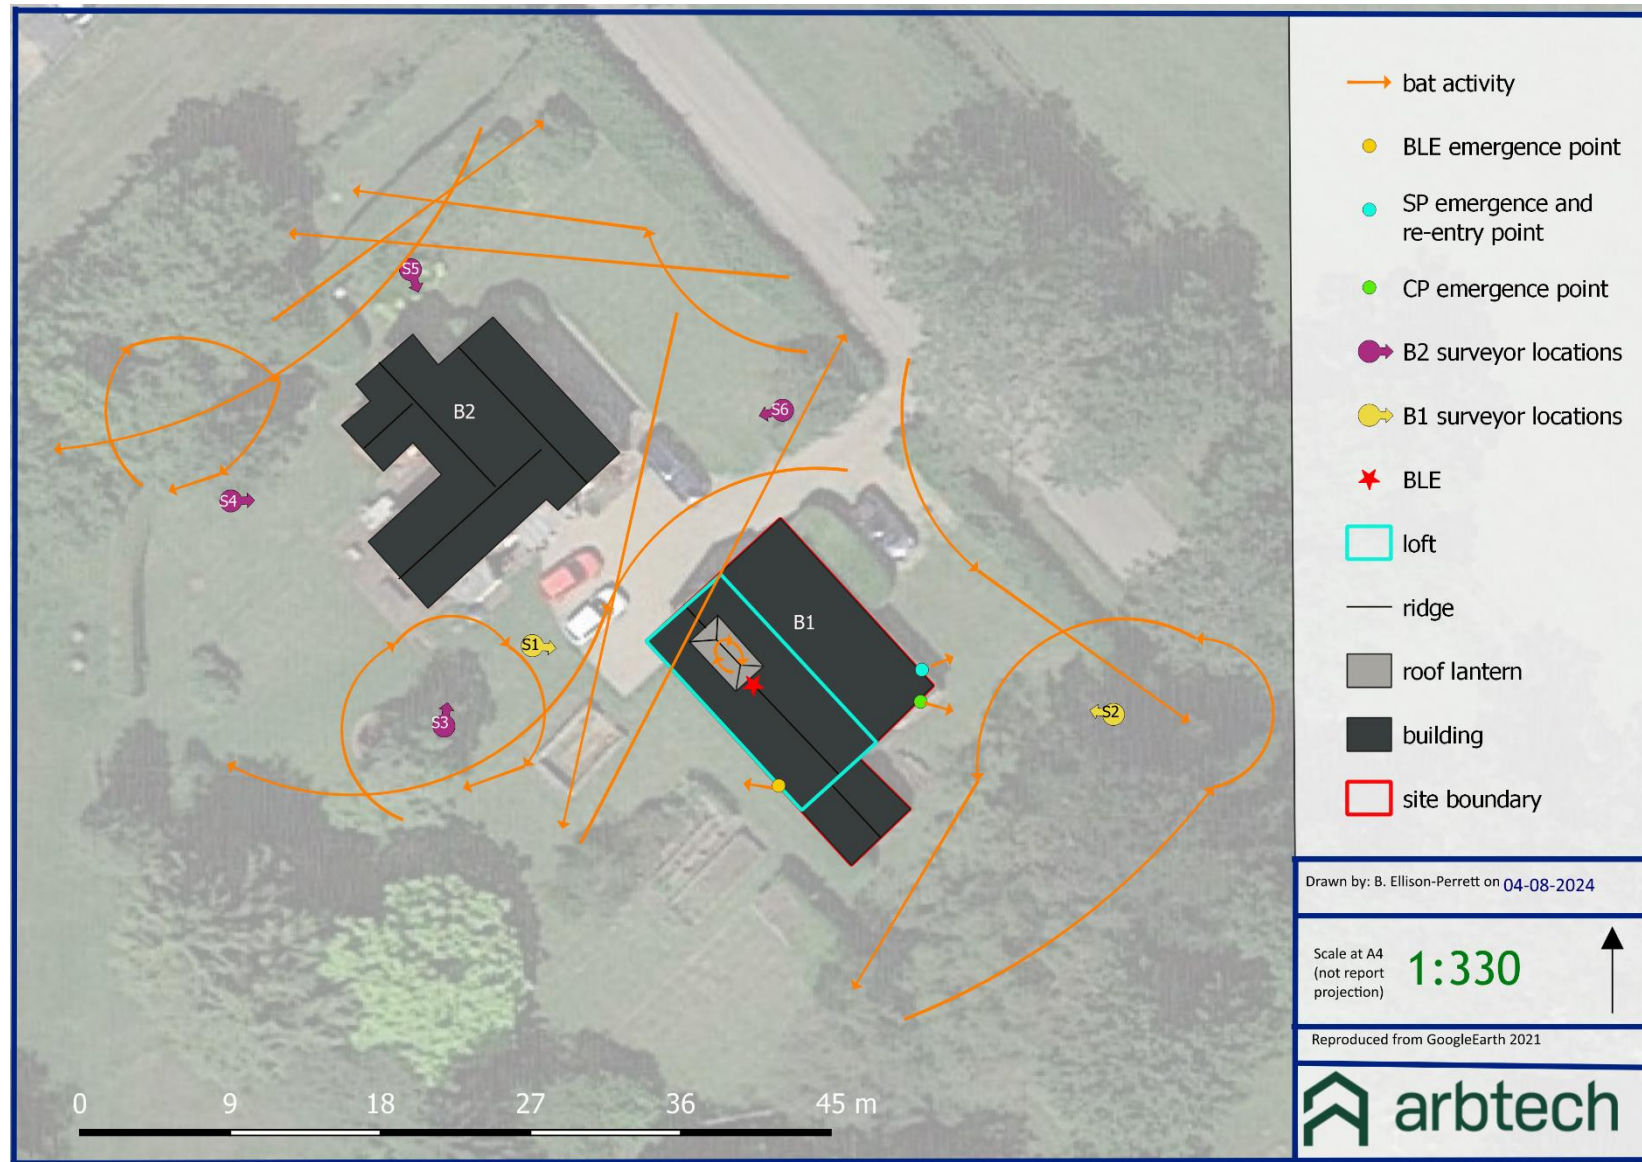
## Appendix 1: BERS plan

| <b>See surveyor locations in the BERS plan in Appendix 1, Bibliography in Appendix 2.</b> | |
