# Park Lane, Charvil, RG10 9TS

P25-0896  
ISSUE: 3

Flood Risk Assessment & Drainage Strategy Report

| <b>Document Reference</b> | P25-896- Flood Risk Assessment & Drainage Strategy Report – Park Lane, Charvil – 28.04.2025 |

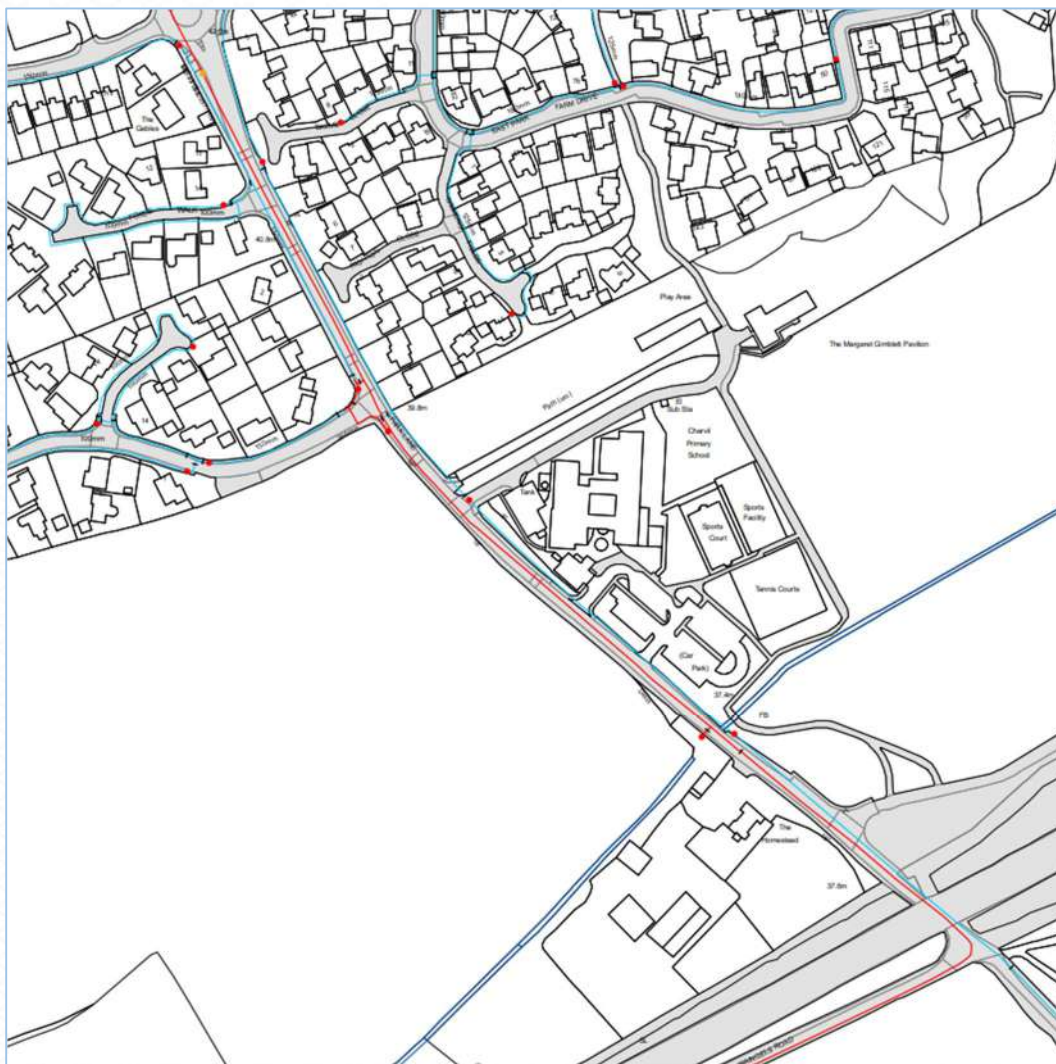
Figure 2.2: Thames Water Sewer Records

2.5.2. Thames Water is the incumbent sewerage utility provider for the area. A review of the Thames Water's Records confirms that there is a surface water sewer running west to east along The Hawthorns to the north of the site and north to south down Park Lane to the east of the site. There is a foul water sewer that runs parallel to the surface water sewer along The Hawthorns. Not shown on the Thames Water plan is a surface water and foul water sewer that has been installed running south to north along Canberra Lake Way that has recently been built as part of an adjacent development. *Figure 2.2* below shows an extract of Thames Water's sewer records for the site.

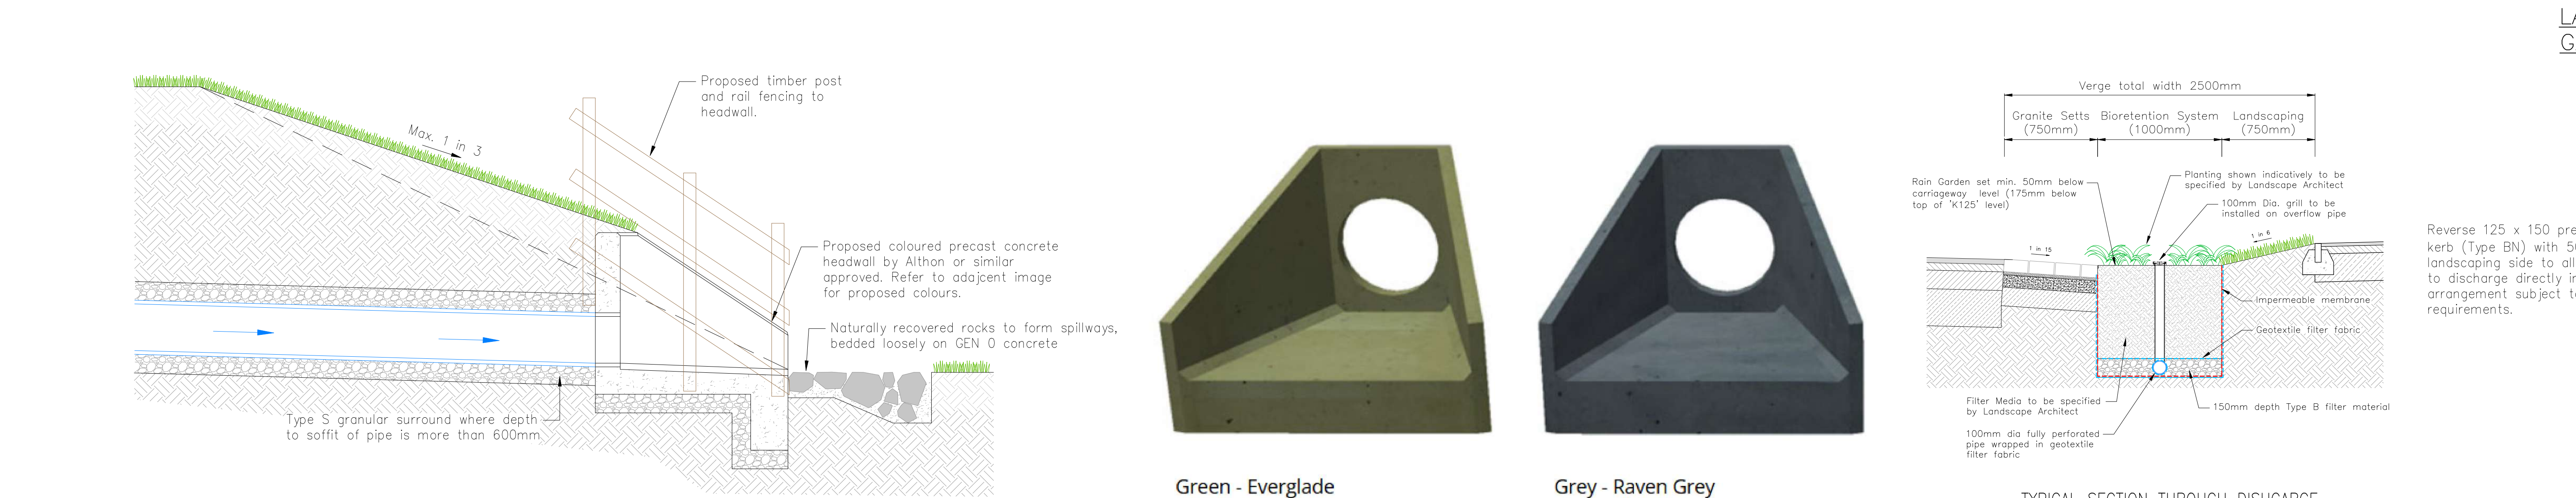
### SuDS Construction Details

LLDPE Impermeable Membrane by Stormwater Management LTD or similar approved

NOTE  
Membranes to be installed in accordance with manufacturers recommendations

| P3 | IMPERMEABLE MEMBRANES ADDED FOLLOWING WATER GROUNDWATER MONITORING RESULTS & REMOVAL TOTAL UPDATED | JPH | 28.04.26 |
