## Preliminary bat roost assessment

| Site Location | 7 Perkins Way, Wokingham, RG41 2TN |
| Document reference | CE4766 |

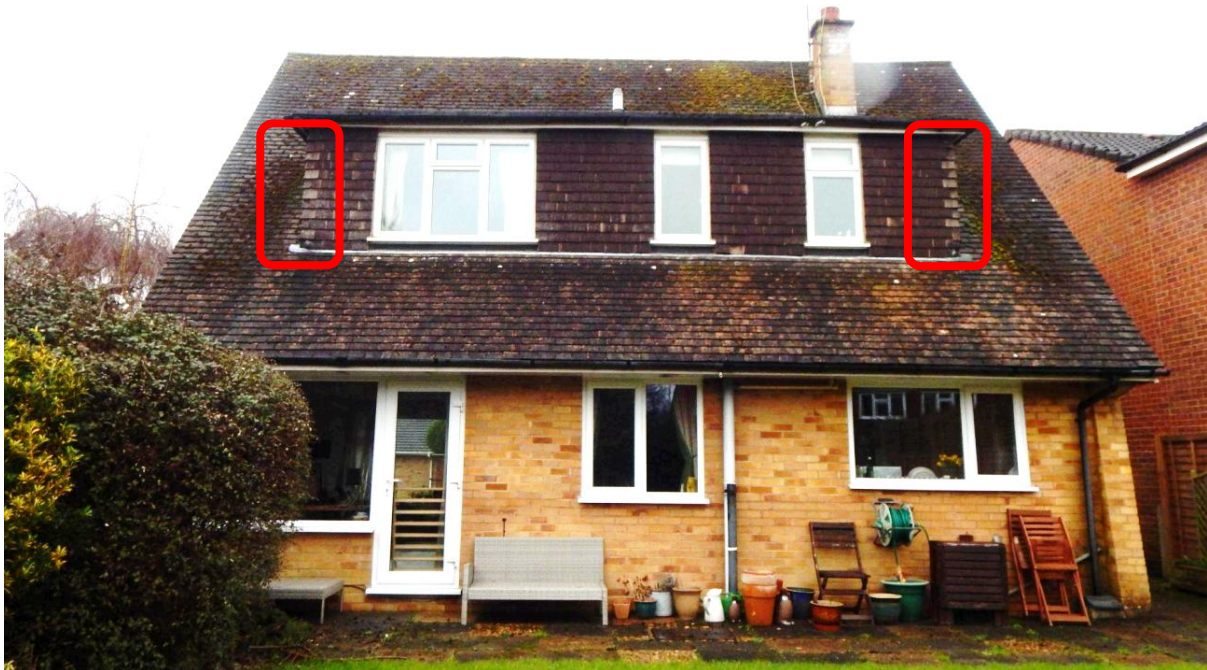
| External | Features of value to bats | Notes |
|---|---|---|
| Roof coverings | Yes | <p>The main tiled roof coverings have demonstrated a fair level of condition throughout with no observed features of value to n=bats noted.</p> <p>However, the vertical hanging tiles to the rear elevation of the property have demonstrated gaps of adequate proportions to offer roosting opportunities for crevice dwelling species of bats such as Pipistrelle which have been recorded locally.</p> |

Image 3 – North facing elevation of the property where features of value to bats were observed within the vertical hanging tiles which look to offer shelter opportunities within

- 6.4 The main dwelling has evidenced roosting features of low value within the vertical hanging tiles and eaves coverings which look to offer access and availability to crevice dwelling bats and could not be fully ruled out during the Preliminary Roost Assessment without causing disturbance to materials which in effect may cause disturbance to possible bat roosts within.

- 6.6 In line with best practice survey guidelines, a structure that has demonstrated low value must have a further single emergence survey to rule out or confirm activity from bats. This survey should be carried out within the recommended survey season from May to August.

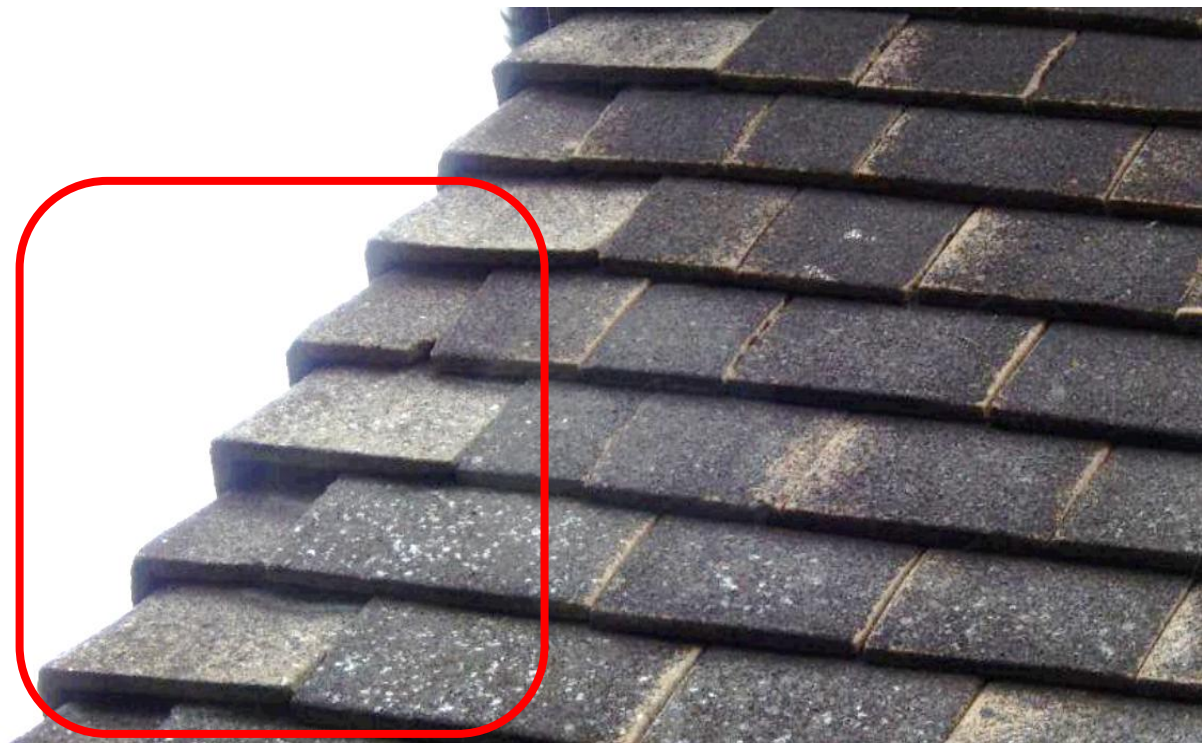
Image 4 – As per image three above

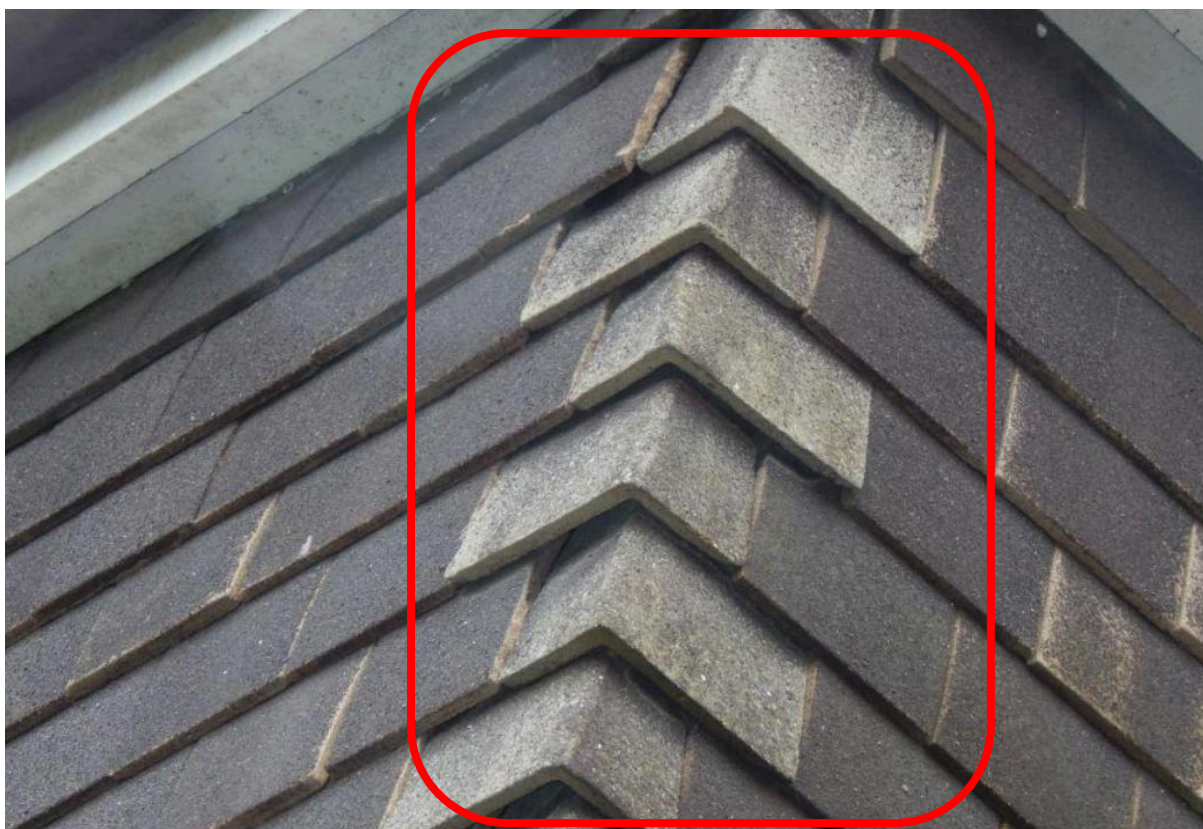
Image 5 – As per image three on the previous page

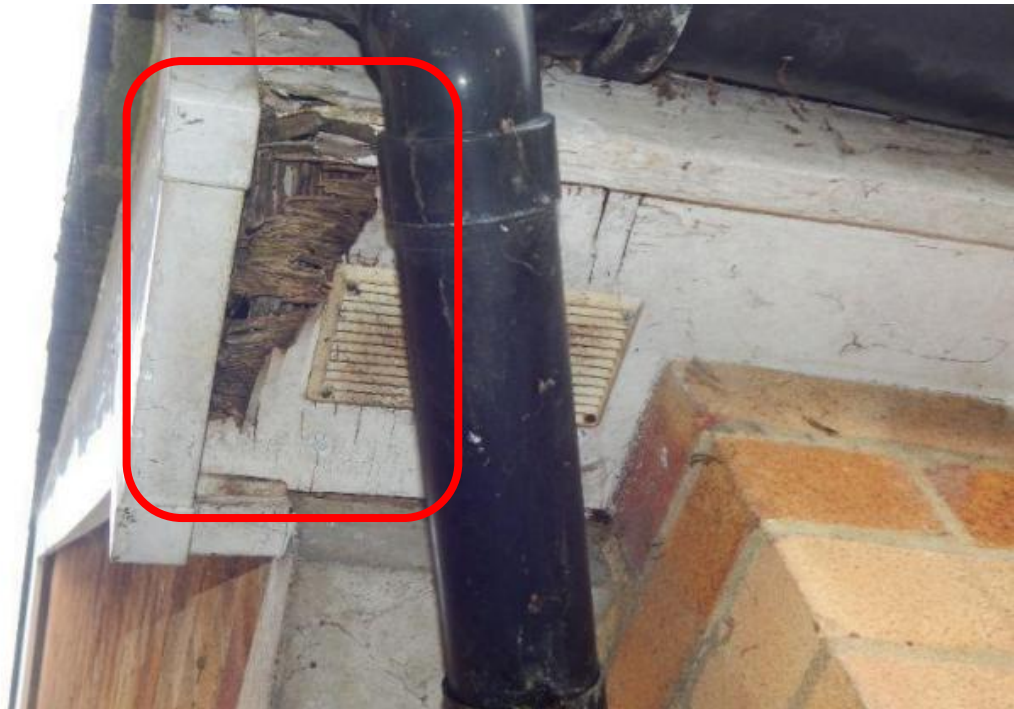
| External | Features of value to bats | Notes |
|---|---|---|
| Eaves coverings | Yes | The eaves covering have demonstrated a single area of deterioration which looks to provide access opportunities for bats within. |

Image 7 – Damage to the eaves coverings which may provide further access opportunities for bats within

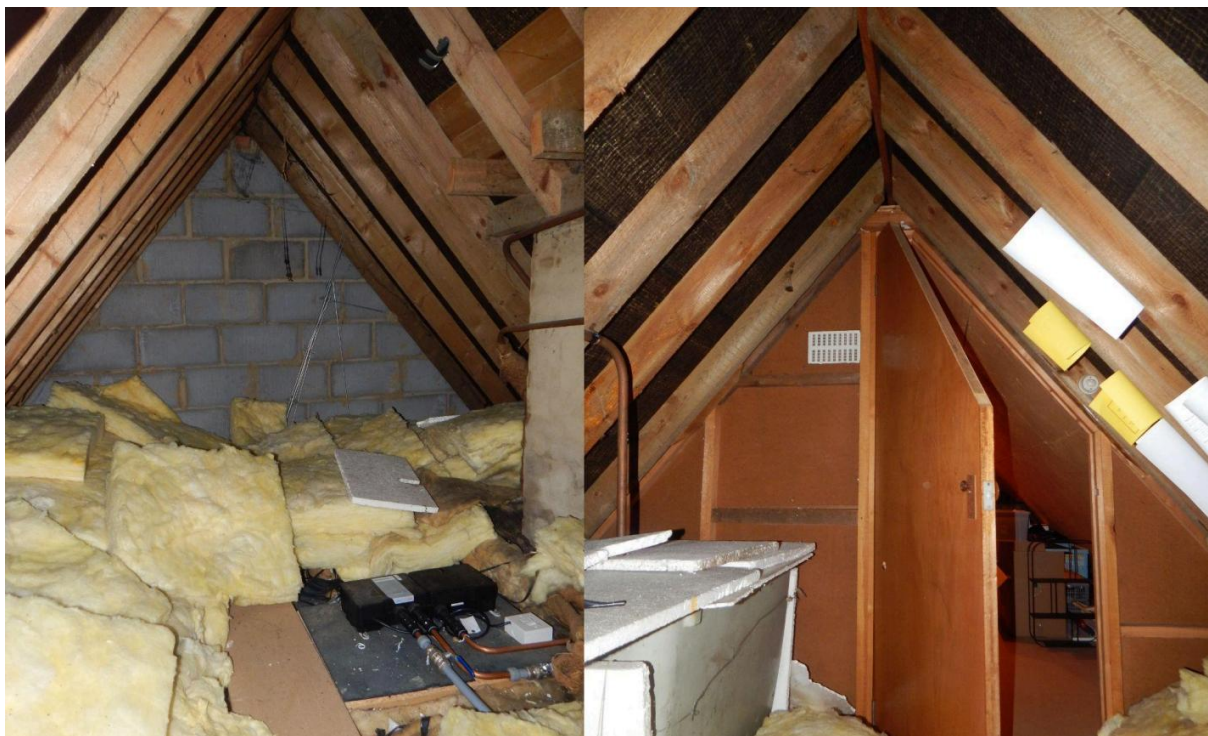
| Internal | Features of value to bats | Notes |
|---|---|---|
| Membrane coverings | Yes | Felt membrane coverings observed below the roof coverings. |
| Daylight/gaps internally | No | No areas of protruding daylight observed within the roof void spaces. |

Image 8 – Internal views from within the accessible roof void spaces of the property

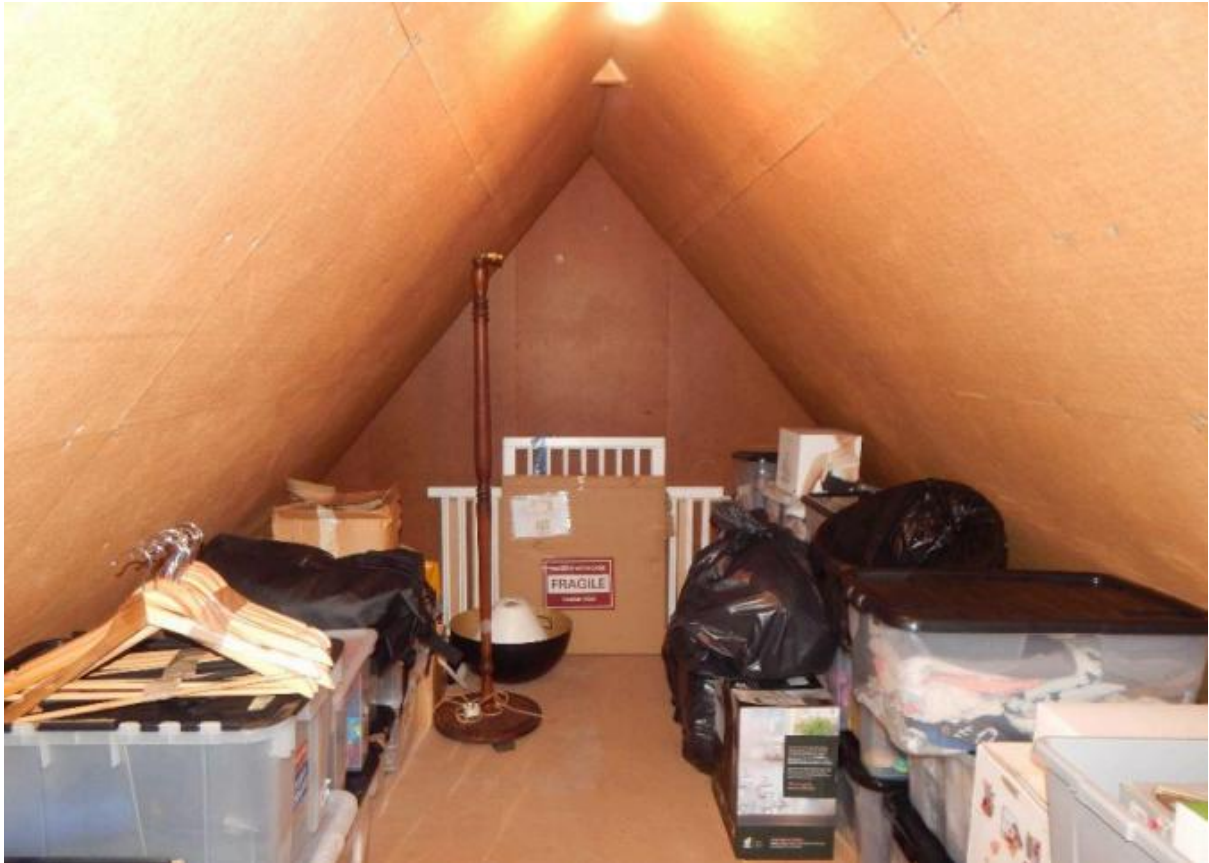
Image 9 – Internal view within the vaulted section of the property

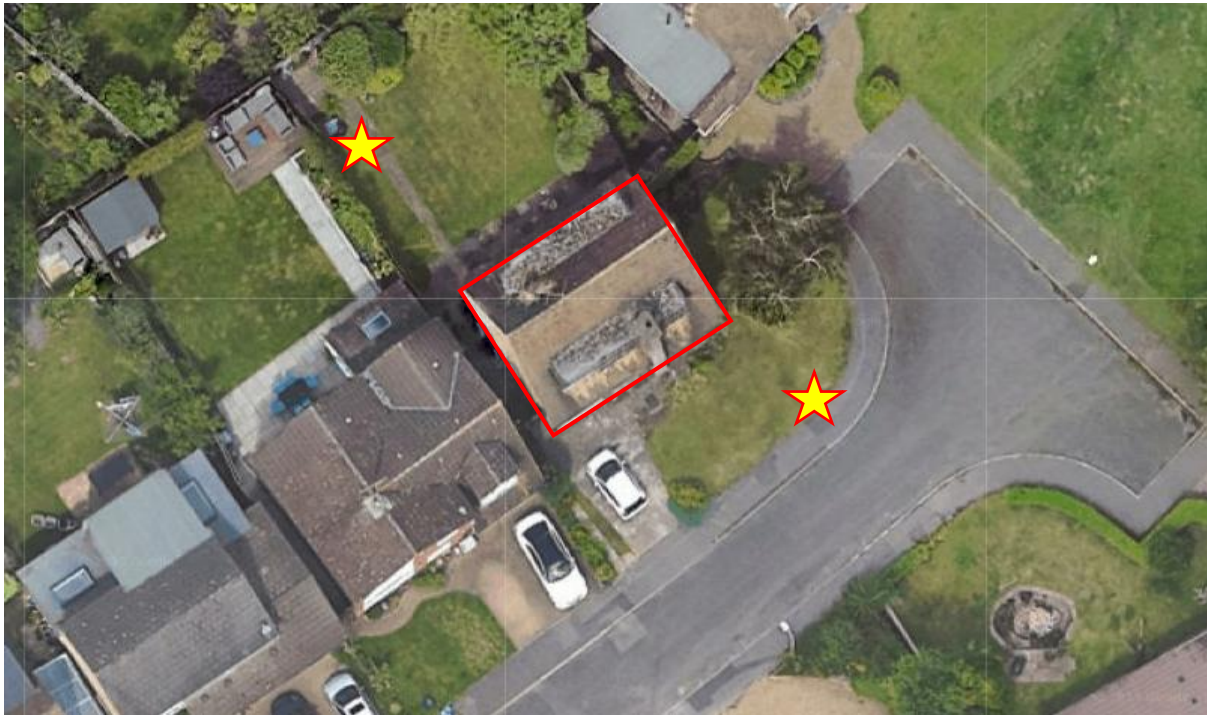
#### Appendix 4: Emergence Survey Location Points

Below site view to show suitable surveyor location points during each emergence survey to maintain visibility of the property.

In line with best practice survey guidelines, a total of two surveyors will be required to visually cover all elevations of the structure during each emergence survey.
