# **BS5837:2012 ARBORICULTURAL METHOD STATEMENT**

THE LAWNS, REDLODGE & THE RANGE,  
OLD BATH ROAD, SONNING, READING,  
BERKSHIRE, RG4 6TQ

ARLINGTON RETIREMENT LIFESTYLES

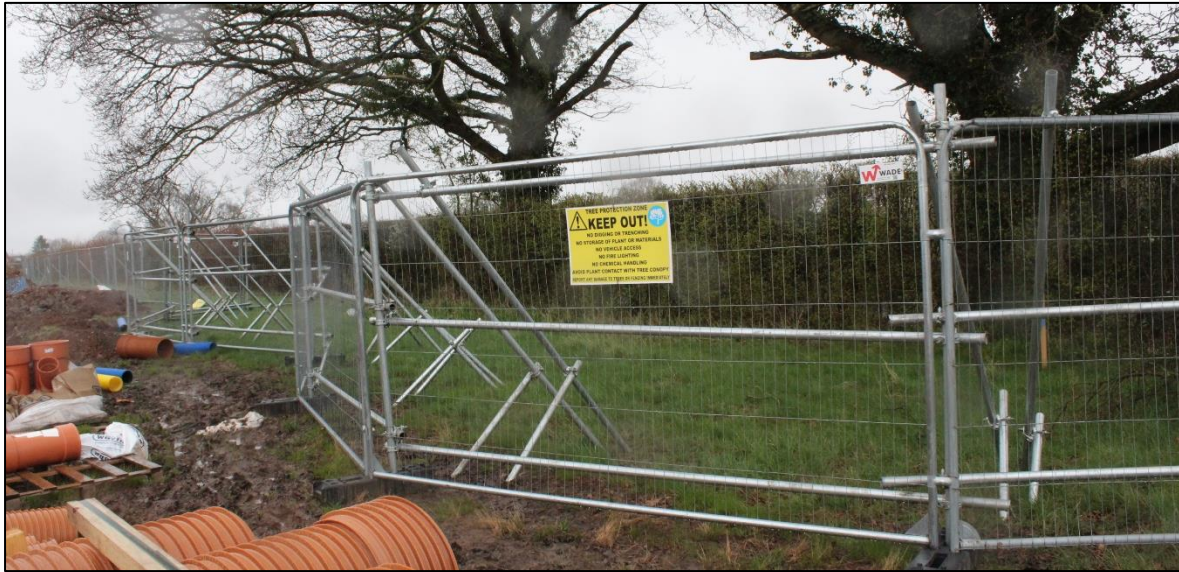
**Plate 1:** An example of the default tree protection fencing specification.

A **vertical and horizontal scaffold framework**, well braced to resist impacts. The vertical tubes will be spaced at a maximum interval of 3m and driven securely into the ground. Onto this framework, **welded mesh panels should be securely fixed**. Fence panels will be joined together using a **minimum of two anti-tamper couplers**, installed so that can only be removed from inside (tree side) the fence.

Two specifications of tree protection fencing have been included for this site. The default specification (Plate 1 below) should be installed where possible. This may not be possible in areas where existing hardstanding prevents scaffold poles from being driven into the ground, a risk of hitting underground services, or the tree protection fencing is set back in the RPA and scaffold poles risk causing damage to significant roots. In such circumstances the alternative specification (Plate 2 below) will be used.

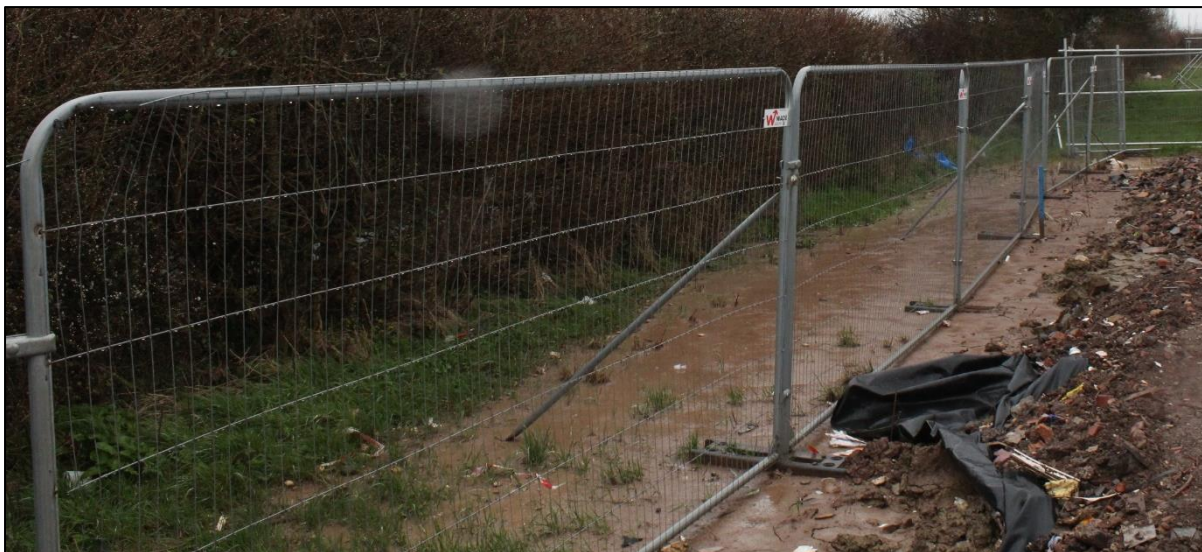
**Plate 2:** An example of the alternative tree protection fencing specification.

The tree protection fencing will comprise of **2 metre high welded mesh panels** on **rubber feet**. The fence panels will be joined together using a **minimum of two anti-tamper couplers**, installed so that they can only be removed from inside (tree side) the fence. The distance of the fence couplers will be at least 1 metre and should be uniform through the fence. The panels will be supported on the inner side by **stabilizer struts** (one installed every two fencing panels), which will be attached to a **base plate** secured with **ground pins**.

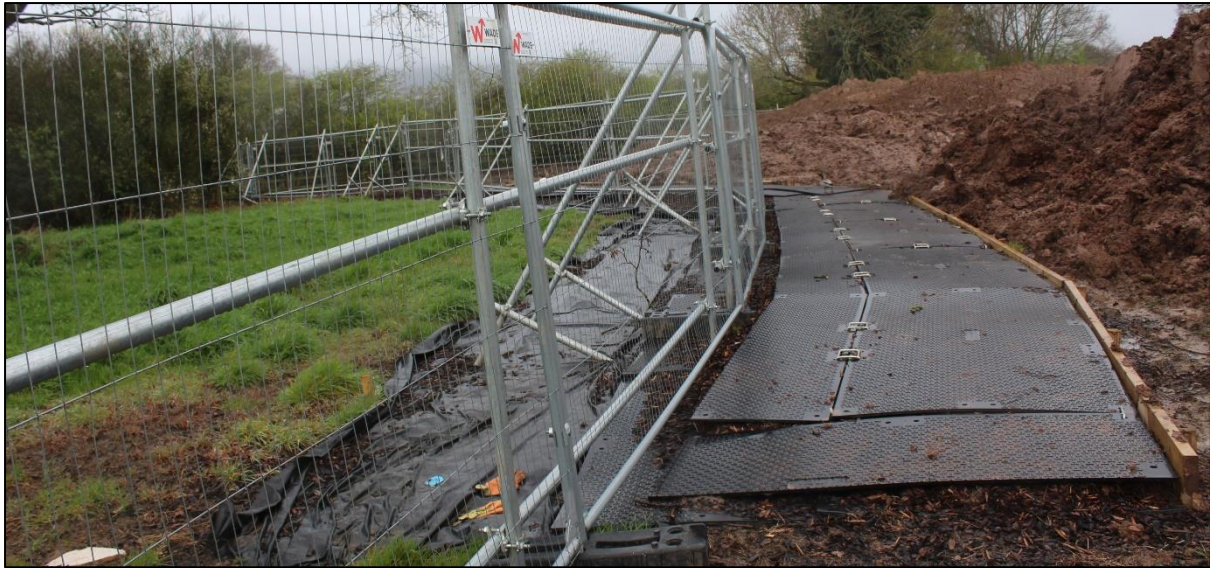
**Plate 3:** An example of temporary ground protection laid up against the tree protection fencing. This protects the RPA whilst also providing adequate space between the fencing and the development footprint.

**Pedestrian-operated plant up to a gross weight of 2t** – proprietary, inter-linked ground protection boards placed on top of a compression-resistant layer (e.g. 150mm depth of woodchip), laid onto a geotextile membrane (Plate 3).

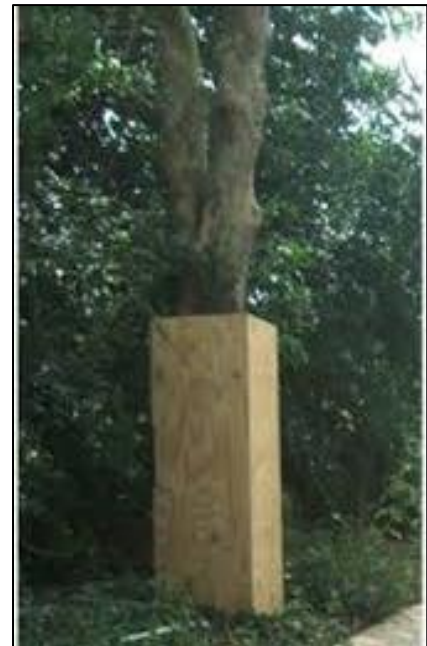
**Plate 4:** Example of plywood hoarding used as tree protection. ©Google.

The plywood hoarding should be securely attached onto a lightweight timber frame that is secured to the ground. The frame will be installed around the stem, maintaining a gap between the stem and the plywood hoarding. The plywood hoarding will be a minimum of 2.5m high. No materials will be attached/nailed to the tree.

With the demolition works being in close proximity to T82 there is a risk of damage being caused by pedestrian operated plant movement. Solid (e.g. plywood hoarding) tree protective stem boxes will be installed around T82's stem to prevent damage being caused by pedestrian operated plant movement.
